S M -120  
RIVER VIEW  
Oakley  
Private

**NATIONAL REGISTER OF HISTORIC PLACES  
INVENTORY -- NOMINATION FORM**

River View

Old House on Oanoe Neck Creek, Mary's County, Md.

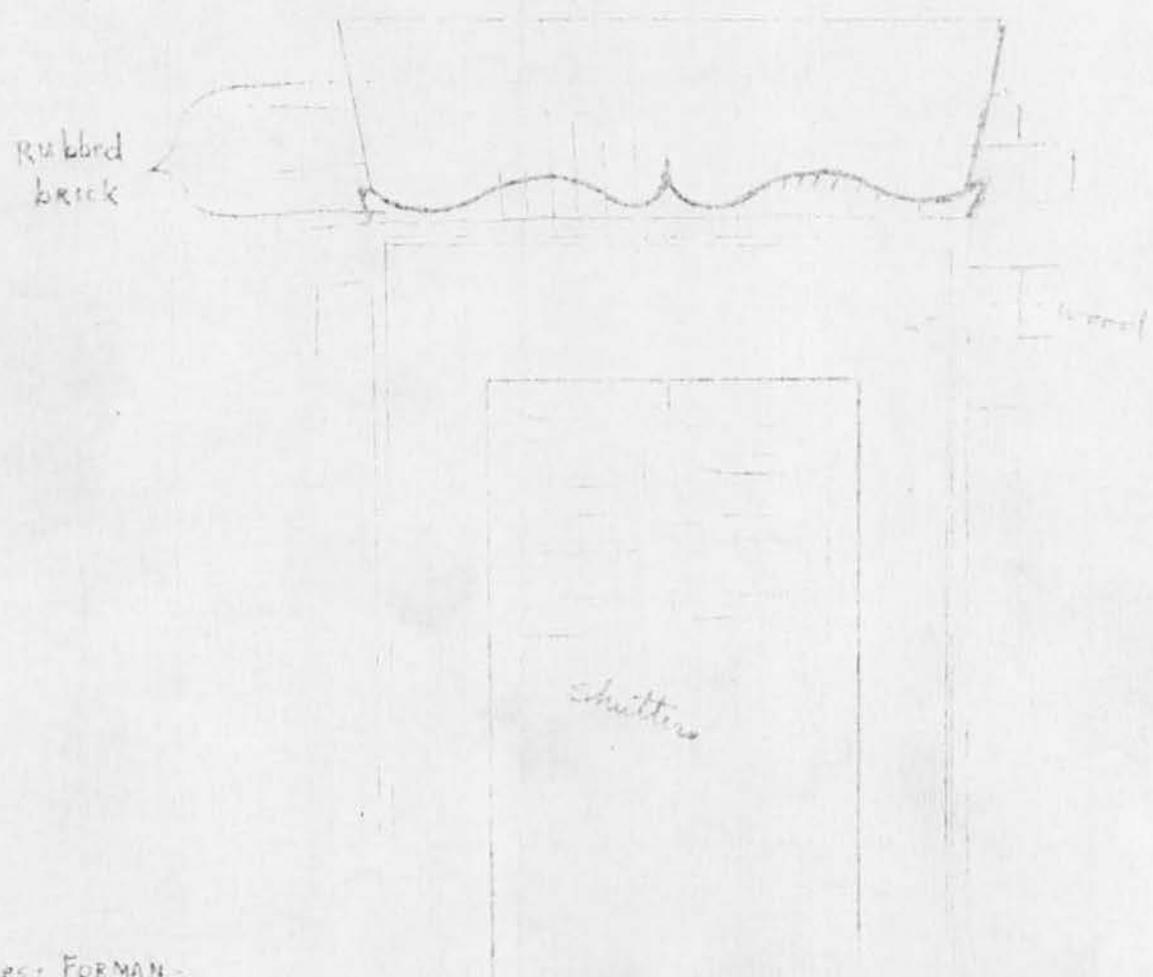
curvilinear windows: heads of carved brick on land front  
(windows on river front appear to be the same but are covered by present porch roof.)

This is similar to Holly Hill (#176 p.131) except that the curves do not touch the wood of the window frame, and are shallower. Also, the ends rise up and extend slightly beyond the rubbed brick. The depressions are about an inch deep and the same rubbed brick extends down to the woodwork. The flat woodwork is very wide around all the windows.

② - The glass in the double hung sash that can be seen is very bumpy and discolored.

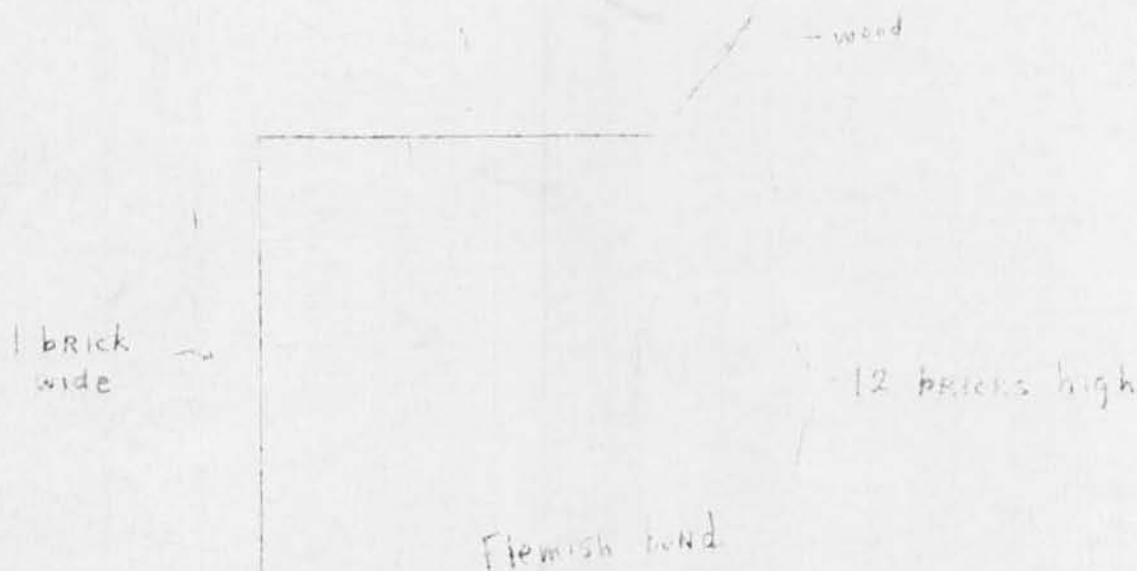
corbeled parapets at the eaves on the land side  
(#51 p.45)

These projections are very striking from the side view. Somehow, the end board of the cornice sticks out and shows.

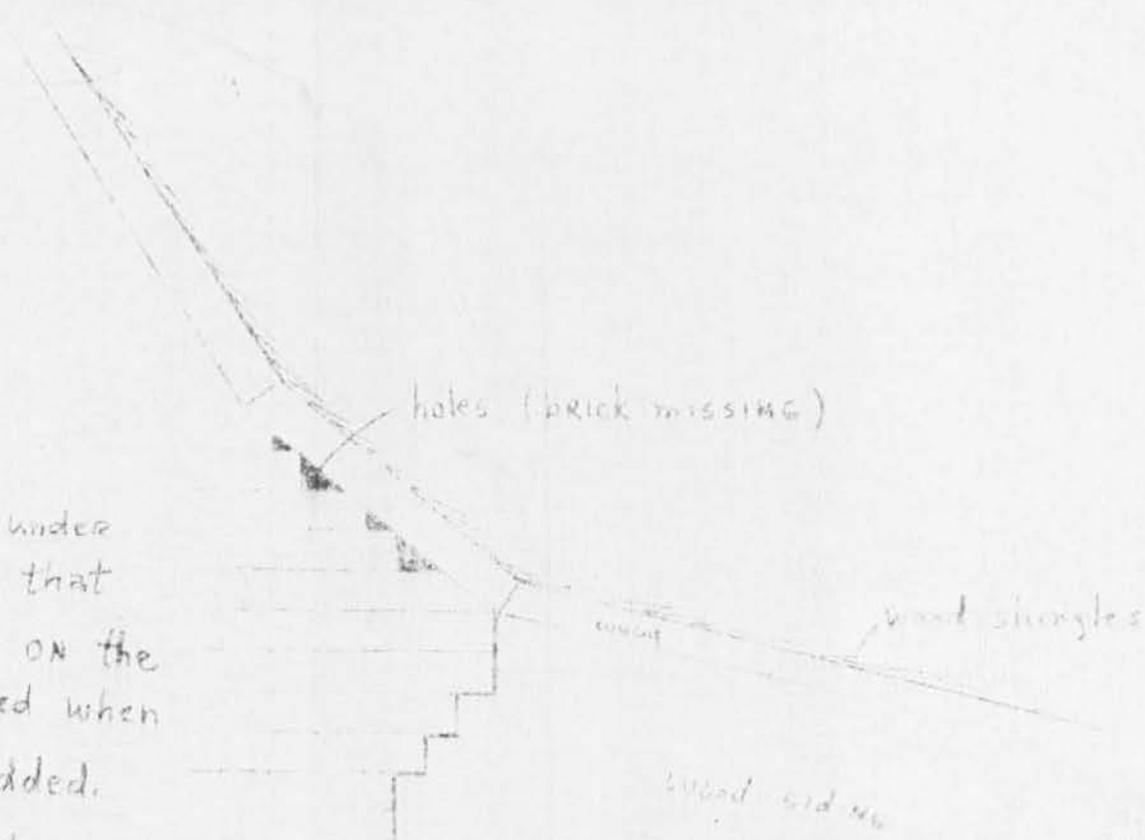
(4) The eaves on the RIVER side are splayed and the brick under them is corbeled.

The missing brick under the splay suggests that arapets like those on the north were removed when the porch was added.

There is no similar deterioration (?) along the steeper parts of the gables.

The splay is a sort of bridge that makes the main roof continuous with the porch roof (I think the splay is larger than I have shown.)

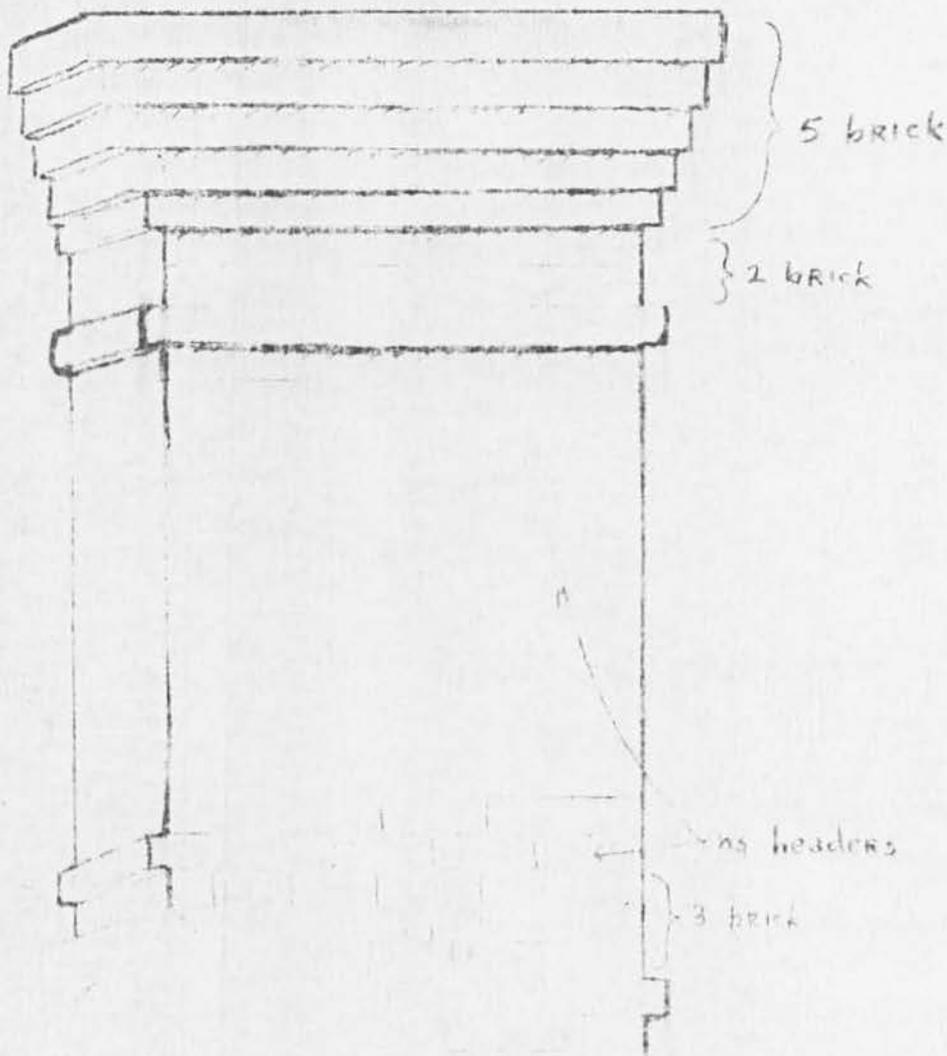
Chimneys (identical on each end).

lemish bond

glazed headers

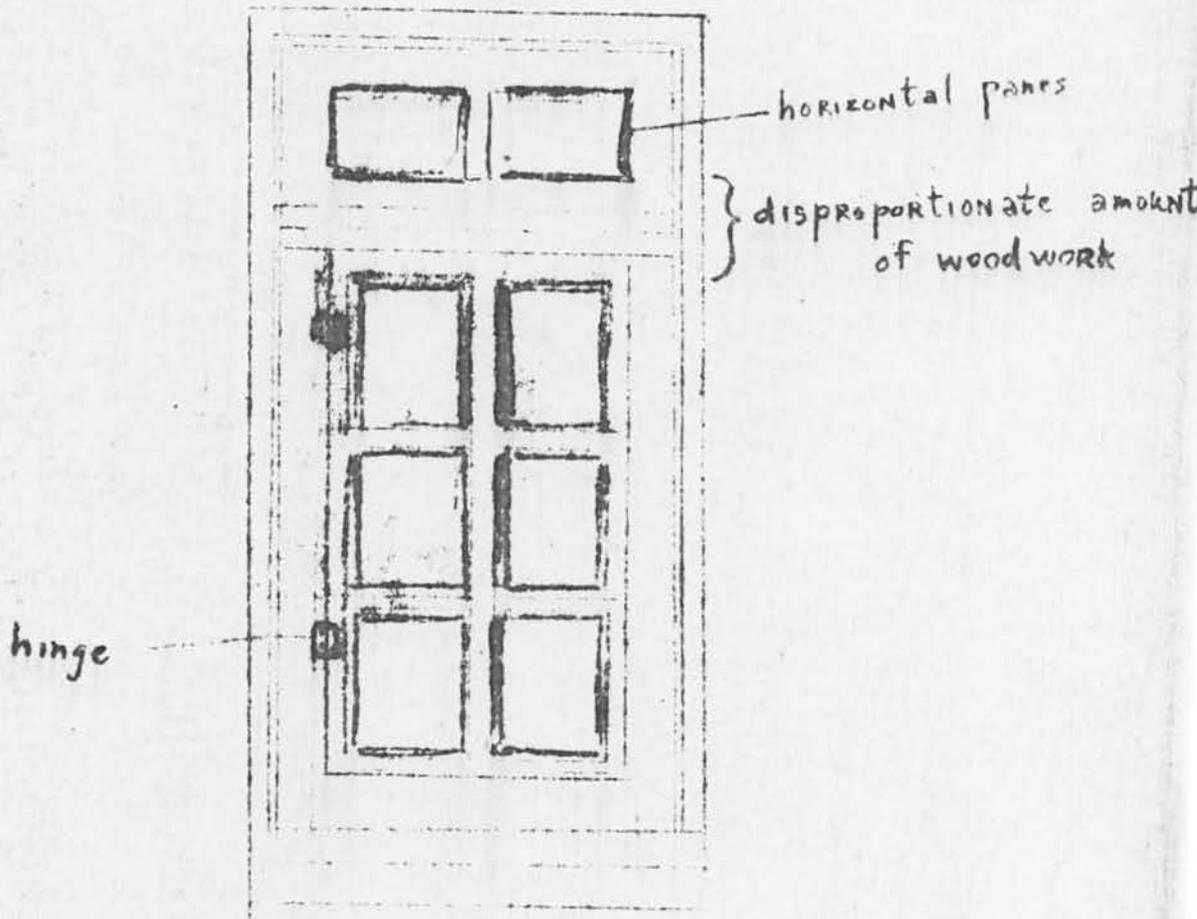
⑥  
 3 small gable windows (very rough sketch)

(The top part looked like a TRANSOM, but I couldn't tell if it is hinged. I couldn't make out the detail of the HINGES. The effect of these little windows is quite odd. They suggest a medieval window made over to sash.)

All windows seem to have wood sills.

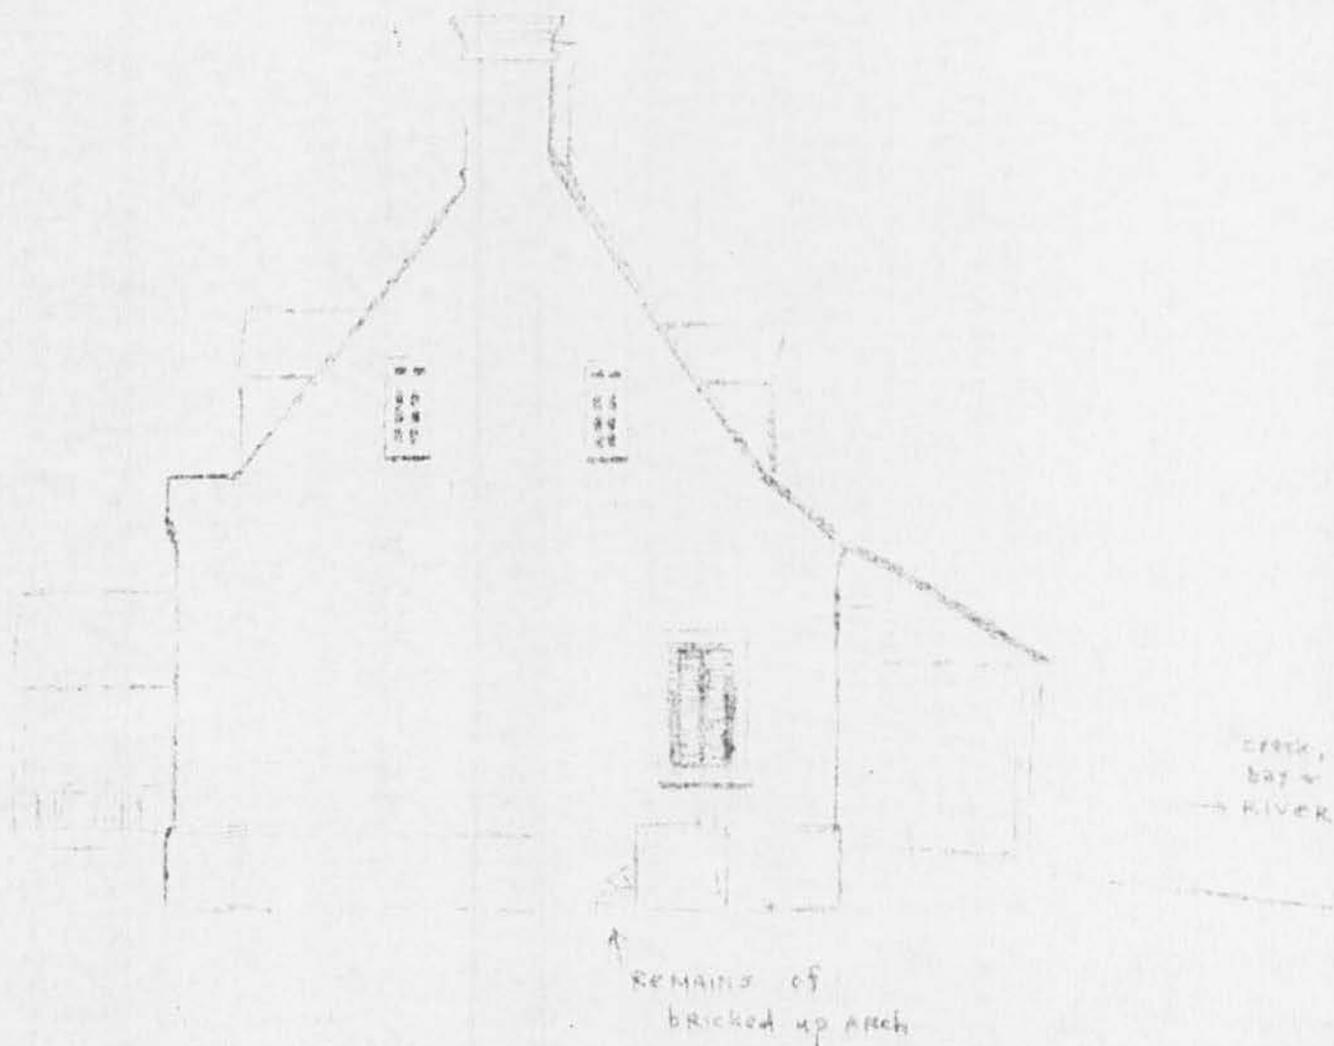
Free sketch of Gable end

(ON the opposite GABLE end extend three attached, low, extremely narrow shutters of wood.

New shutters on the first floor window seen in this end seem to conceal the wide woodwork (?). Also, this window lacks the curvilinear rubbed brick head. Headers on this end do not seem to be glazed as on opposite end.
