MATTAPANY
Lexington Park

Patuxent River Naval Air Station

Maryland Historical Trust State Historic Sites Inventory Form

historic Mattapany (preferred)

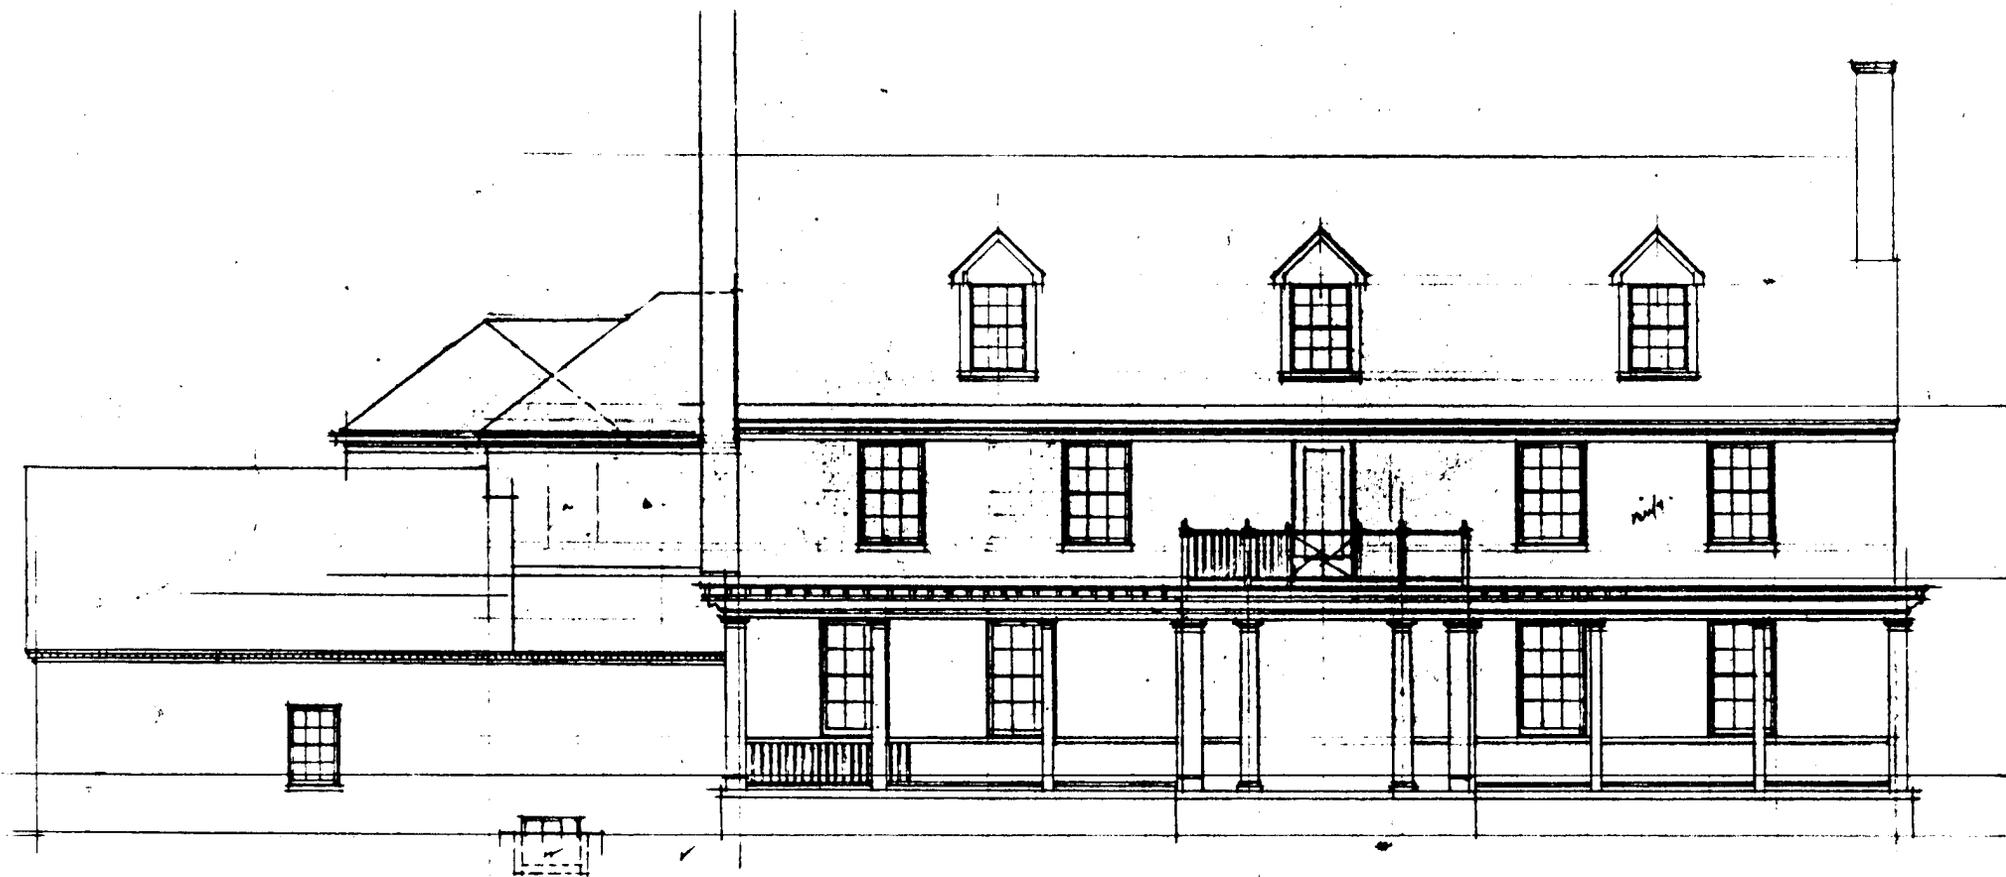
WATER FRONT ELEVATION. (NORTH)
Scale 1/4" = 1'-0"

The north facade, facing the Patuxent River, exhibits a one-story columned porch running its length, a centrally-placed double door (with side lights and fan light) and three regularly-spaced dormers. The fenestration is generally regular, but two first-floor windows east of the door do not align either with those on the second floor above or with those on the south facade. All the windows are 6-over-6 double-hung sash (Figure 1). The brickwork is completely covered with stucco.

The wing consists of an irregularly-shaped two-story kitchen/living space and one-story garage. The two-story section is of English bond, the garage of Flemish bond (Figures 1, 3, and, 4).

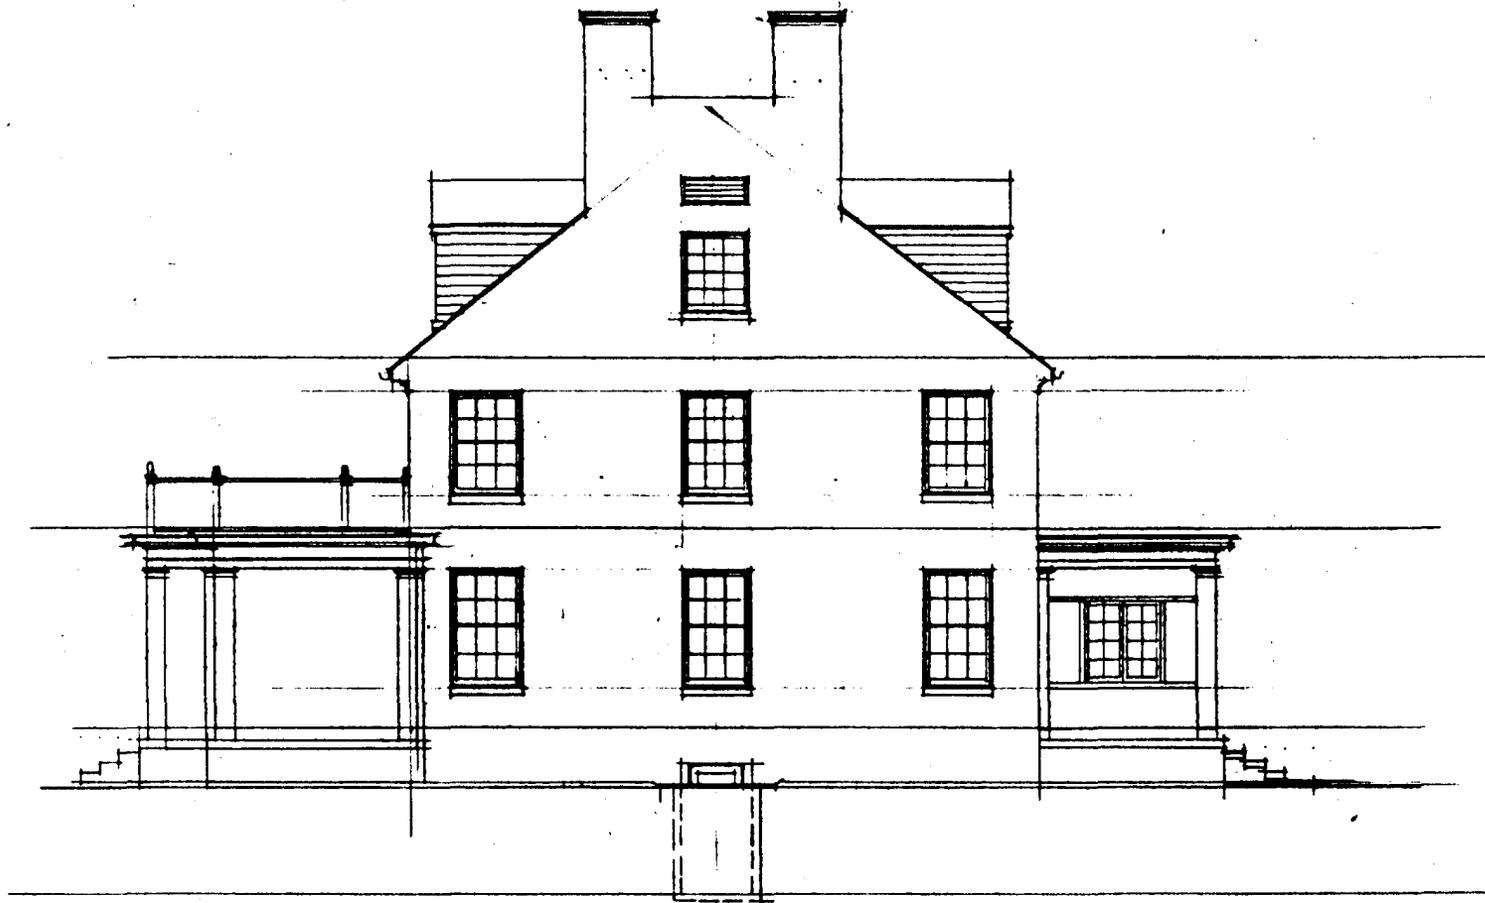
END ELEVATION (WEST)
Scale 1/8" = 1'-0"

The west gable exhibits three 6-over-6 sash windows, regularly spaced on each of the first two floors, with a smaller 6-over-6 window centrally placed on the top floor. The two brick chimneys are flush with the gable wall. A below-grade walk-in basement entrance is also centrally located. Stucco does not cover the brickwork on this facade, revealing it to be of English bond (Figure 2).

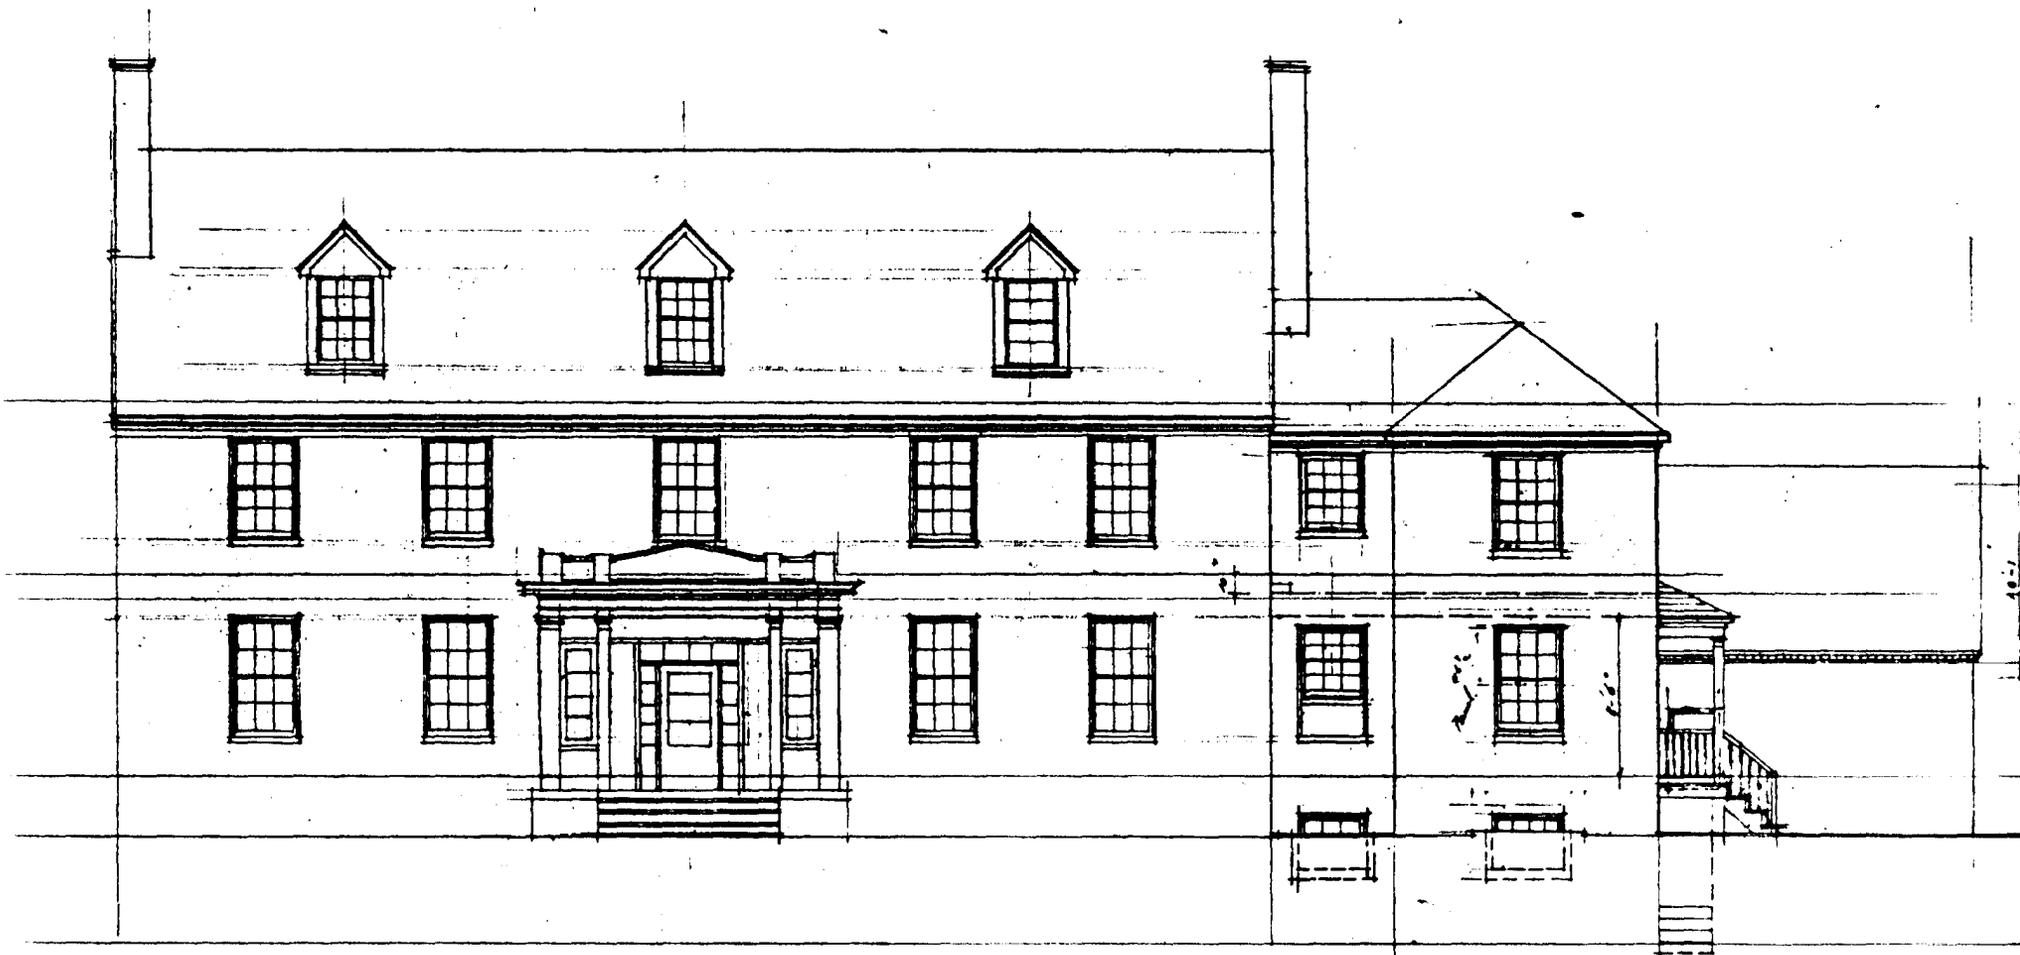
INSHORE ELEVATION (SOUTH)
Scale 1/8"=1'-0"

The south facade differs from the north in that the porch does not extend the entire length but instead only encloses the centrally-placed doorway, serving as an enclosed vestibule. The double door is flanked by side lights and a fanlight. The fenestration is regular (all 6-over-6 sash); stucco covers the brickwork (Figure 3).

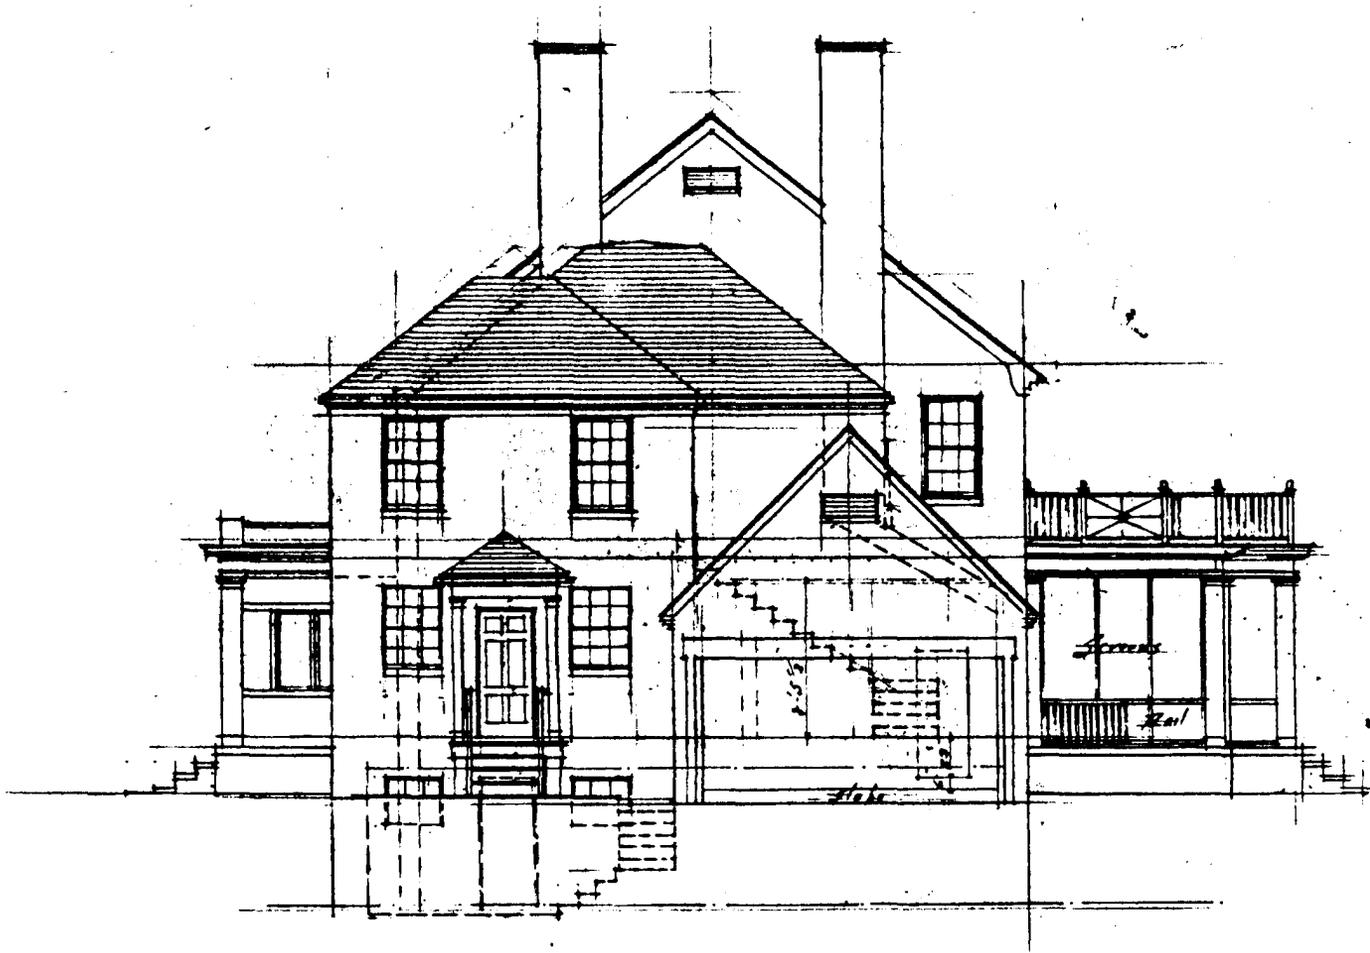
Fig. 4

The east gable is almost completely obscured by a complex, multi-component brick wing. What can be observed is that the double end chimneys on this side extend beyond the gable wall, and also are farther apart than the west gable pair. One second-floor 6-over-6 sash window remains uncovered (Figure 4).

END ELEVATION (EAST)

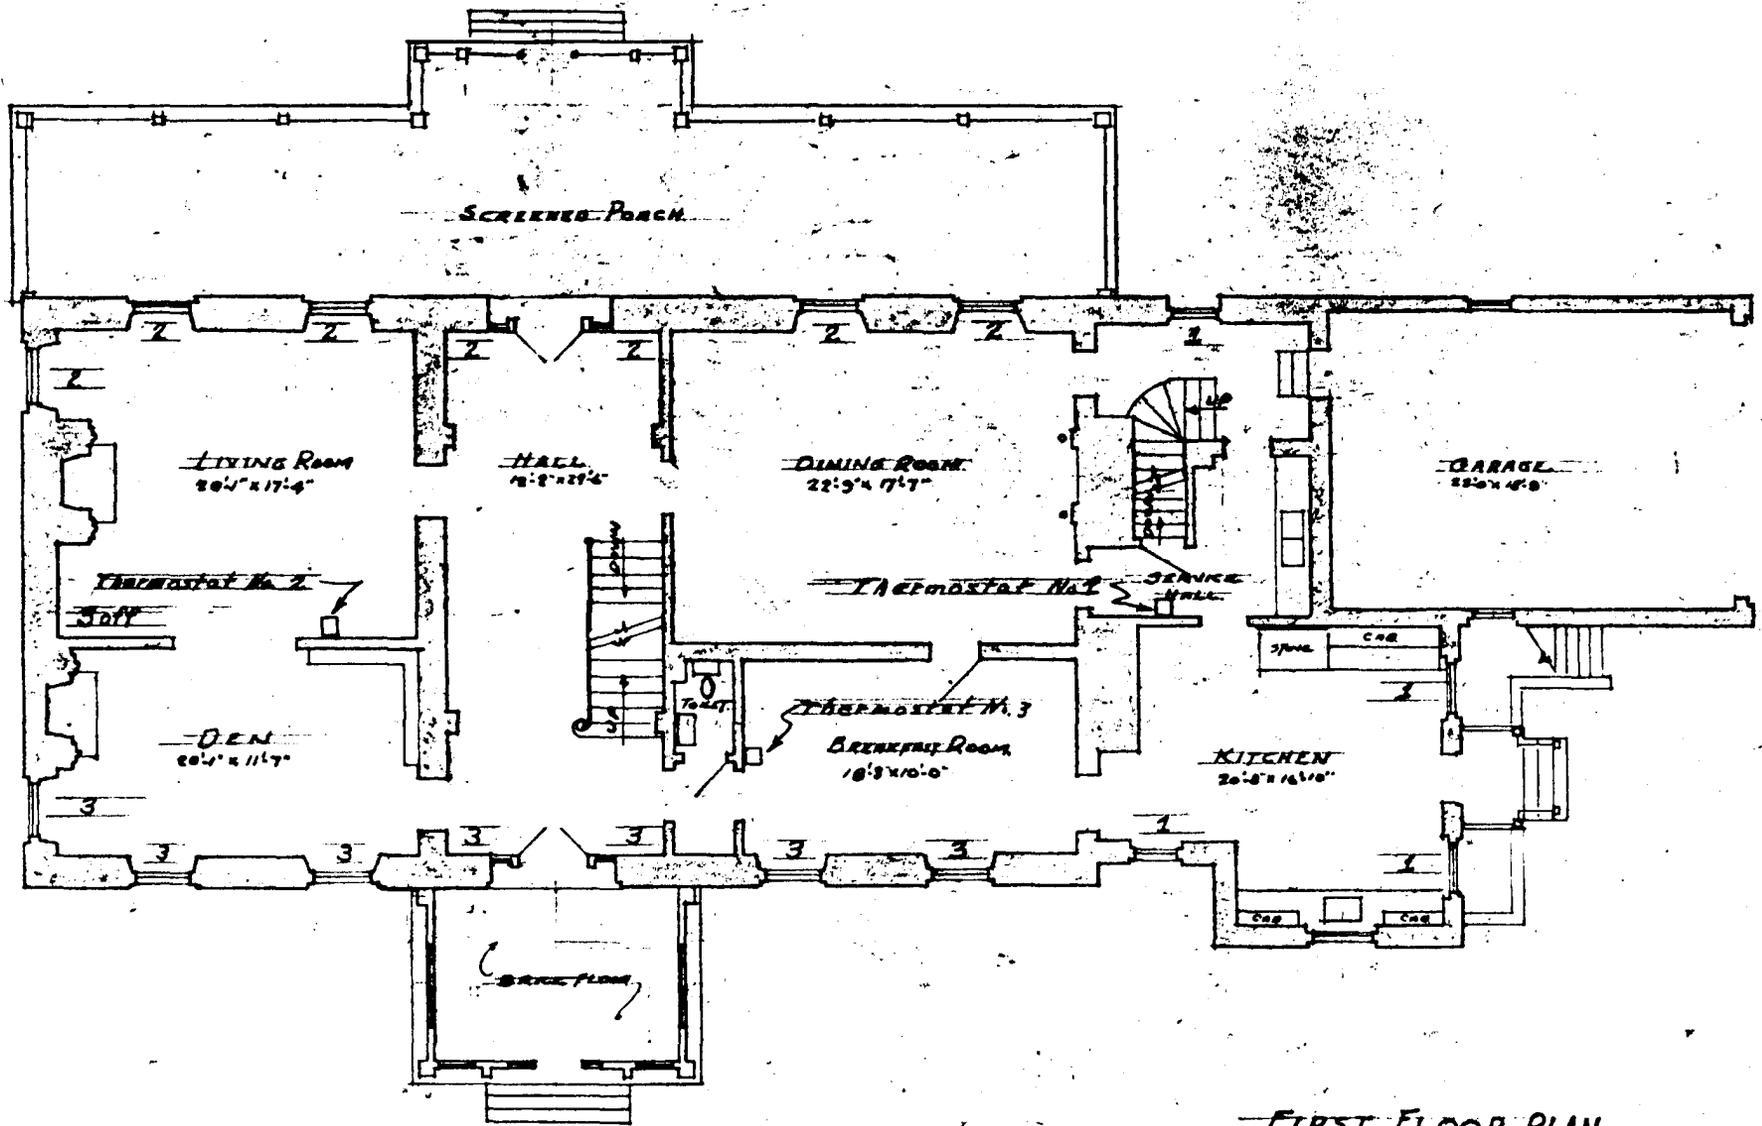
FIG. 5

The interior plan (excepting the wing) is generally regular, with a central cross passage/hall and four flanking rooms on each floor. The entranceway double doors are panelled with a single vertical panel with raised pyramidal panel and flattened ogee panel mold. Numerous other doors in the house are six-panel with Greek ogee panel molds, plain square section raised panel. Most architrave trim is rich ogee/astrayal backboard, beaded frame.

The wide, spacious passage has two arches supported by panelled pilasters with Greek details. A wide open-strung stair is situated against the east wall and rises in a straight run. The newel posts ^{are} turned walnut; the balusters are painted; the rail is molded walnut. The flooring and treads are new.

FIRST FLOOR PLAN
Scale 1/8" = 1'-0"

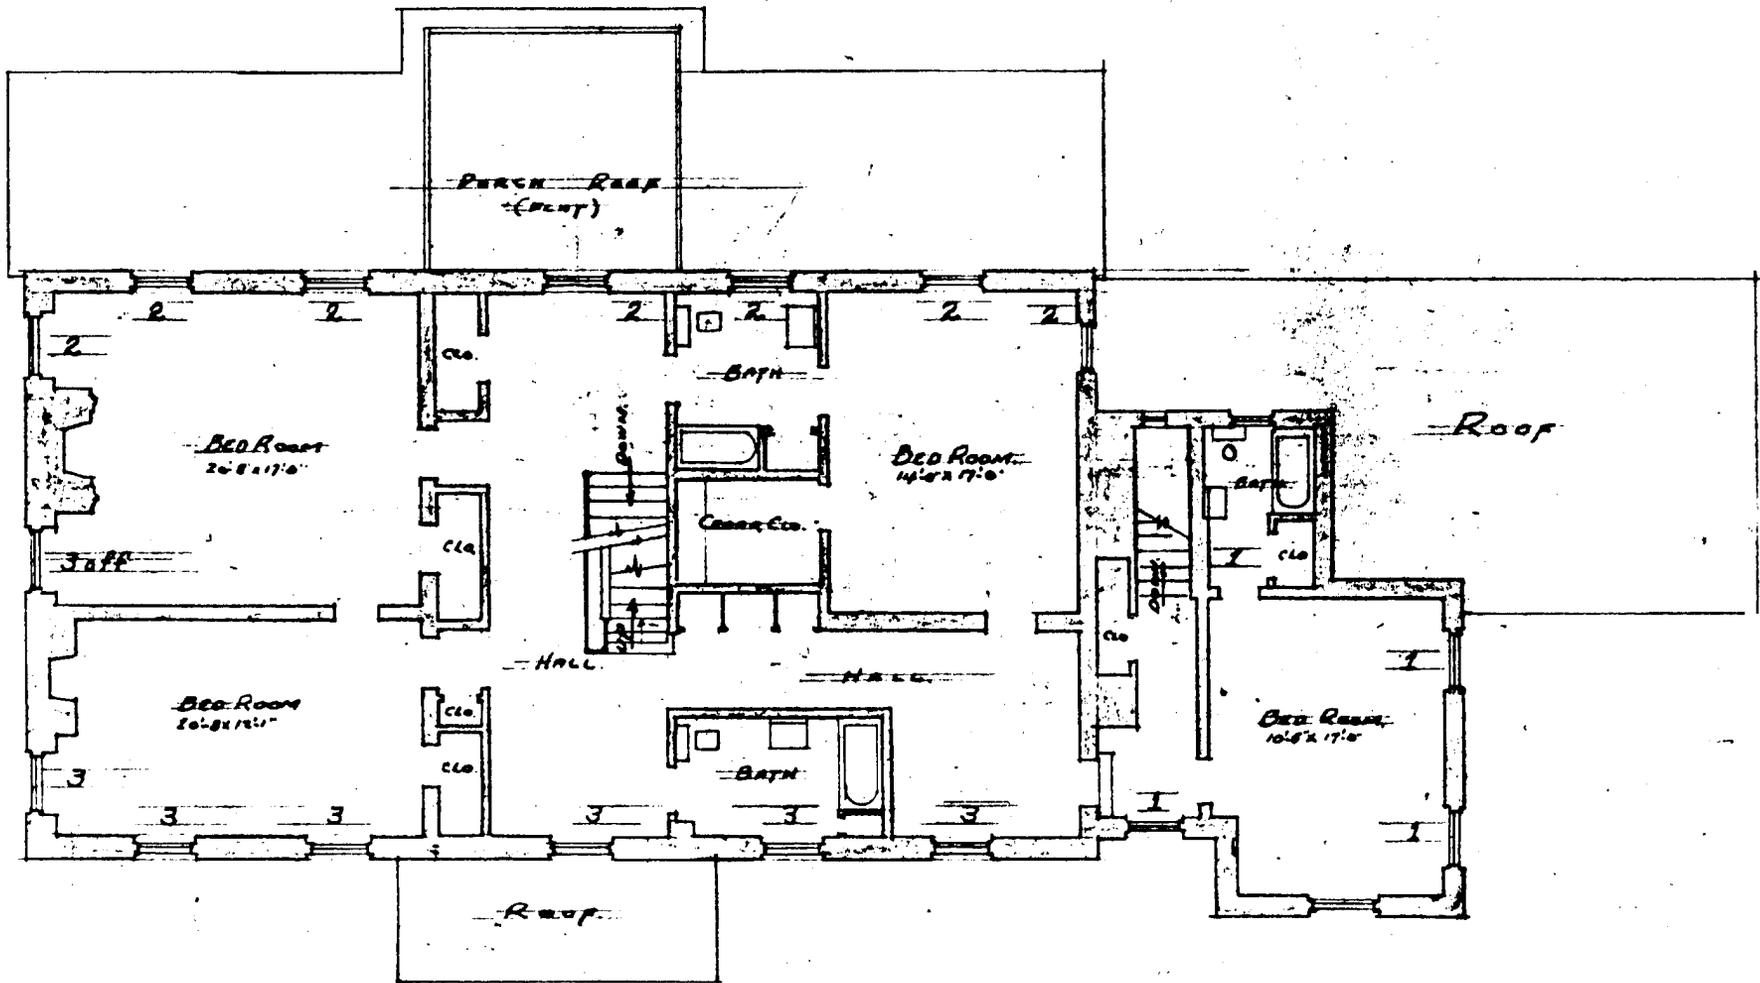
FIG. C

The second floor also has four chambers, all with numerous closets with 19th-century doors and locks, but all appear to be 20th century additions with re-used materials. The third floor, wing, and full basement have all been completely renovated.

SECOND FLOOR PLAN
Scale 1/8" = 1'-0"

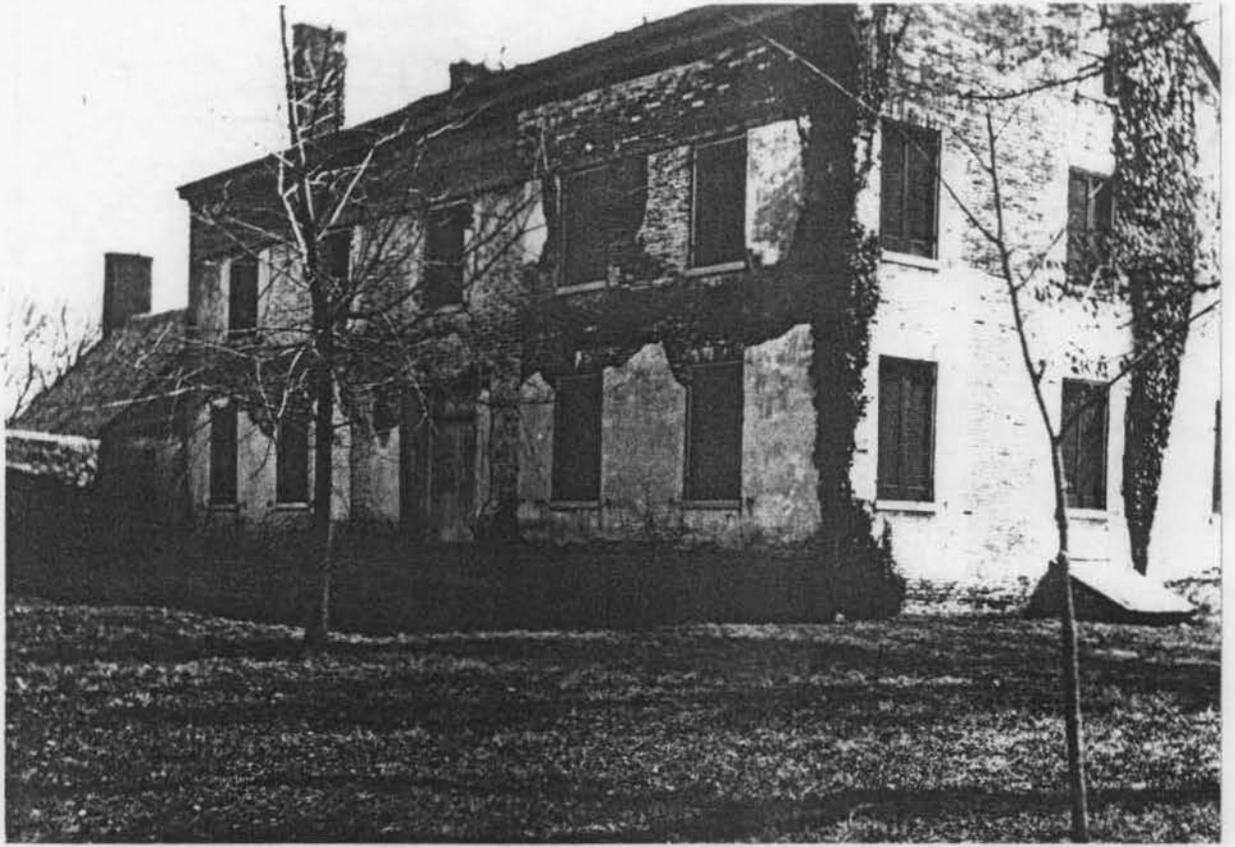
Fig. 7

Based on a combination of both documentary and photographic evidence, a sequence of several construction/alteration phases can be determined. This evidence--based largely on a series of photographs (see Figures 7-11) and two documentary sources, Thomas (1963) and Fenwick (1956)--suggests that Mattapany began as a two-story, three-bay, flemish bond dwelling with double gable-end chimneys on the east facade, with a detached one-story kitchen. That structure may date to the mid-18th century. In the mid-19th century (c. 1840s) a 2½-story addition to the west gable and the placement ^{of} parallel north-south facade doorways created a symmetrical facade that with only slight modification has remained unchanged. The detached kitchen was connected to the east gable, very possibly at the time of the construction of the addition, through an intervening two-story addition. By 1912 what appears to have been a brick garage was attached to the north facade of the wing; by 1936 that garage was removed and the old detached kitchen probably converted to a garage (its function at present). In 1941-43 the frame addition was replaced with a two-story brick kitchen. A two-story, apparently columned, porch may have been

c. 1912

added to the north facade in the 1840s; by 1912 that porch no longer existed, replaced by the present one-story porch by 1936. The roofline on the north facade was several feet higher than that of the south, apparently as a consequence of the two-story porch there; the roof was lowered to the level of the south facade by 1947.

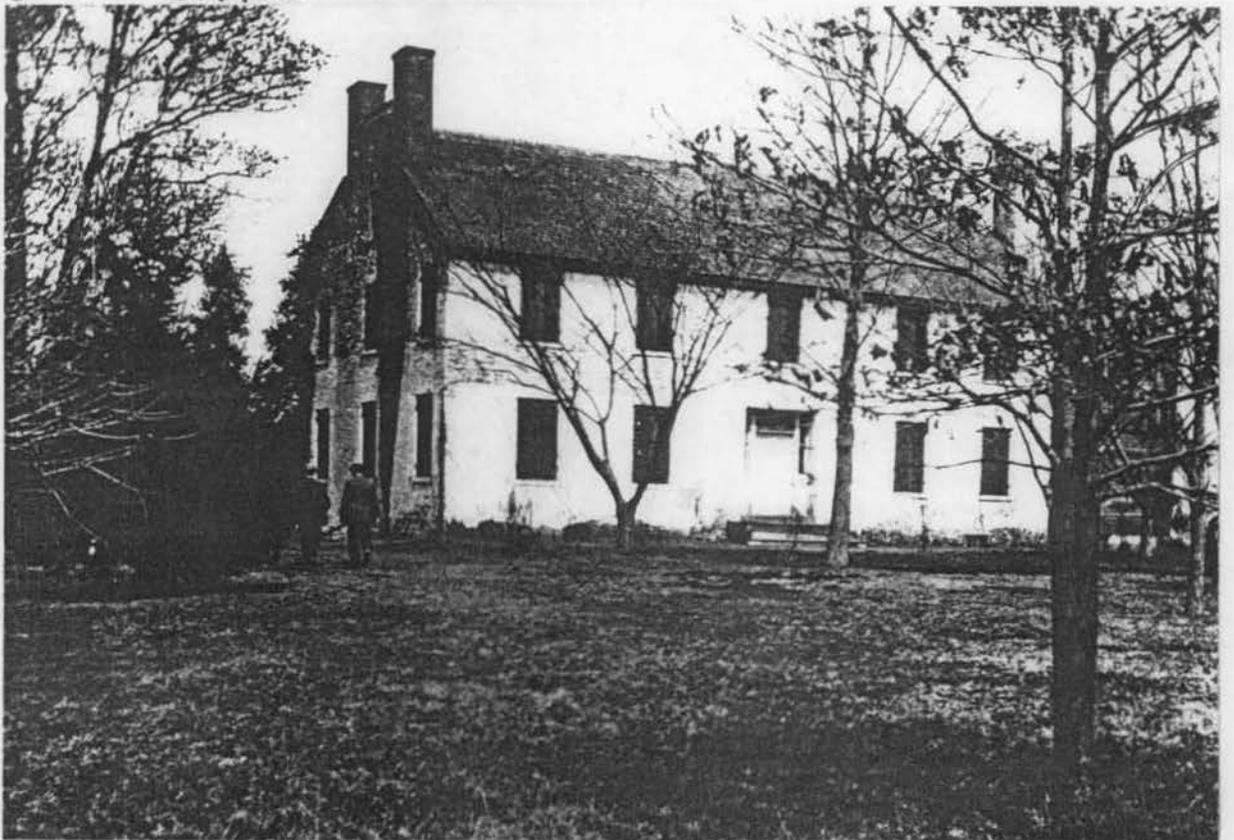
Fig. 8

c. 1912

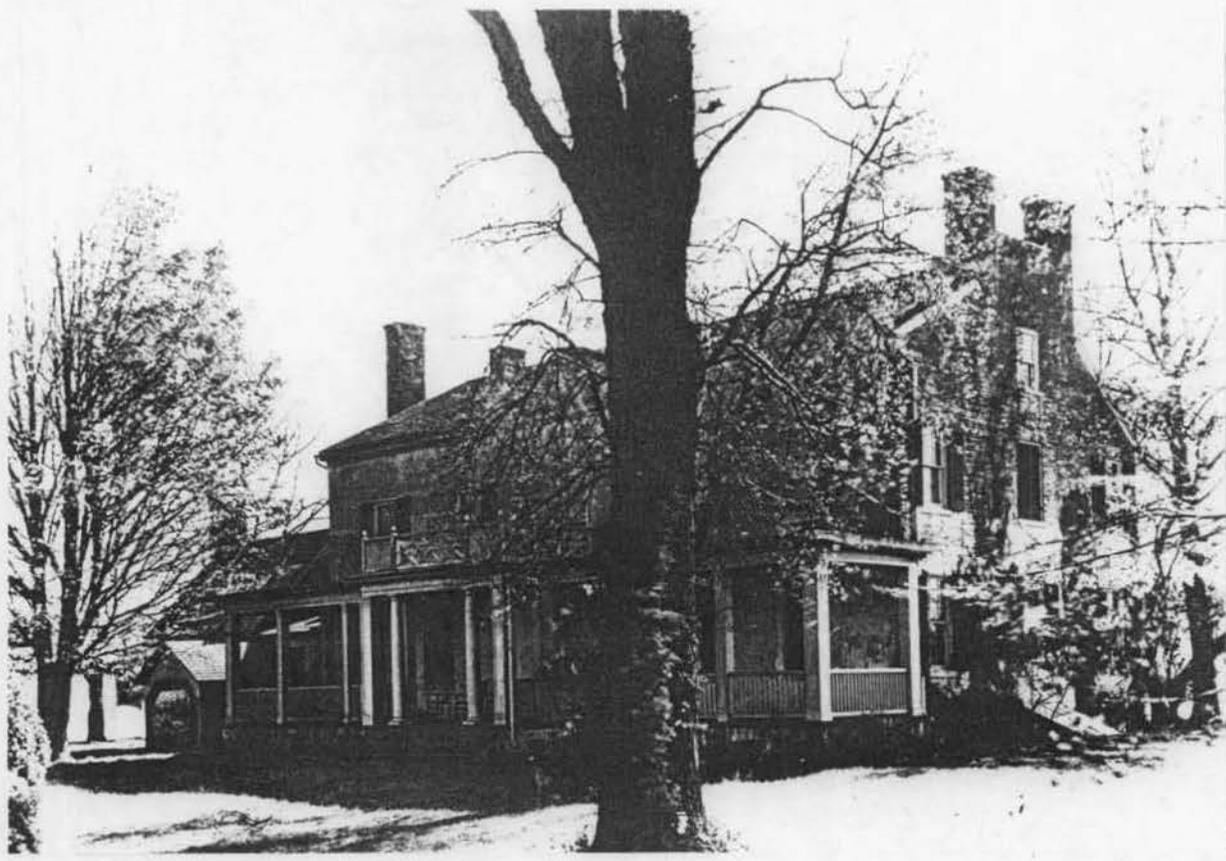
FIG. 9

1936

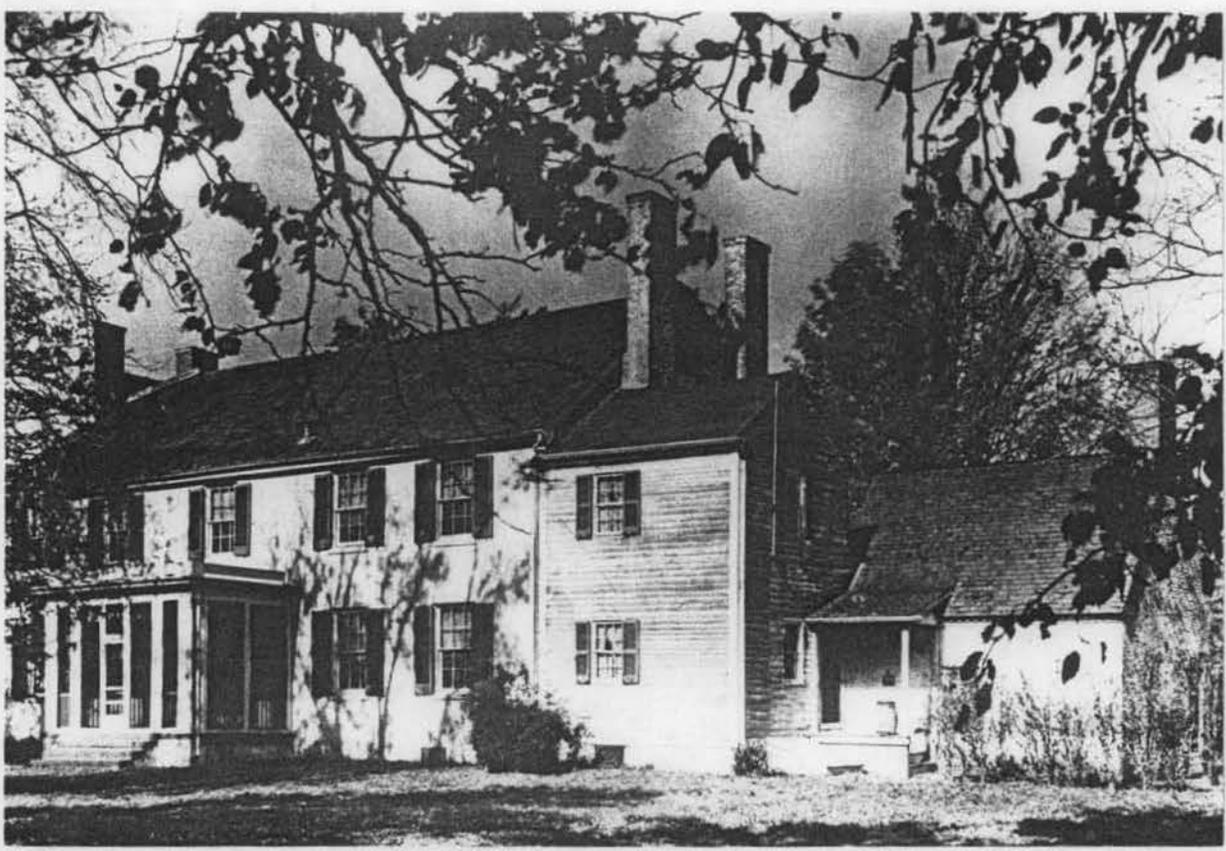
FIG. 10

1936

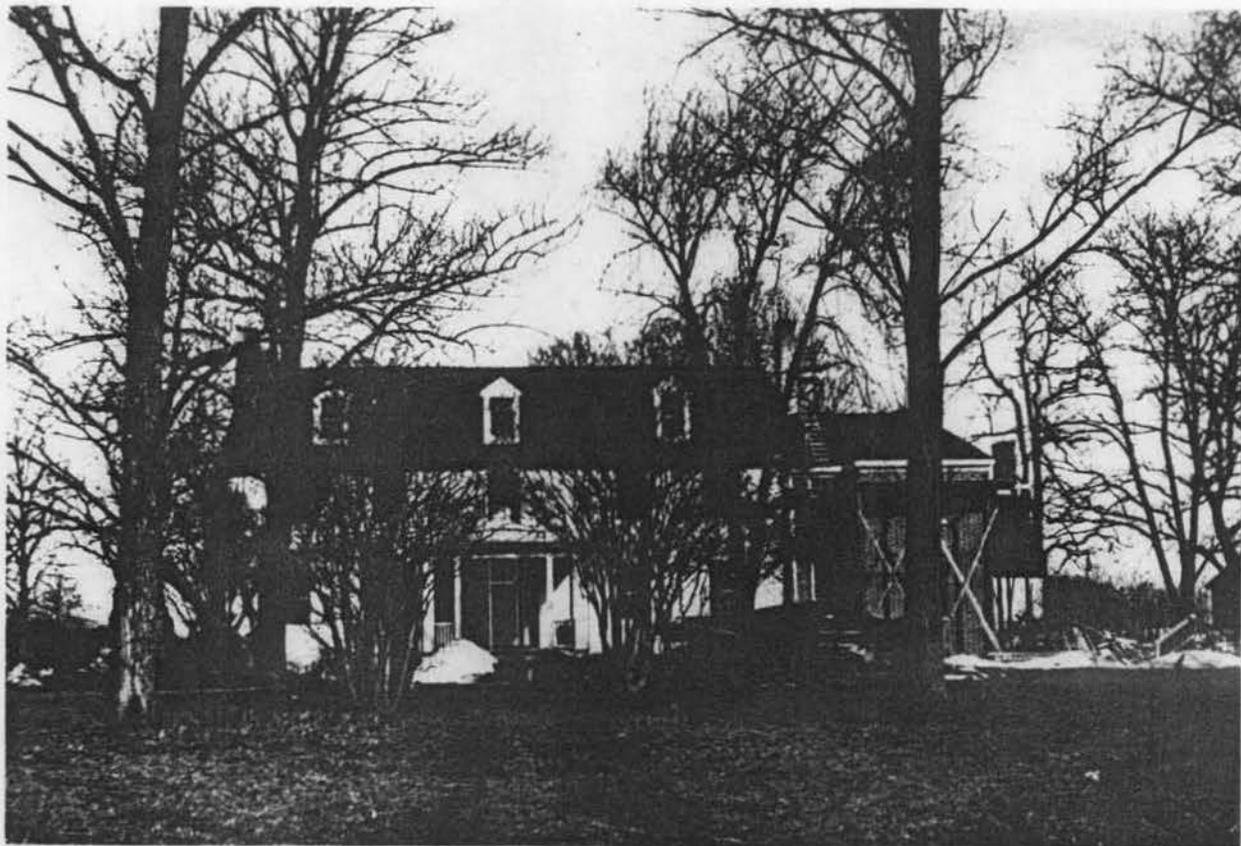
FIG. 11

1942
