Maryland Historical Trust

State Historic Sites Inventory Form

historic Ridgell House

Survey No. SM-364

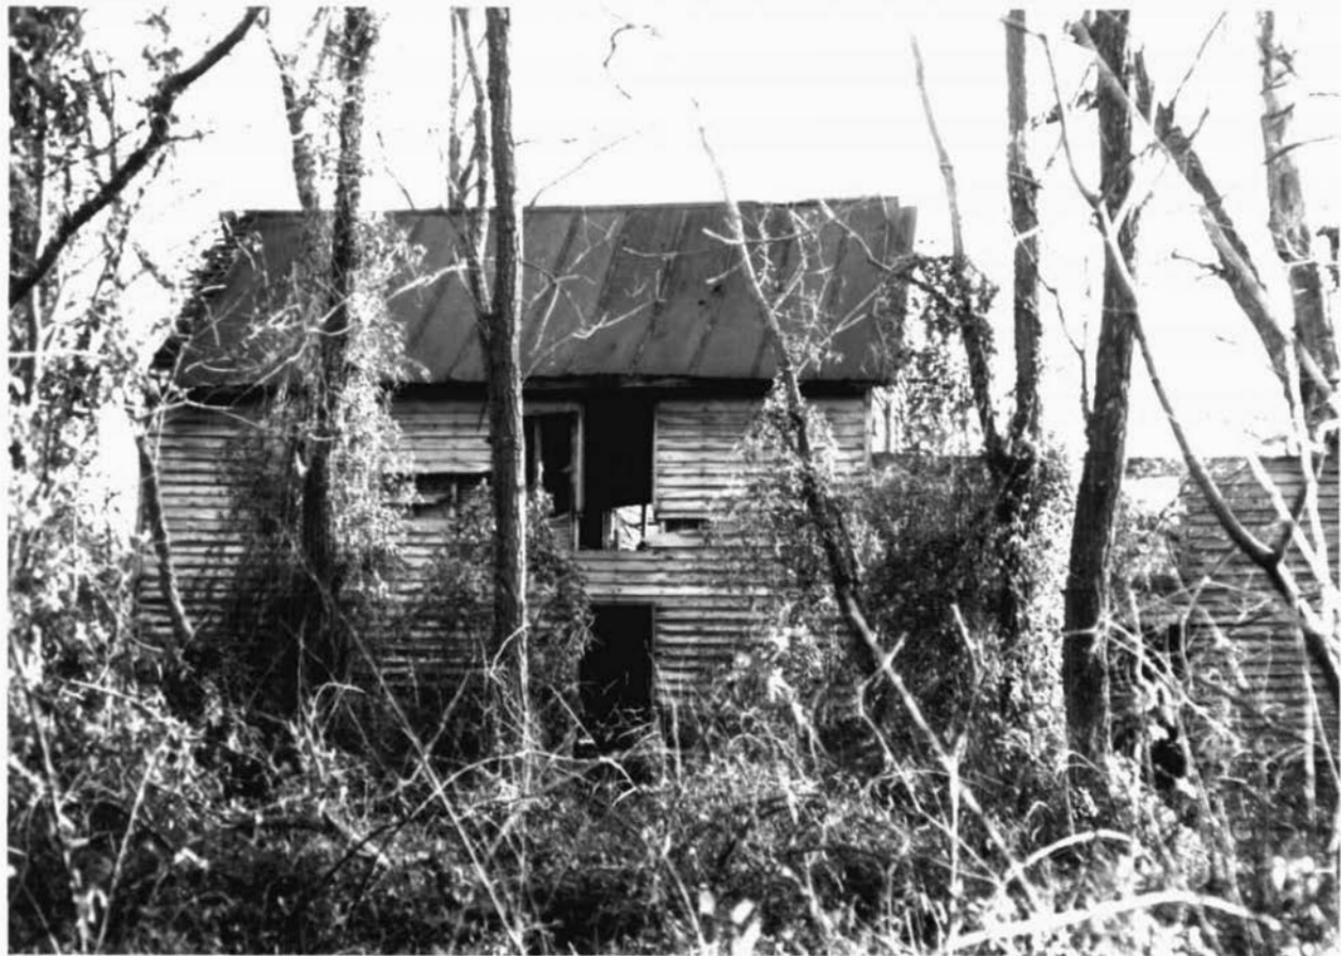
Ridgell House (Elms Property) SM-364
St Marys County, Md
Susanne Moore
Jan 1983
Md Historical Trust, Annapolis, MD
North elevation
2/6

The north facade of the house is two bays wide, with a door in the east bay and an altered window opening on the west. There are two window openings on the second story.

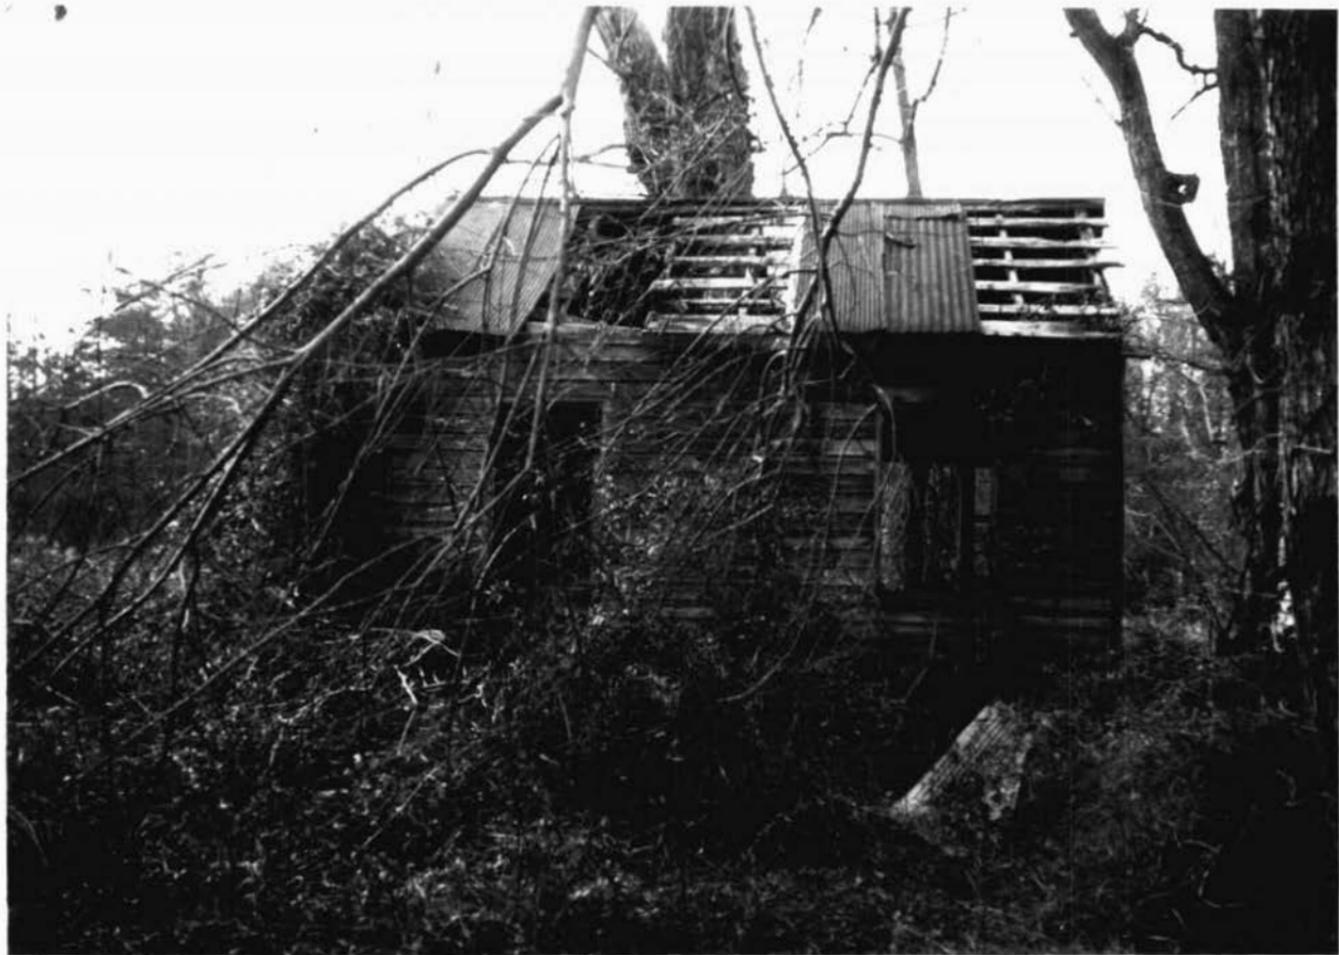
Ridgell House (Elms Property) SM- 364
St. Marys County, MD
Susanne Moore
Jan 1983
Md Historical Trust, Annapolis, MD
East elevation, kitchen/storage building
5/6

The kitchen/storage building measures approximately fourteen-and-one-half by sixteen-and-one-half feet. It is a one-story gable-roofed frame structure resting on concrete piers. A cellar with poured concrete walls underlies the center of the structure, measuring approximately ten by fifteen feet. The structure has a center doorway on its north facade. The east and west walls are identical, each containing two windows. A brick stove chimney is centered on

the south gable end and flanked by a door with a transom to the east and a small lean-to or pent closet to the west. This pent is an addition and measures four by five feet. A window in the south wall is the only opening in the pent, which is covered with plain weatherboard siding and a corrugated metal roof.
