State Historic Sites Inventory Form

historic DAVIS HOUSE

street & number East side of Old Route 5, 1000 ft. north of not for publication
Charlotte Hall School Road

Survey No. SM-371

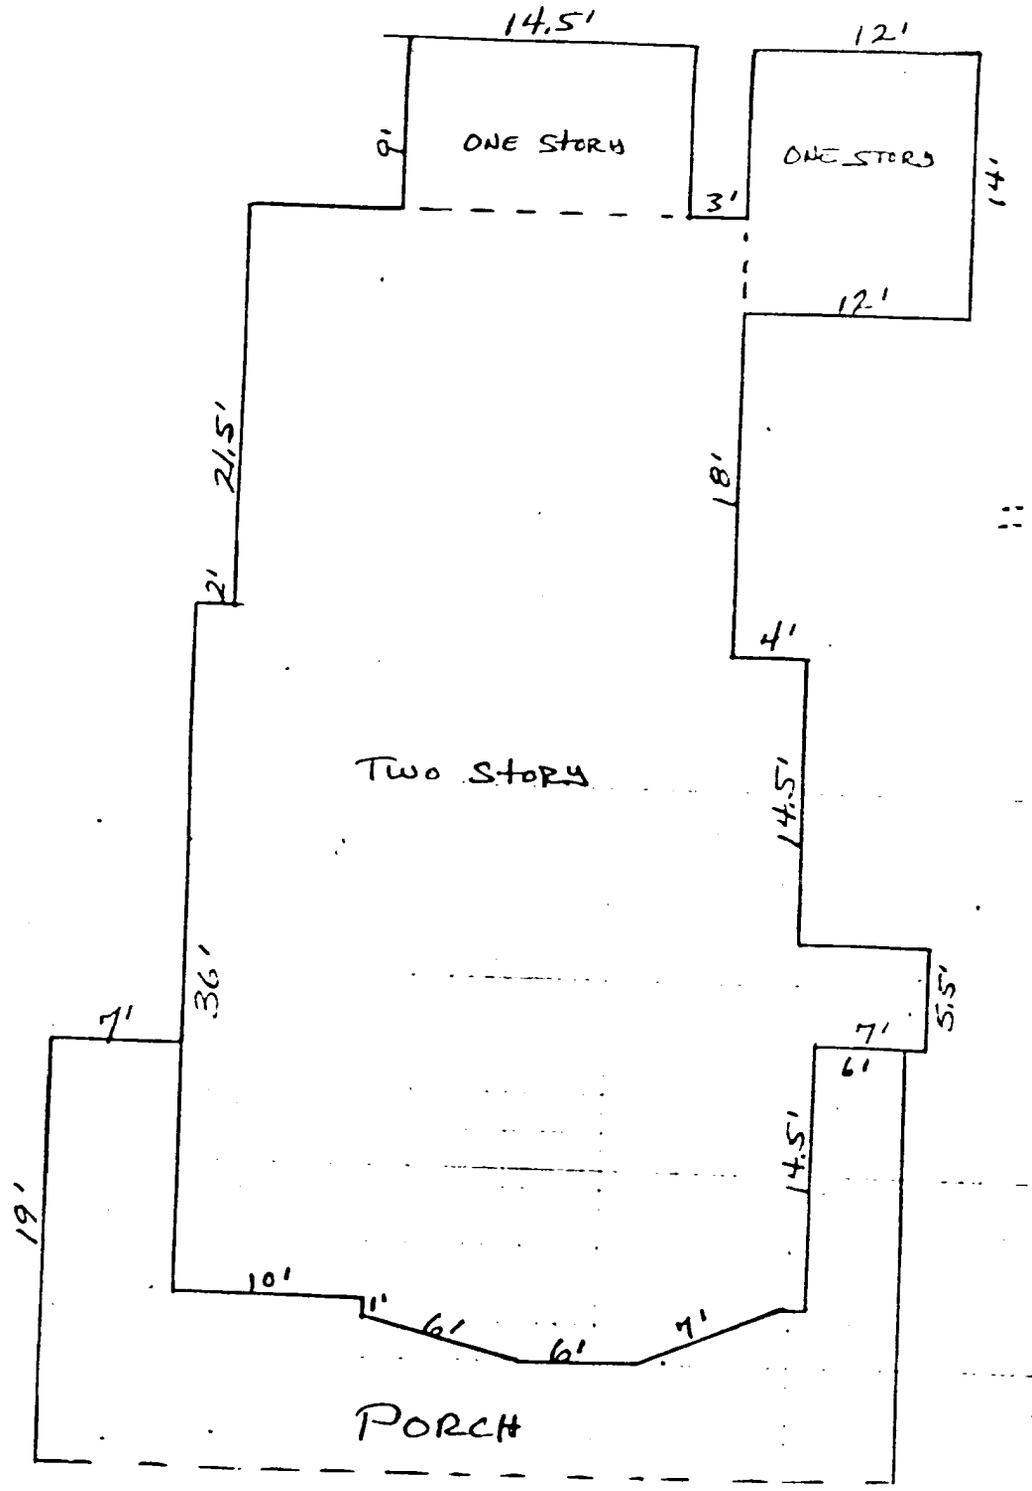
BUILDING #9 - DAVIS HOUSE

SUBJECT IMPROVEMENTS - FLOOR PLAN

Scale 1" = 10'

In the interior, there is a narrow entrance hall, with stairs leading to the second floor rising from the left hand side. The two largest rooms are to the right of the hallway and are linked by a paneled sliding door. There is a fireplace on the south wall of the first room flanked by large window seats. Most of the rooms on the first floor have closets or cupboards. The door and window trim is late nineteenth century, usually with bullsege corner blocks. The rooms in the various additions on the east side of the house have plain trim as well as dropped ceilings of asbestos panels.

The second floor consists of four bedrooms, a bathroom, a kitchen and the porch. The window and door trim are identical to that on the first floor, but most of the walls are covered with thin plywood board and all have dropped asbestos ceilings.

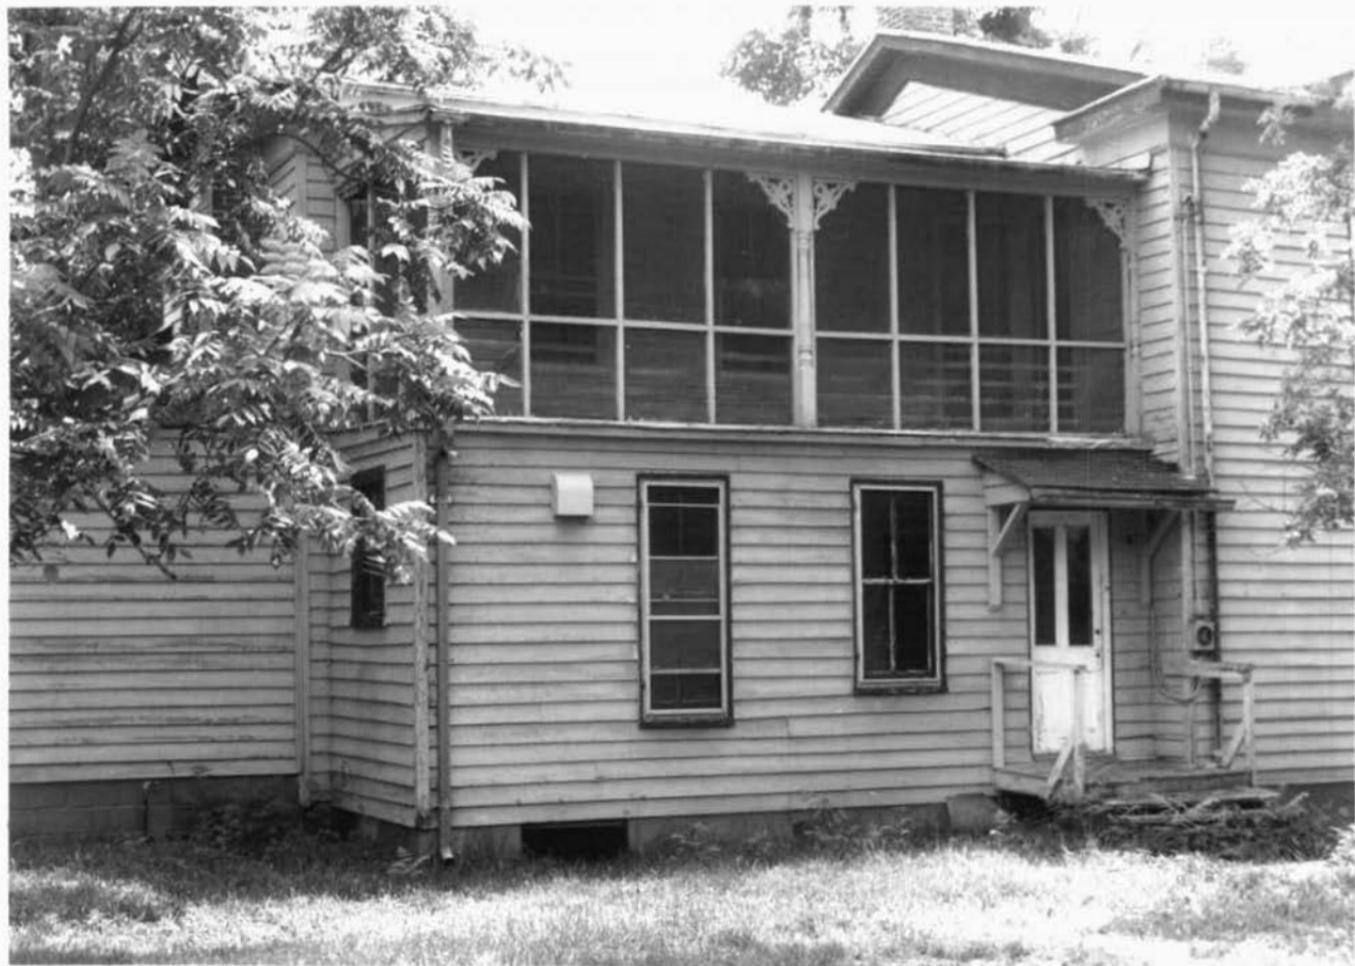
SM-371

Porch on north facade

A one bay wide two story porch addition extends along the three northern bays of the two story wing. The first story is enclosed and is used as the kitchen. Each bay of the second story porch is marked by a turned post with jig sawn brackets.

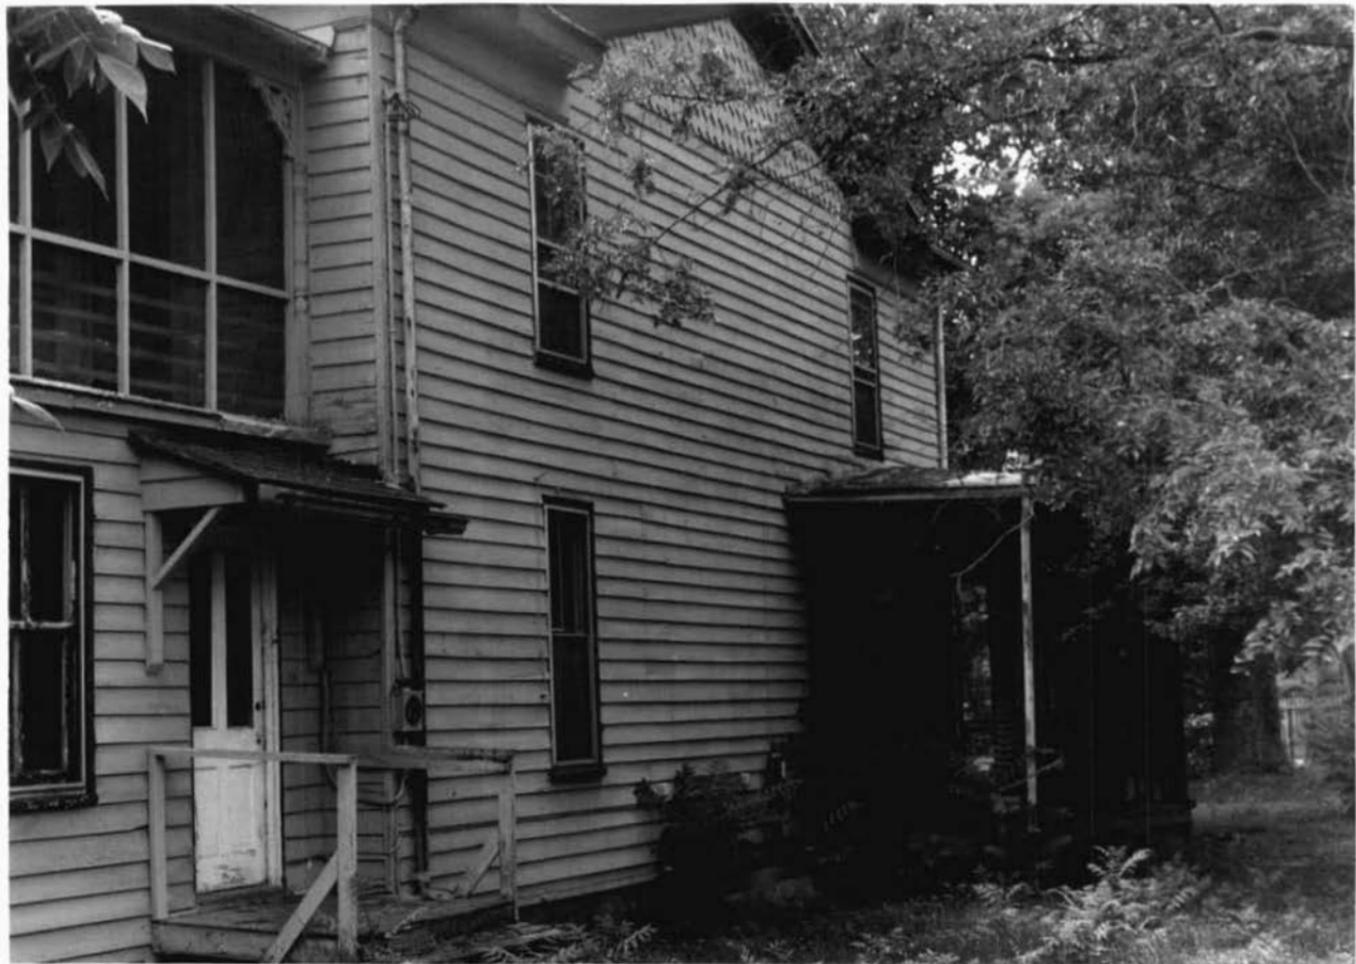
SM-371

North Facade

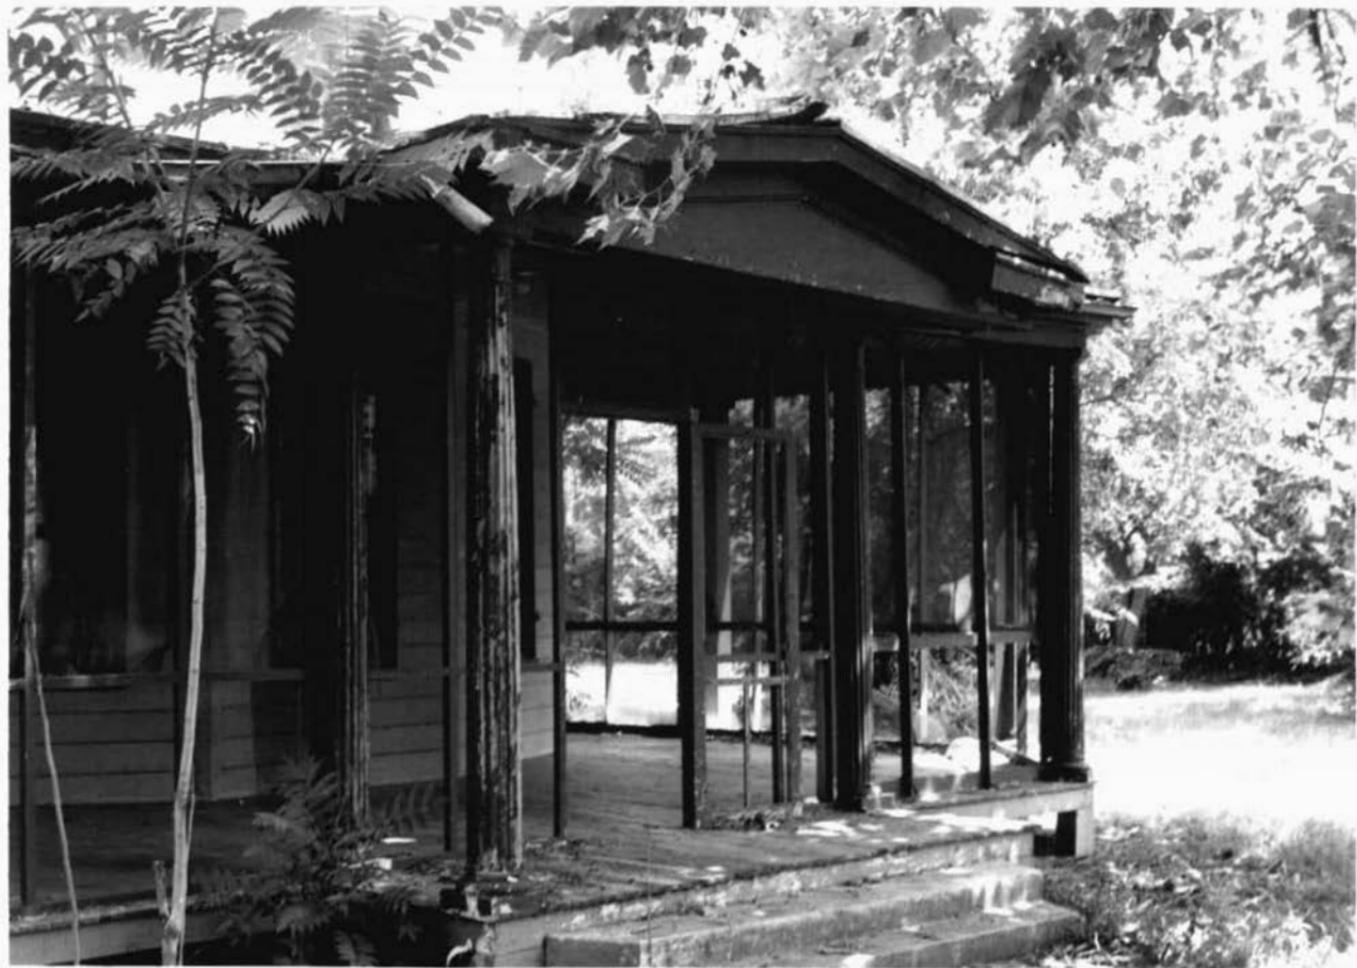
SM-371

Detail of porch on west facade

A one story screened porch with diagonal corners wraps around the west, north and south elevations and is supported by fluted Tuscan columns which taper at the top to a narrow capital. A pedimented entrance portico with cornice returns is at the center of the west elevation of the porch.

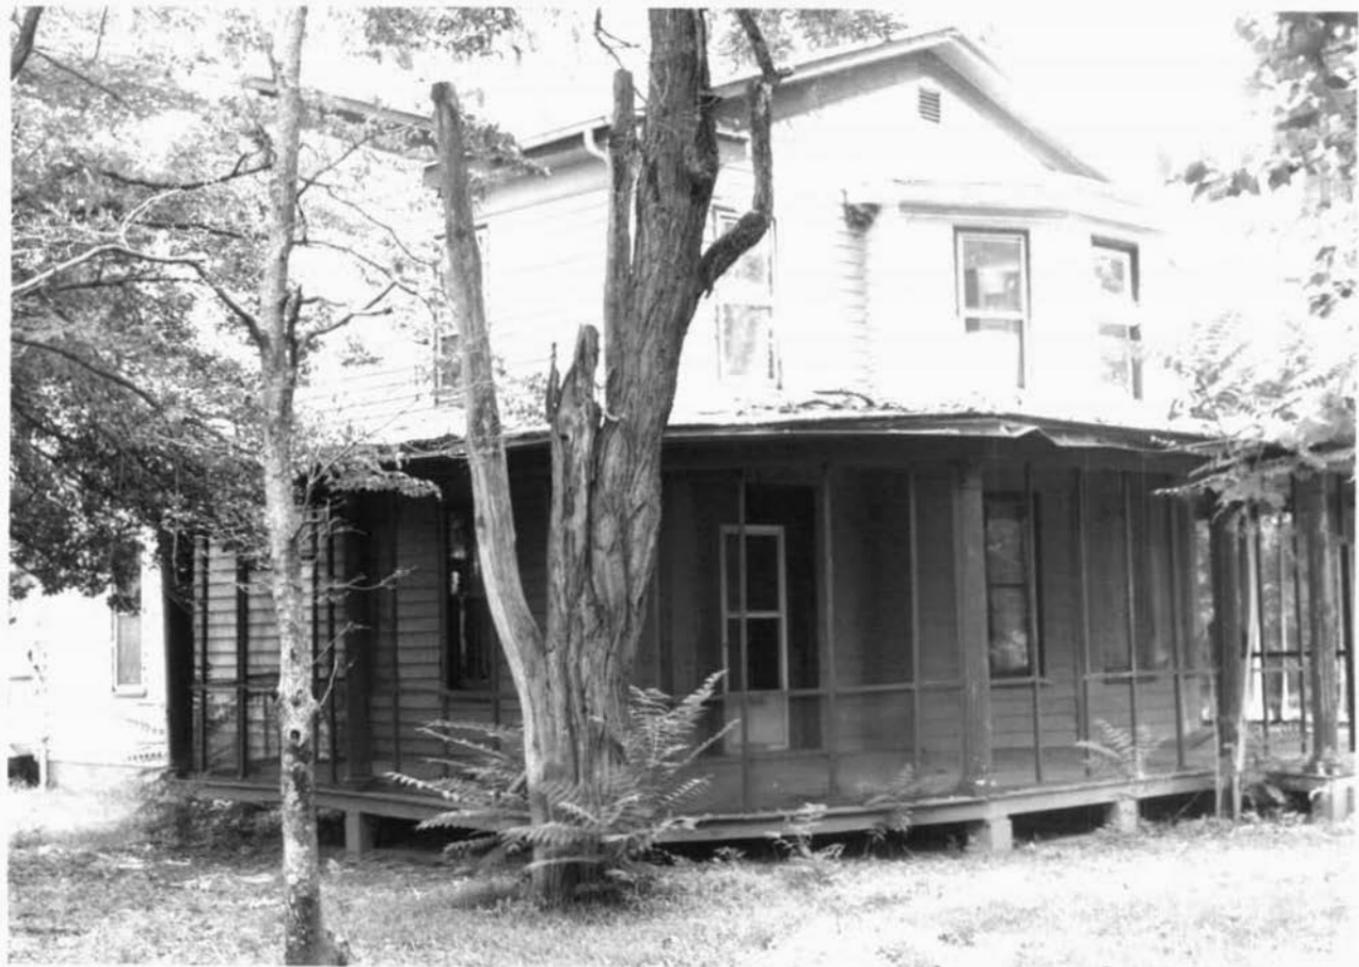
SM-371

Davis House
Charlotte Hall, Md.
West Facade

The main section of the Davis House is two and one half stories tall and four bays wide with a cross gable roof. A three sided bay with a pyramidal roof extends from the south end of the west elevation. A boxed cornice runs along all four sides of the frame house and returns at each of the four gable ends. The house is sheathed with weatherboard siding, except for the attic story of the gable ends which are covered with diamond shaped wood shingles.

The main entrance to the house is on the north end of the west elevation. The door, with four horizontal panels, is framed by narrow sidelights and a transom. The windows on both the first and second stories have either 1/1 or 2/2 sash.

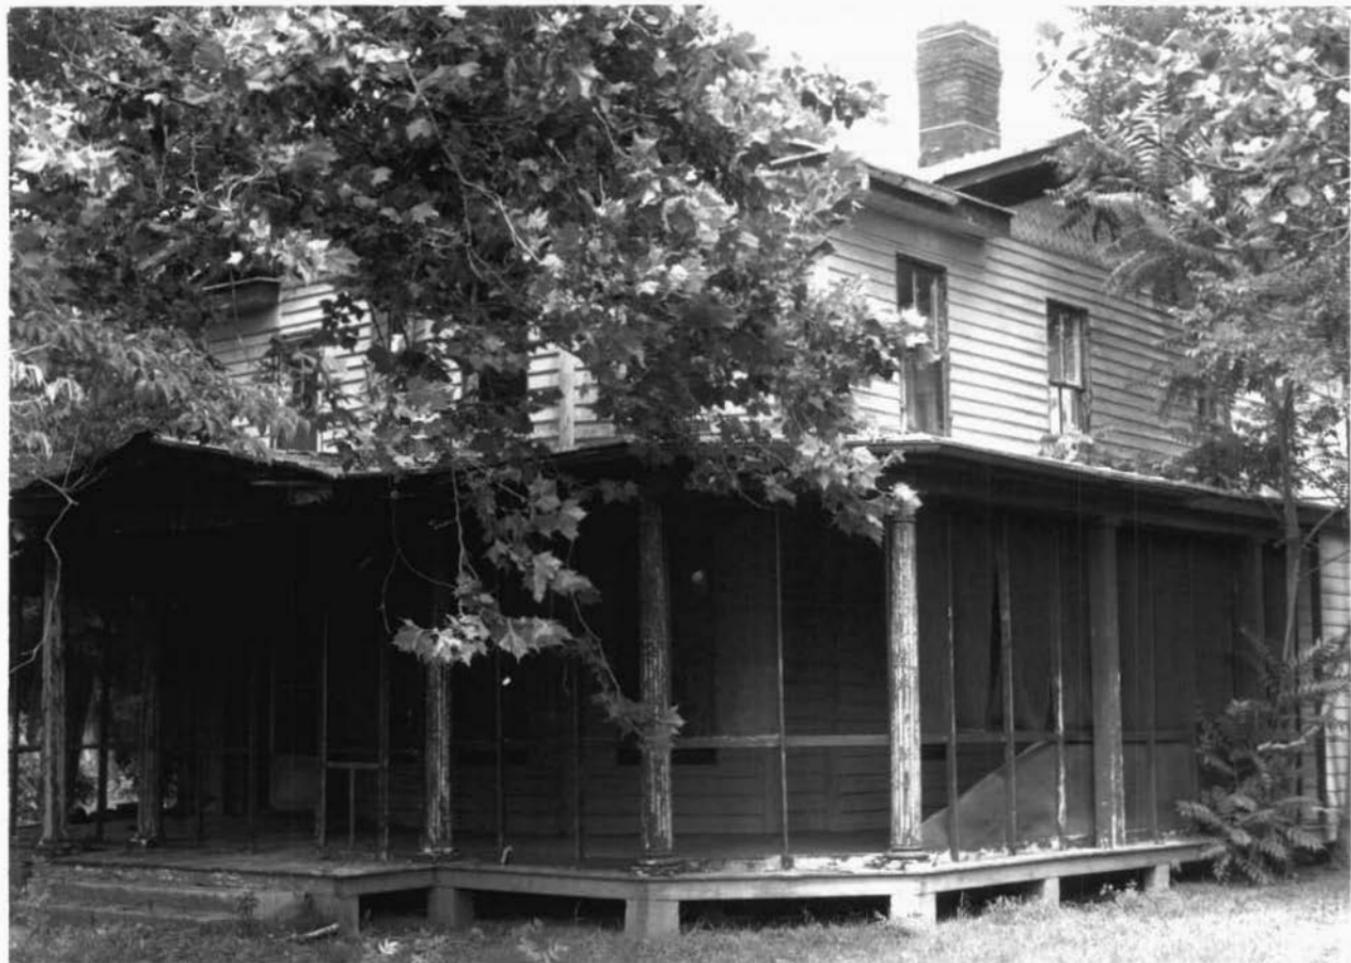
SM-371

Southwest elevation

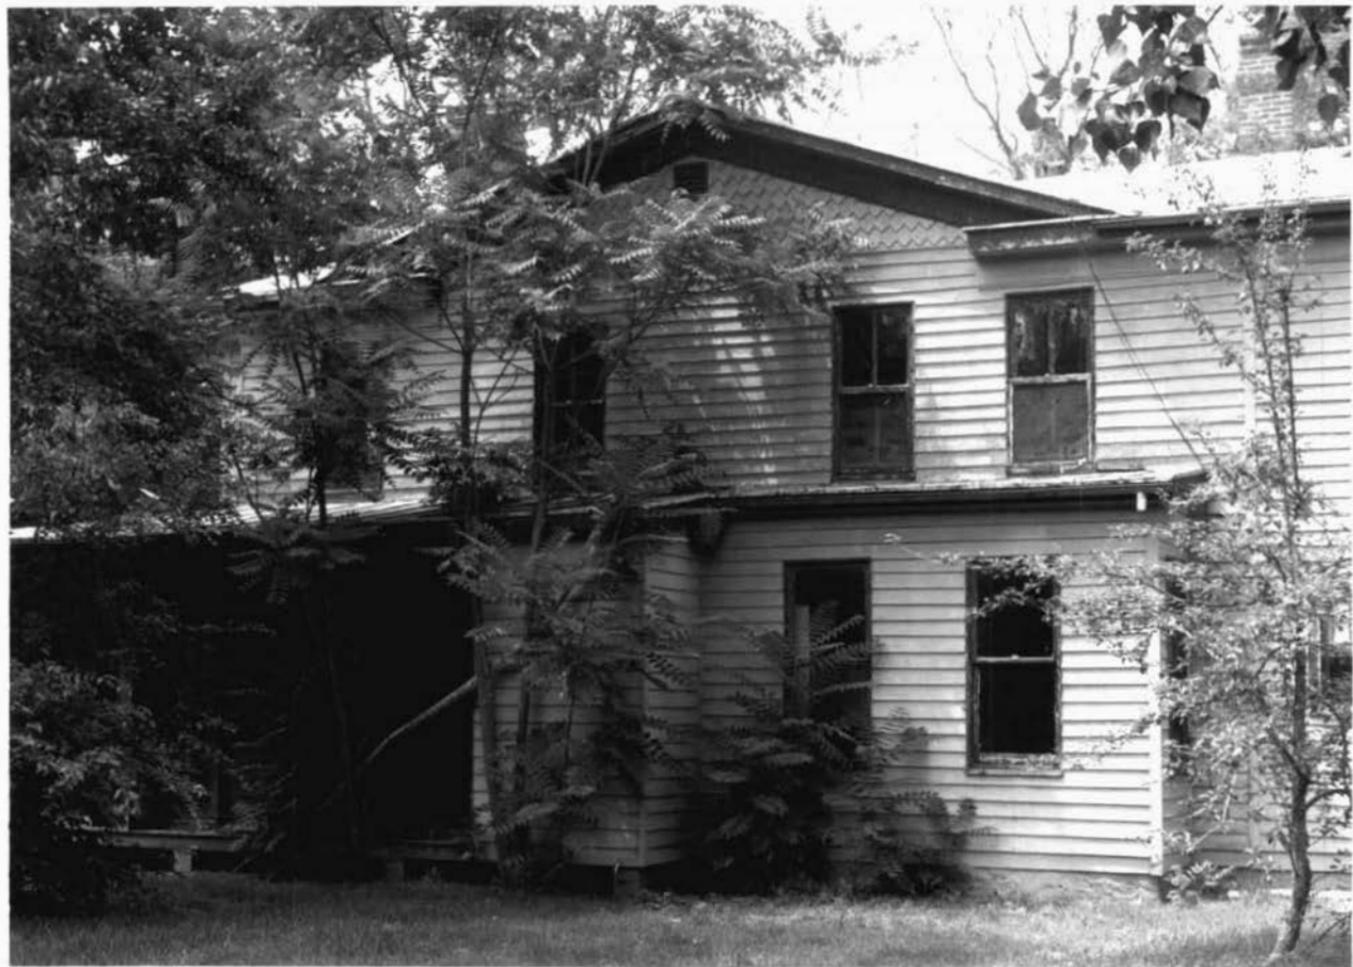
SM-371

South elevation

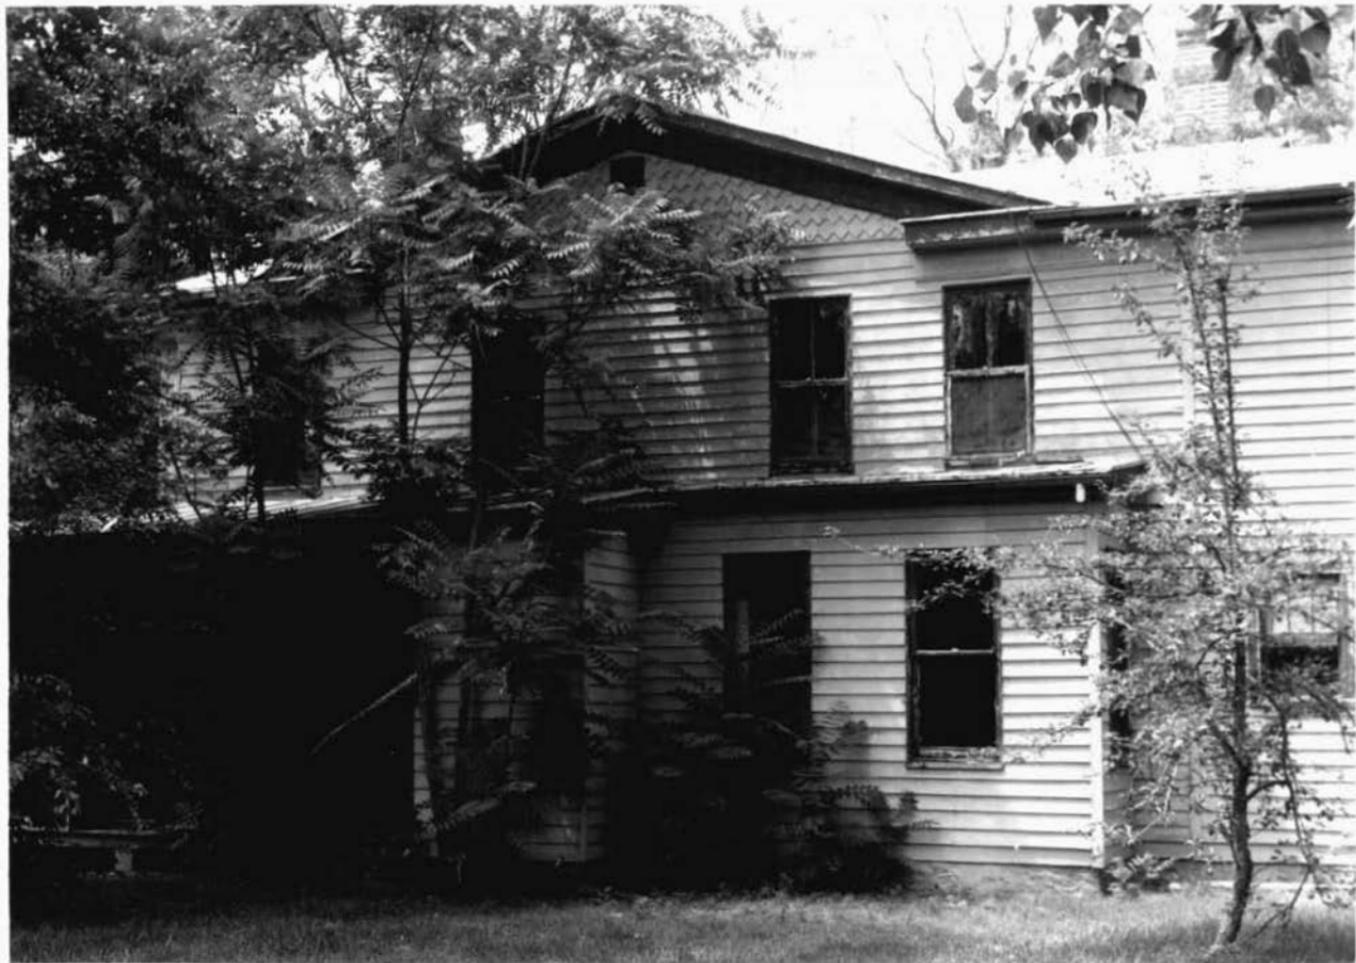
SM-371

South elevation

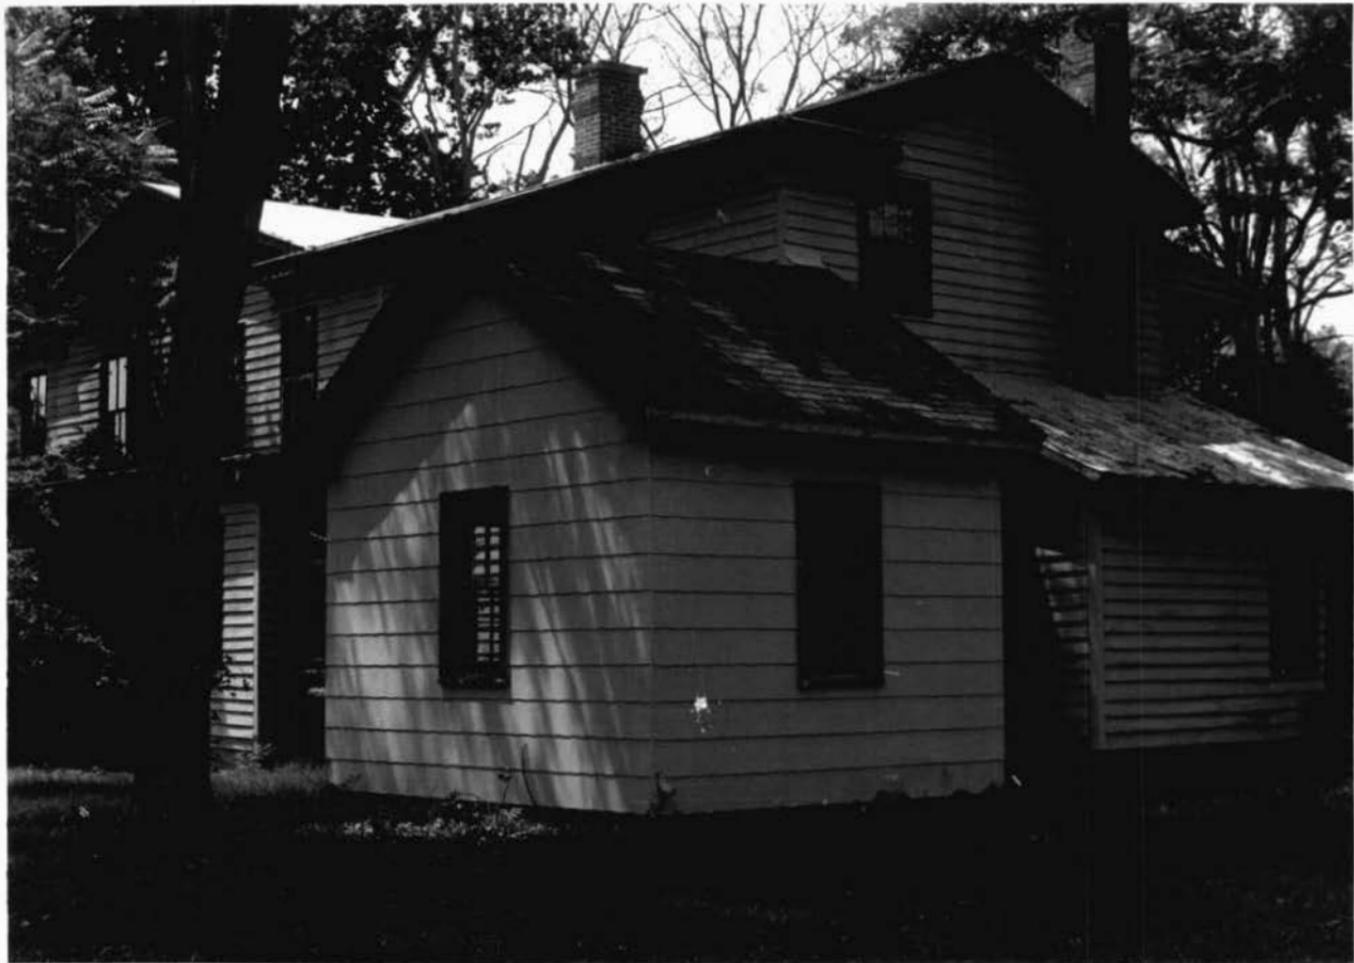
SM-371

SE Corner

A two bay wide and three bay deep gable roofed wing extends from the east elevation. It also has a boxed cornice with returns on the gable end. There is a small entrance with a hood roof on the north elevation. A one bay wide and one bay deep gable roofed addition extends from the south-east corner of this wing. The addition is covered with asbestos siding and has 6/6 sash windows.
