Maryland Historical Trust State Historic Sites Inventory Form

Survey No. SM-376
Magi No. 1903765505
DOE yes no

and/or common LOG BUILDING ON PAGAN POINT

street & number East side of Pagan Point, on West St. Mary's Manor Road not for publication

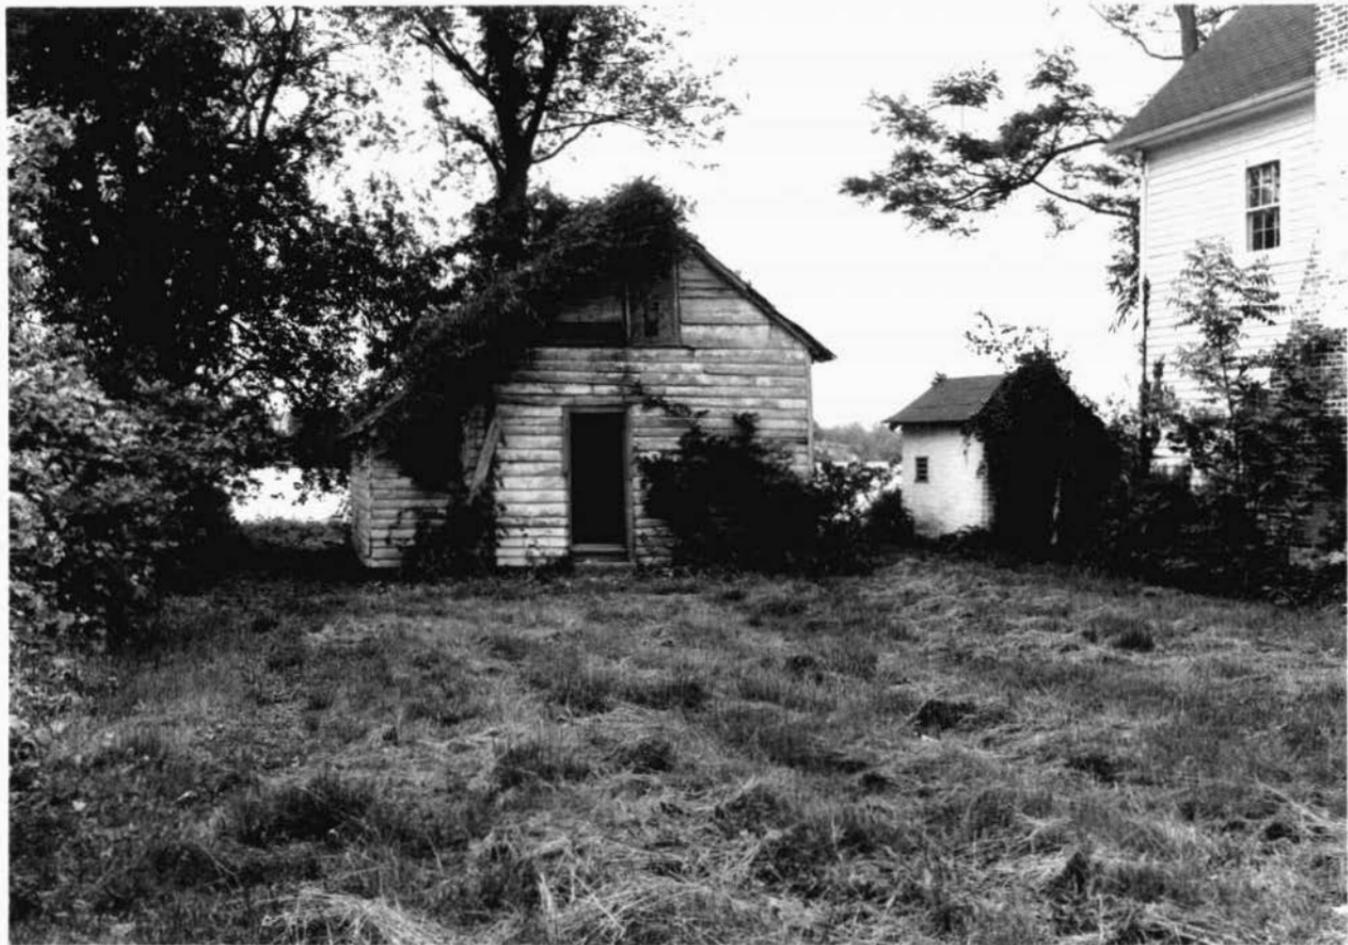
Log Cabin on Pagan Point 376
Photos by Stephen Israel/Jim Durkay SM-~~369~~
May 1985

Clapboard cover log cabin
on Russell Crenshaw property
Photo taken 5/21/85
