MARYLAND HISTORICAL TRUST
DETERMINATION OF ELIGIBILITY FORM

Property Name: Willow Tree Farm Inventory Number: SM-478
Address: 20316 Willows Road Historic district: yes no
City: Lexington Park Zip Code: 20653 County: St. Mary's
USGS Quadrangle(s): Saint Marys City
Property Owner: Patrick Wayne & Veronique M Adams Tax Account ID Number: 204
Tax Map Parcel Number(s): 0089 Tax Map Number: 0058
Project: MD 5 over Eastern Br. Bridge Replacement (SHA # 1800800) Agency: SHA
Agency Prepared By: KCI Technologies, Inc.
Preparer's Name: Kristine Chase Date Prepared: 8/25/2012
Documentation is presented in: MIHP Form
Preparer's Eligibility Recommendation: Eligibility recommended Eligibility not recommended
Criteria: A B C D Considerations: A B C D E F G
Complete if the property is a contributing or non-contributing resource to a NR district/property:
Name of the District/Property: _____
Inventory Number: _____ Eligible: yes Listed: yes
Site visit by MHT Staff yes no Name: _____ Date: _____

MIHP # SM-478

MARYLAND INVENTORY OF
HISTORIC PROPERTIES

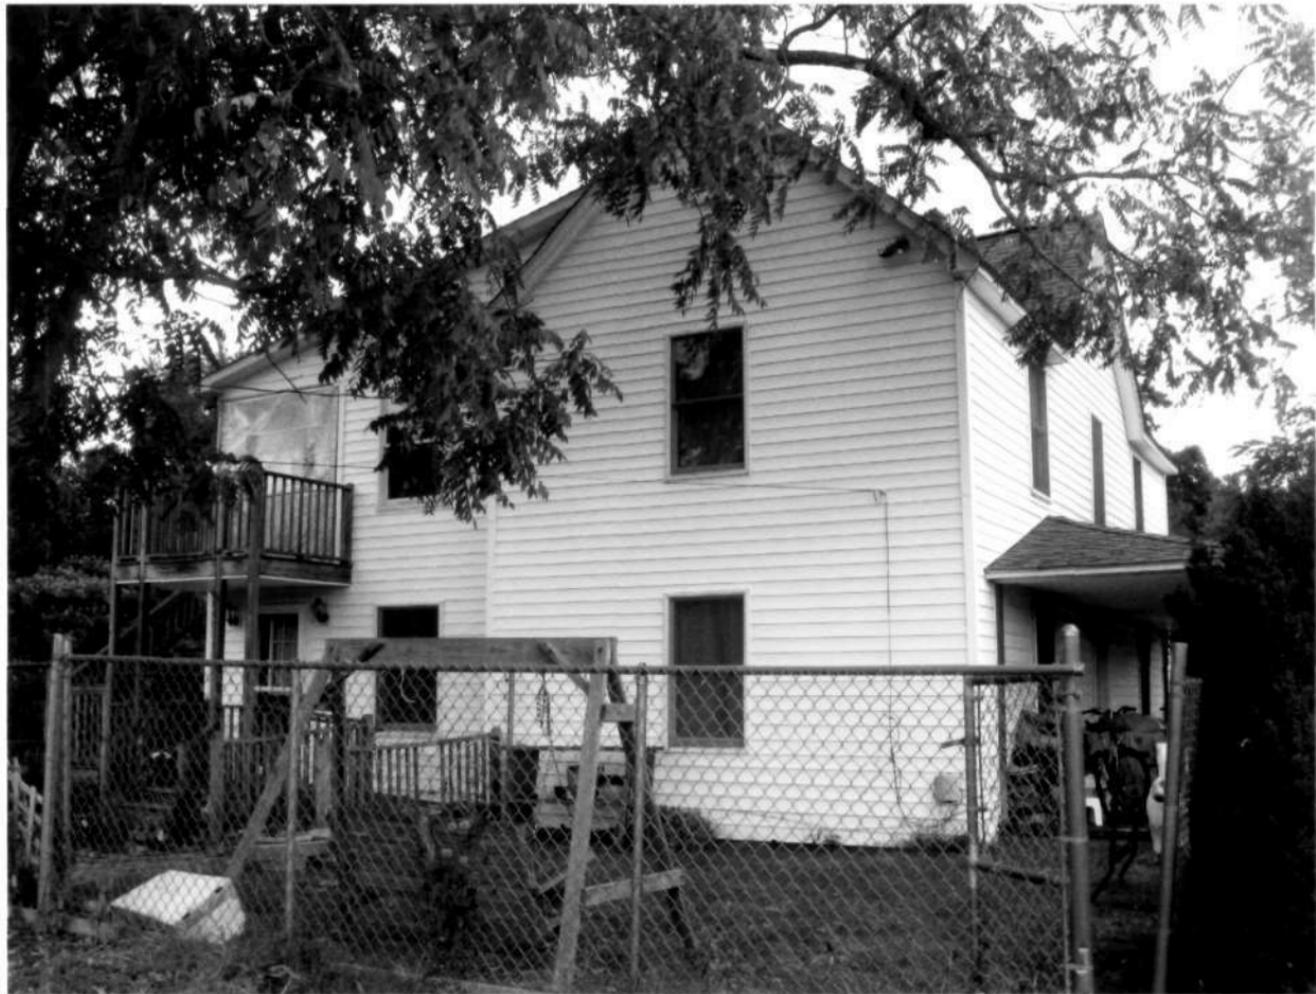
1/9

| No. | Name | Direction | Description |
|---|---|---|--|
| 1 | SM-478_2012-07-30_01.tif | Northeast | Southwest Elevation Looking Northeast |

Southwest elevation looking NE

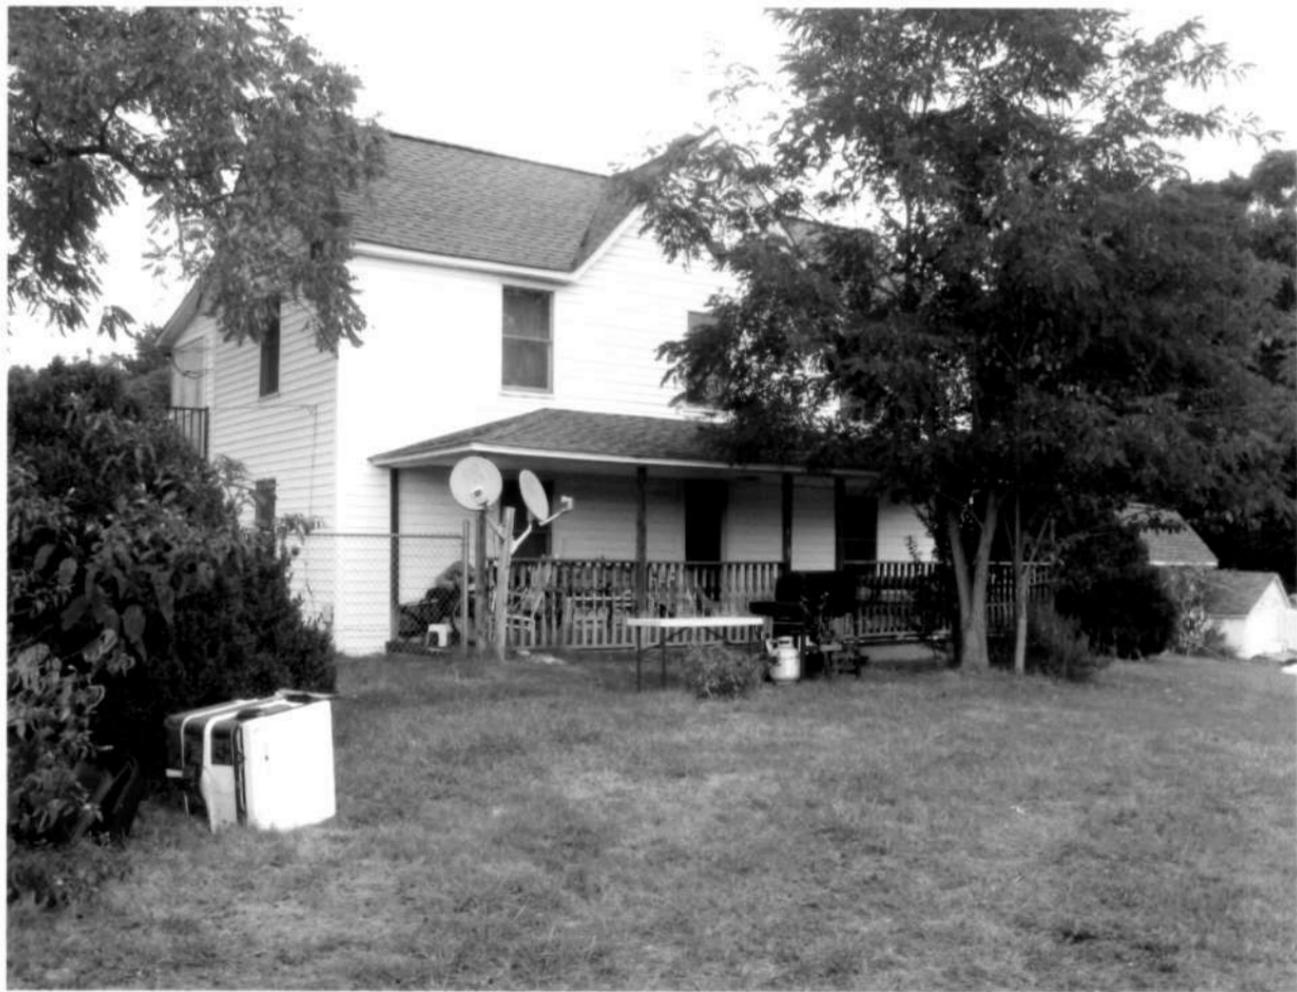
2/9

On the south (front) façade the residence still retains the three bay orientation but the cross gable-end window has been removed and the first floor full-width porch has been modified. The porch roof has been changed to have a fuller hipped appearance and is supported by plain timber posts with wood railing on a concrete floor covered in indoor/outdoor carpet. The screened enclosure no longer exists and the center front entry opening appears to be clipped on the upper portion by the porch roof. The two corbelled-top interior chimneys remain. The windows appear to have been replaced with one-over-one double-hung vinyl windows.

| No. | Name | Direction | Description |
|---|---|---|--|
| 2 | SM-478_2012-07-30_02.tif | North | South (Front) Elevation Looking North |

South (front) elevation looking north

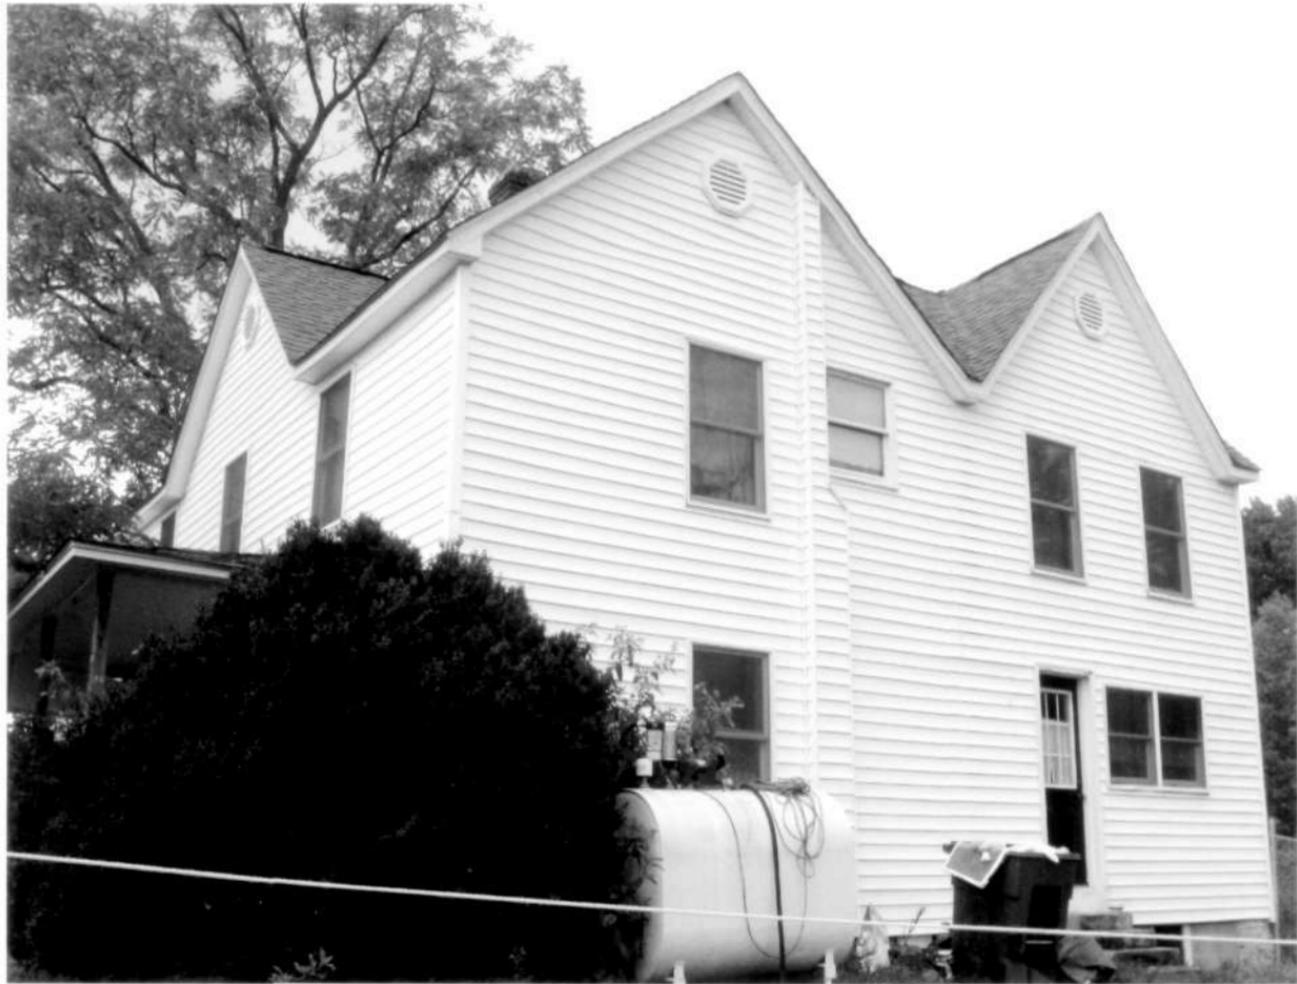
3/9

The east elevation's shape has largely remained but the modified ell's door has been changed to a nine-light-over-two-panel door with the intact paired one-over-one double-hung vinyl windows on the first floor of the modified ell. The main block's first floor remains one bay with a modern one-over-one double-hung vinyl window. The second floor retains a gable break along the roofline and four bays, but the windows have been replaced with one-over-one double-hung vinyl windows. The gable-end windows have since been removed from the main block and ell. The gutter piping is now enclosed with vinyl siding.

| No. | Name | Direction | Description |
|---|---|---|--|
| 3 | SM-478_2012-07-30_03.tif | Northwest | Southeast Elevation Looking Northwest |

Southeast elevation looking NW

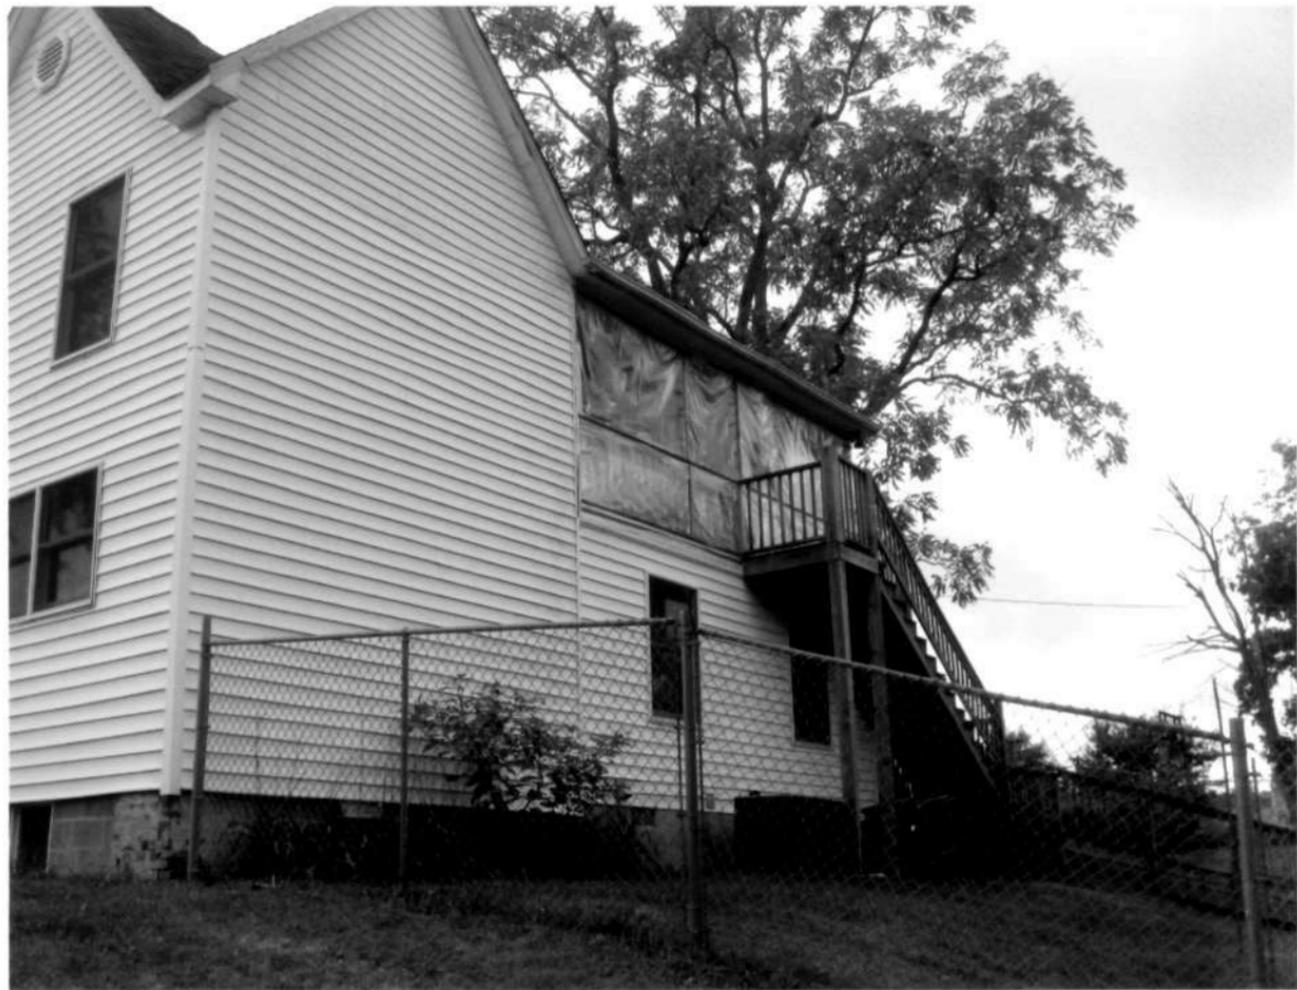
419

The north elevation of the ell remains a blind gable end and the interior brick chimney has been removed. The north elevation of the main block has since been modified to include a two-story addition which includes an enclosed second floor porch and two one-over-one double-hung windows on the first floor.

| No. | Name | Direction | Description |
|---|---|---|--|
| 4 | SM-478_2012-07-30_04.tif | Southwest | North Elevation Looking Southwest |

North elevation looking SW

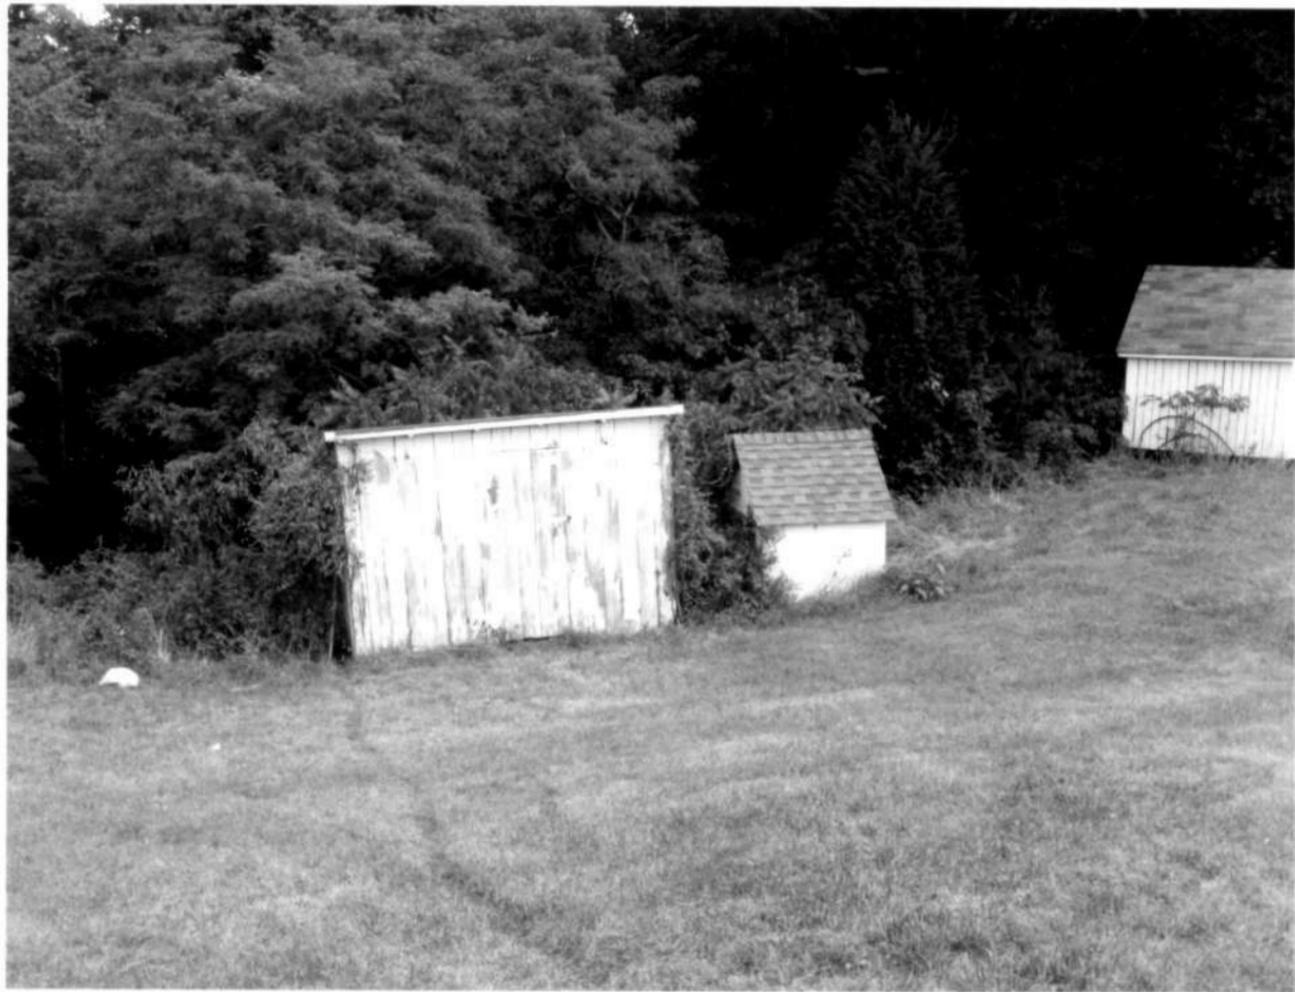
5/9

| No. | Name | Direction | Description |
|---|---|---|--|
| 5 | SM-478_2012-07-30_05.tif | Northeast | View of Frame Shed and Cinderblock Pump House Looking Northeast |

View of frame shed and cinderblock
pumphouse looking NE

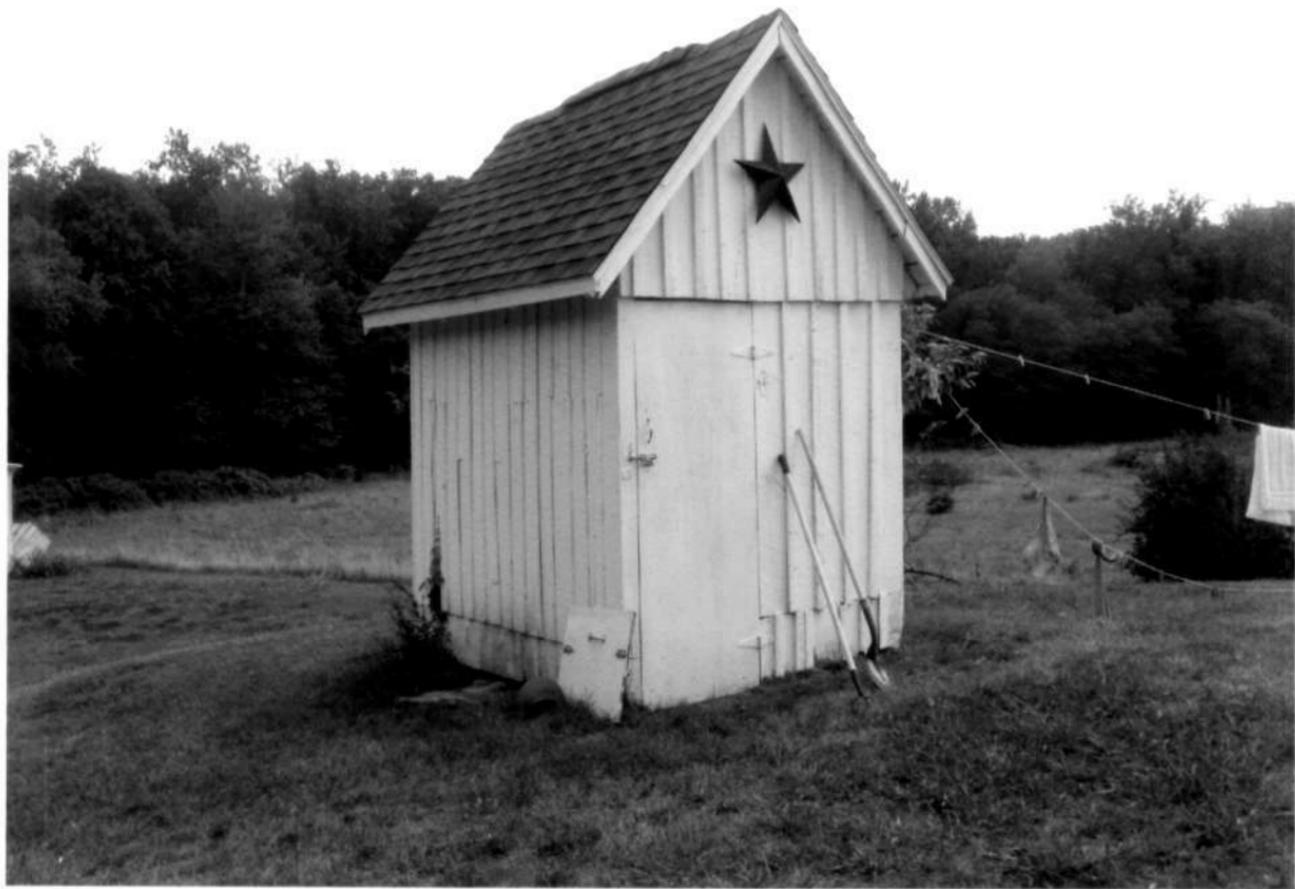
6/9

| No. | Name | Direction | Description |
|---|---|---|--|
| 6 | SM-478_2012-07-30_06.tif | East | View of Frame Meathouse Looking East |

View of frame meathouse looking east

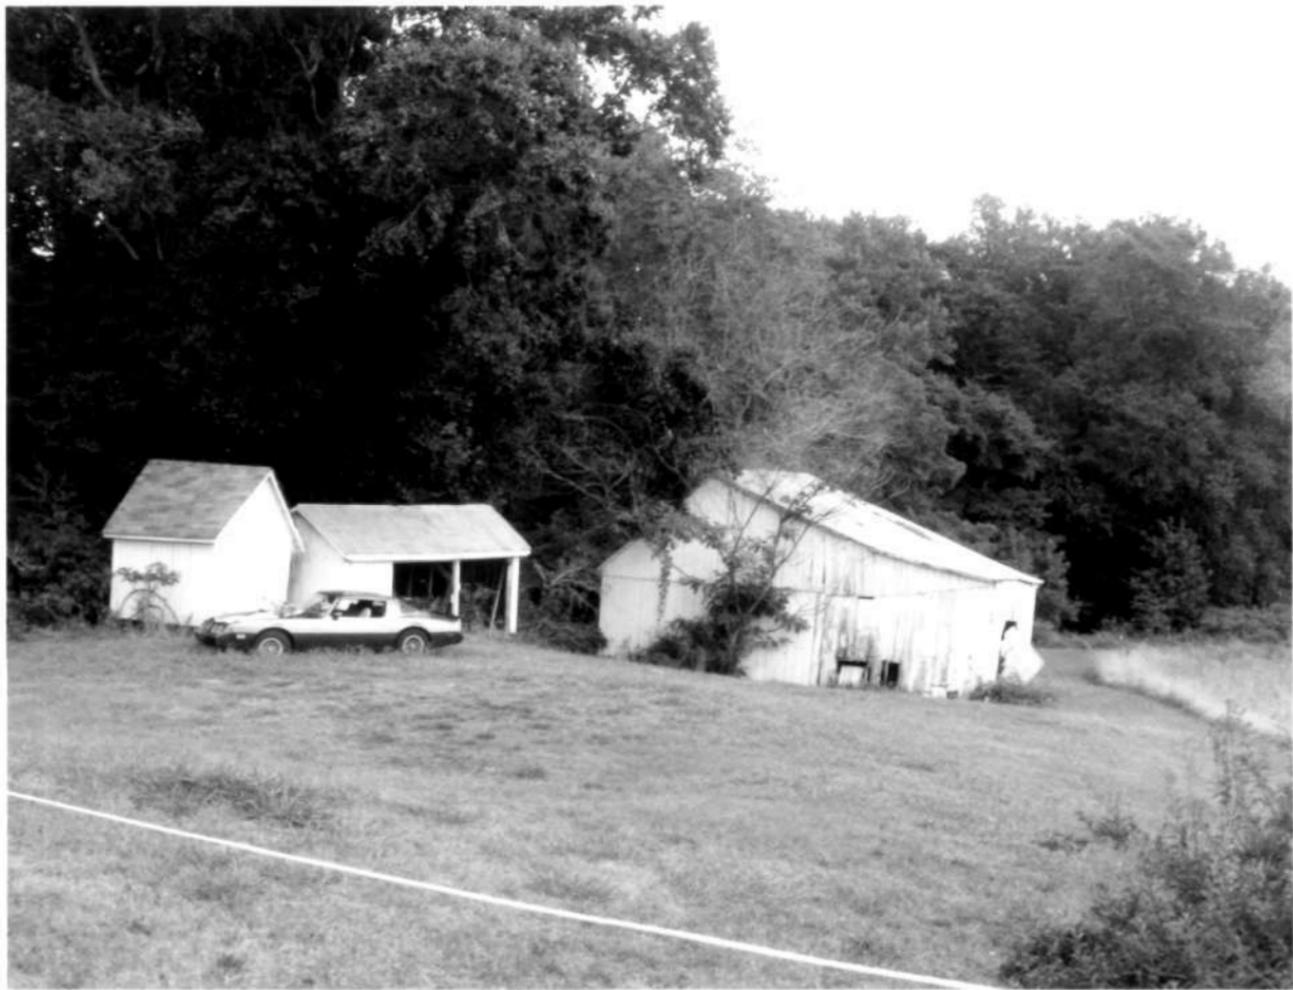
7/9

| No. | Name | Direction | Description |
|---|---|---|--|
| 7 | SM-478_2012-07-30_07.tif | East | View of Frame Corn House, Tractor Shed, Saltbox Roof Tobacco Barn Looking East |

View of frame corn house, tractor shed,
saltbox roof tobacco barn looking east

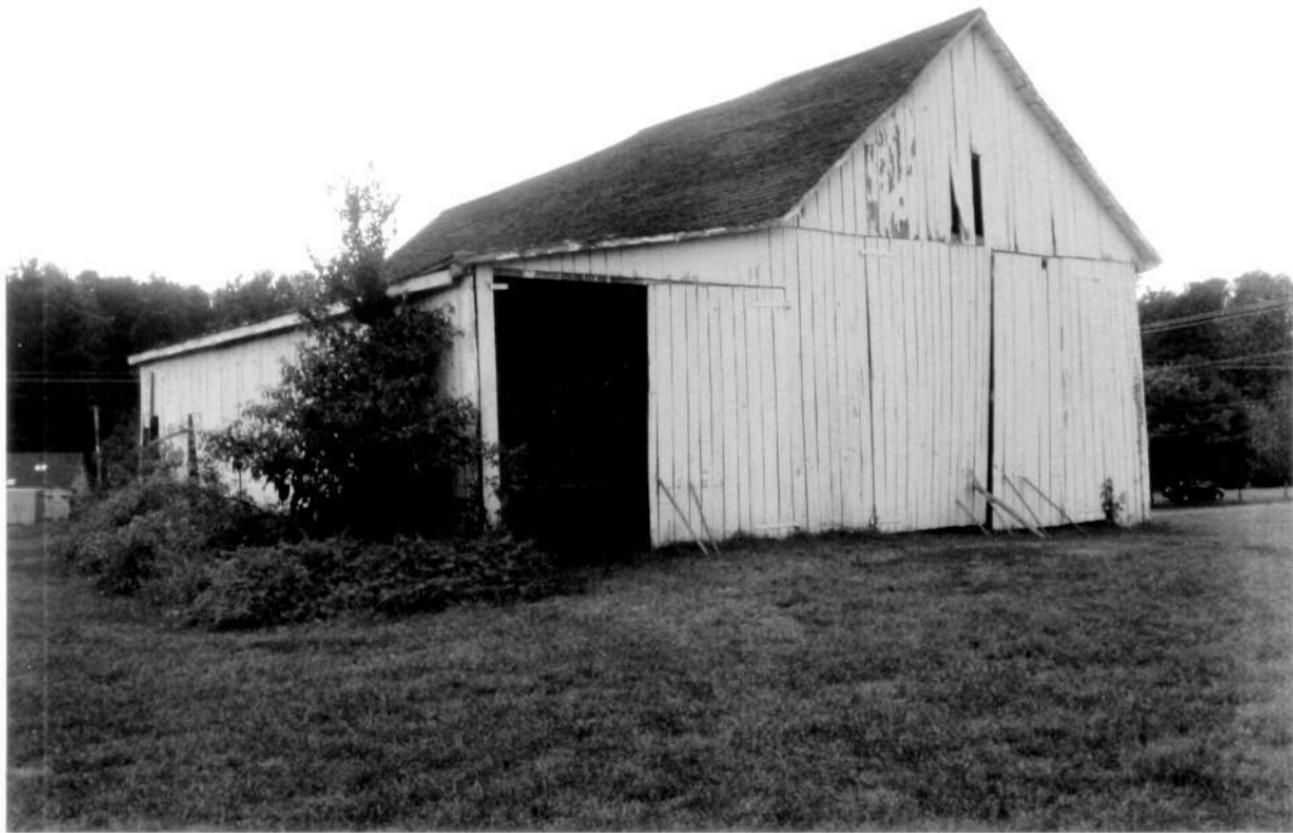
8/9

| No. | Name | Direction | Description |
|---|---|---|--|
| 8 | SM-478_2012-07-30_08.tif | Southwest | View of Side-Gable Tobacco Barn Looking Southwest |

View of side-Gable Tobacco Barn Looking SW

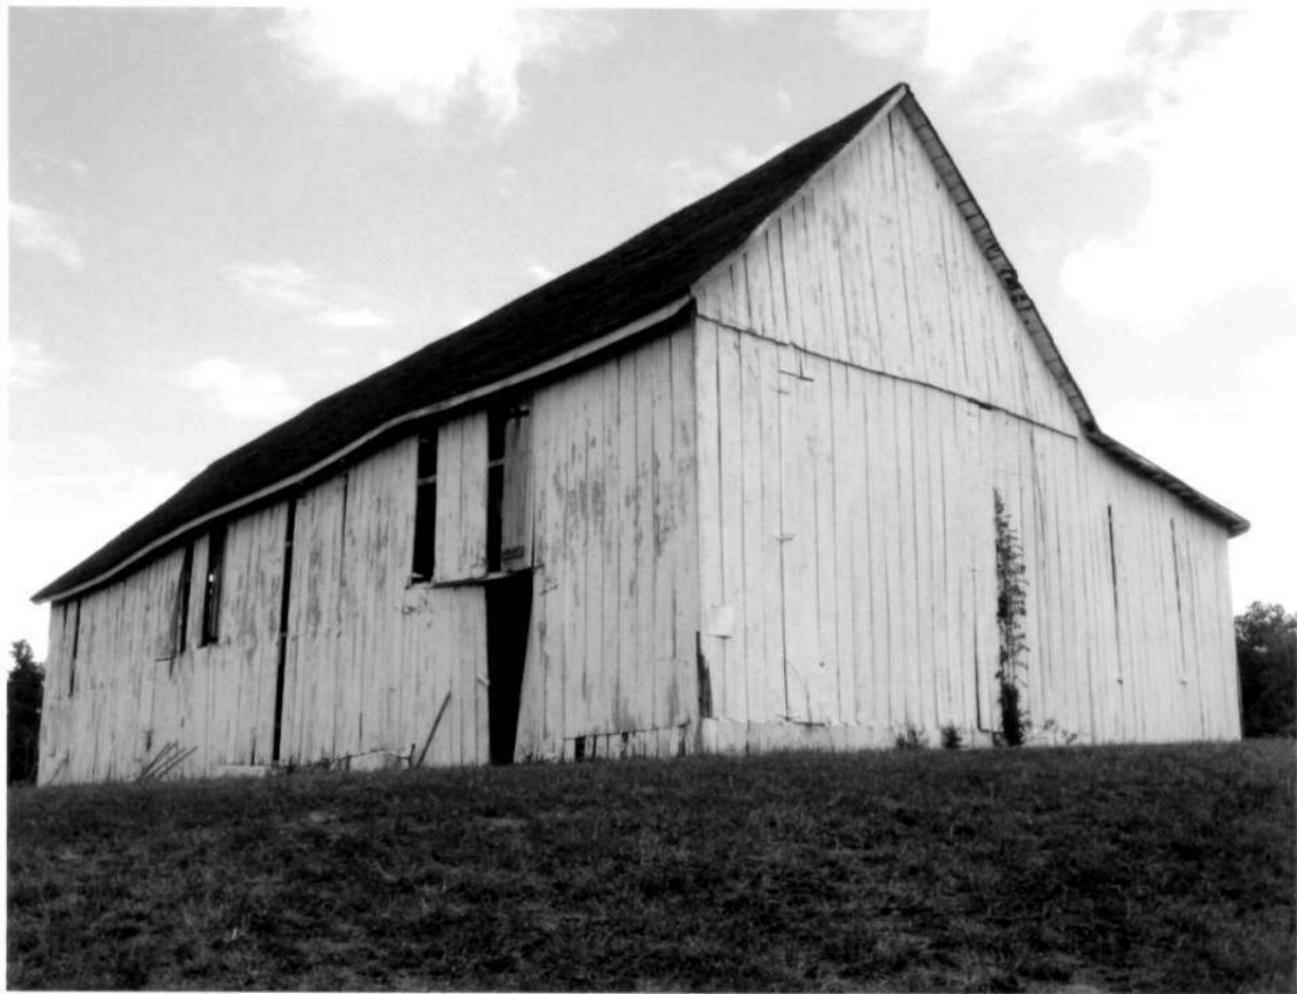
9/9

| No. | Name | Direction | Description |
|---|---|---|--|
| 9 | SM-478_2012-07-30_09.tif | Northeast | View of Side-Gable Tobacco Barn Looking Northeast |

View of side gable tobacco barn looking NE

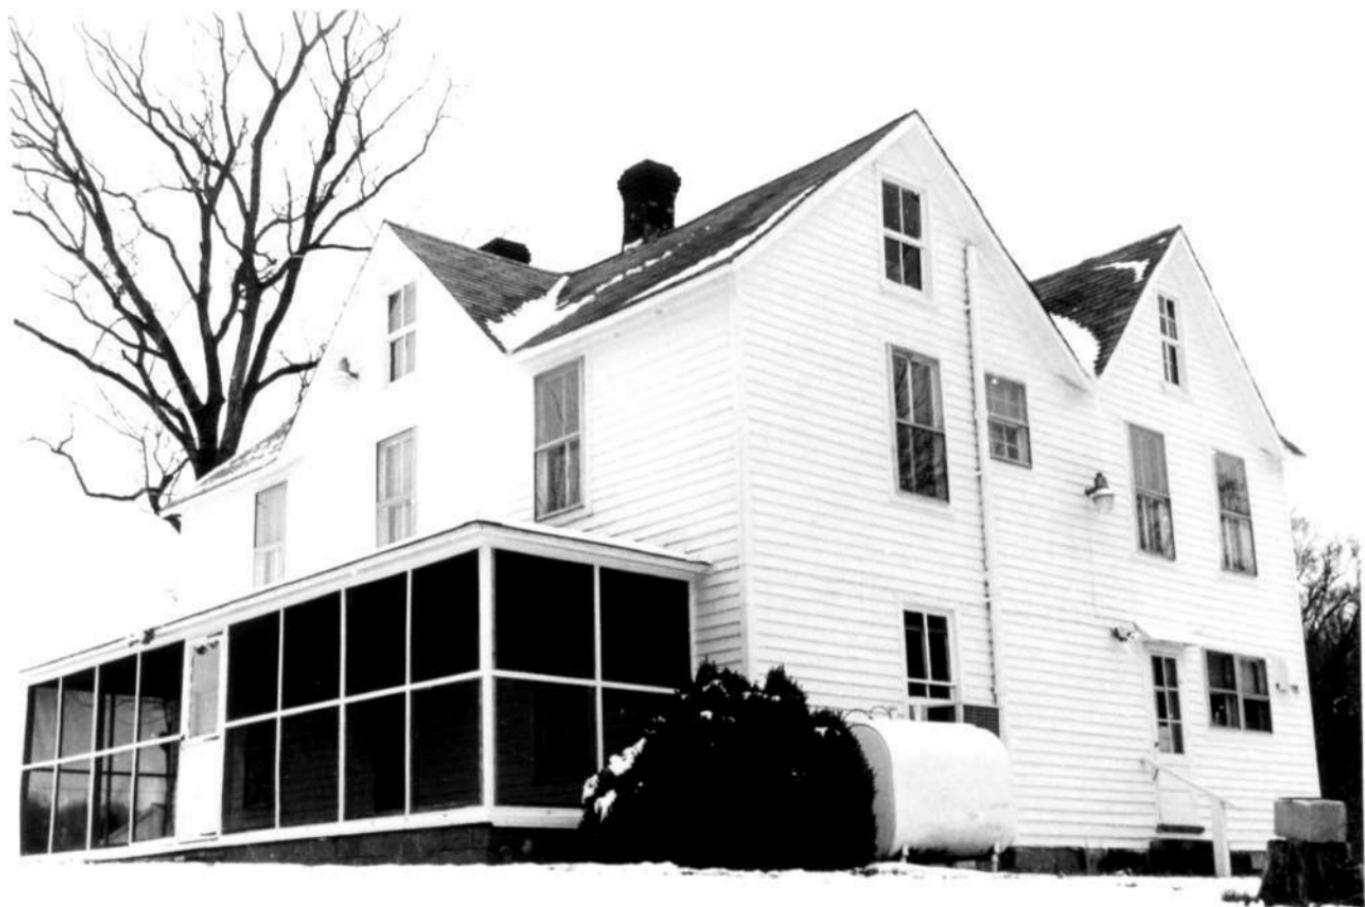
1/3

SE Elevation

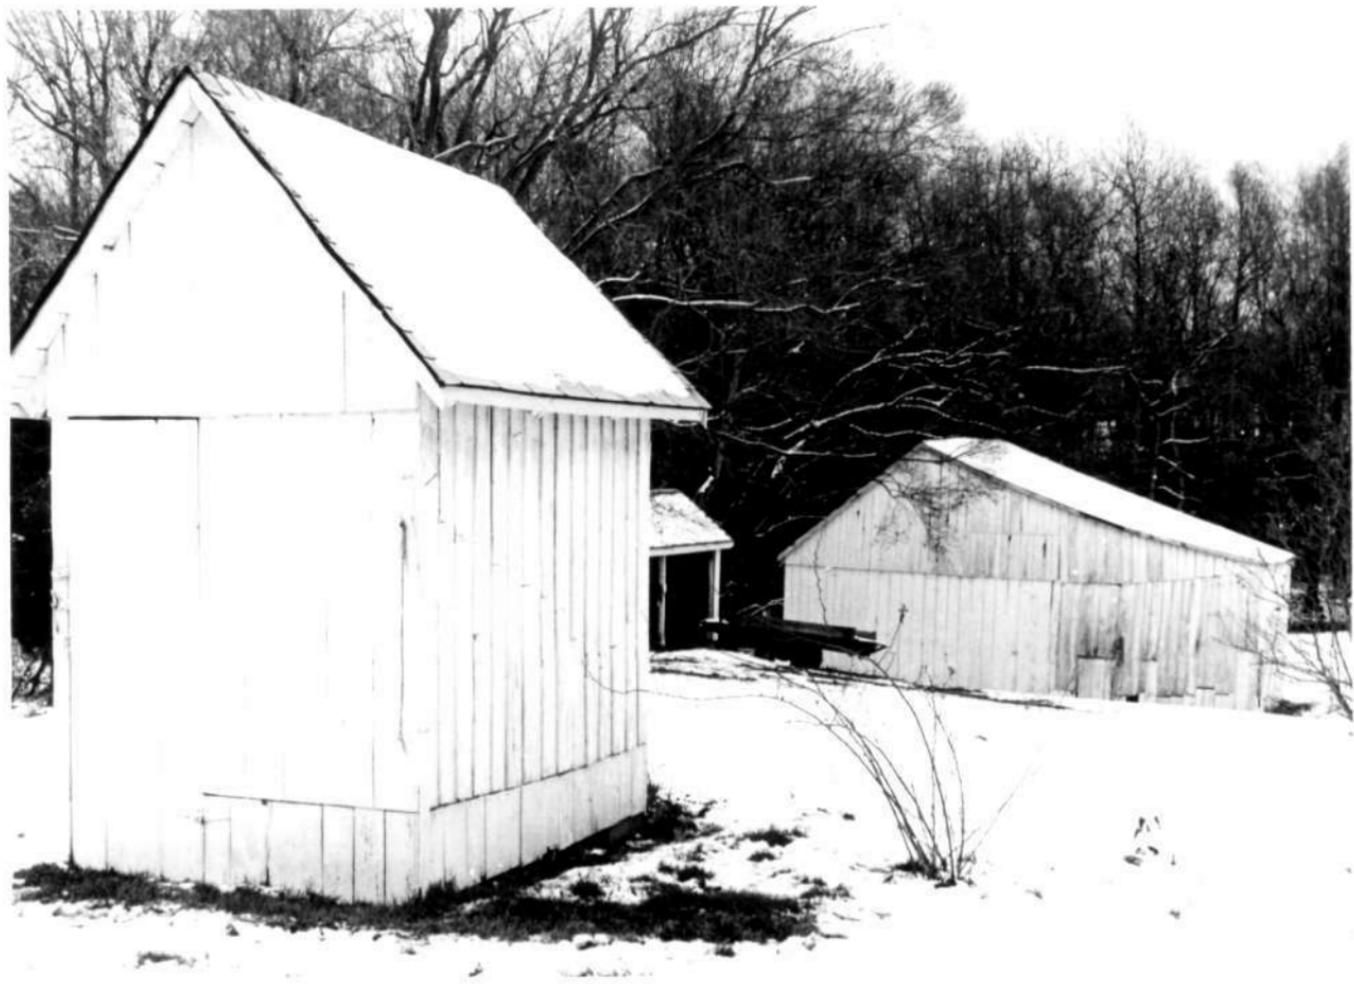
3/3

Seven outbuildings are located on the Willow Tree Farm property. A frame meathouse is located closest to the house. This structure is supported by cinderblock piers and is sheathed with board and batten siding. The asphalt shingle roof is oriented on an east/west axis. The door, located on the west side of the structure, faces the side entrance door on the east elevation of the house.

A small cinderblock pump house and a frame shed are located to the northwest of the house. A frame corn house supported by wood piers, a tractor shed, and a tobacco barn stand northeast of the house. A larger tobacco barn, sheathed with vertical siding and roofed with metal, is located at the southwest corner of the property. The roof of this rectangular shaped structure is oriented on a north/south axis. A shed extends along the east side of the building. Both barns on the property continue to be used for the curing of tobacco.

Outbuildings
