Capsule Summary
SM-577
Woodburn Hill Farm
Thompson's Corner Vicinity
Private

SM-577, Woodburn Hill Farm
St. Mary's County
Maryland Comprehensive State Historic Preservation Plan Data

Maryland Historical Trust State Historic Sites Inventory Form

Survey No. SM-577

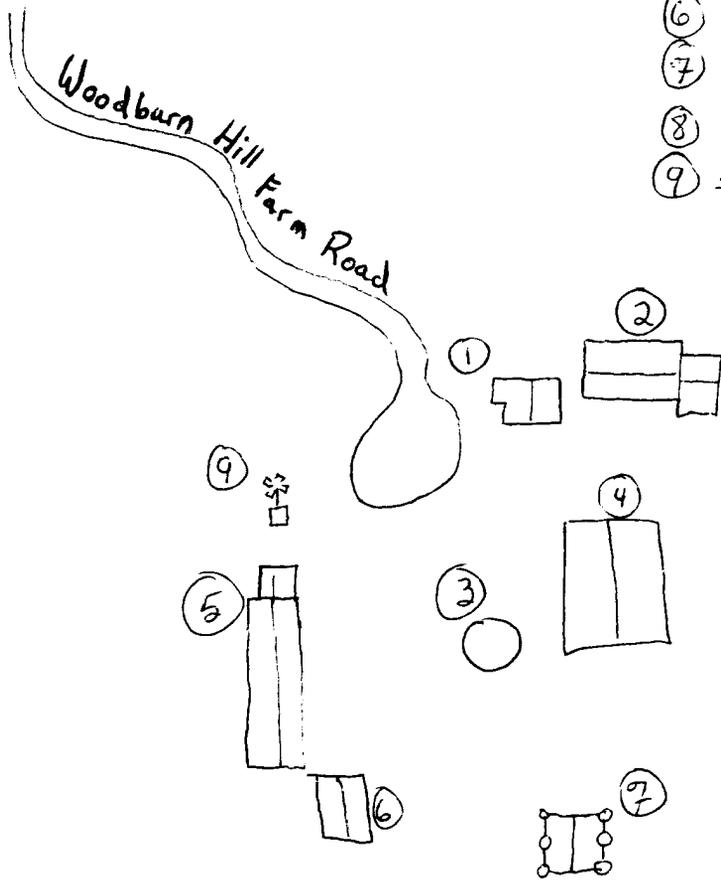
Site plan

- ① = c. 1840's dwelling
- ② = Amish dwelling, c. 1940's
- ③ = Silo
- ④ = bank barn
- ⑤ = Equipment shed
- ⑥ = corn crib
- ⑦ = hay barrack
- ⑧ = site of slave quarter
- ⑨ = windmill

Woodburn Hill Farm is located at the terminus of Woodburn Hill Road approximately 1.5 miles southeast of the intersection of Maryland Route 236 and Woodburn Hill Road near Chaptico, Maryland. The farm includes an assemblage of agricultural outbuildings that contain a bank barn, grain silo, a corn crib, a hay barrack, a windmill, an equipment shed, and two dwellings situated on a hill overlooking a number of wooded ravines. While one dwelling and the outbuildings were erected by Amish/Mennonite dairy farmers in the 1950s, the other dwelling predates the complex to c. 1840. As a whole, the complex of buildings forms a circle that encloses a central courtyard and circular drive. The c. 1840 house, oriented on an east/west axis, and the modern Amish/Mennonite house, oriented on a north/south axis, are located within only a few feet of each other and represent the northeast anchor of the complex.

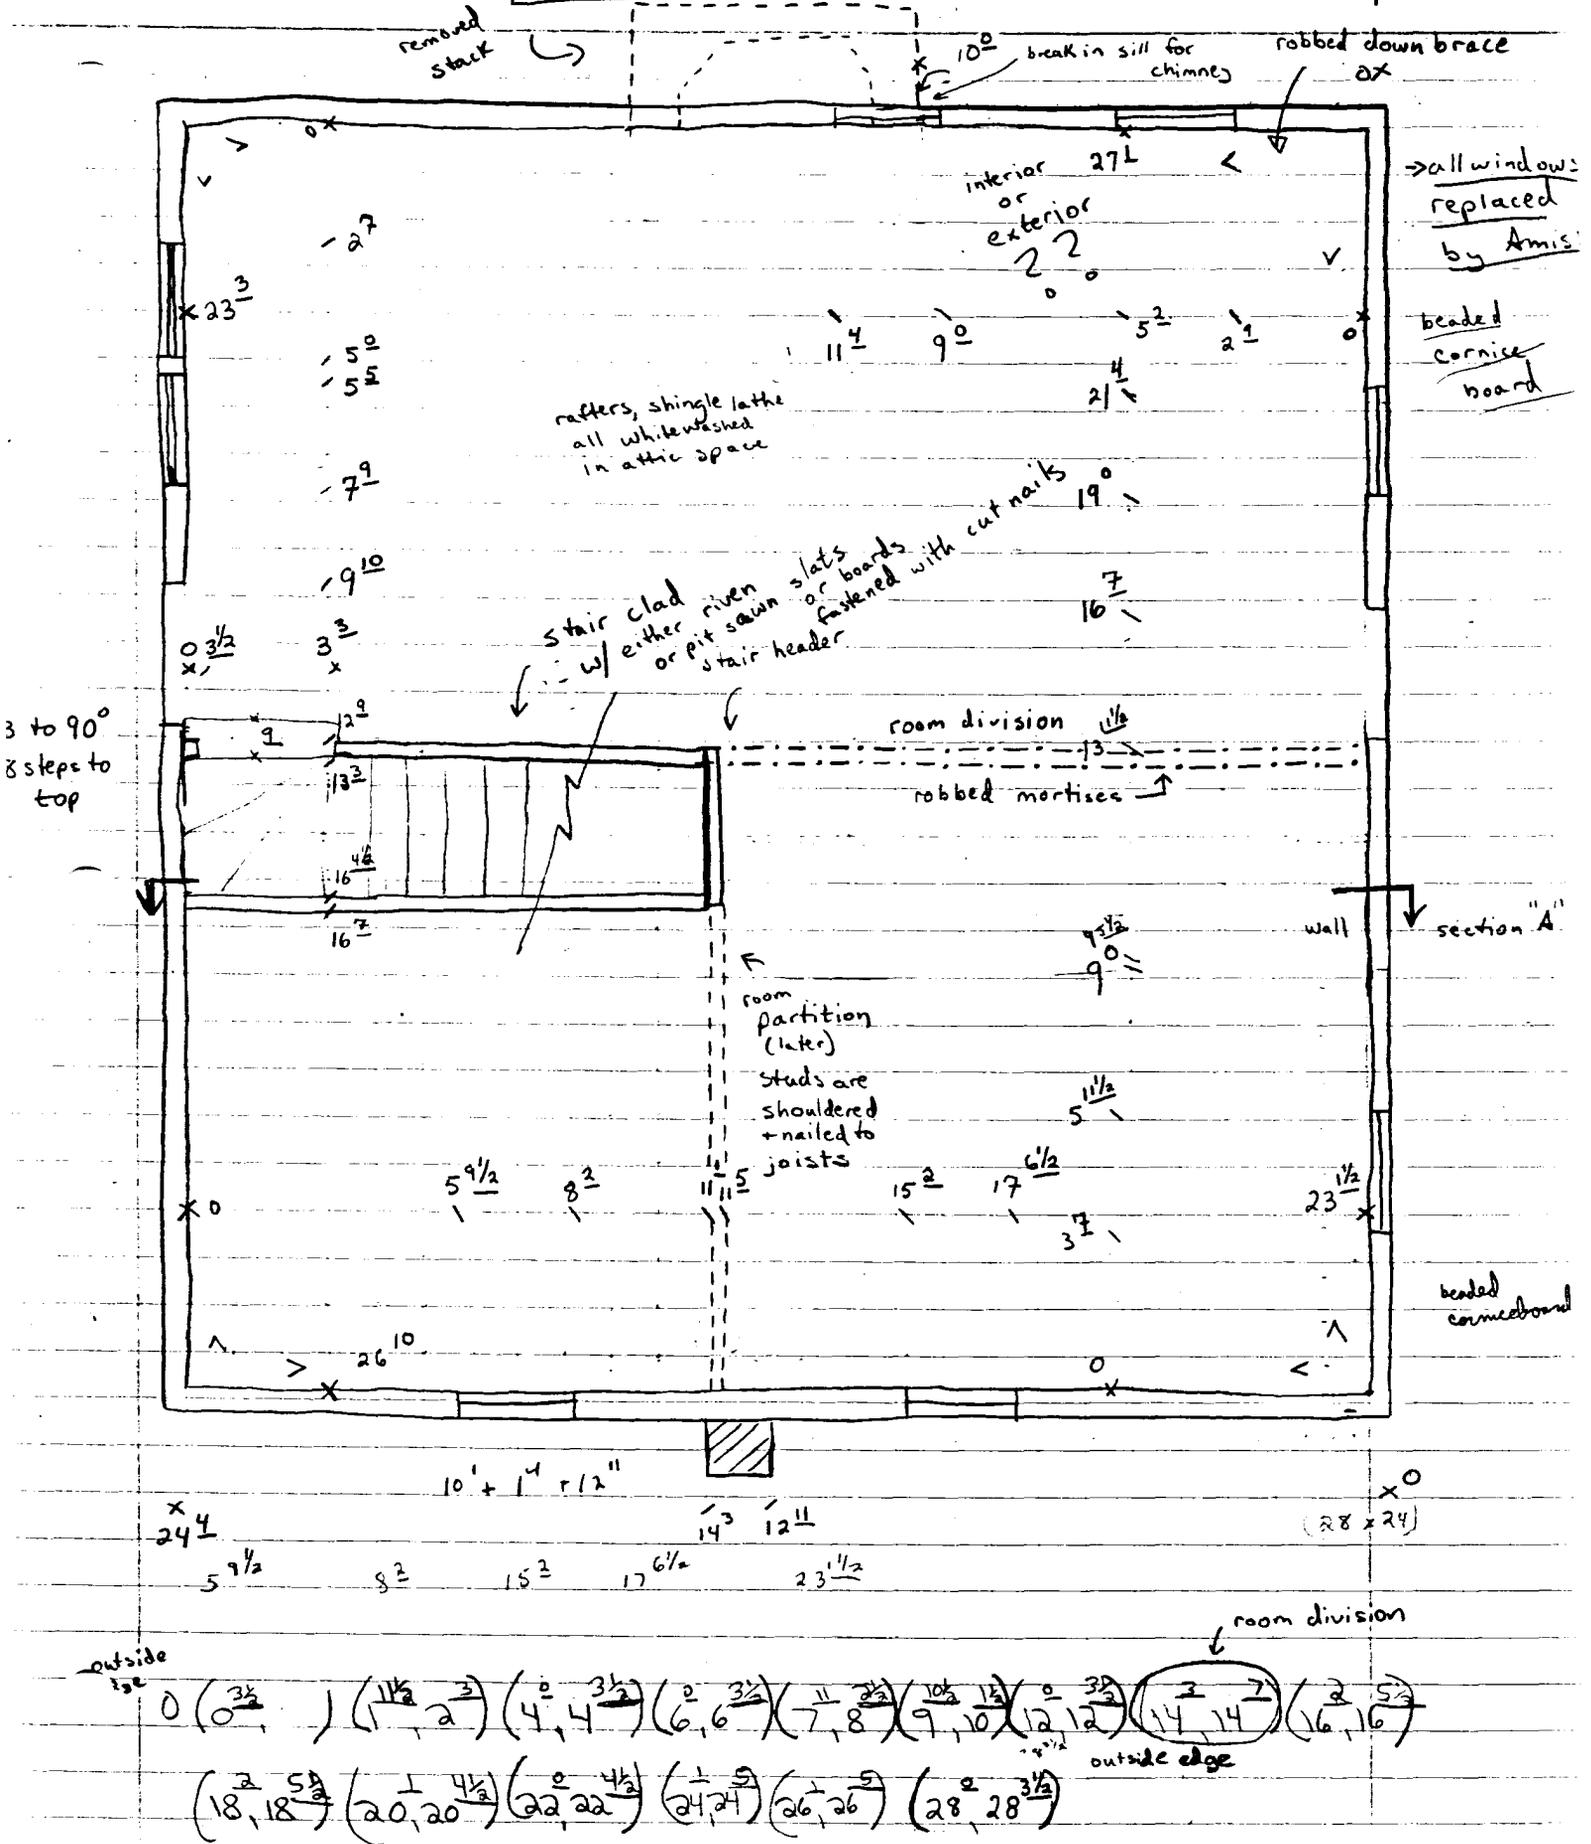
Woodburn Hill Farm
Thompson's Corner
S.M. - 577
March 12, 1997

5 walls

The original (c. 1840) Woodburn Hill farmhouse is a one-and-a-half story, braced frame dwelling with a three room plan, steep gable roof, and two shed additions. The house is sheathed with faux brick asphalt siding that covers an earlier siding of horizontal, pit sawn boards. The roof is covered with a raised-seam metal. Much of the building's original appearance has been largely obscured by modern changes such as the installation of modern sash, the removal of the exterior end chimney, and the installation of stove flues.

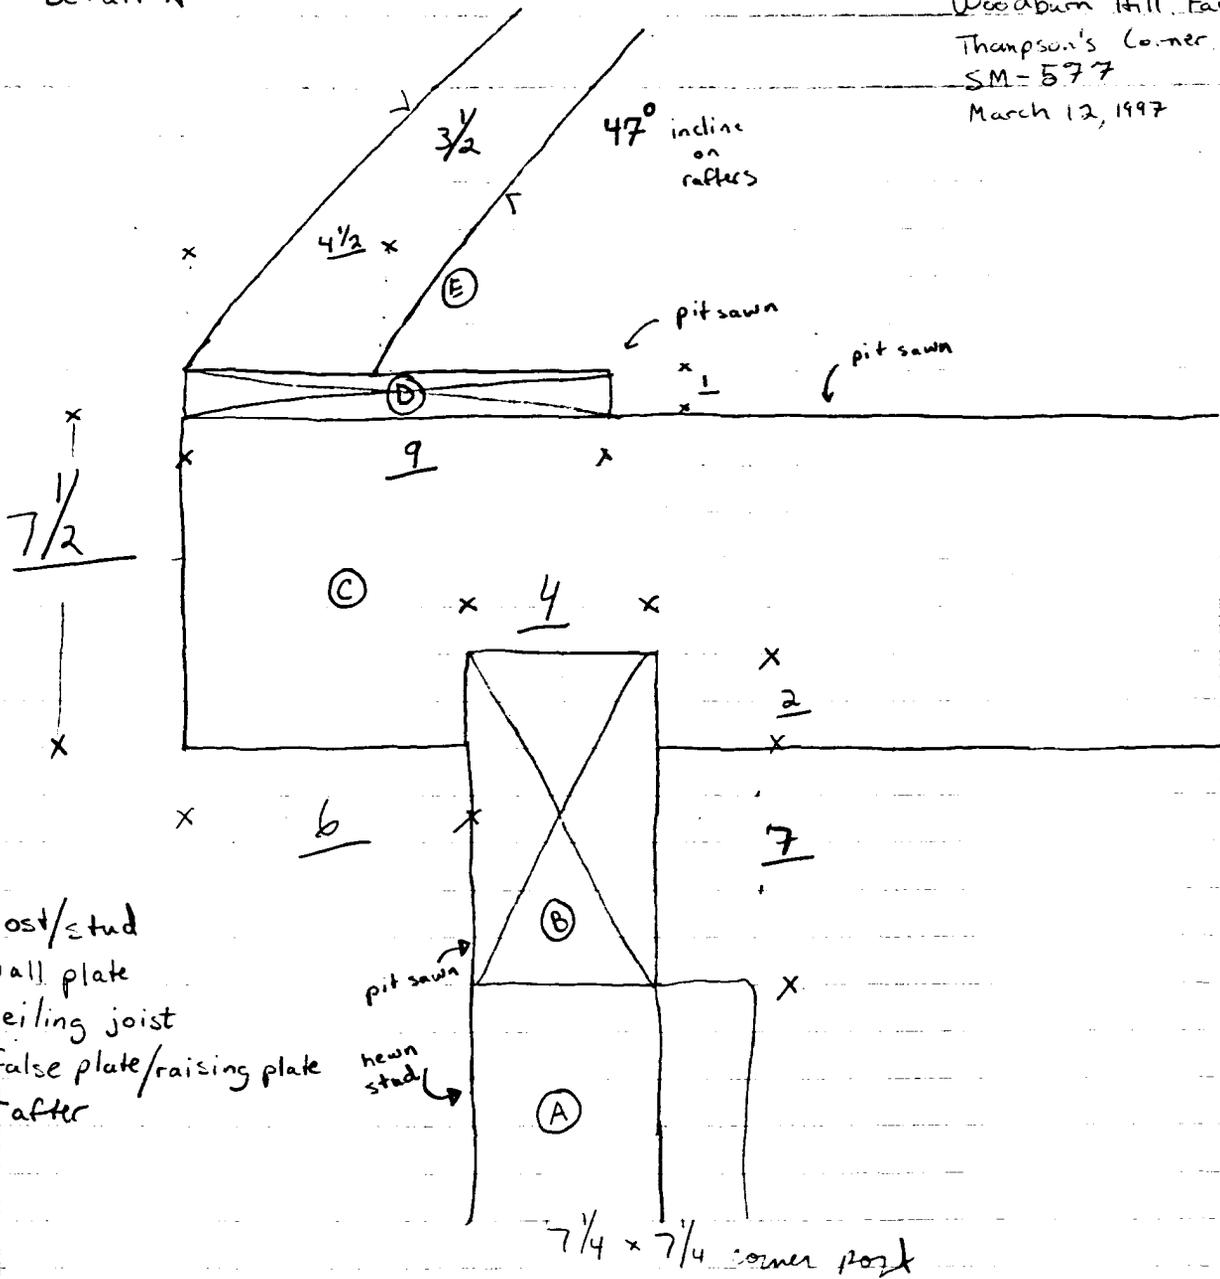
Detail "A"

- (A) = post/stud
- (E) = wall plate
- (C) = ceiling joist
- (D) = false plate/raising plate
- (E) = rafter

7 1/4 x 7 1/4 corner post

- whitewash on all first floor framing members
- stair between the two sections was enclosed using horizontal boards fastened w/ cut nails
-

- collar ties → 3 x 2 3/4
- rafters → 3 3/4 x 2 1/2
- floor joists → 7 1/2 x 3 1/2
- wall plate → 7 1/2 x 4
- false plate → 9 x 1
- posts → 3 1/2 x 2 1/2
- corner posts → 7 1/2 x 7
- down braces → 7 1/2 x 4
- sill →
- girt →

The interior has been totally gutted exposing most of the building's framing members. The framing consists of hewn and pit sawn sills, studs, joists, wall plates, and down braces. Evidence, namely the presence of numerous robbed mortises and bevel lap joints on a centrally located ceiling joist, suggest that the dwelling was originally divided into three spaces on the first floor—one large room that extended the full length of the house and two smaller spaces. The consistent presence of whitewash on the studs, down-braces, and ceiling joists suggests that the walls were originally left unfinished and never plastered over. The interior also lacks door and window surrounds, mantles, and other decorative elements. While obscured by several changes the presence of a large hearth, more characteristic of the building's period, was detected only on the north elevation. It was here that the sill was interrupted by mortar and brick for a hearth. The attic story is entered via an open winder stair located in the center of the dwelling. The stair was originally enclosed by horizontally laid wood strips or planks fastened (almost like clapboard) to vertical studs with fully formed cut nails. The half story flooring is comprised of random width, gauged planks fastened to the joists with cut brads. The presence of whitewash on the hewn rafters, collar ties, and shingle lathe on the north side as well as the presence of a robbed bevel lap joint suggests that the attic was divided into two spaces. The roof framing is comprised of a flat, pit sawn false plate that supports hewn rafter pairs held together by collar ties. The ties are half-lapped and fastened with fully formed cut nails to the rafters. At the roof peak the rafters meet in an open-mortise joint tenoned together with a wood peg. Judging from the frame and roof construction methods, nail use, and lack of interior finish, the dwelling probably dates from 1840 and may have served as either a tenant house or overseer's residence.

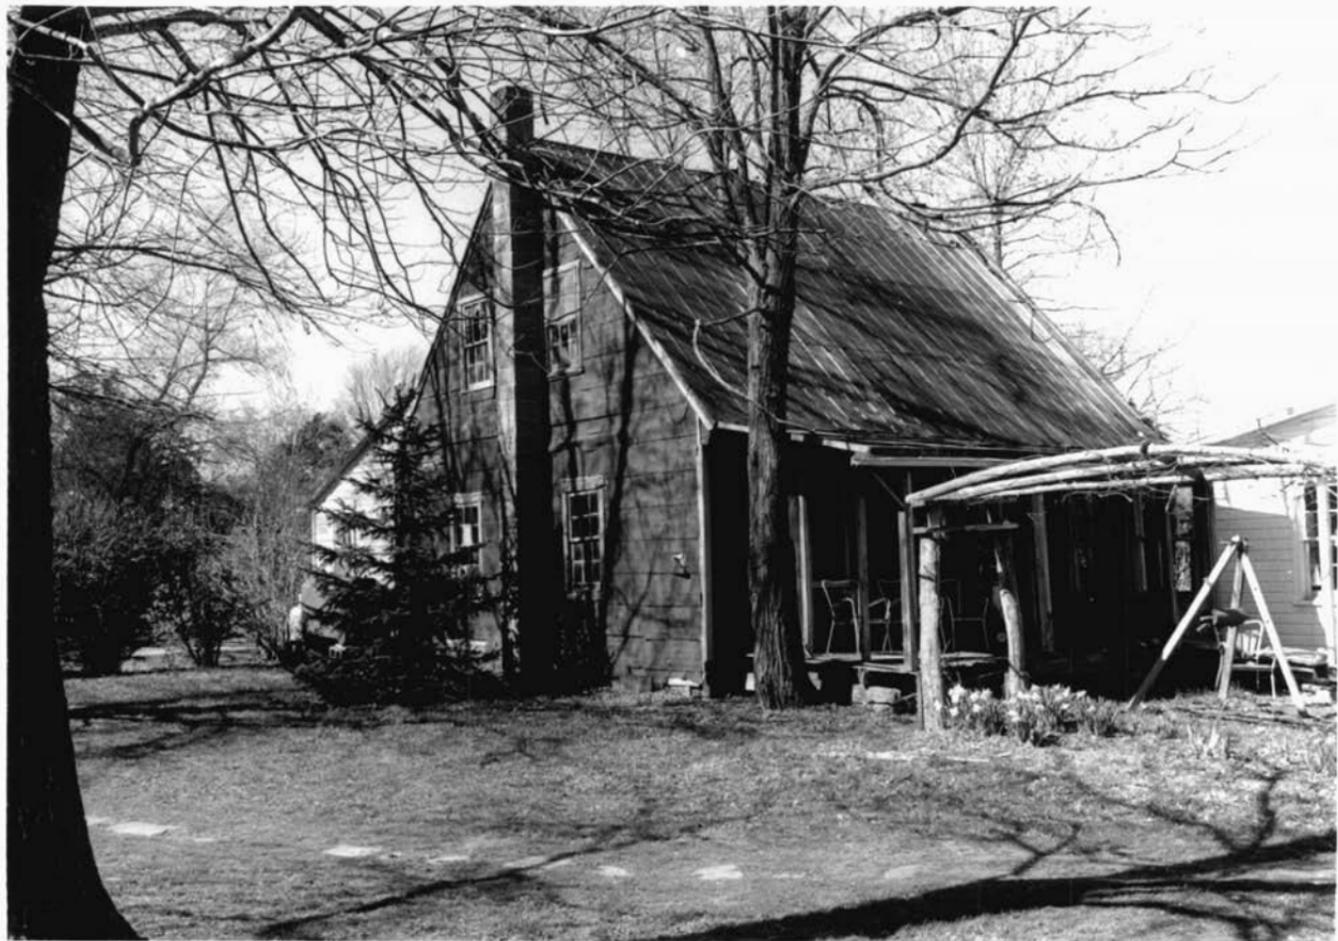
1 of 11

E+S elevations:

The primary or east elevation features a porch with a shed roof supported by four vertical posts. The porch may have been enclosed at one point because a set of paired six-over-six, double-hung sash windows are located on the porch's north side. The porch shades a centrally located wood panel door flanked on either side by a six-over-six, double-hung sash window. At the juncture of the wall and the roof is a wide, circular sawn, beaded fascia and soffit that encloses the end of the first floor ceiling joists.

The south elevation consists of the main block's gable end and the side of a one story shed addition that projects from the west elevation. The main block features a centrally located cinder block chimney flue flanked on either side by a six-over-six window on the first and second floors. The shed addition, sheathed with German (or drop) siding and topped with a raised seam metal roof, features six-over-six window.

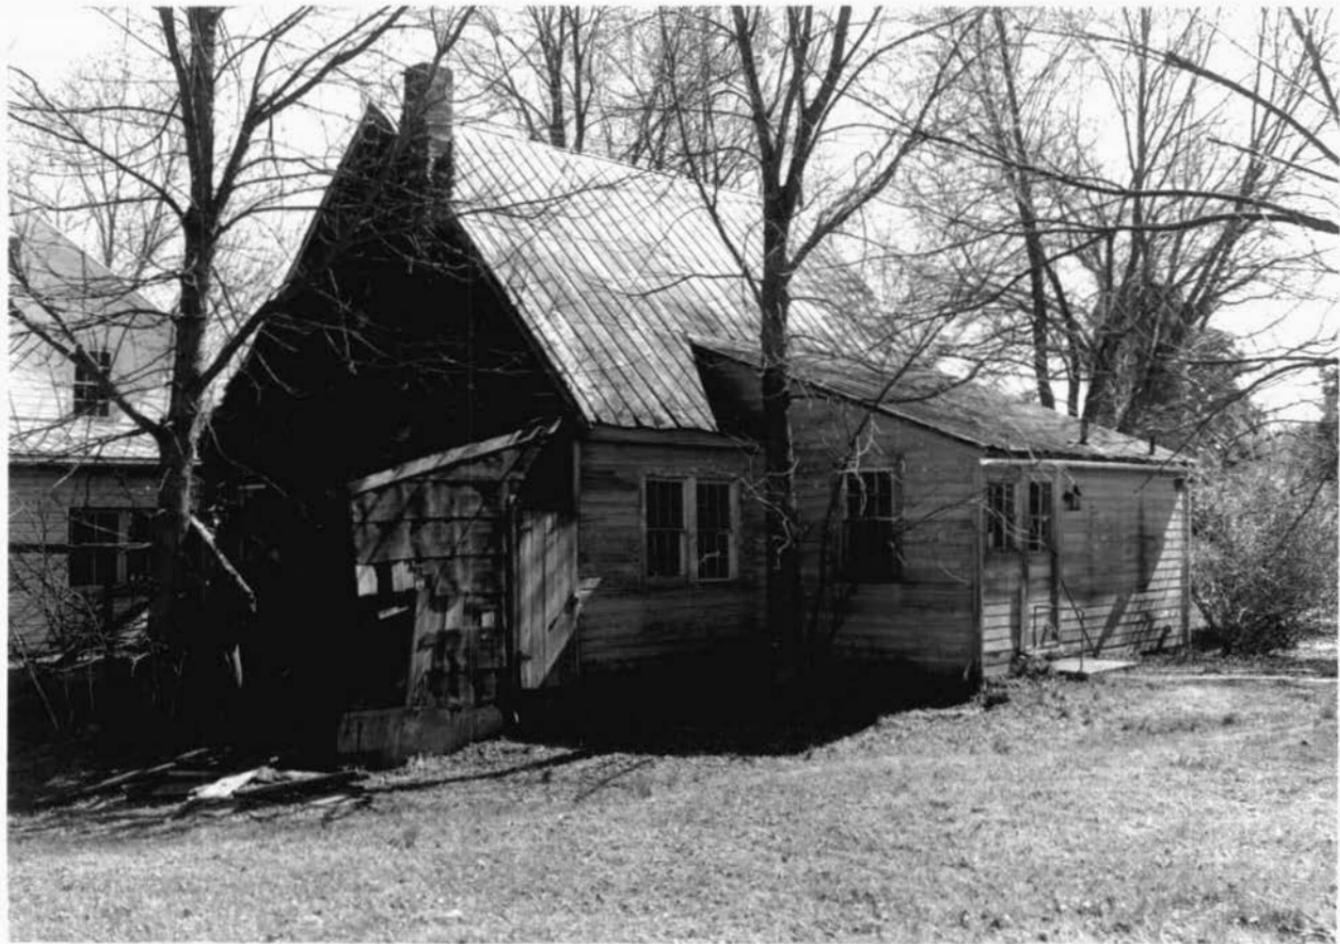
2 of 11

W + N elevations

The west elevation is dominated by the shed addition that extends for three-quarters of the main block. The shed addition features a six-over-six window and three panel, four light door. The main block exhibits a paired set of six-over-six double-hung sash window. To the north is another shed addition that extends from the north elevation. It features a single wood door and is in an advanced state of disrepair obscuring presence of other openings.

The north elevation consists of the deteriorating shed addition and two, six-over-six windows on the first floor and a single six-over-six window on the second floor. The elevation also contains a centrally located, exterior brick and cinder block chimney flue.

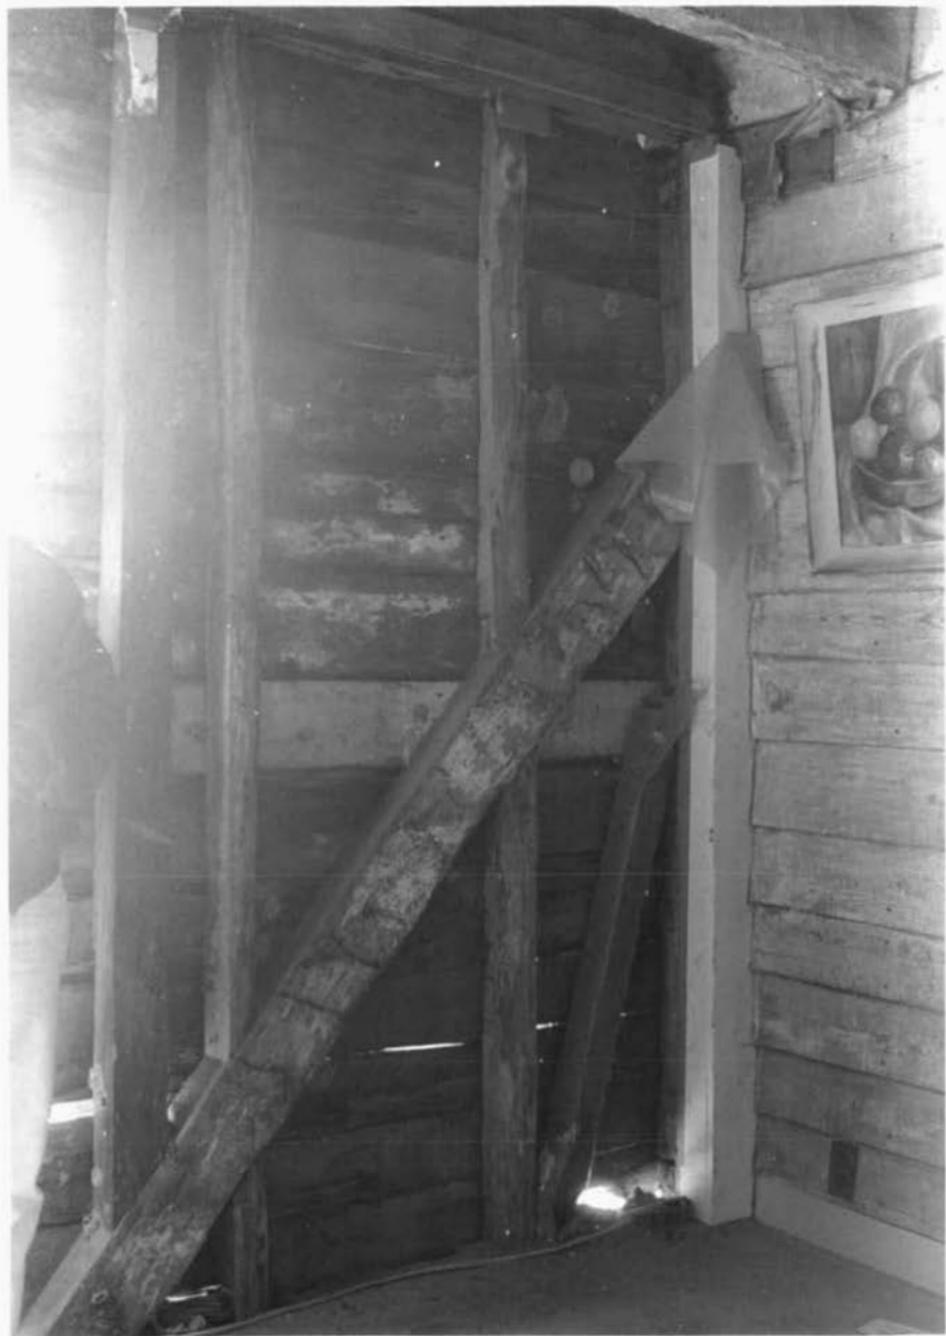
20

Interior, 1st floor, looking W

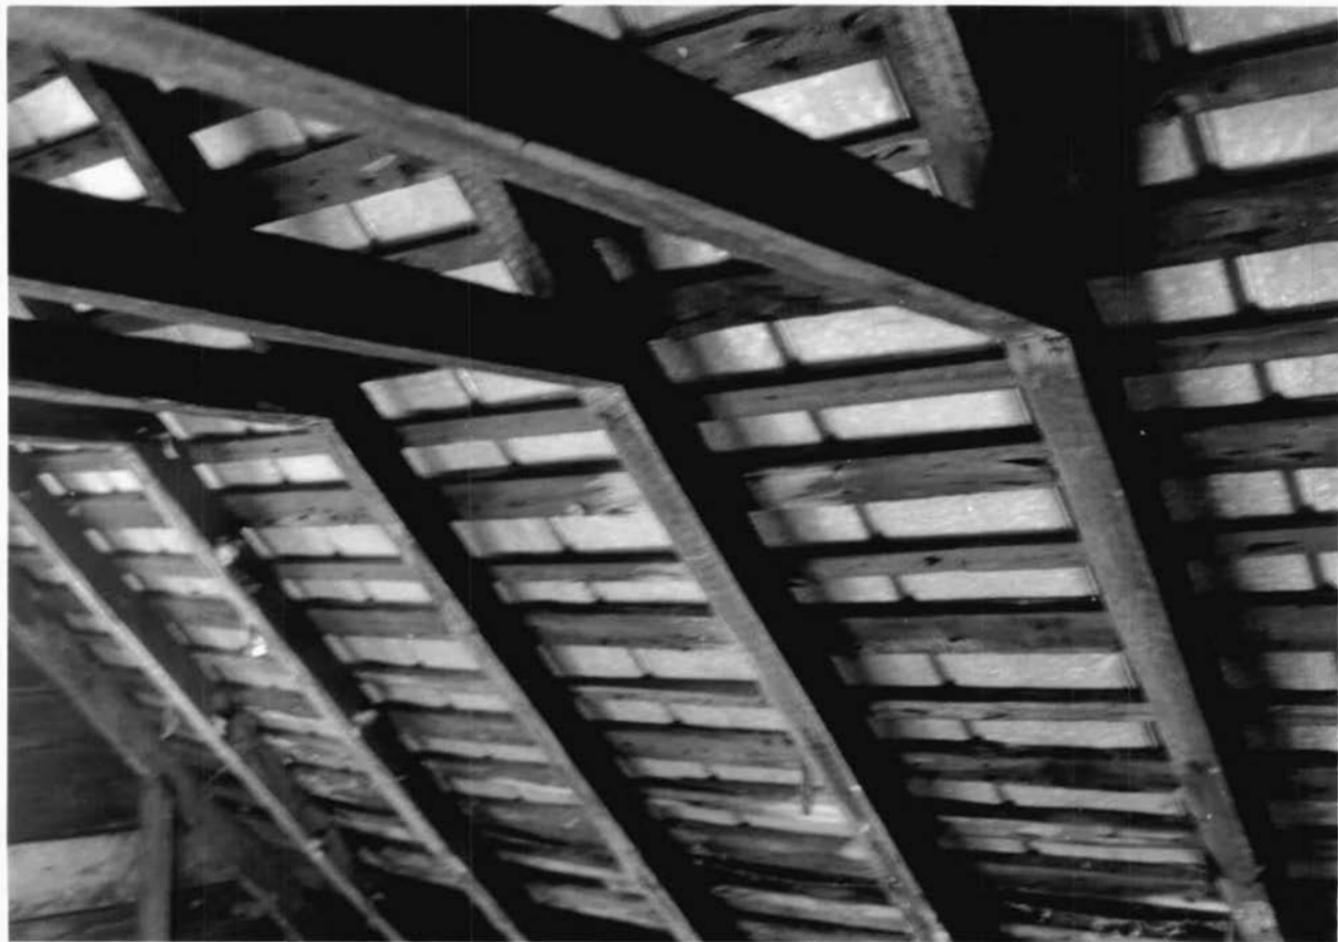
4 of 11

Interior, roof framing, looking W

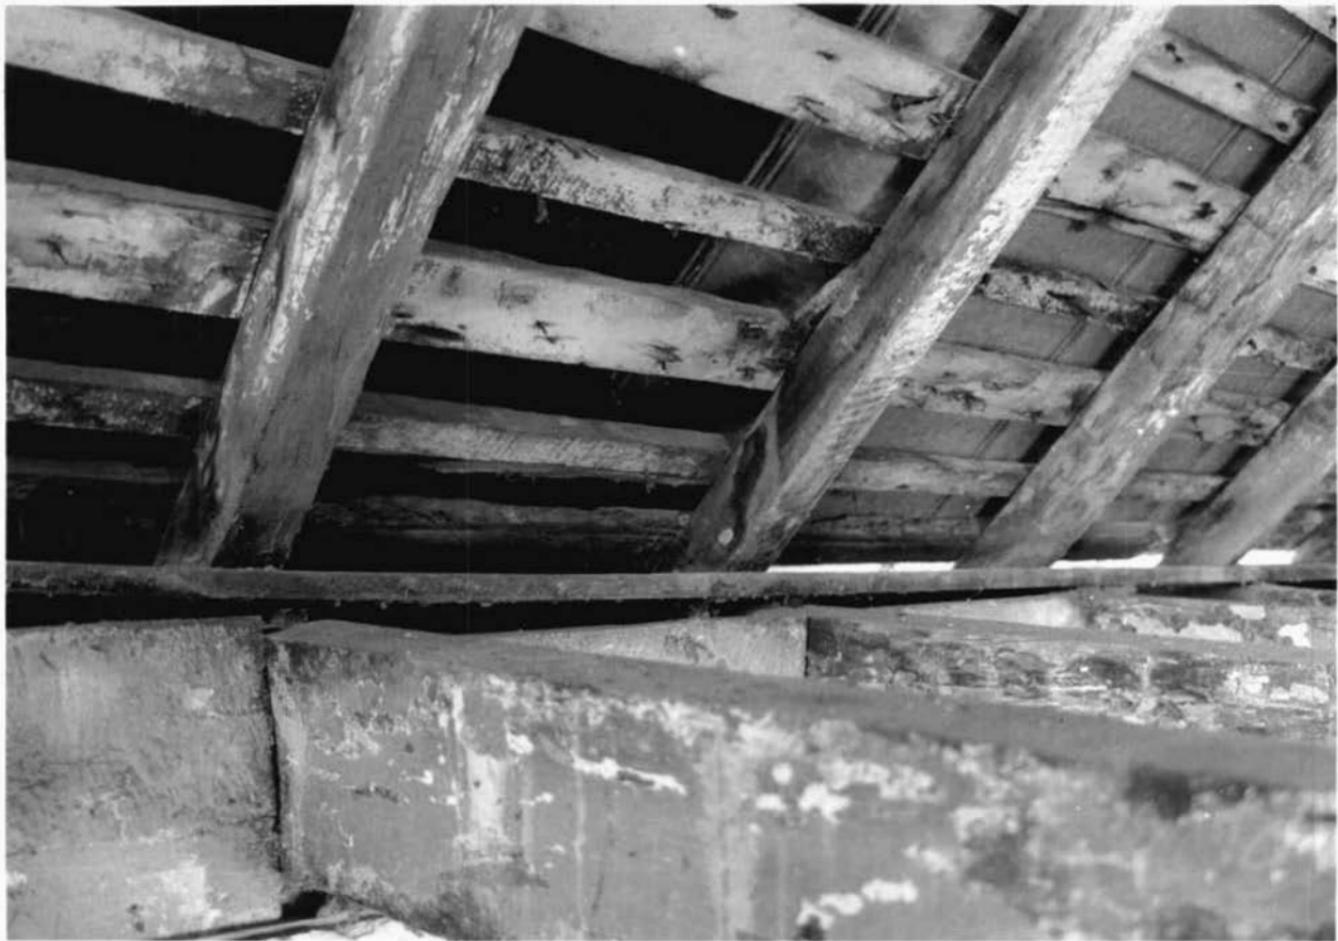
5 of 11

Interior, rafters, false plate, joints, looking N

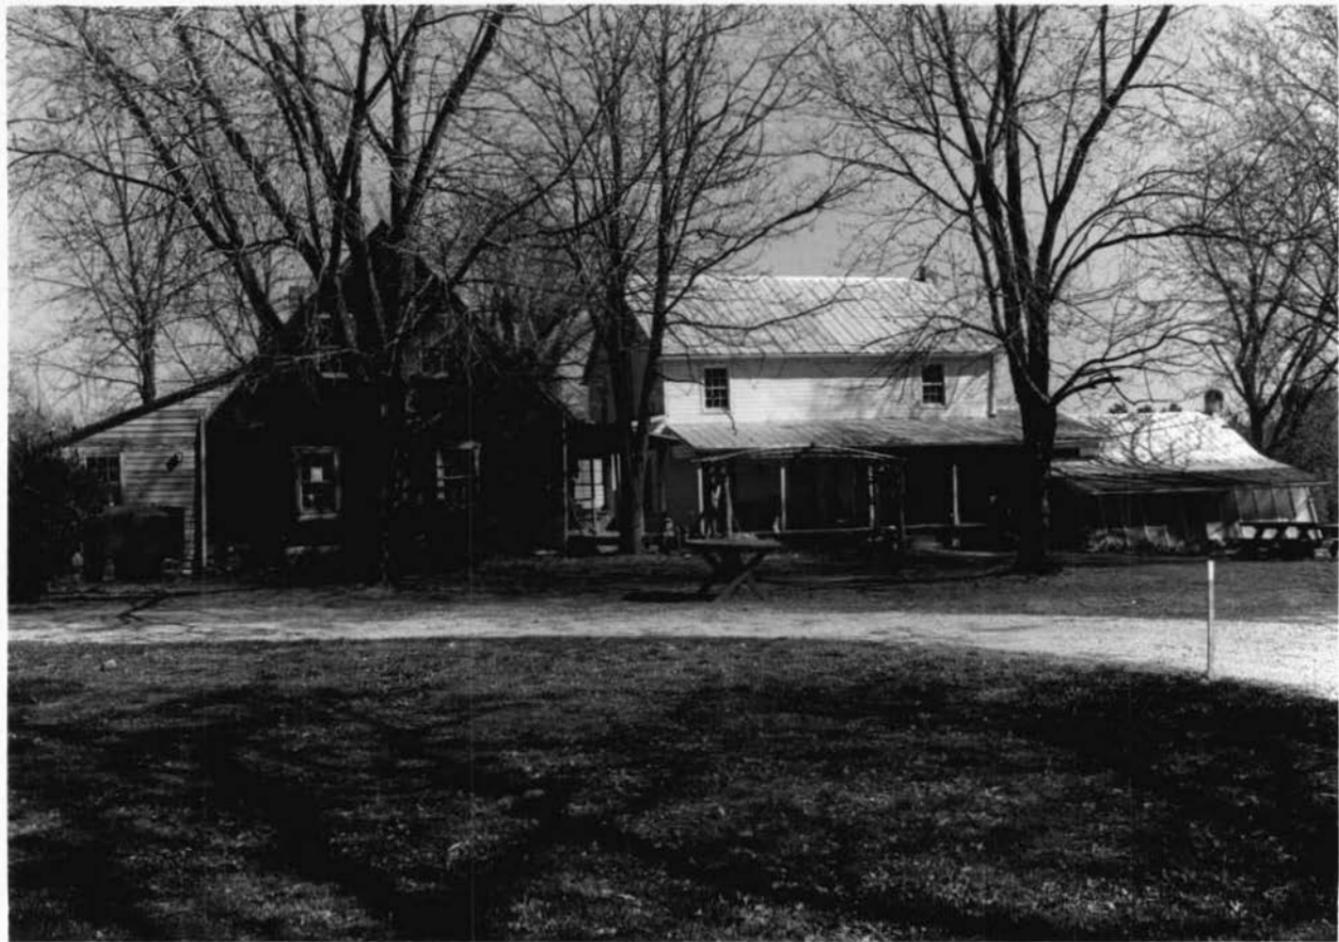
6 of 11

View of Amish House & Tenant/Overseer's House - looking N

The Amish dwelling located immediately to the east of the older farmhouse is a two-over-four bay, clapboard covered house with a raised seam metal roof and a one-story wing. The front or south elevation is shaded by a porch. This elevation is also pierced by four bays—two doors and two six-over-six double-hung sash windows. Constructed in the 1950s, the dwelling epitomizes Amish design and construction sensibilities. Its open interior plan with movable interior walls and boxy form represent distinctive characteristics.

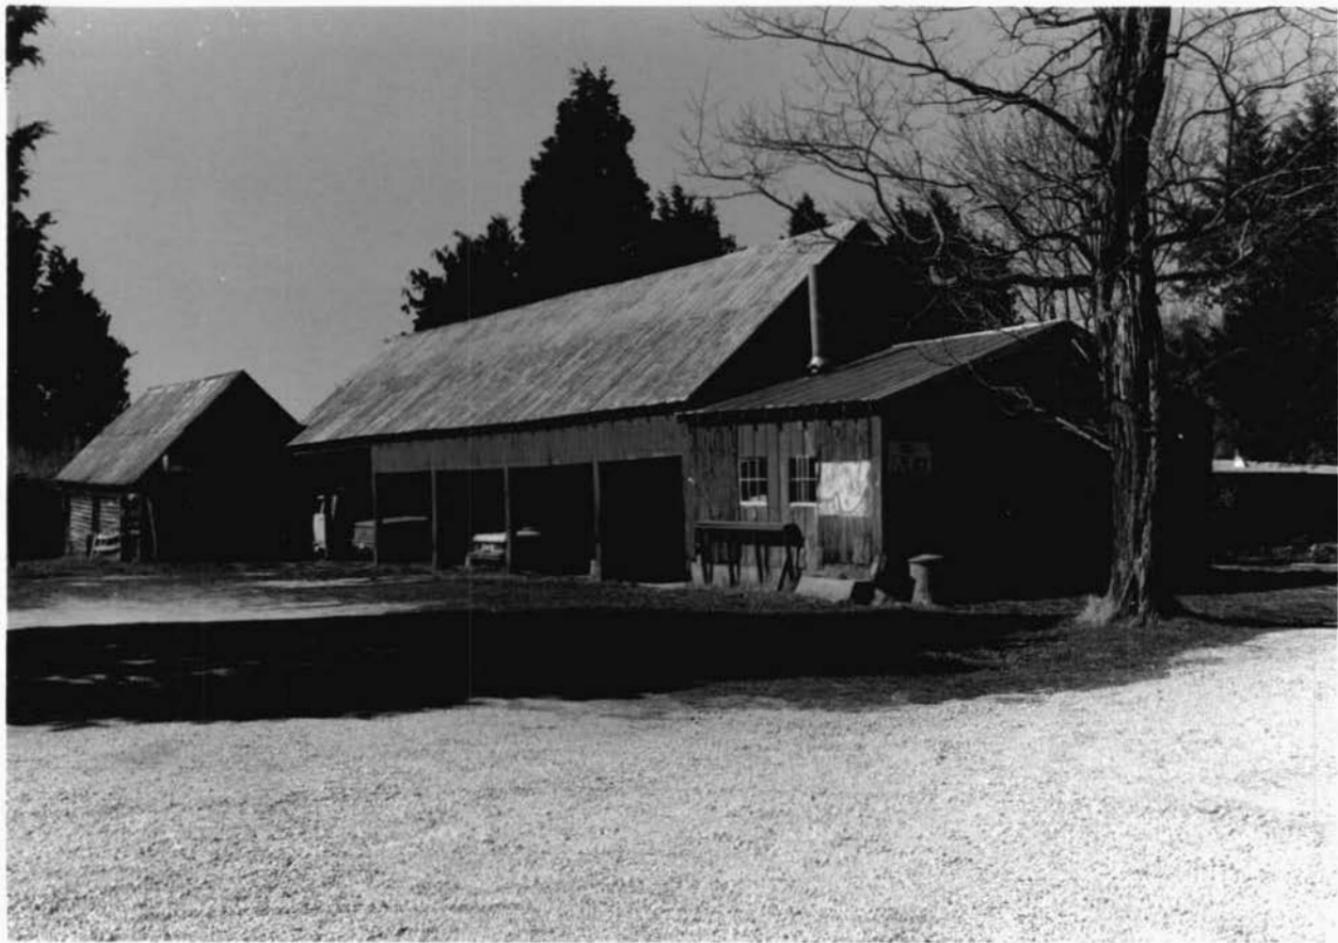
7 of 11

View of Equipment shed & corn crib - looking SW

To the west of the bank barn is an equipment and work shed as well as a corn crib. The equipment shed is sheathed on three sides by horizontal boards with the east side open for the storage of farm equipment. This building's roof is covered with corrugated metal. To the north of the equipment storage building is a one story work shed that is lit by a series of six-light fixed sash windows. The building is covered with horizontal boards and its roof is covered with raised-seam metal. This building may have served as a stripping shed or merely a workshop. To the south of the equipment shed is a frame corn crib. Covered with horizontal clapboard the building's roof is covered with raised-seam metal. The interior of the corn crib is divided into a central carriage way flanked on either side by cribs. The cribs consist of horizontal strips of wood attached to vertical framing members.

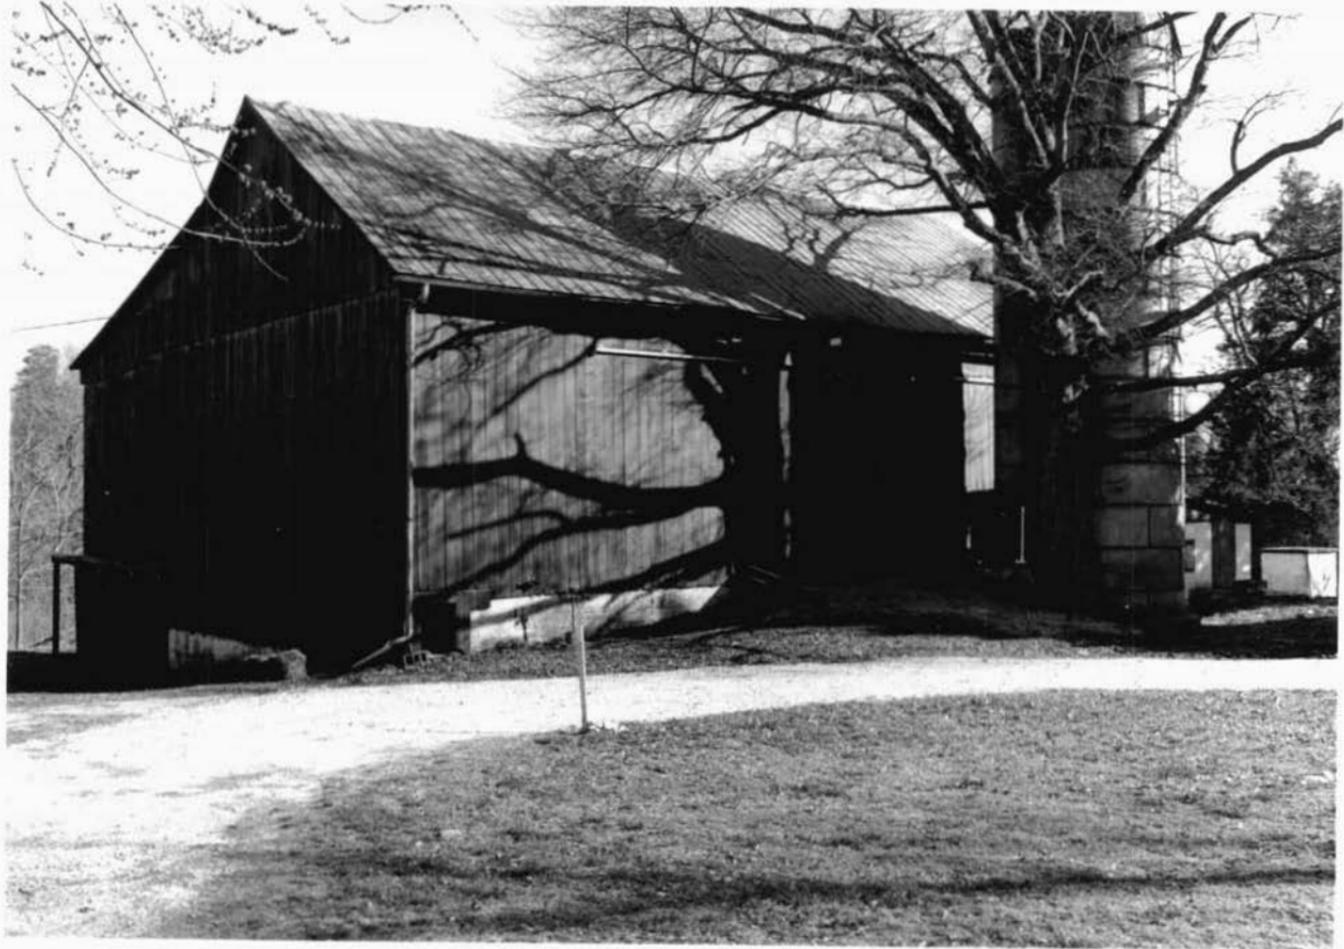
8 of 11

Bank Barn

W + N elevations

The bank barn, constructed contemporary to the Amish house, is a large braced frame structure that features a gable roof with a rear shed extension. The building is situated on a concrete foundation and is sheathed with vertical, circular sawn planks. The roof is covered with raised-seam metal. The west or primary elevation of the barn features a pair of sliding doors that are entered via a dirt ramp. Immediately to the south of the ramp is a metal covered grain silo. The north elevation features a concrete foundation pierced by several window openings and a sliding door that permits entry into the basement. The barn's rear or east elevation does not feature any windows or doors but an open vent extending the entire elevation has been cut just below the eaves to facilitate aeration. The south elevation features a shed roof addition and another sliding door into the bottom story of the barn.

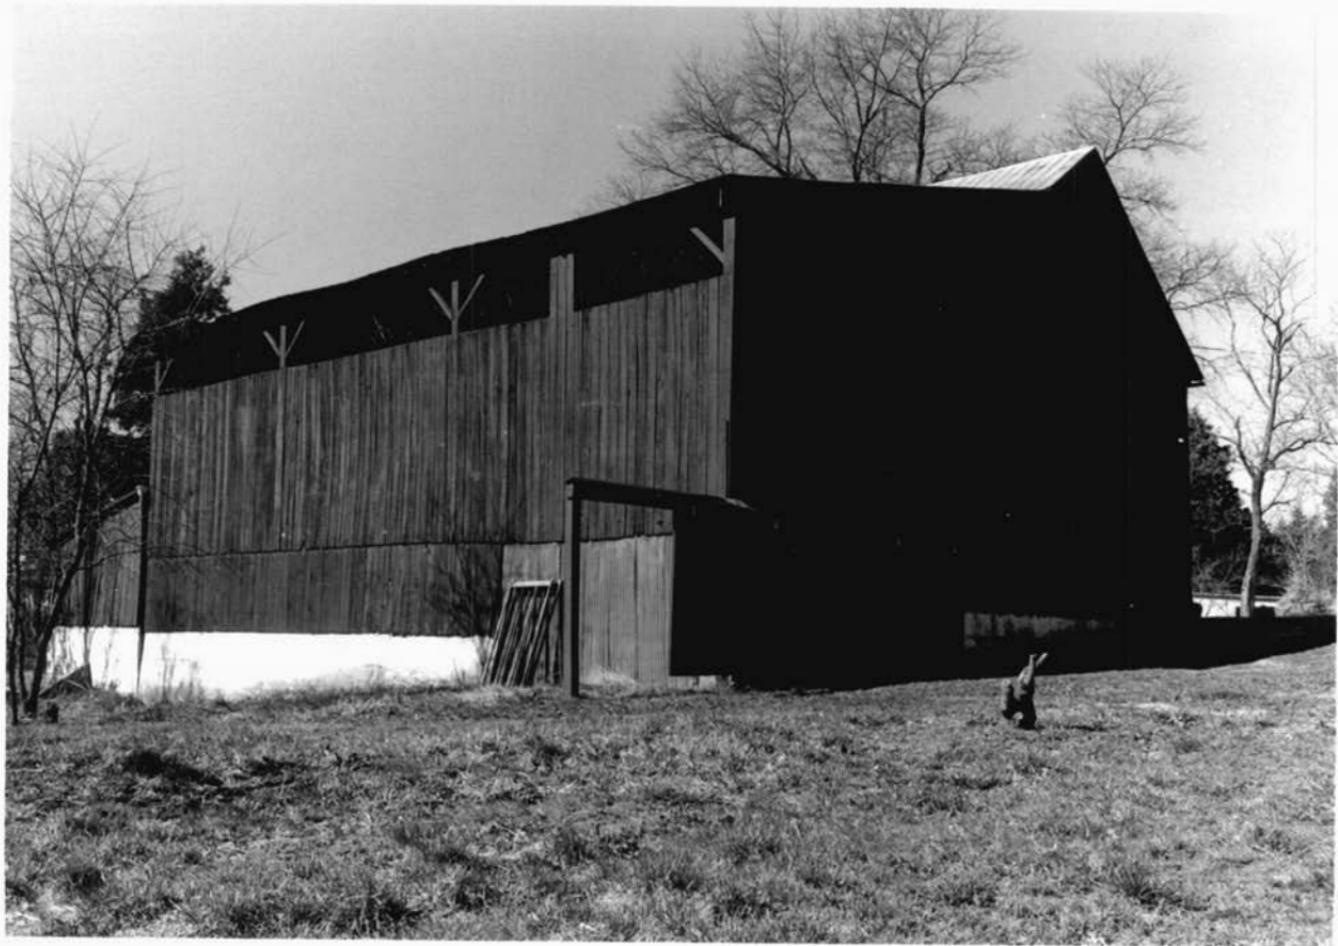
9 of 11

Bank Farm

N + E elevations

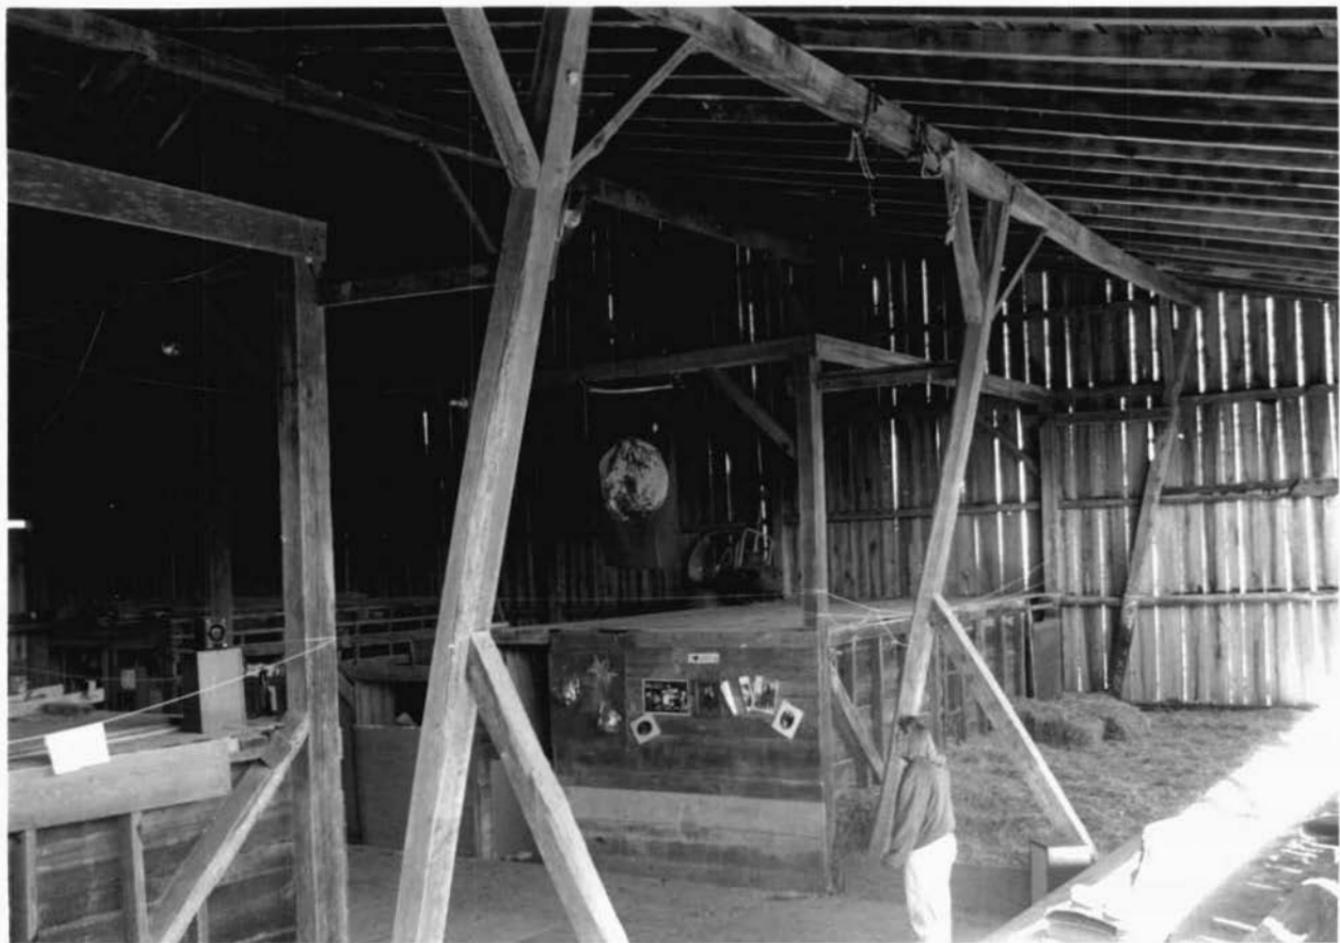
10 of 11

Bank Barn, hay lot, looking N

other equipment associated with operation remain in the room. The hay loft above the stalls and dairy operation features a central carriage-way entered via the door on the west elevation. The carriage way is flanked on either side by spaces that may have served as stalls at one time. The rear or east section of the barn was primarily use for hay storage. Trap doors and chutes in the barn floor reveal how hay could be lowered into the basement stalls. The interior framing, consisting of a series of braced posts, struts, wall plates, and roof purlins gives the interior an open feeling and appearance. The most interesting feature is the 30° tilted struts that support a purlin for the rear section of the barn. The purlin, in turn, supports the rafters for the roof.

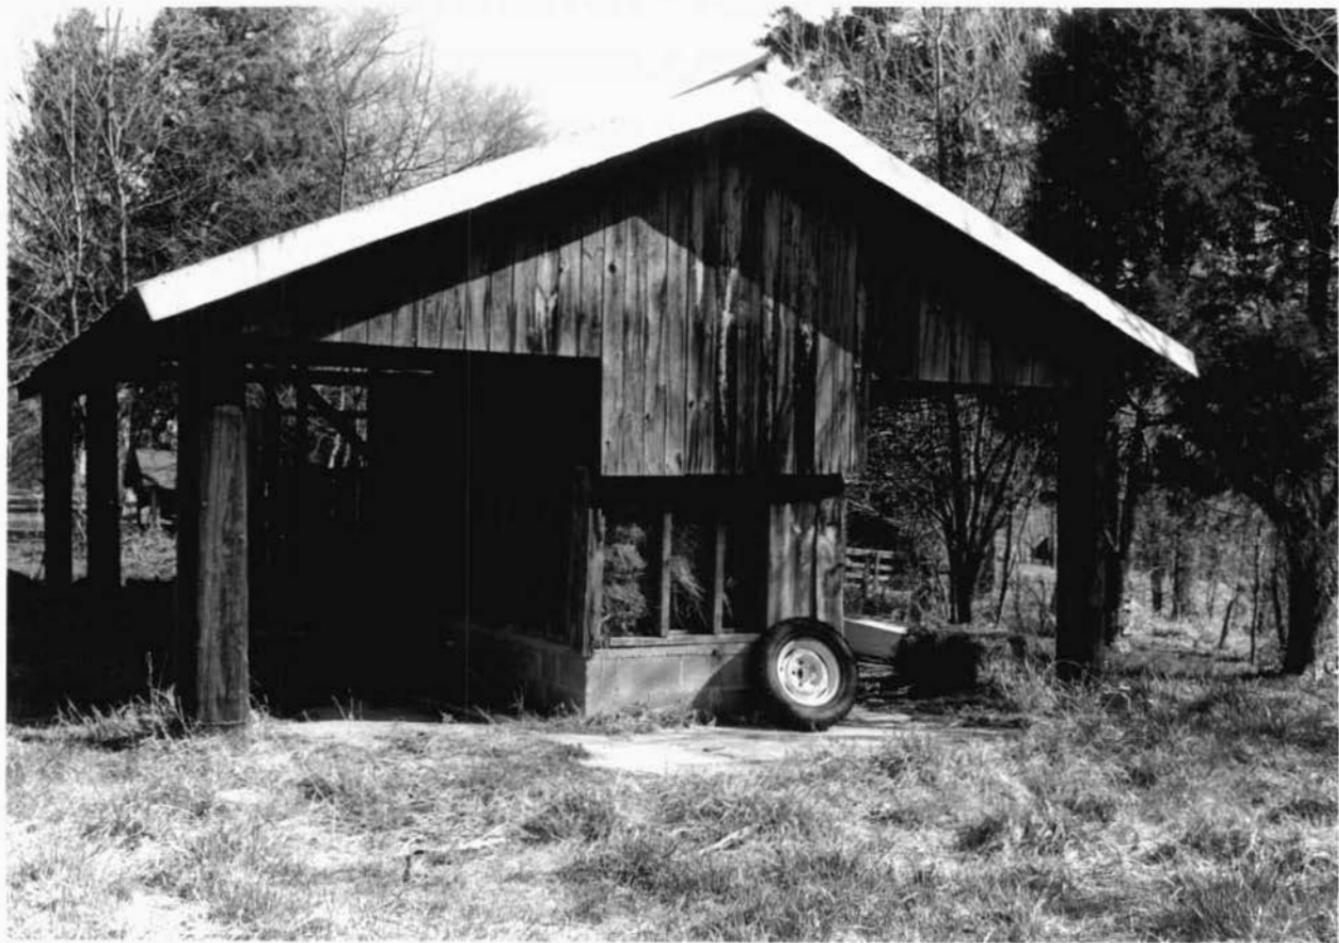
11 of 11

hay barrack, looking NE

To the south of the barn is a hay barrack. This open-air gable roof structure is supported by a series of earthfast poles that line the east and west sides. The tops of the gable ends are sheathed with horizontal boards and the roof is covered with asphalt shingles. The building serves as a hay storage facility as well as a shelter for feeding domestic animals. The hay bales, stored in the center section that rests on a cinder block foundation, were held in place by a two-by-four frame or cribbing thus permitting the organized feeding of animals.
