MARYLAND HISTORICAL TRUST
DETERMINATION OF ELIGIBILITY FORM

Property Name: Hen Coop Farm Inventory Number: SM-612
Address: 49780 Cornfield Harbor Road City: Scotland Zip Code: 20687
County: Saint Marys USGS Topographic Map: Point Lookout
Owner: MD Department of Natural Resources Is the property being evaluated a district? ___ yes
Tax Parcel Number: 61 Tax Map Number: 73 Tax Account ID Number: 01011588
Project: Wetland Mitigation Site for MD 5 Camp Ground Road Agency: State Highway Administration
Site visit by MHT staff: **X** no ___ yes Name: _____ Date: _____
Is the property is located within a historic district? ___ yes **X** no

Capsule Summary
SM-612
Hen Coop Farm
Scotland Vicinity
Public

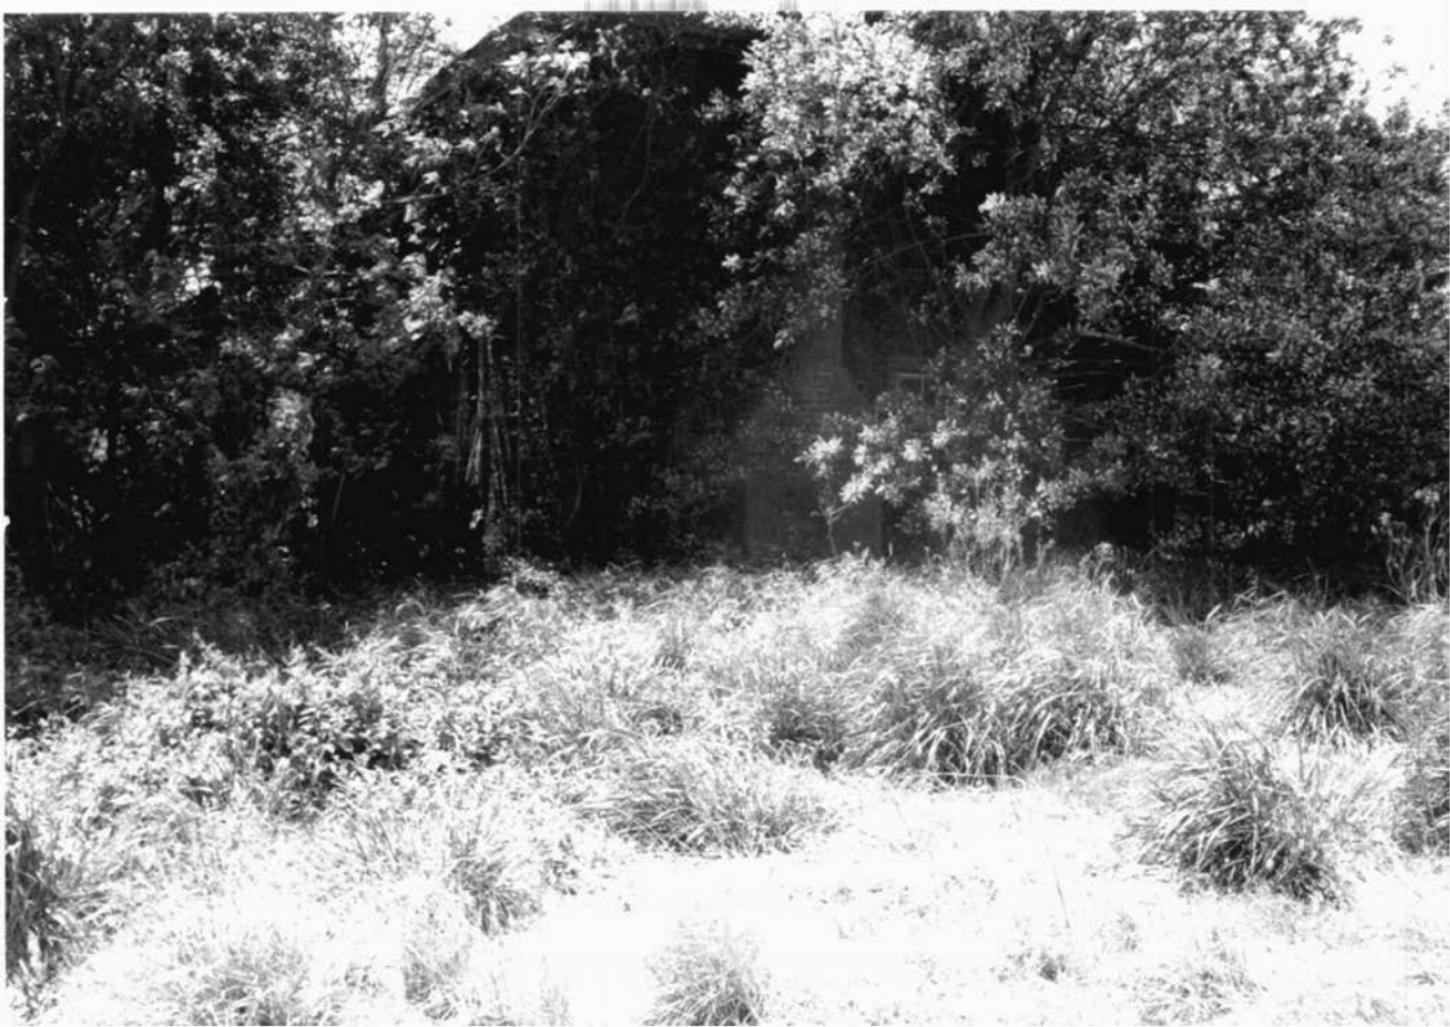
Looking north from the
road - very visible in the
distance

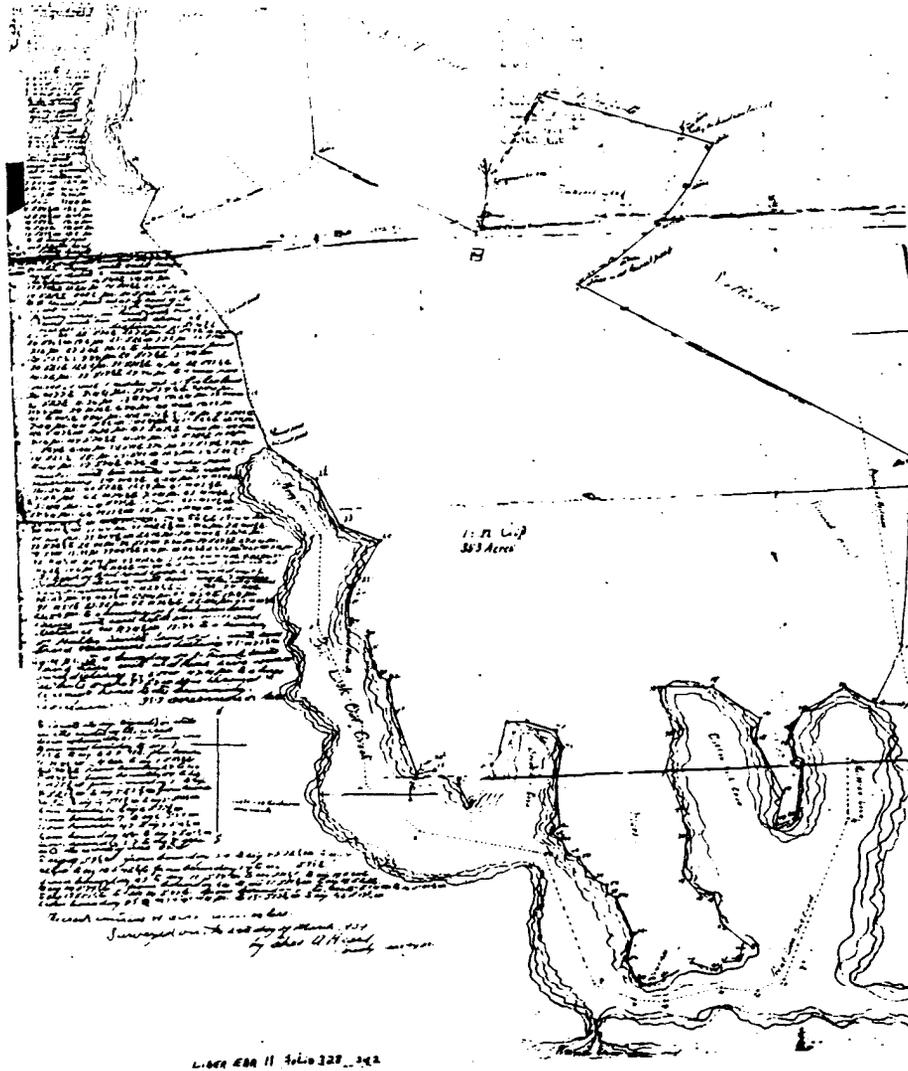
Figure 1. Plat of "Hen Coop" made by surveyor Charles A. Heard on March 29, 1909. The orange highlight represents the location of the present house. The yellow highlight notes the locations of barns and other houses that are no longer evident. The red highlight marks the shores of Pt. Lookout Creek to the south and Potter's Creek to the north. St. Mary's County Land Records, Plat Record Liber EBA 11, Folio 328.

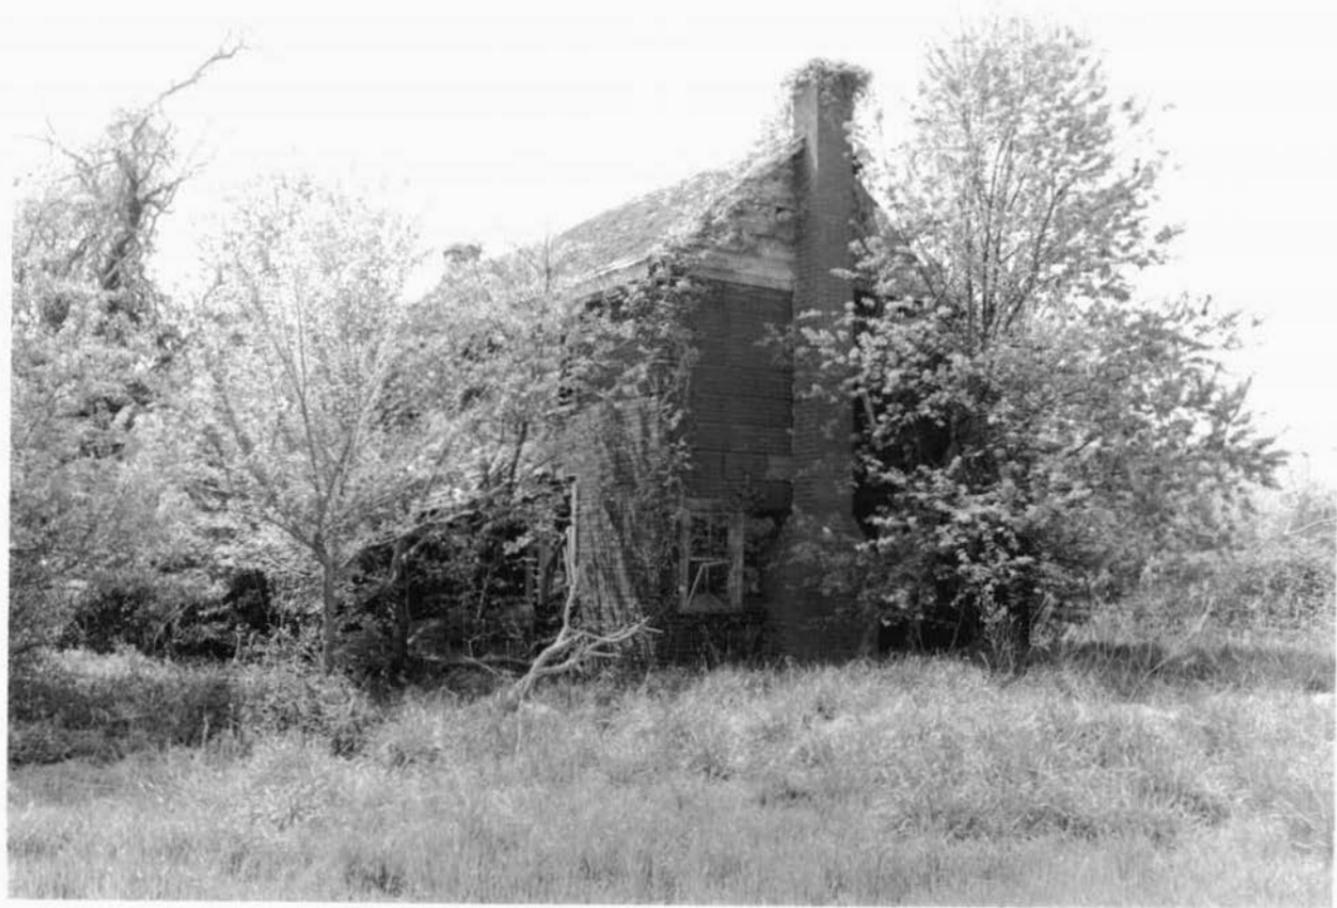
1 of 3

E + N elevations

The east elevation, consists of the main block's gable end and the rear ell's side. The main block exhibits a rebuilt chimney constructed of mid-twentieth century brick flanked on either side by a two-over-two window. The second floor does not feature any openings. The ell is pierced on the first and second floors by now broken out two-over-two windows.

The north elevation, which faces Potter's Creek, consists of the ell's gable end, the rear of the main block, and the rear of the kitchen. The main block is pierced by two, six-over-six windows on the first and second floors. The ell, meanwhile, exhibits a window on the first and second floors -- probably two-over-two sash which have been broken out. The wing features two, two-over-two windows.

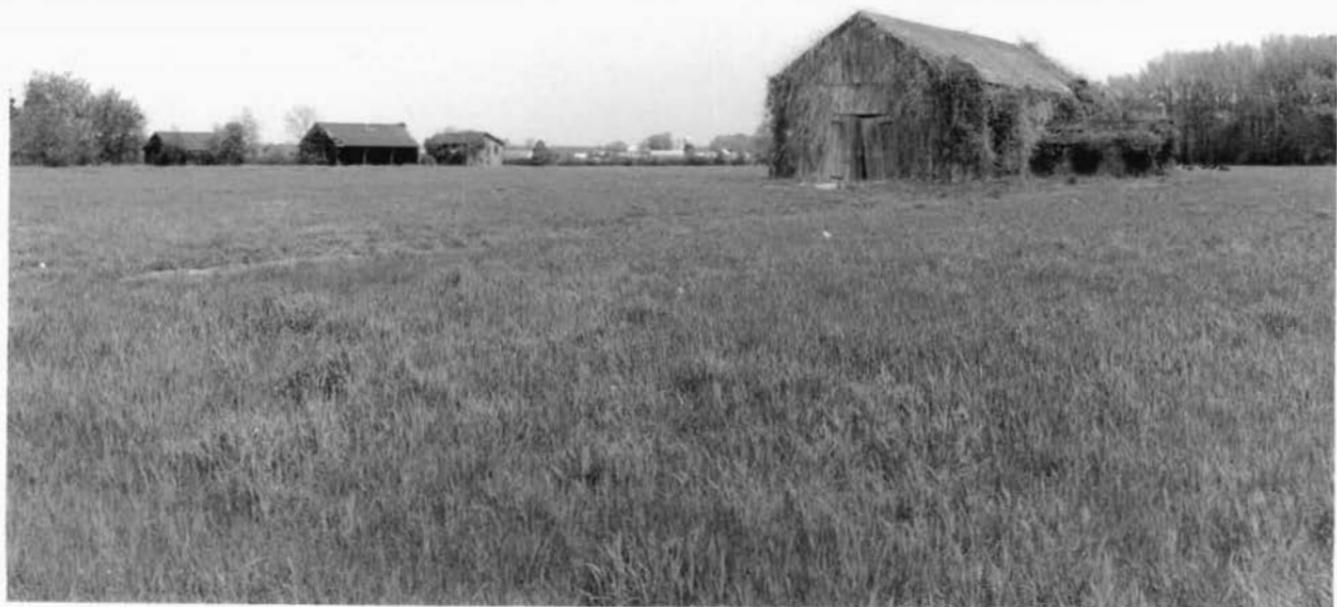
3 of 3

outbuildings - looking N

To the north of the tobacco barn is another farm lane that leads to three more outbuildings -- a corn crib, equipment shed, and a storage shed. All three buildings feature concrete pier foundations and raised seam metal roofs. The corn crib features slatted sides that bow out as the wall rises. The equipment shed features three bays. The storage shed was not readily accessibly due to overgrowth but was constructed of circular sawn boards attached to the frame with wire nails. Just to the north of the house are a pair of domestic outbuildings. Unfortunately, due to substantial deterioration their exact functions could not be determined, but they appear to served as meathouse and storage shed.
