Maryland Inventory of Historic Properties number: SM-618.

Name: MD 242 over Locust Run

Maryland Inventory of Historic Properties
Historic Bridge Inventory
Maryland State Highway Administration
Maryland Historical Trust

SHA Bridge No. 18019 Name: MD 242 over Locust Run

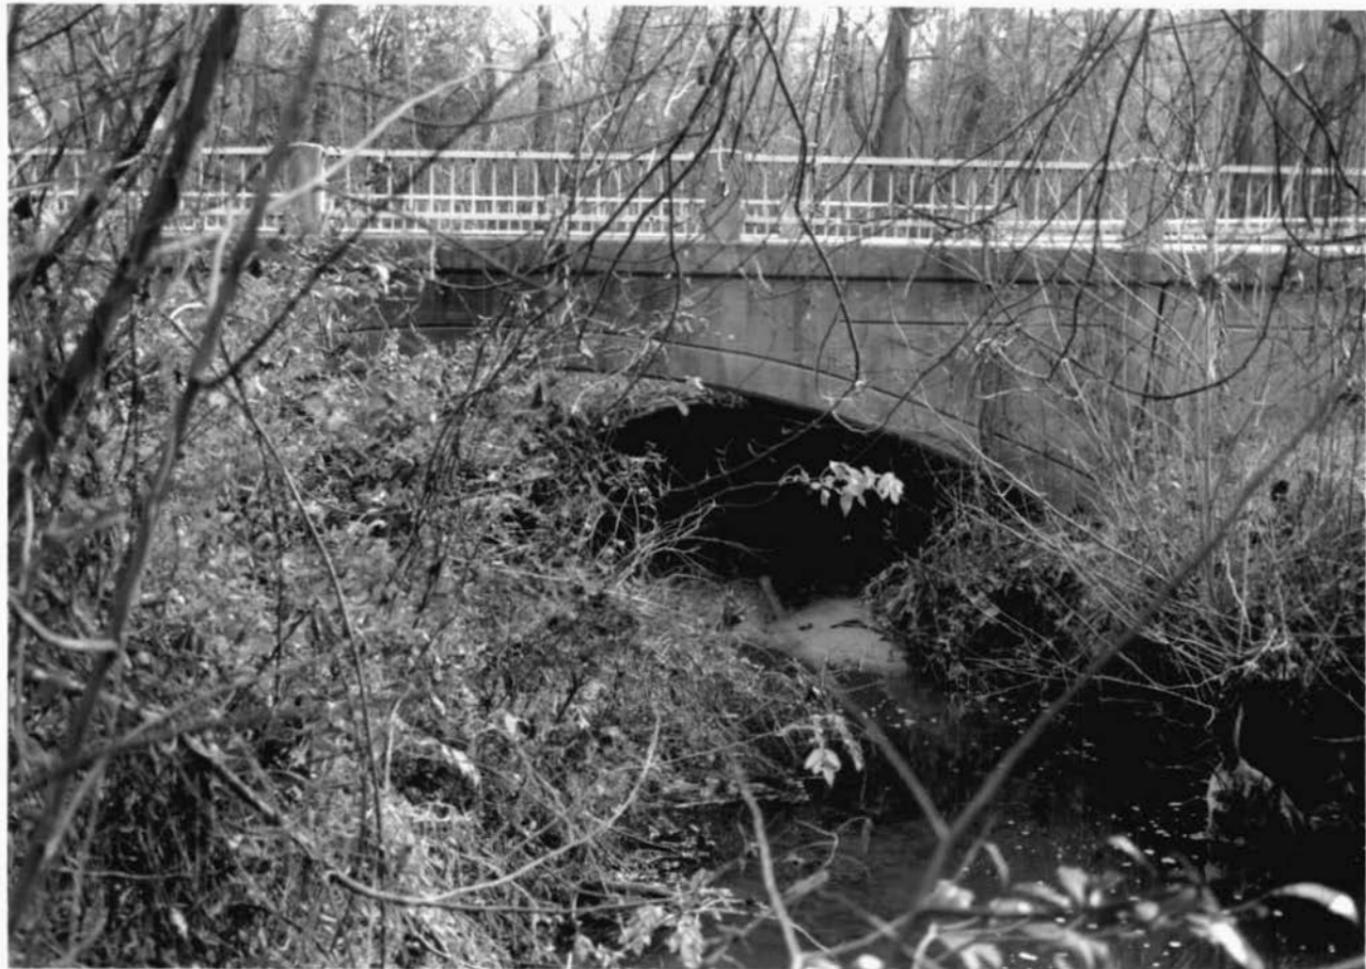
1. SM-618
2. MD 242 over Locust Run
3. St. Mary's Co., MD
4. Wallace, Montgomery & Assoc.
5. 12/97
6. MD SHPO
7. Elevation looking upstream
8. 1 of 4

Bridge 18019 is a single span filled concrete arch bridge. The length of the bridge is 47 feet with a clear span of 30 feet. The roadway width is 38 feet, with an overall bridge width of 44 feet 4 inches. The spandrel wall has a 2-inch cove molding around the arch and a 1-inch molding on the spandrel wall. The spandrel walls are approximately 10 feet high and 15 feet wide. The bridge has a rise of approximately 5 feet from springline to the crown. According to a 1997 inspection report, the bridge is in good condition with a sufficiency rating of 90.3.

The sidewalk on the east side of the bridge is spalling along the top outer edge approximately 20 feet from the south end with no reinforcement bar showing. Also, at each corner there is a section of concrete missing at the end of the curb where a steel guardrail may have been mounted. The concrete arch has fine scattered map and transverse cracks with some very light efflorescence. There is a spall at the corner of the southeast retaining wall, which is unchanged. There are scattered small spalls throughout up to 6 inches in diameter and 3/8 inch deep. The spandrel walls have scattered fine vertical cracks, and most have light efflorescence and a few chipped spots along the edges.
