Capsule Summary
SM-665
Fox Tenant House
Leonardtown vicinity
Private

Survey No. SM-665

Maryland Historical Trust
State Historic Sites Inventory Form

and/or common Fox Tenant House (pref.)

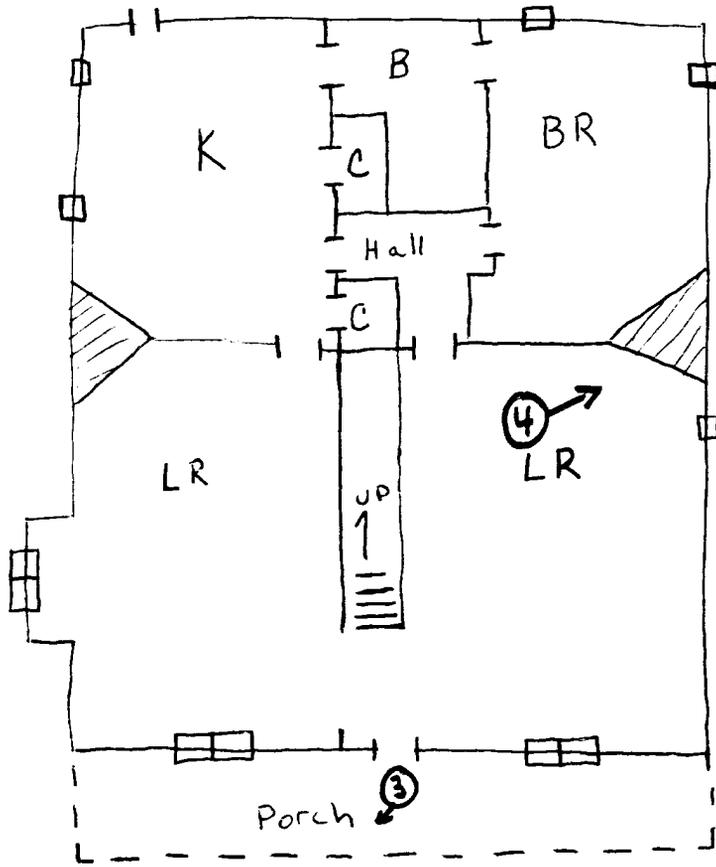
First Floor Plan

The interior features a relatively open plan. Immediately upon entering the cottage, a modest, open-string stair lies directly in front of the main entrance. The stair featured square balusters and a handrail that is no longer extant. On either side of the stair is a living room. Each of these spaces have corner fireplaces. Scars mark the location of modest mantels that once adorned the fireplaces. The room behind the northwest living room is a kitchen that exhibits a number of doors that lead to a pantry, bathroom, closet, and hallway into a bed chamber situated in the southeast corner of the house. This chamber has retained parts of its original mantel. The half story contains two rooms that appear to have never been finished. They feature no architectural elaboration.

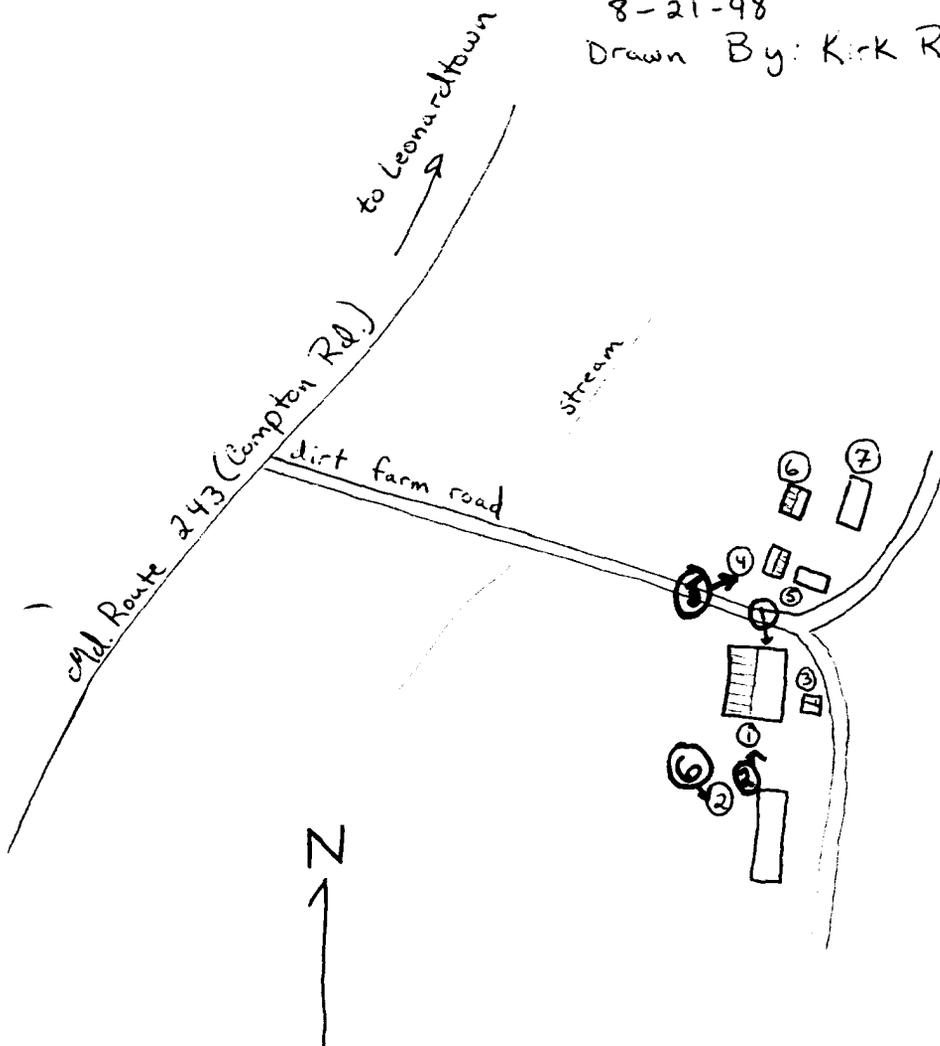
Site Plan

- ① Main House
- ② Corn Crib
- ③ Storage Shed
- ④ Garage
- ⑤ Storage Shed
- ⑥ Granary
- ⑦ Chicken Coop

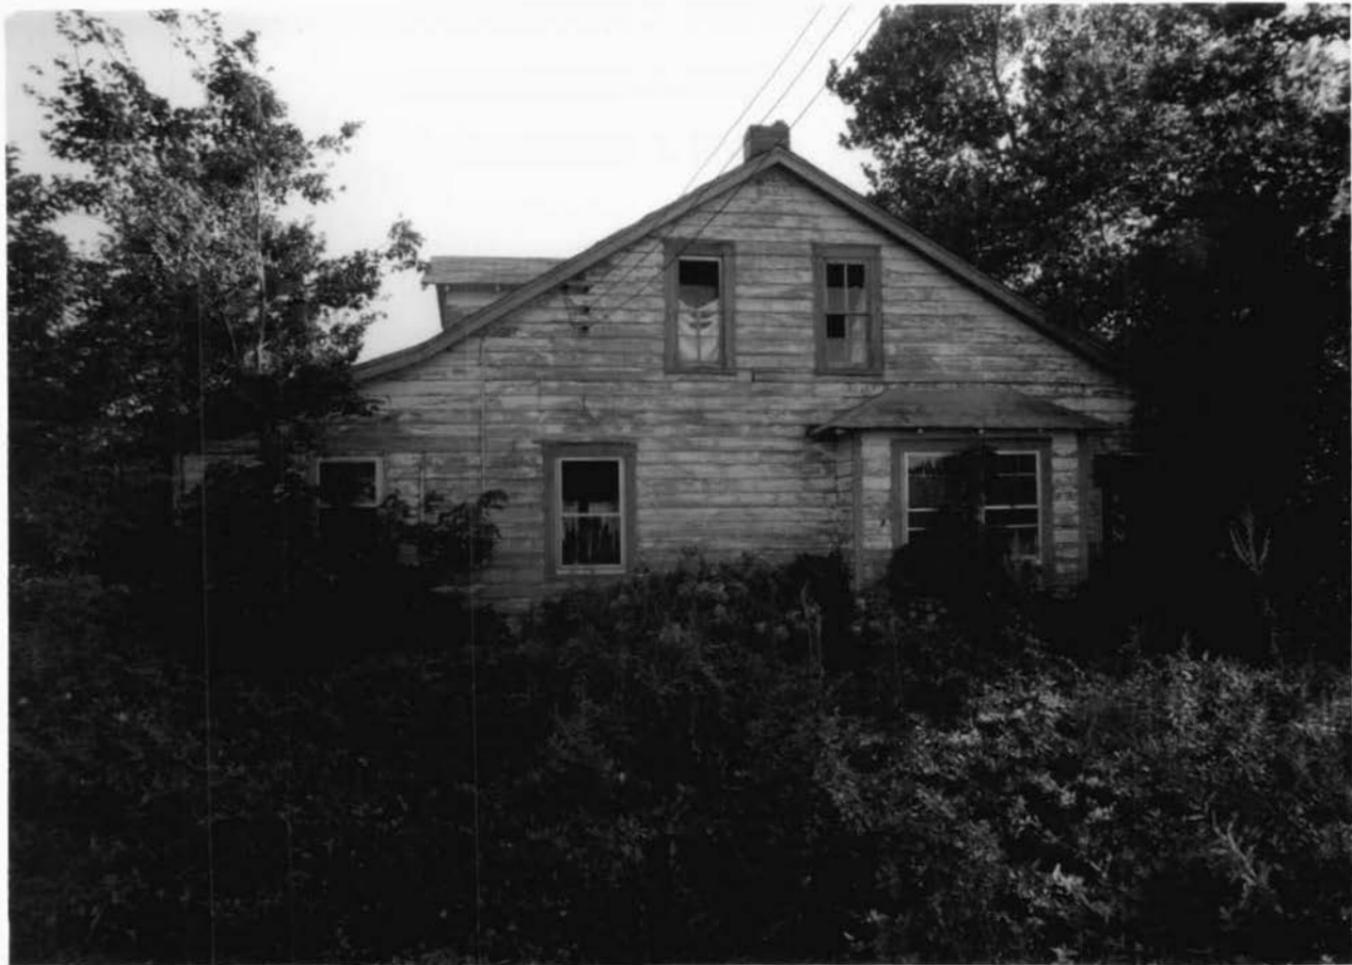
1 of 6

The north elevation's first floor is lit by two six-over-six windows and a shed roof projection with the aforementioned roof of decorative, pressed metal shingles. This projection is pierced by a paired set of six-over-six windows. Like the south elevation, the half story is lit by two, four-over-four windows that lie on either side of a centrally located interior end chimney flue.

N elevation

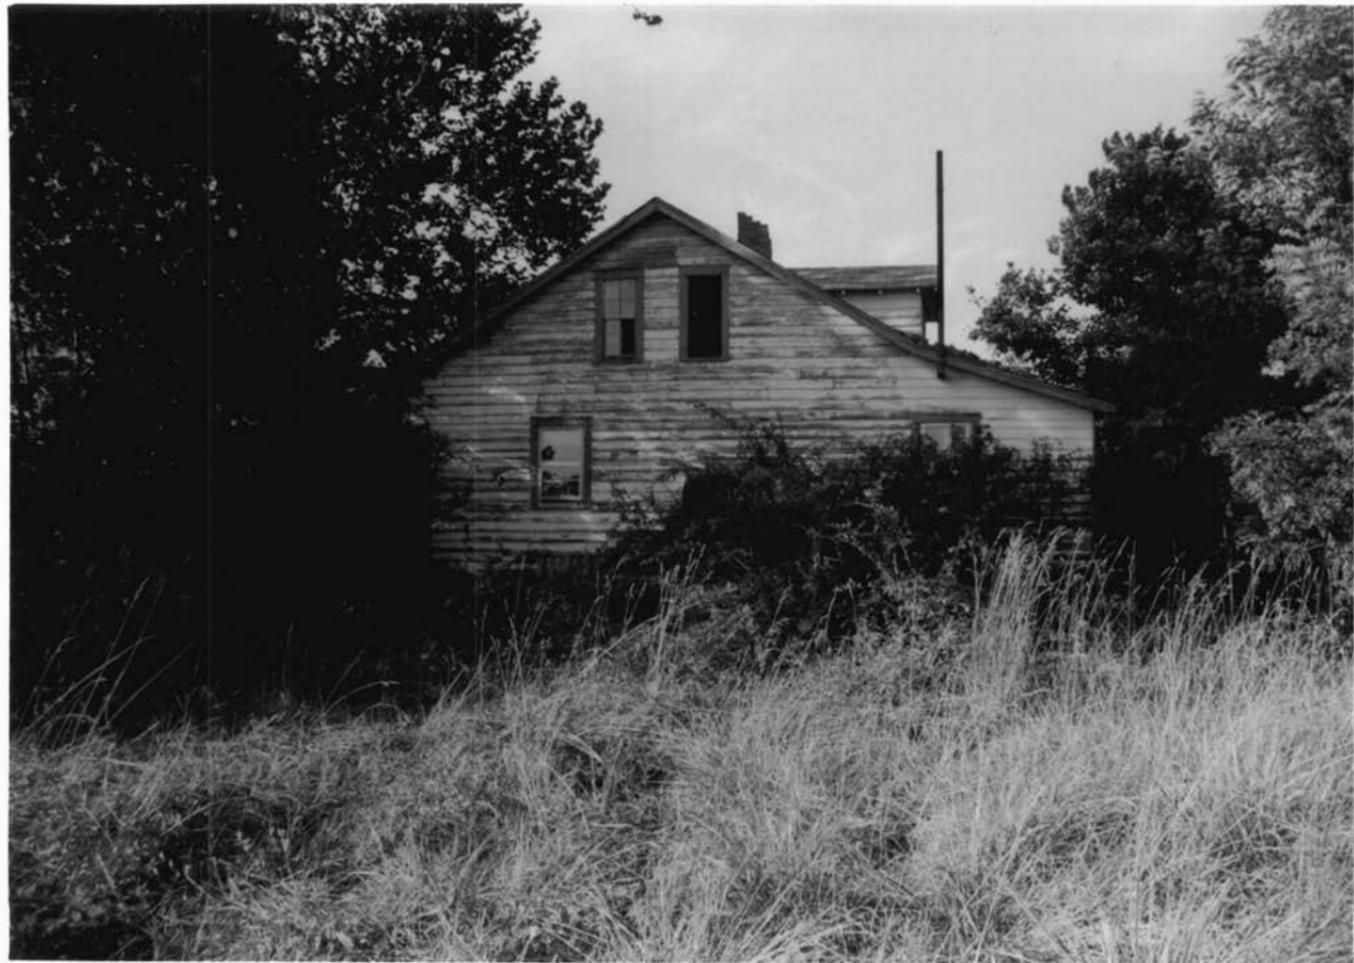
2 of 6

The south elevation consists of the house's gable end. On the first floor, the fenestration is composed of two, six-over-six windows that lie on either side of the slightly offset chimney flue. The second floor features two, attenuated, four-over-four windows.

Selevation

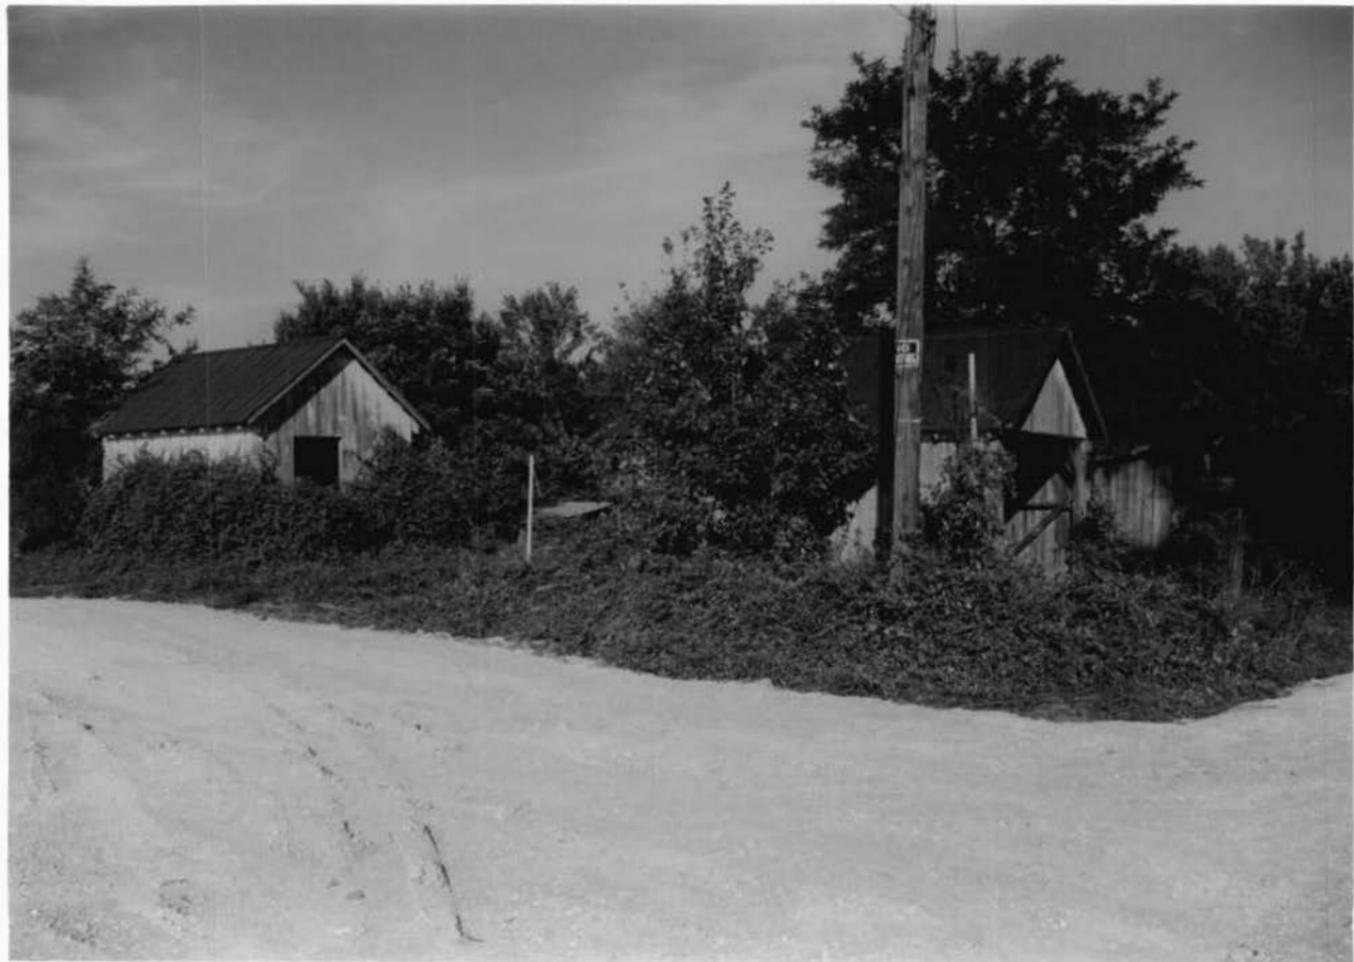
5 of 6

The group of outbuildings situated to the north of the house include the garage, chicken coop, granary, and storage shed. All of these buildings are sheathed with clapboard fastened to the circular sawn frame with wire nails and have roofs covered with raised-seam metal.

out buildings - looking E

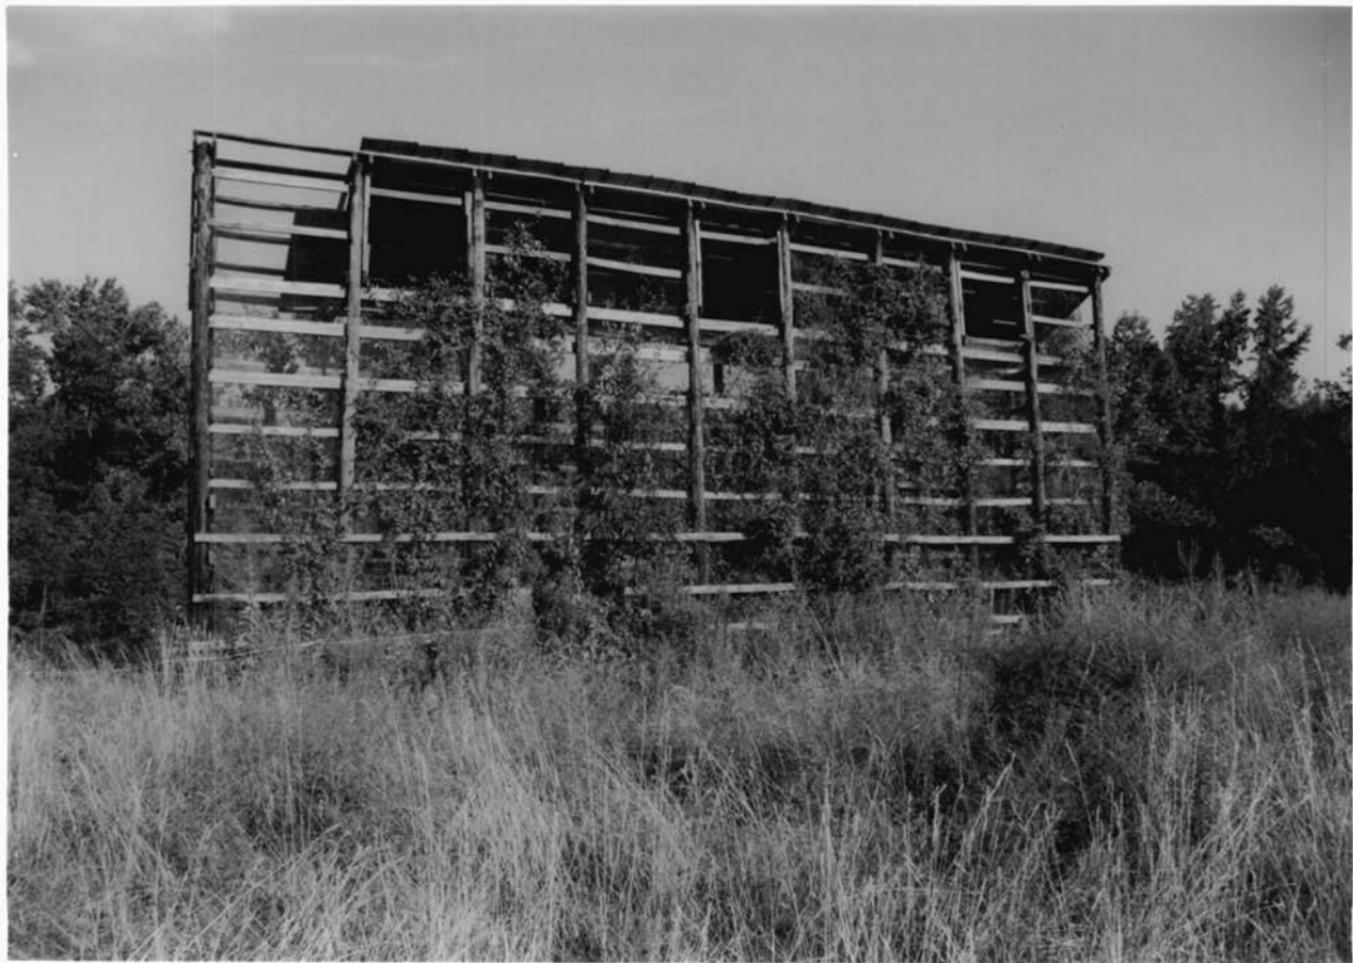
6 of 6

The corn crib and storage shed are located to the east and south of the house. While the storage shed is similar in construction to the aforementioned outbuildings, the corn crib exhibits a mid-twentieth century carry-over of earthfast construction. The crib consists of a series of earthfast, creosote-covered pilings set at regular intervals. Rising up to 25 feet, these pilings support a shed roof covered with raised-seam metal. A tongue-and-groove floor and wire mesh between the pilings represent the primary means of keeping the corn ears from spilling out. A single door is located on this outbuilding's north side.

new crib - looking SE
