Capsule Summary  
SM-666  
Turkey Cock Hill Tenant House  
Leonardtown vicinity  
Private

c. 1900

**Maryland Historical Trust  
State Historic Sites Inventory Form**

## SM-666, Turkey Cock Hill Tenant House

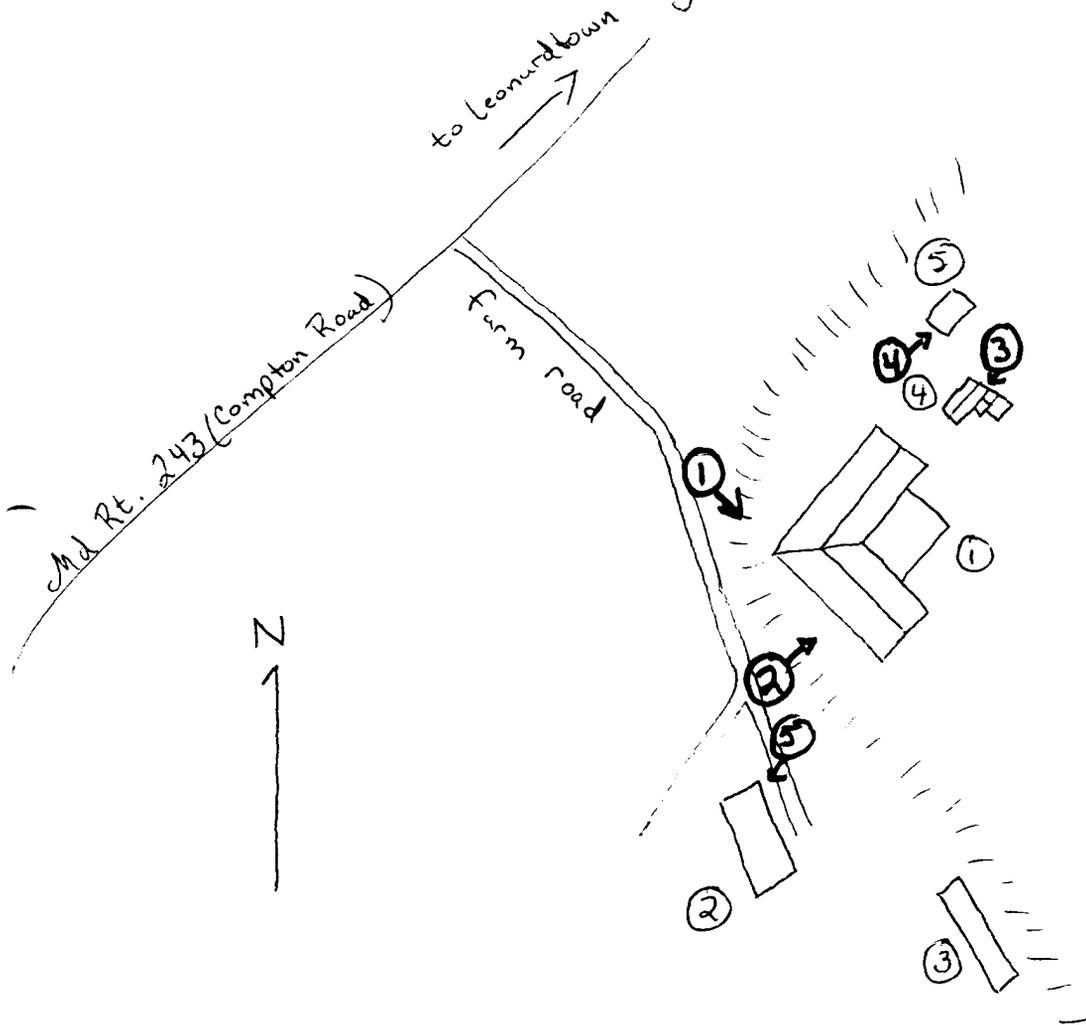
## Site Plan

- ① Main House
- ② Tobacco Barn
- ③ Trailer
- ④ Stripping Shed/Coop
- ⑤ Garage

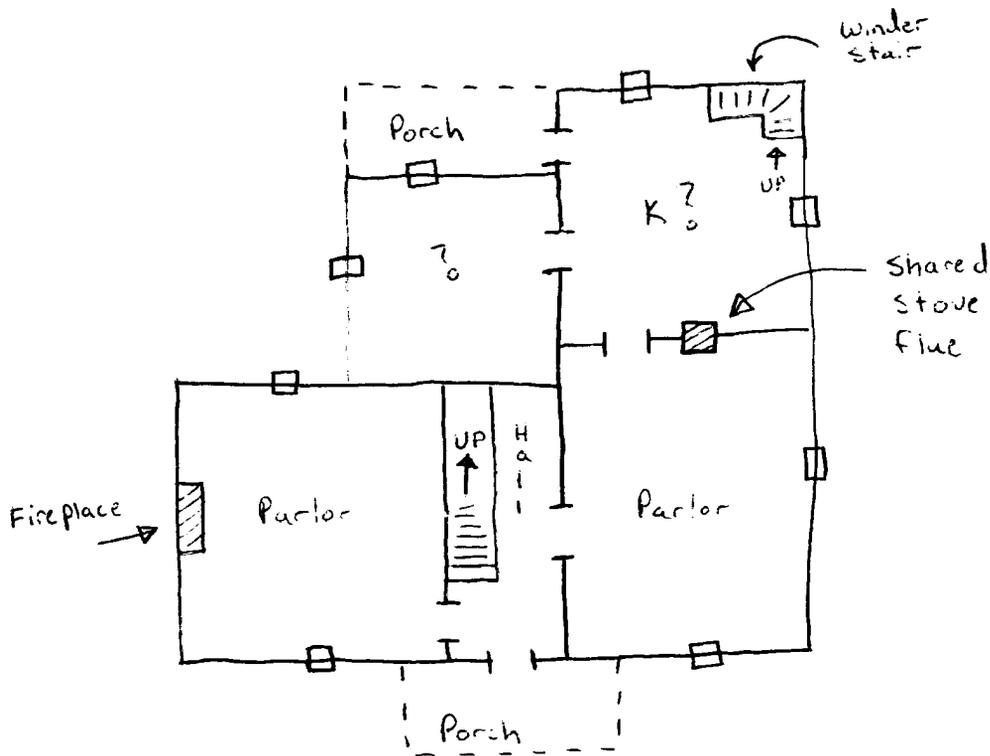
First Floor Plan  
Turkey Cock Hill Tenant House  
SM-666  
9-15-98  
Drawn By: Kirk Ranzetta

The interior plan and modest decoration of the house follows early-twentieth century conventions. The front section of the L-plan consists of a center-passage, single pile component that effectively segregates the interior spaces. The center stair allows entry into nearly every space of the house. The open-string stair, itself, originally featured a molded handrail as well as turned balusters and newels. Similar details have been seen in other period dwellings such as Part Massum (SM-235) and the Katie Stevens House (SM-493). Rather than plaster, the entire interior

of the house is sheathed with horizontal, beaded, tongue-and-groove, four inch boards. The stair and northernmost room appear to have been the most decorated spaces of the house. The north room presently exhibits a scar on its north wall indicating where a mantel was once situated. To the south of the passage is another heated parlor that is then connected to another room that extends to the east. This east room features a boxed winder stair to the second floor. A door located on the north wall of this space represents the only entrance into the one story addition. The second floor of the dwelling mimics the floor plan of the first as it contains three bedrooms and a passage.

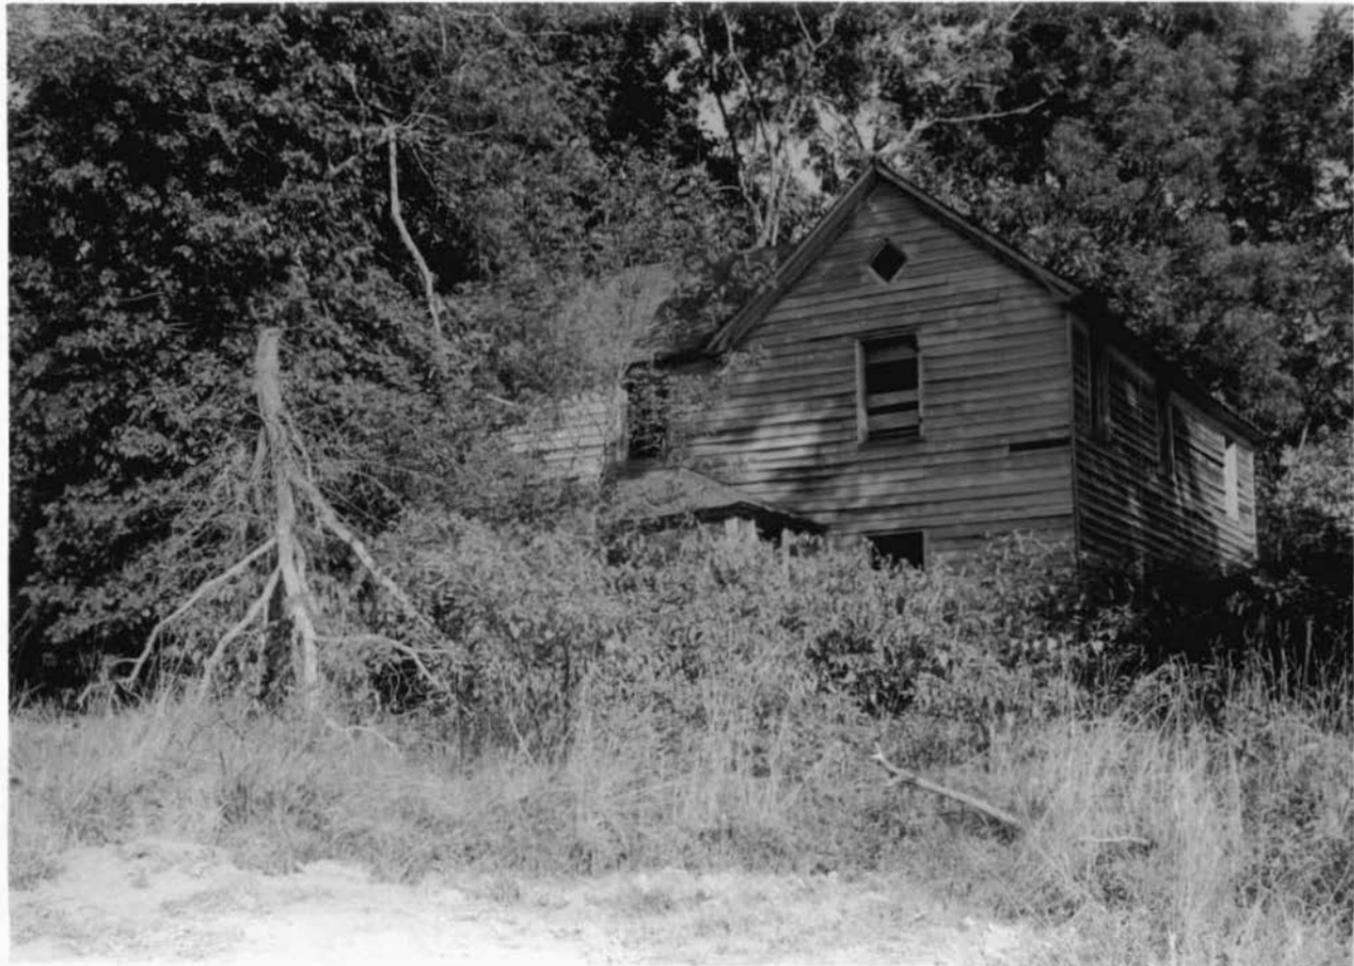
1 of 2

The primary or west elevation's bays are symmetrically arranged and consist of a centrally located panelled door flanked on either side by a two-over-two, double-hung sash window (All windows in the house are two-over-two windows unless otherwise noted and almost all have been broken out.). Only the door is shaded by a porch that is supported by square posts once decorated with scroll sawn brackets. The second floor is pierced by three two-over-two windows. Above the southernmost window is a diamond-shaped pane that is no longer extant. An interior end, brick chimney flue is located on the north side of the elevation.

The south elevation's fenestration is composed of two windows on the first floor and three windows on the second floor. A brick chimney flue projects from the center of the roof.

W + S elevation

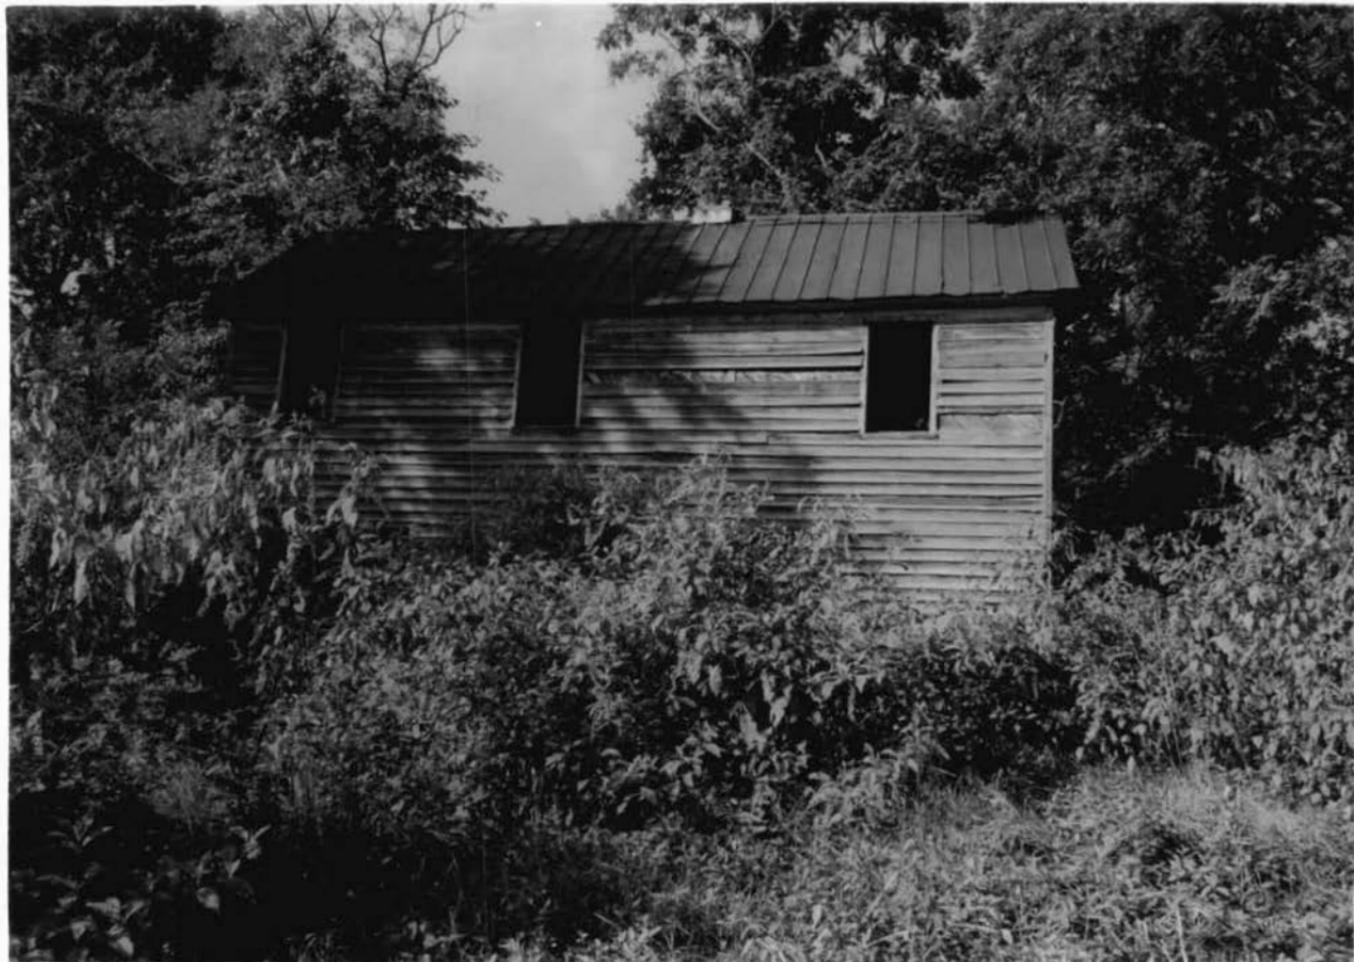
2 of 6

The east elevation of the house features the projecting gable end of the main block, a one story addition, and the side of the main block. The gable end has a window on the first and second floors. Like the west elevation, the attic story is lit by a diamond shaped pane that has also been broken out. Sheltered by a connecting shed roof porch, the one story addition is pierced by a window. The second floor of the main block's side exhibits two windows.

Elevation

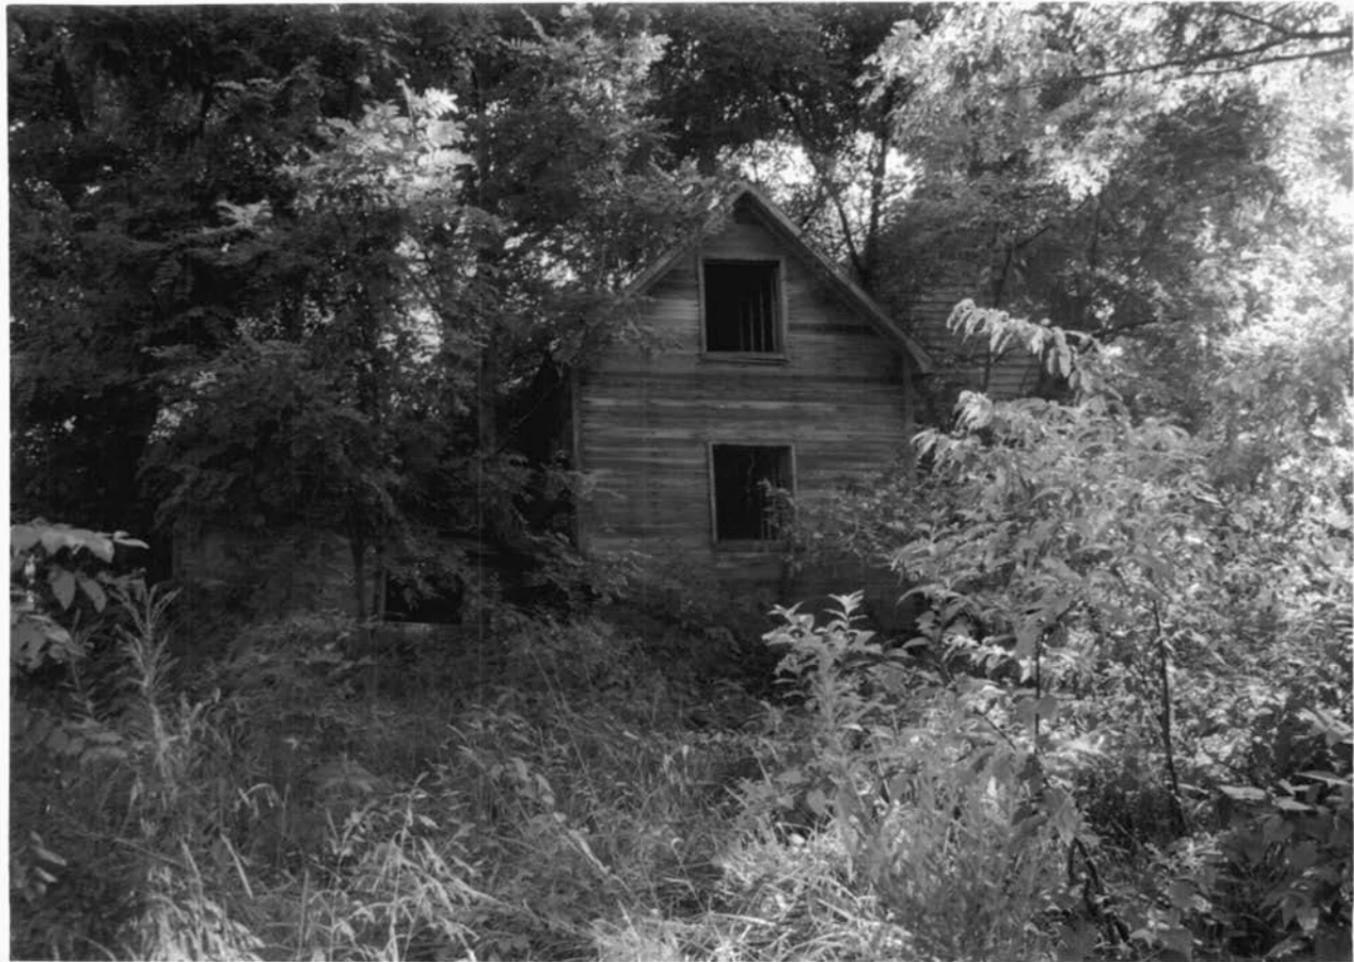
3 of 5

A frame, one story stripping/storage shed lies in close proximity to the north of the main house. It contains three distinct spaces and may have also been used as a chicken coop. The clapboard sheathed, circular sawn frame lies on a poured concrete foundation and the roof is covered with raised seam metal. A small frame garage lies to the northwest of the main house.

Stripping shed coop - n + w elevations

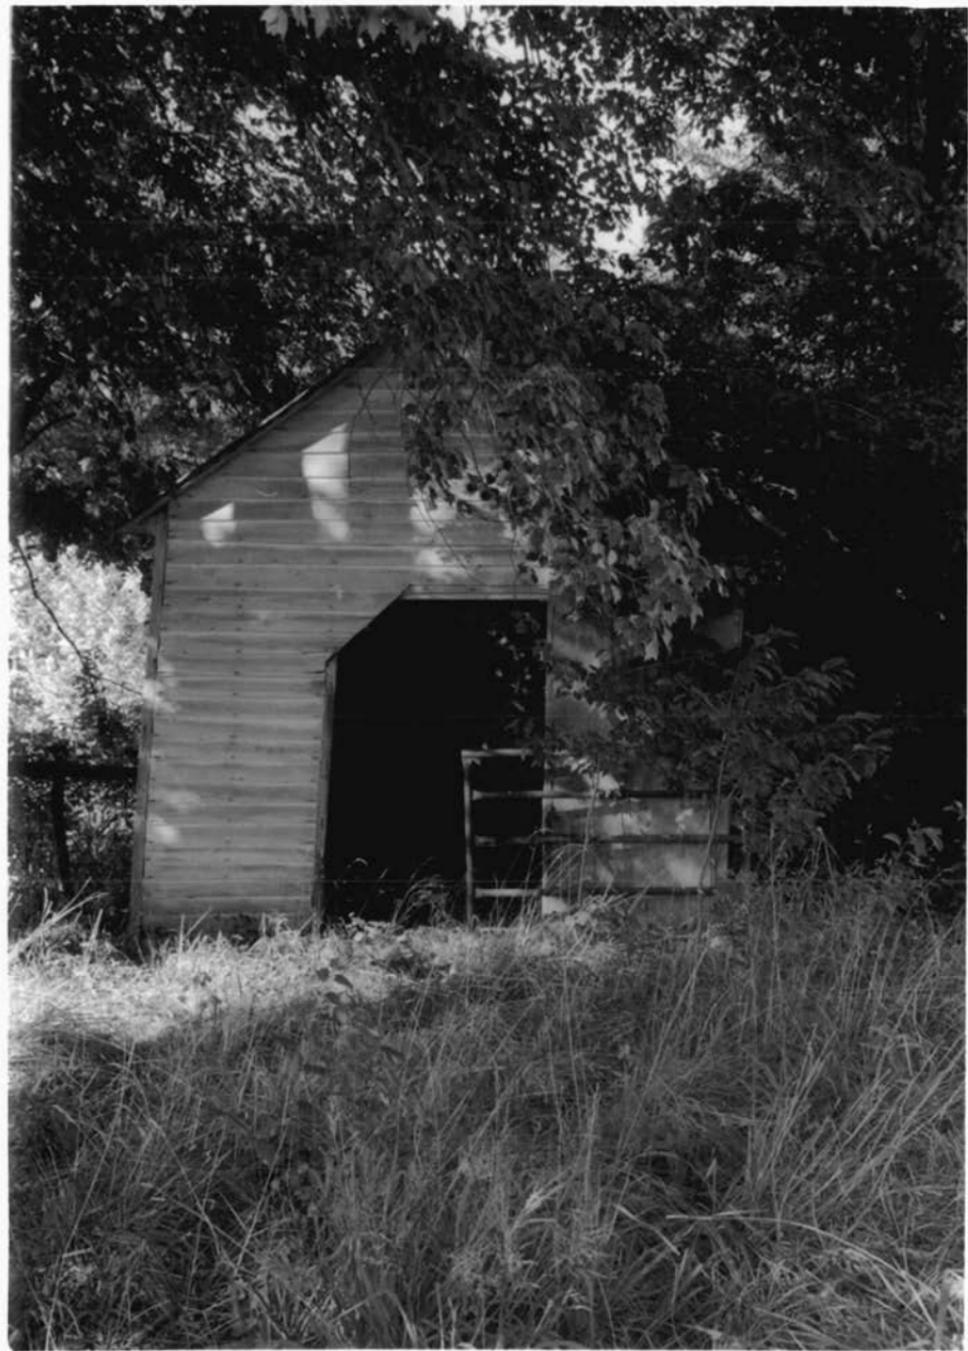
4 of 6

garage - S elevation

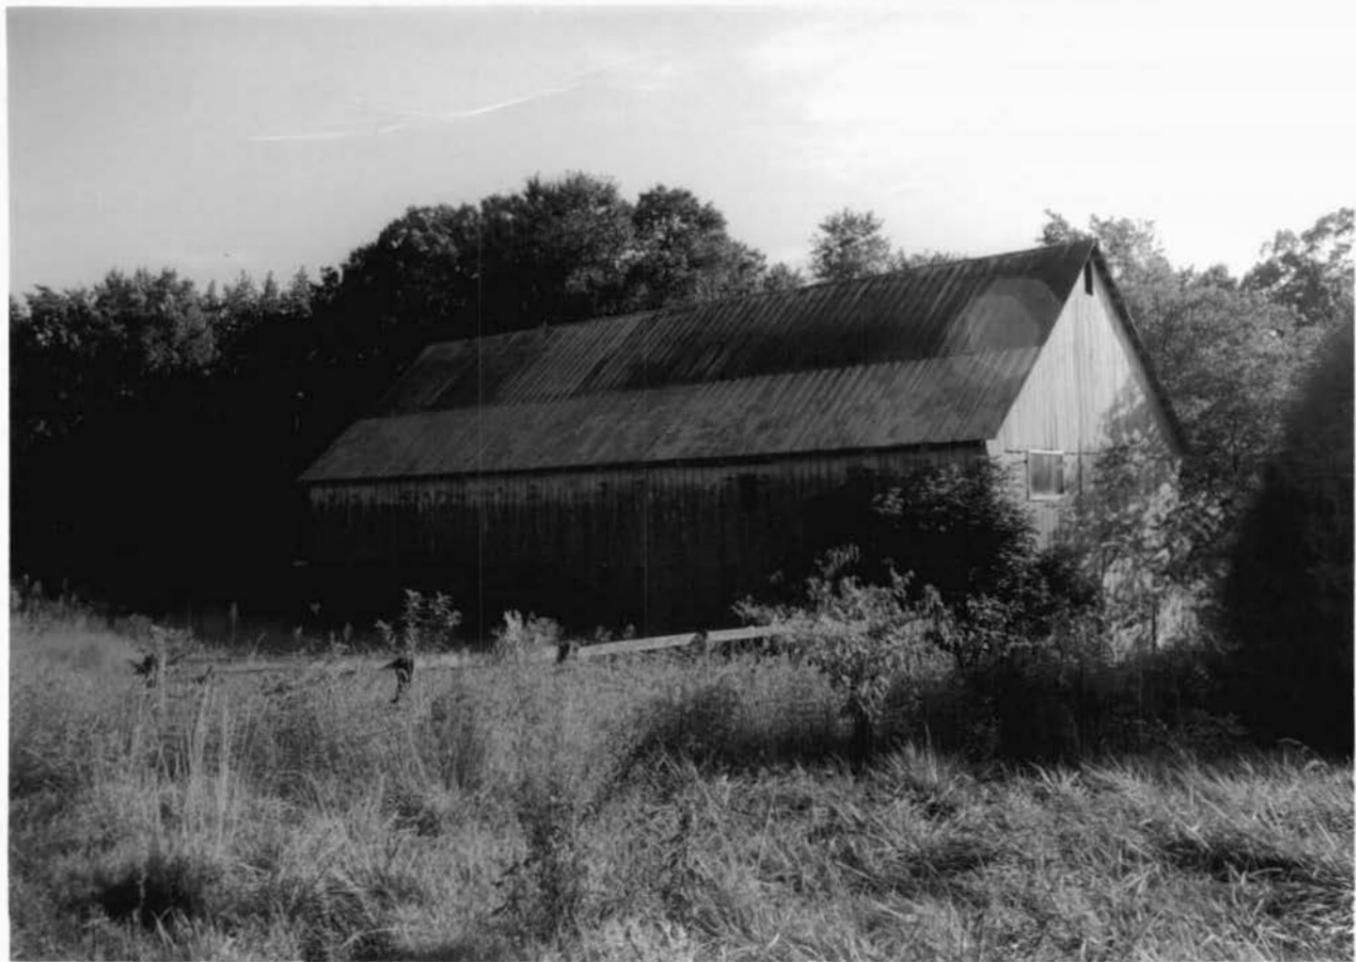
5 of 5

The tobacco barn, situated to the south of the main house, is a one story frame structure sheathed on the exterior with vertical boards that are hinged to allow for proper ventilation. The roof is covered with raised-seam metal. Most likely constructed in the mid-twentieth century, the barn will be retained. A non-contributing, one story, metal sheathed trailer lies just to the east of the barn.

Tabacco Barn - E + Elevations
