National Register of Historic Places  
Registration Form

historic name CHRIST EPISCOPAL CHURCH  
other names/site number \_\_\_\_\_

street & number State Route 238 (Maddox Road) N/A  not for publication  
city, town Chaptico N/A  vicinity  
state Maryland code MD county St. Mary's code 037 zip code 20621

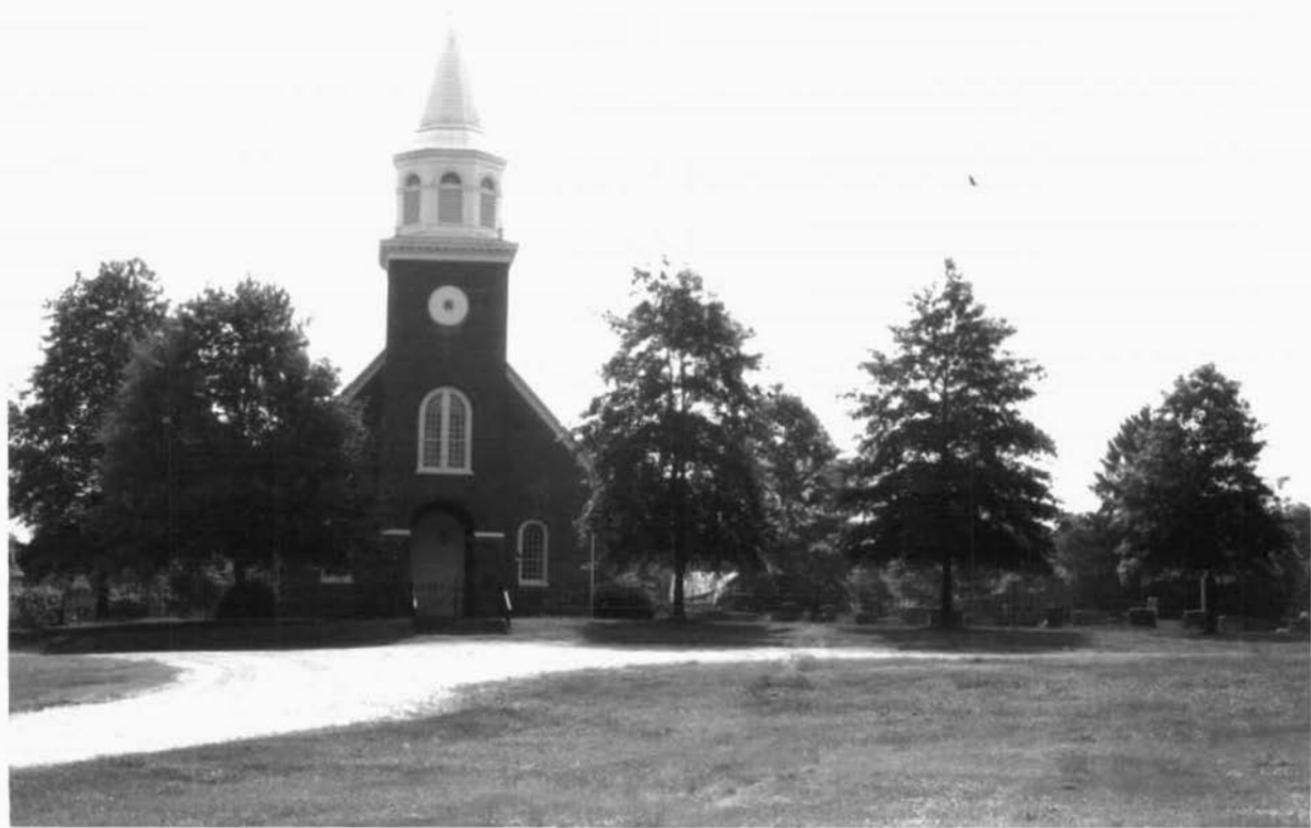
St. Mary's Church - SM-70  
Chaprico, St. Mary's County  
Maryland

West side with tower, door and St. Mary's

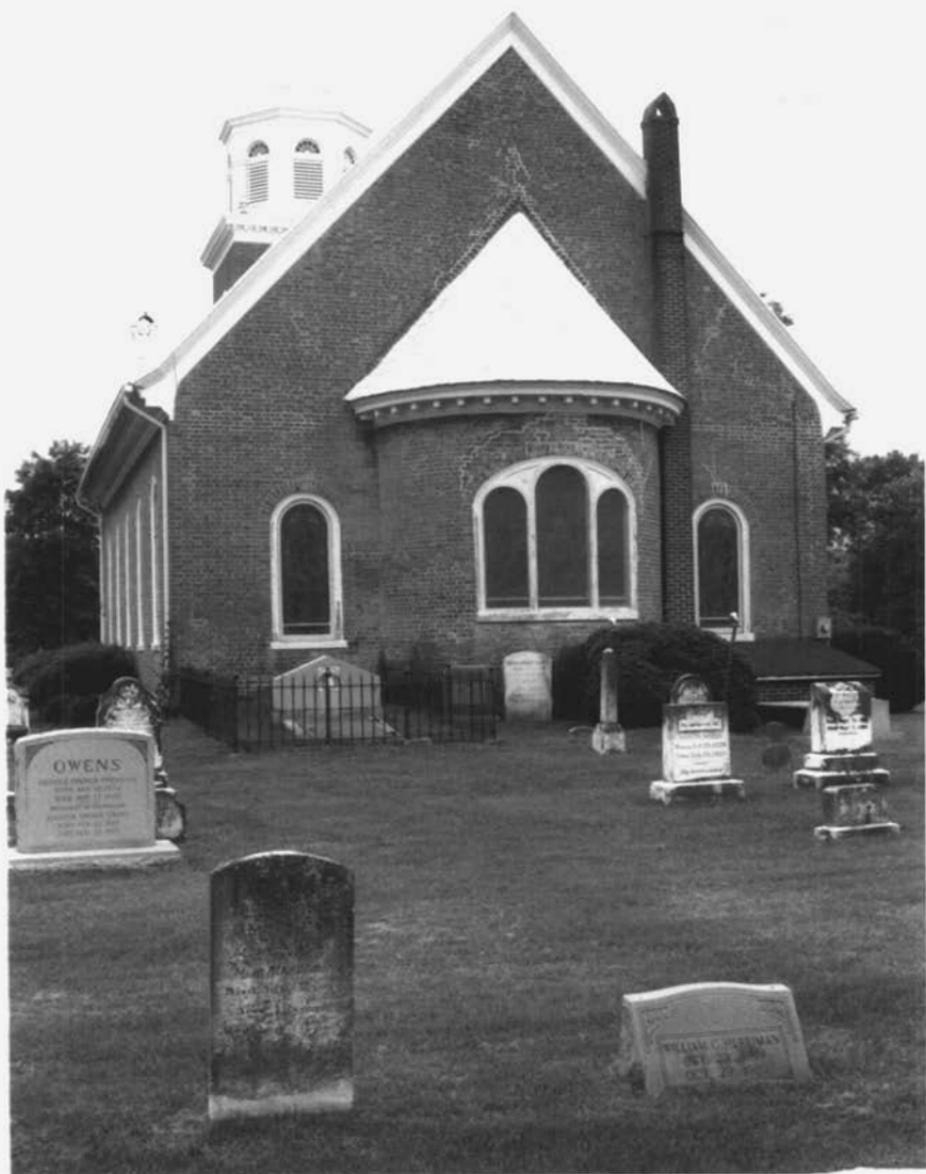
Christ Church  
Chapter, St. Marys County  
Maryland

Rose with fenced area road  
From east

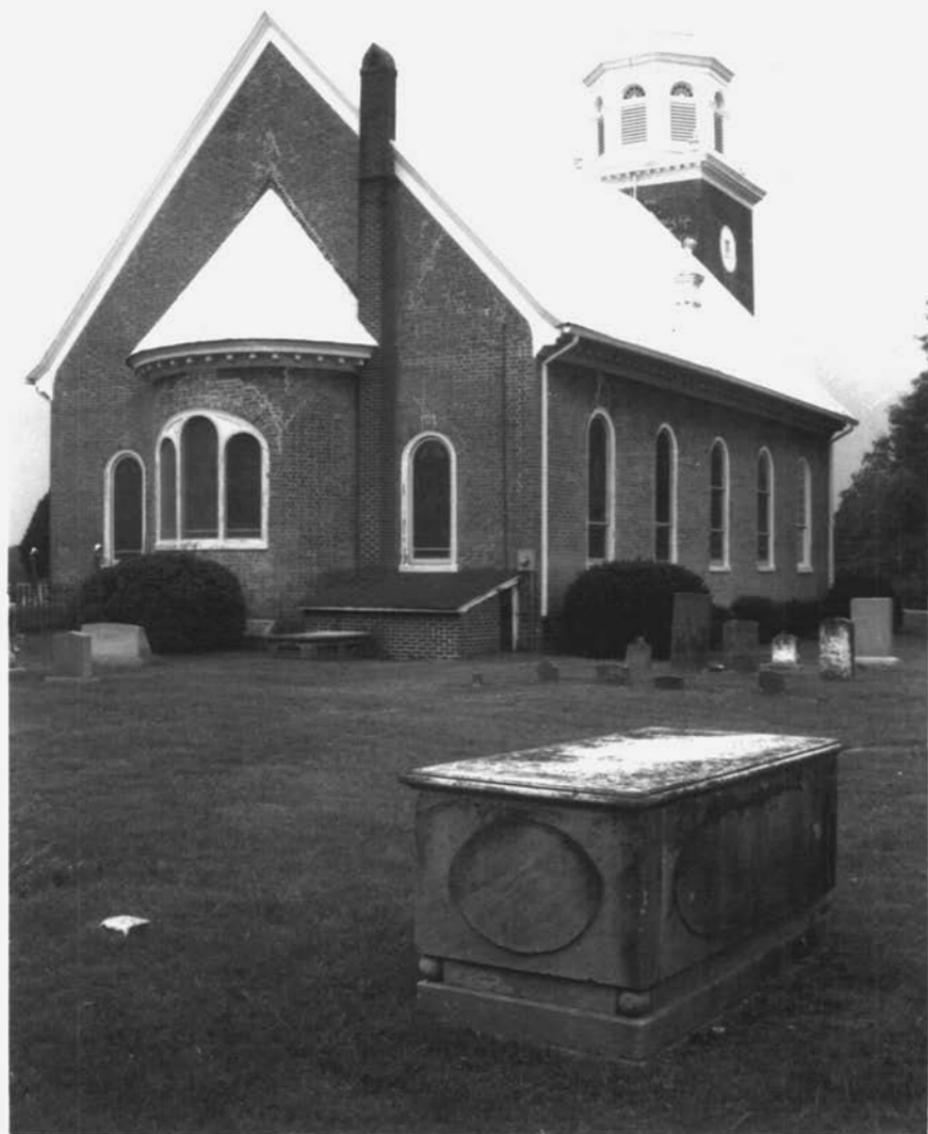
Christ Church

Apse with box-type  
grave marker in foreground,  
from east

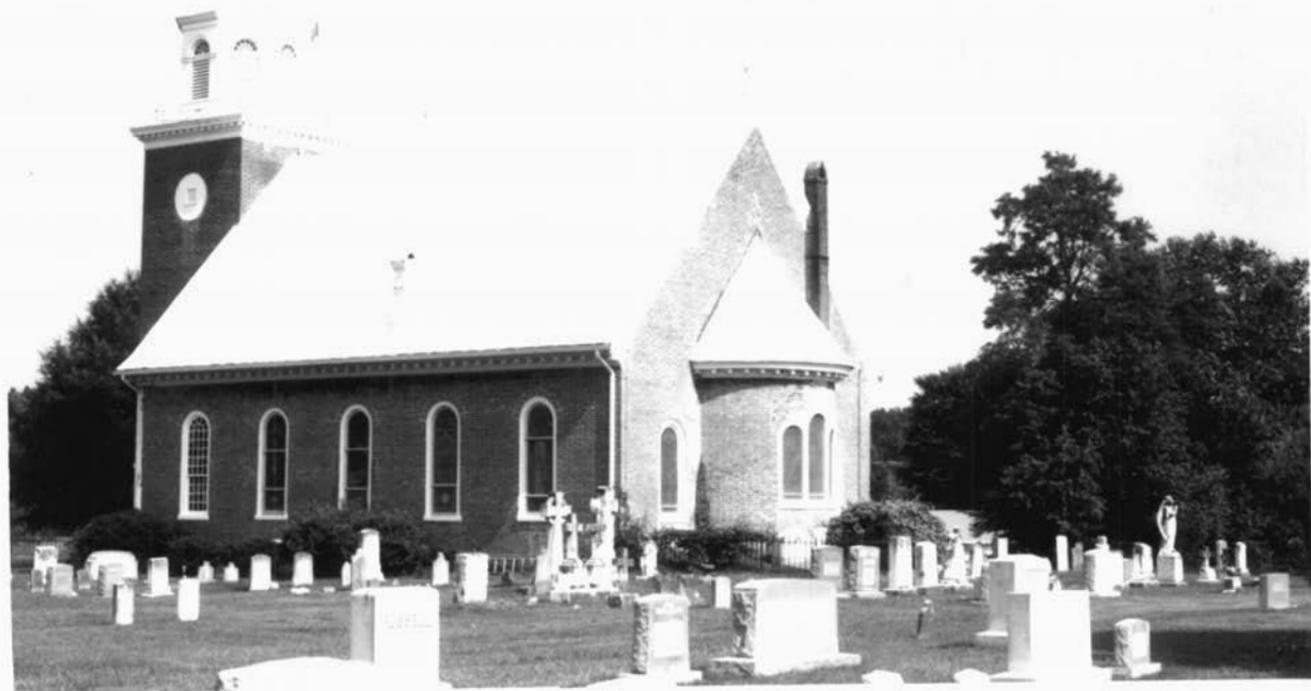
Christ Church  
Chapline  
St. Mary's County  
Maryland

View of church and surrounding  
area from far. southeast

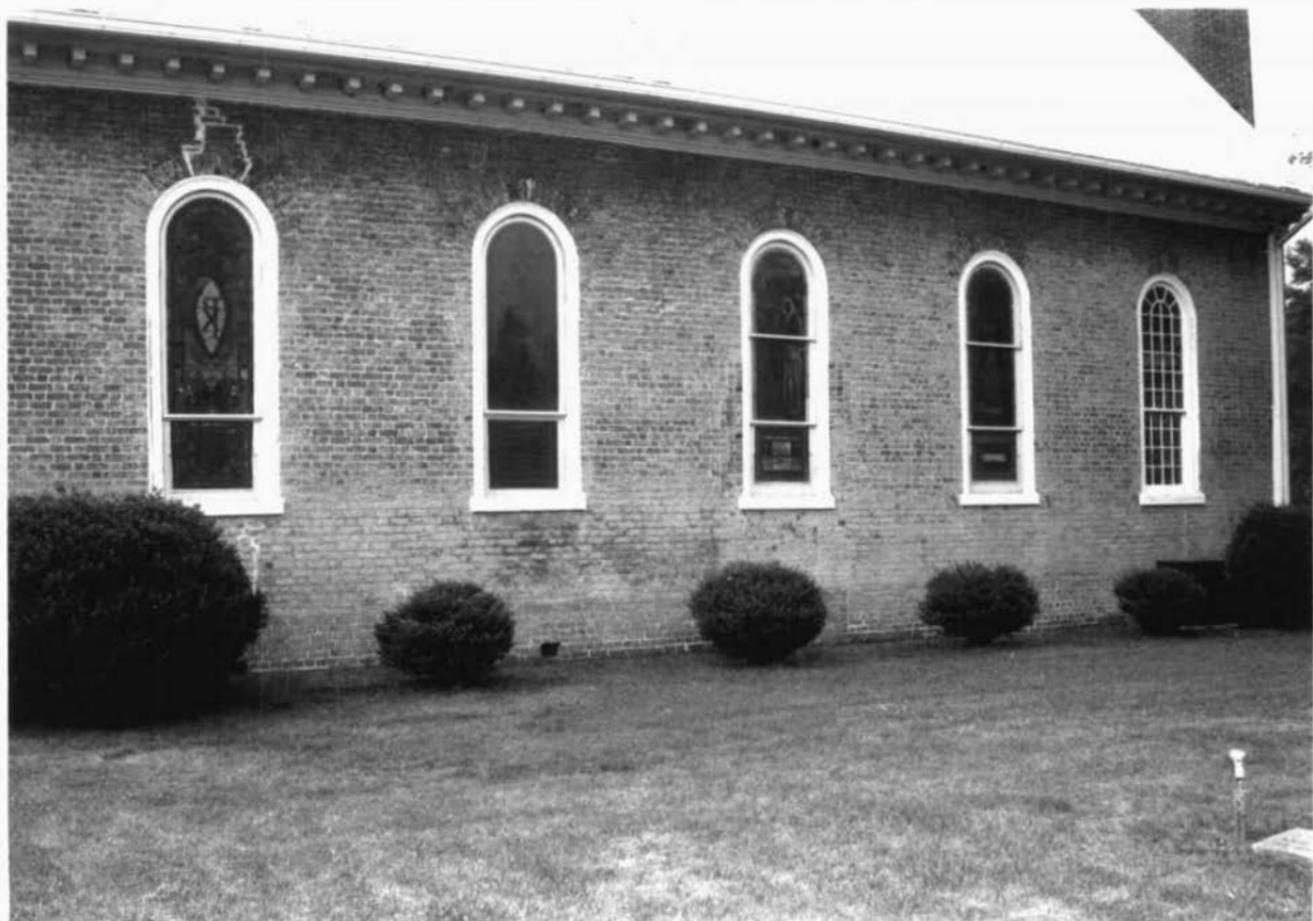
Christ Church

North side

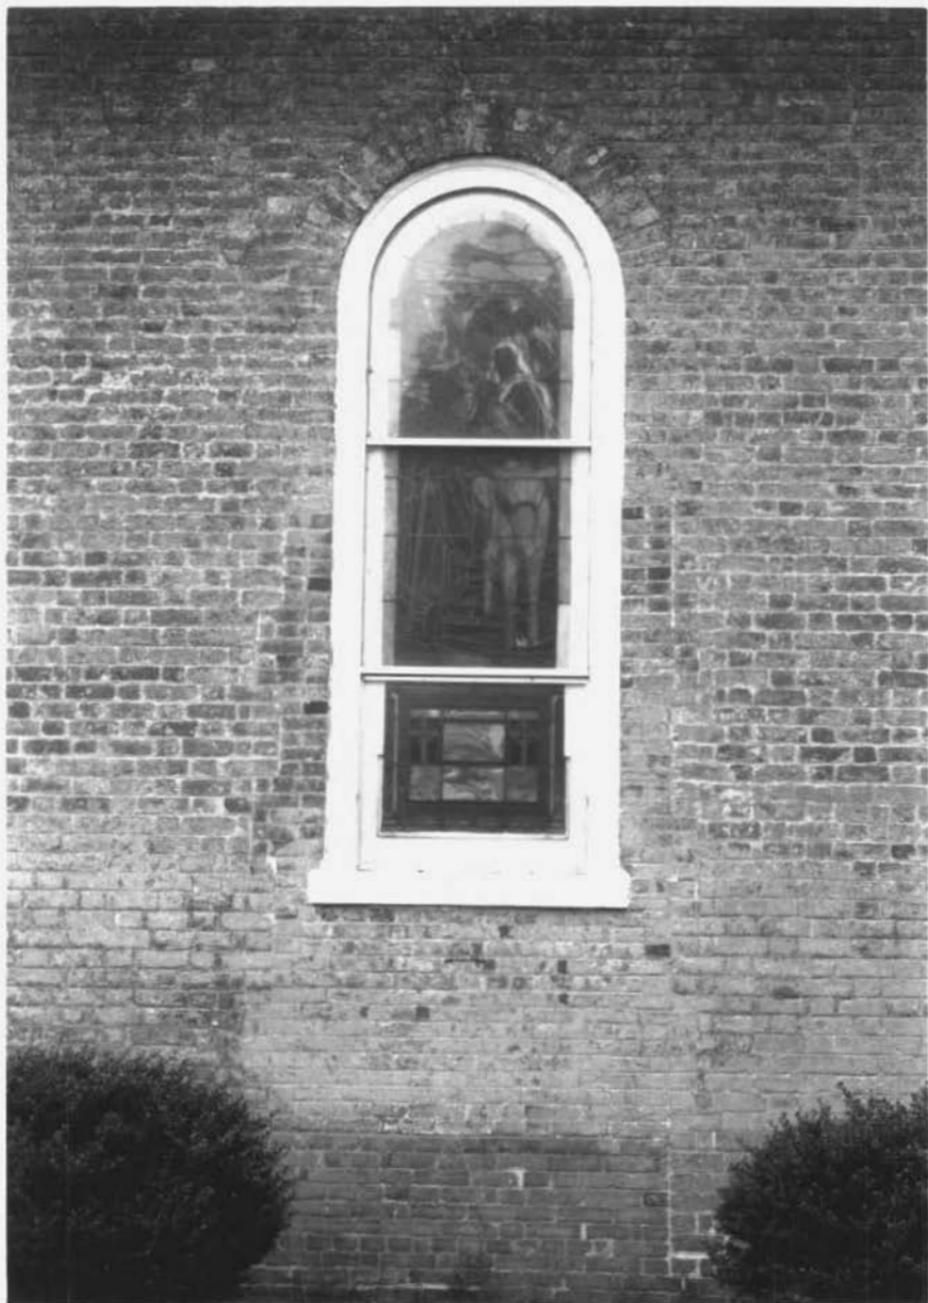
Christ Church  
Chaptico

Window, North side, where  
door once was

After the British raid, modifications to the interior of the church were made. The floor was raised eight inches. The doors on the sides of the church were bricked up so that only the west door remains. The pulpit was moved to the apse. A partition was placed across the west end of the church to make the church warmer and stoves were installed.

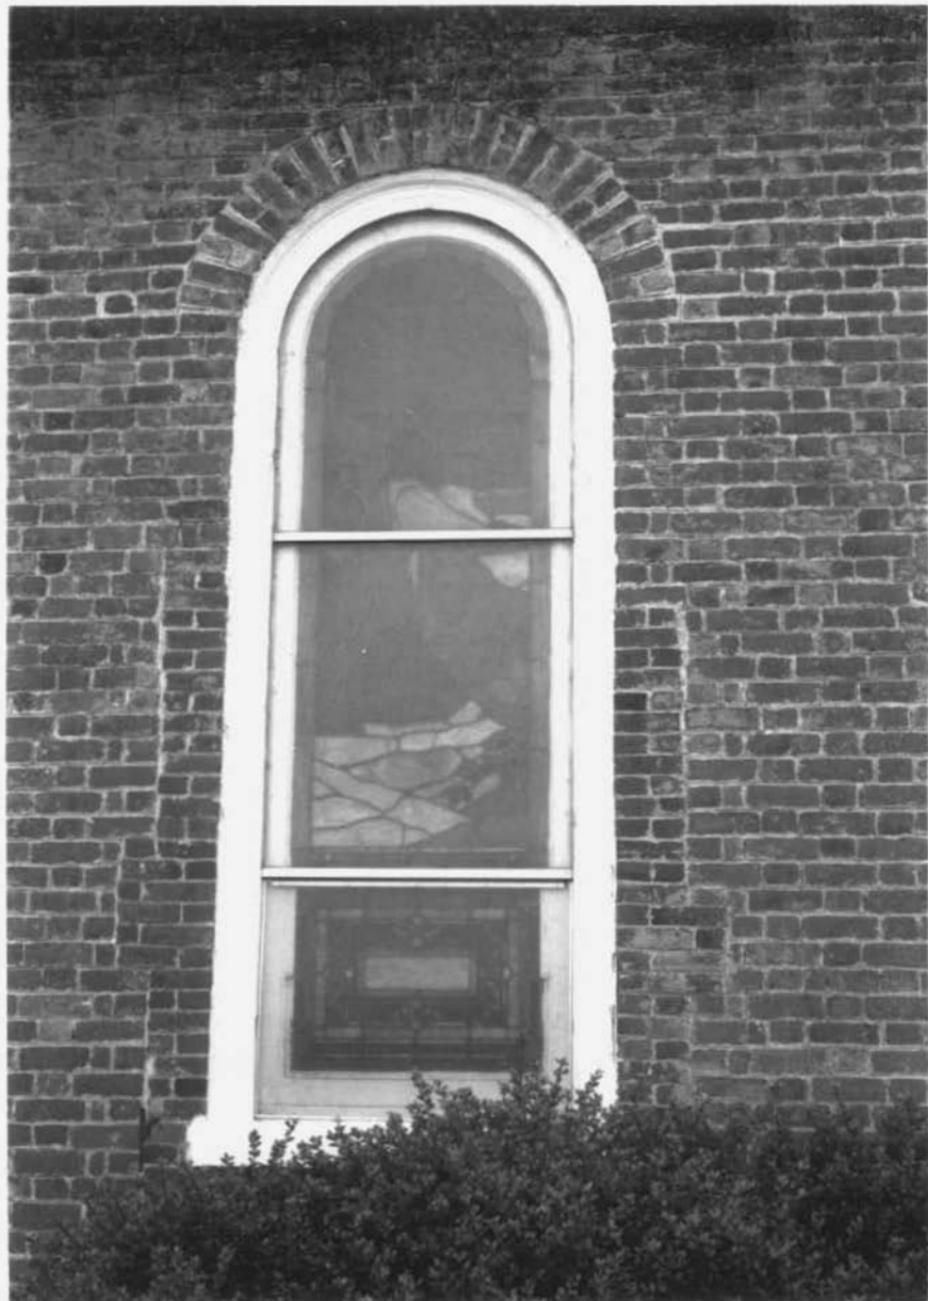
Christ Church  
Chapter

Window, south side, where  
door once was

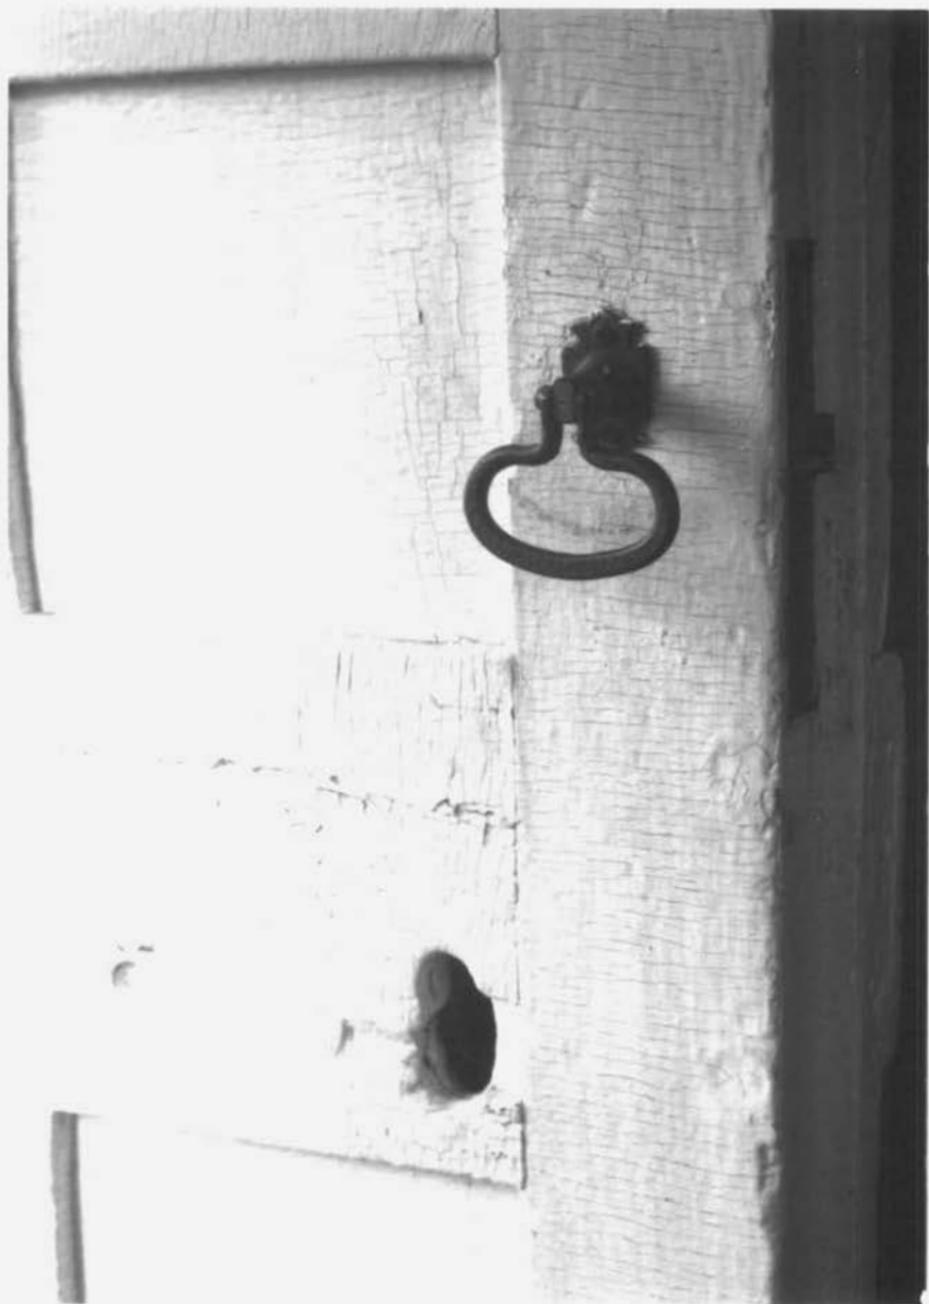
Christ Church  
Chapico

Latch, front door

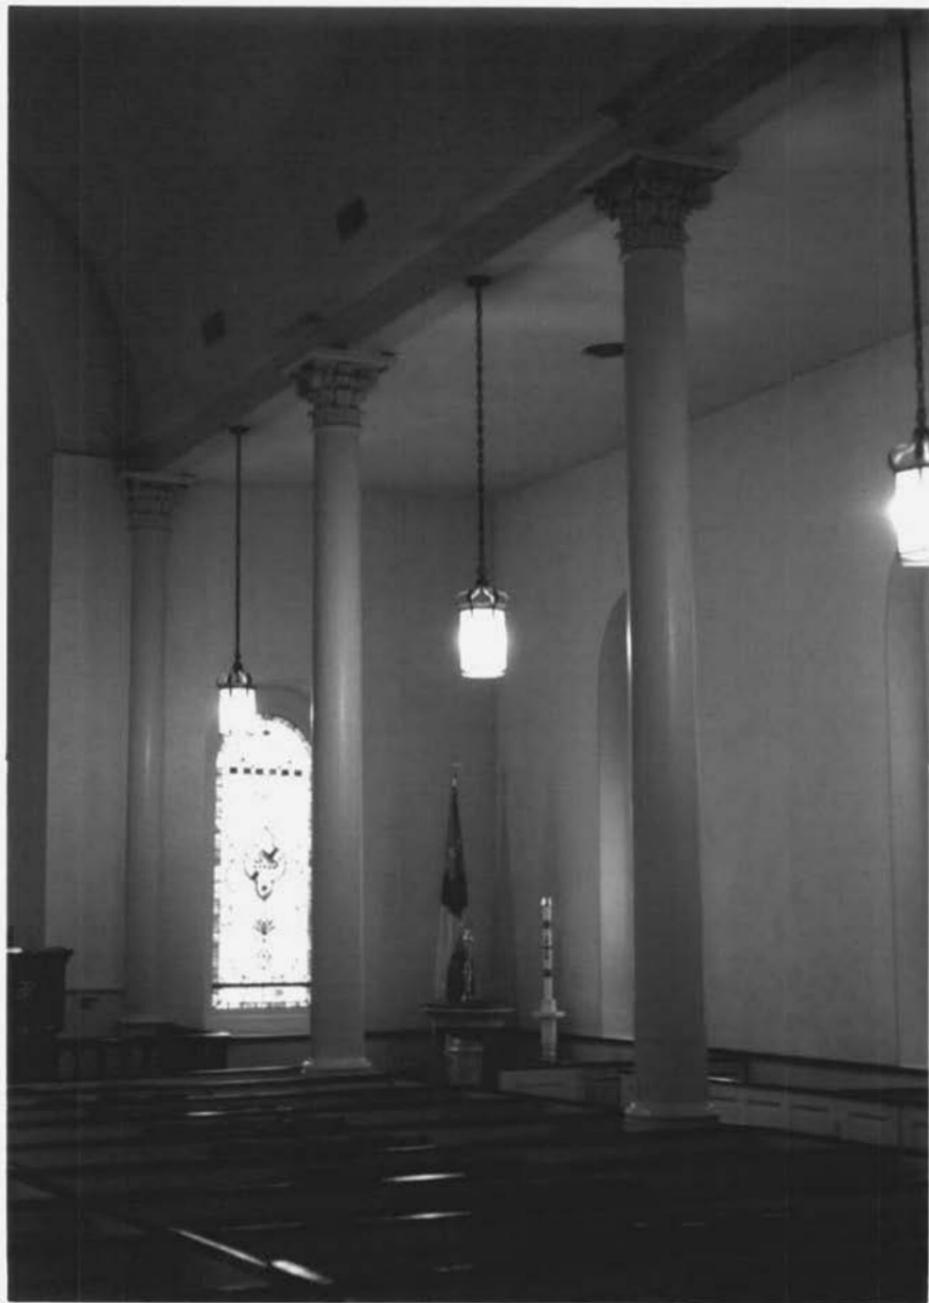
Christ Church

Columns from rear of church  
toward baptismal font

In the interior of the church, the central barrel-vaulted ceiling of the nave and flat ceiling of the side aisles are supported by eight wooden columns topped by elaborately carved capitals of the composite order. This is the earliest of five colonial Anglican churches of Southern Maryland where columns express a nave and side aisles; a design not found elsewhere except in the great city churches in Charleston, S.C., Philadelphia, New York and Boston.

A marble baptismal font, a bowl on a fluted pedestal, is perhaps the oldest article in the church. It dates from the 18th century and is patterned after the published designs of James Gibbs and Batty Langley.

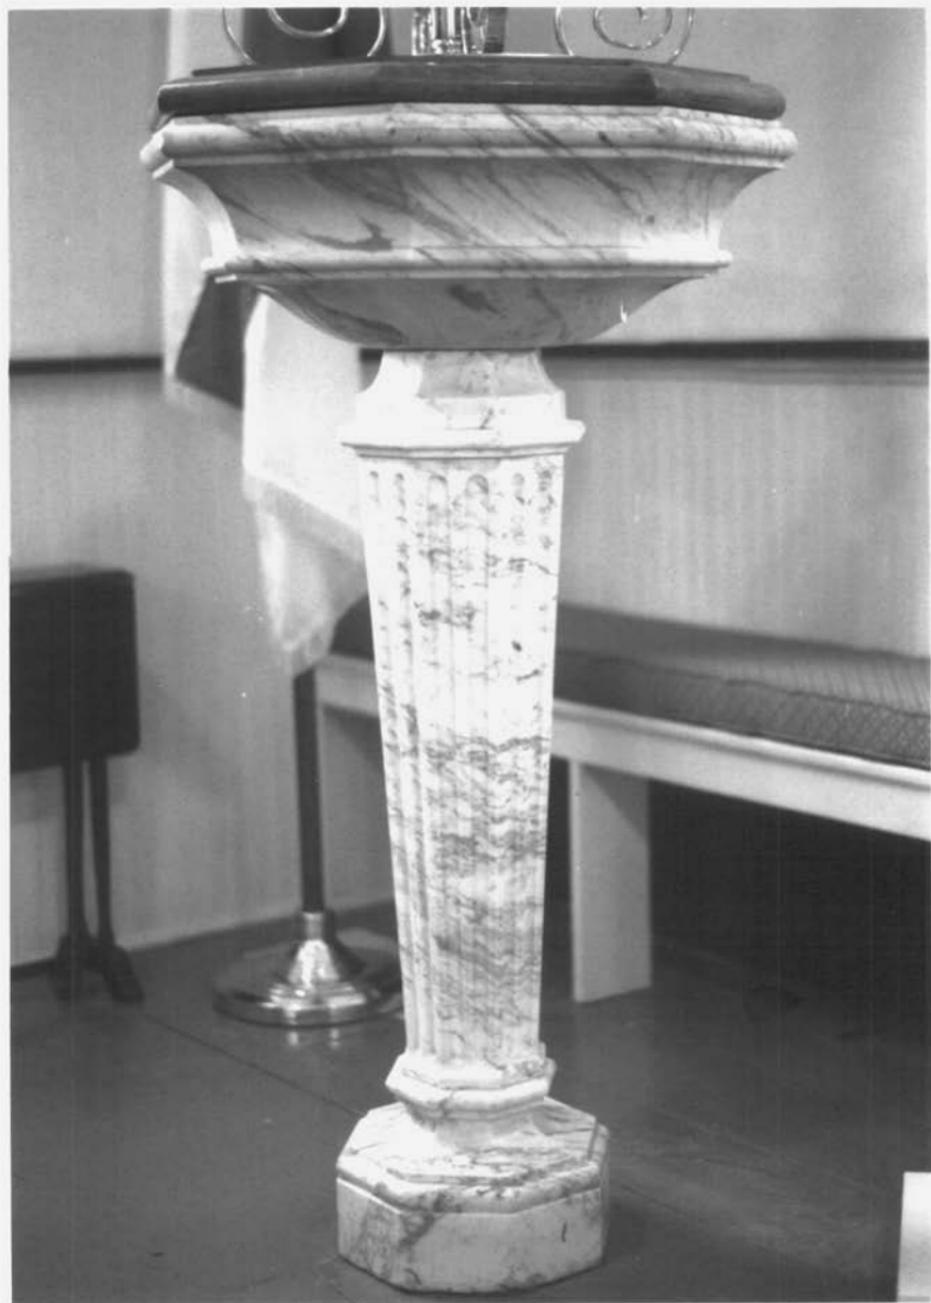
Christ Church

Baptism font

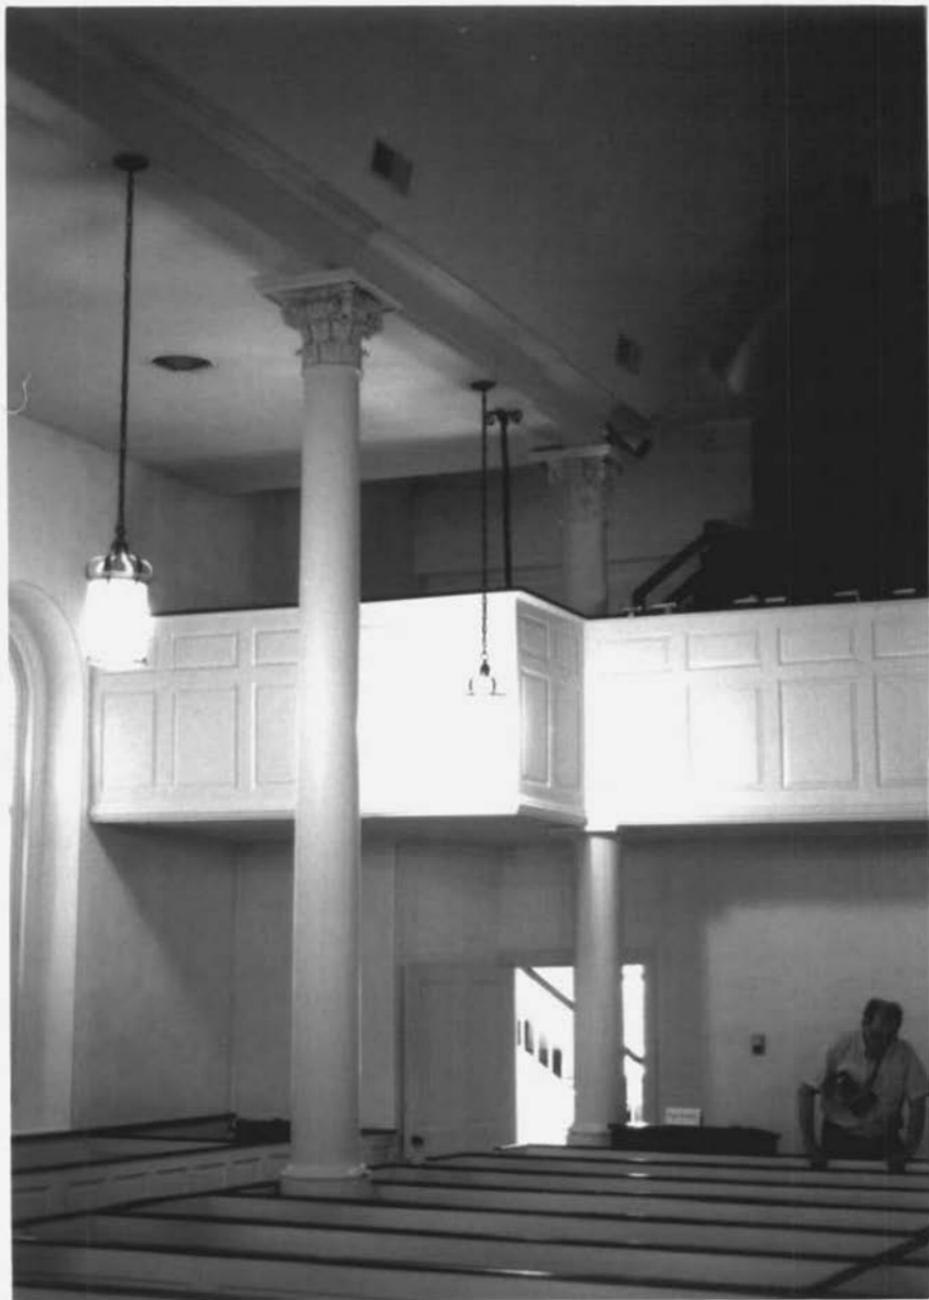
Christ Church  
Chaptico  
St Marys County  
Maryland

View toward church door,  
showing choir loft

Stairs lead to a gallery, which was formerly set aside for the black congregation. It is now used by the choir and contains a large pipe organ manufactured by M.P. Moller of Hagerstown, Maryland and installed in 1913.

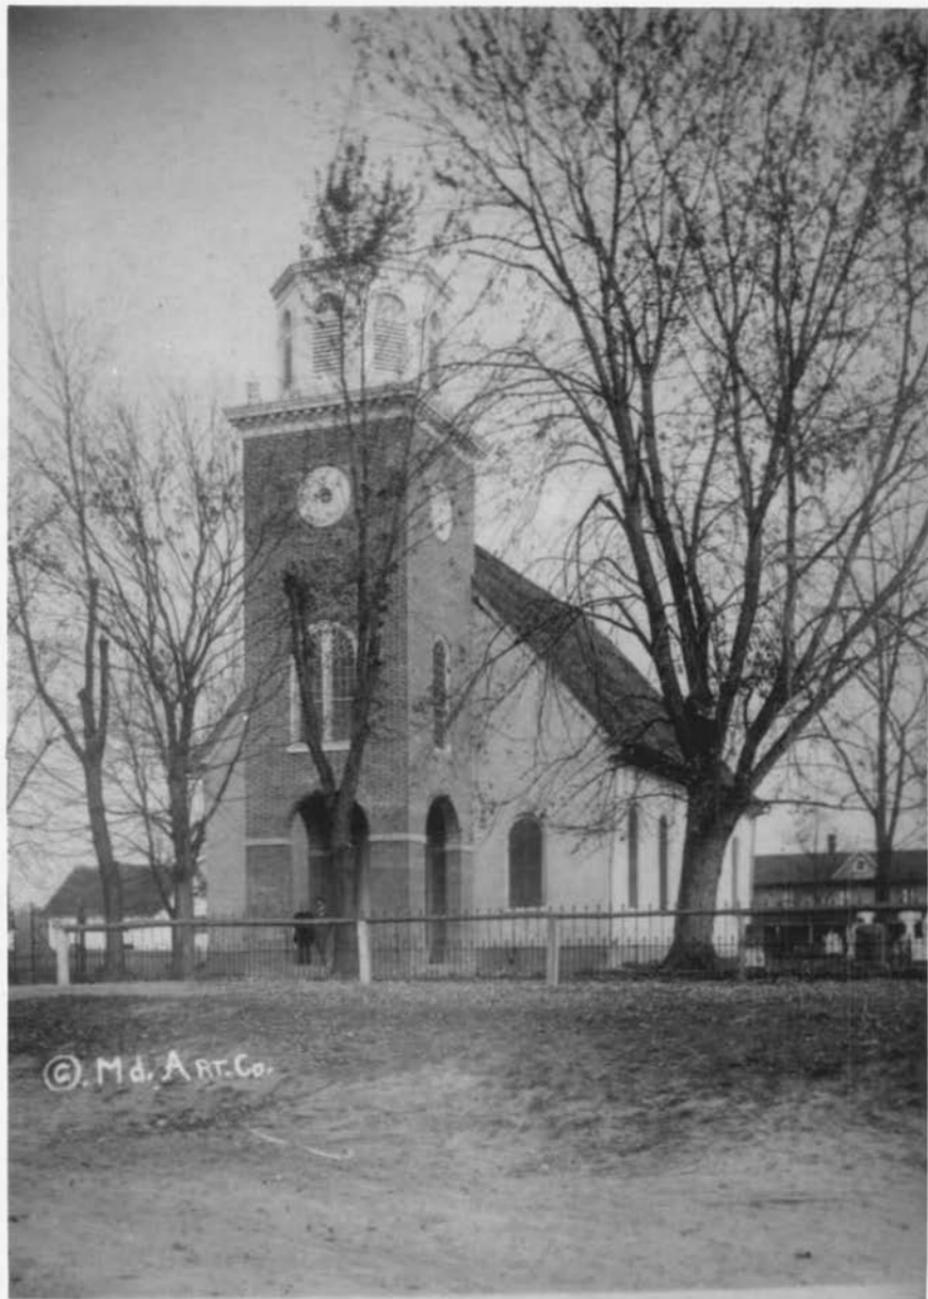
Christ Church  
Chapico

View of church shortly after  
addition of tower, from  
west

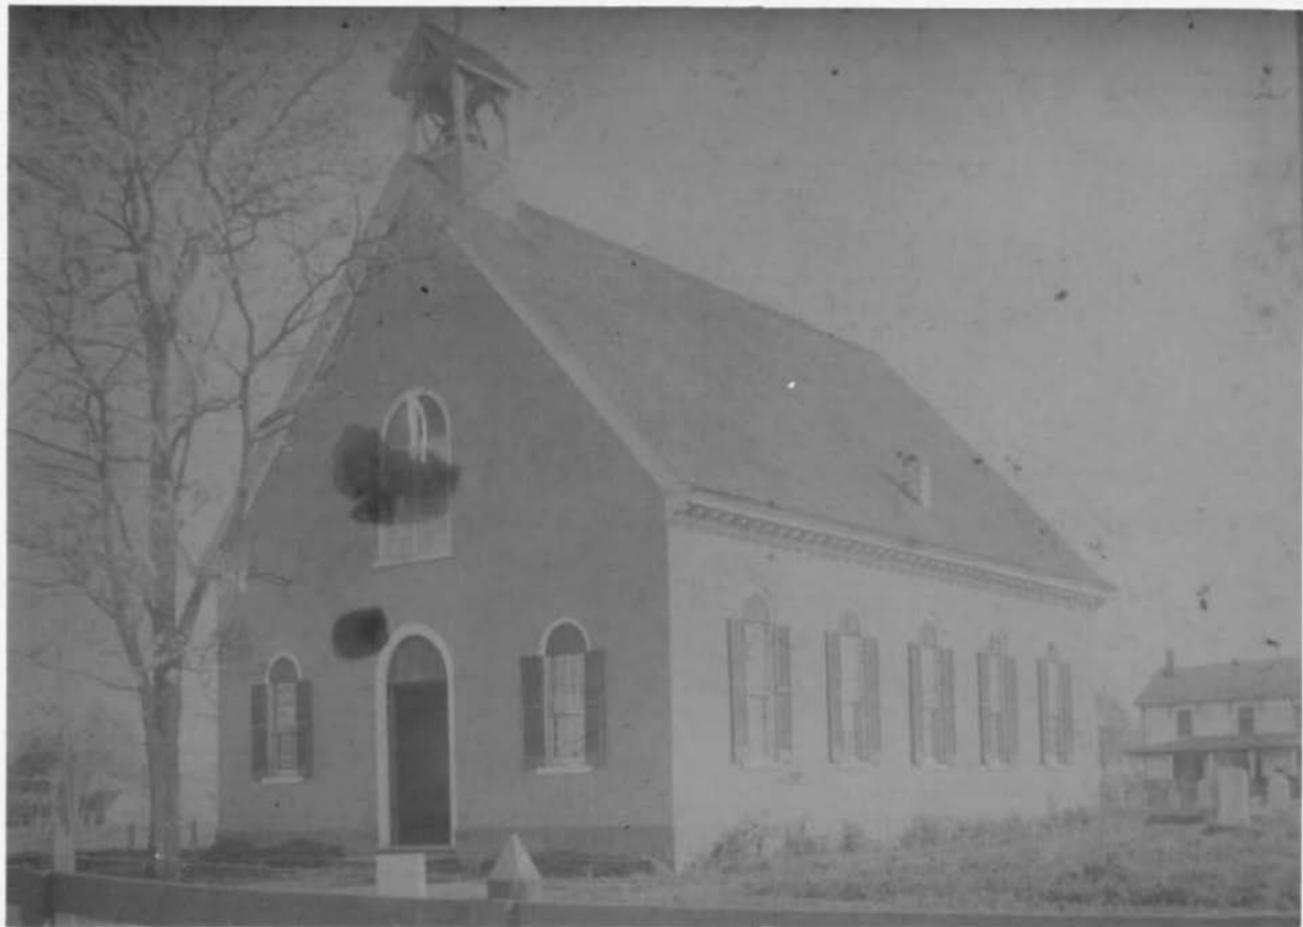
Christ Church  
Chaplin  
St. Marys County  
Maryland

View Before Tower,  
from west
