SM-7A

SOTTERLEY FIELD HAND'S QUARTER

Maryland Historical Trust State Historic Sites Inventory Form

SM-7A, Slave House at Sotterley
Hollywood
7.1 Description

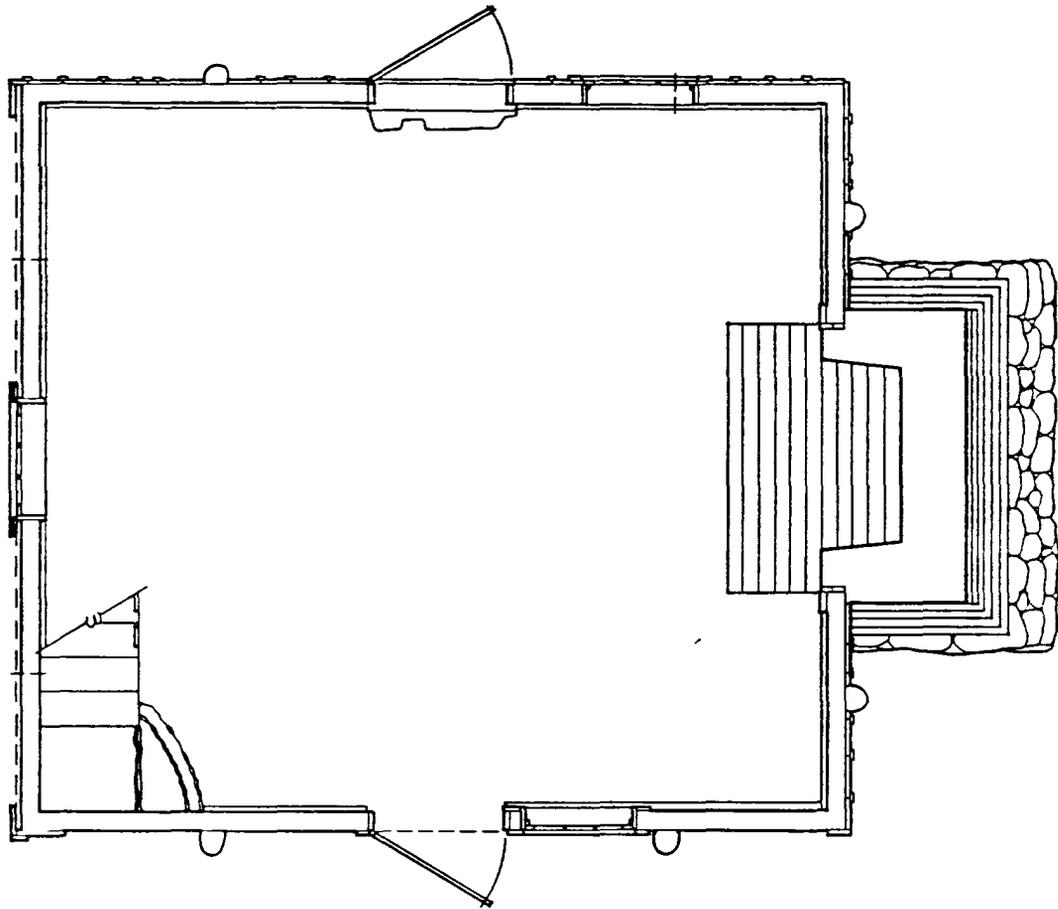
fig. 8. First-floor plan. This and subsequent drawings are by Jeffrey Bostetter, Colonial Williamsburg Foundation.

The interior consists of one room with a hearth located at the south end and a stair in the northwest corner. Headroom in the first-floor room is now 6'8". The main floor was originally clay, although a wood floor was added in the early twentieth century and later removed. Around 1950, the clay floor was brought up nearly to the top of the sills.

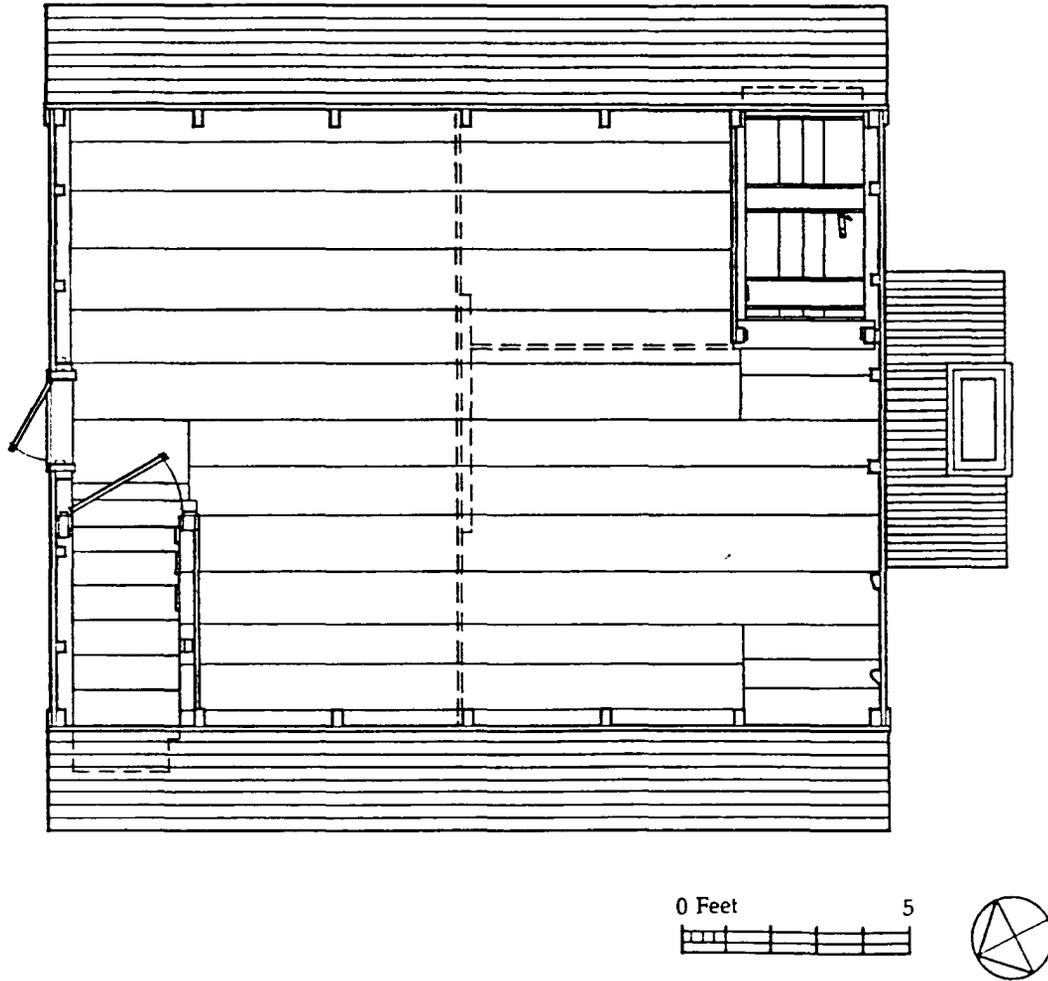
fig. 9. Attic plan.

The attic was left unfinished, with rafters, roof collars, and shingle lath exposed. Where the stair formerly rose to the southeast corner of the loft, there is an enclosure which was created by nailing rough, unplaned boards to the side and top of a door frame hung with a board-and-batten leaf on cast-iron butt hinges. Once the old stair was torn out, the original stair enclosure was converted for use as a doorless closet. A hole drilled in the side of the stair at collar height may indicate that a cloth was hung along the back (east) slope to separate a small space there for privacy or storage. Like the old stair, the new stair was enclosed with a similar box constructed of thin, rough boards and hung with a door of the same character. A partition of similar thin, rough boards was built to separate two attic spaces, presumably to create two separate bedrooms upstairs.

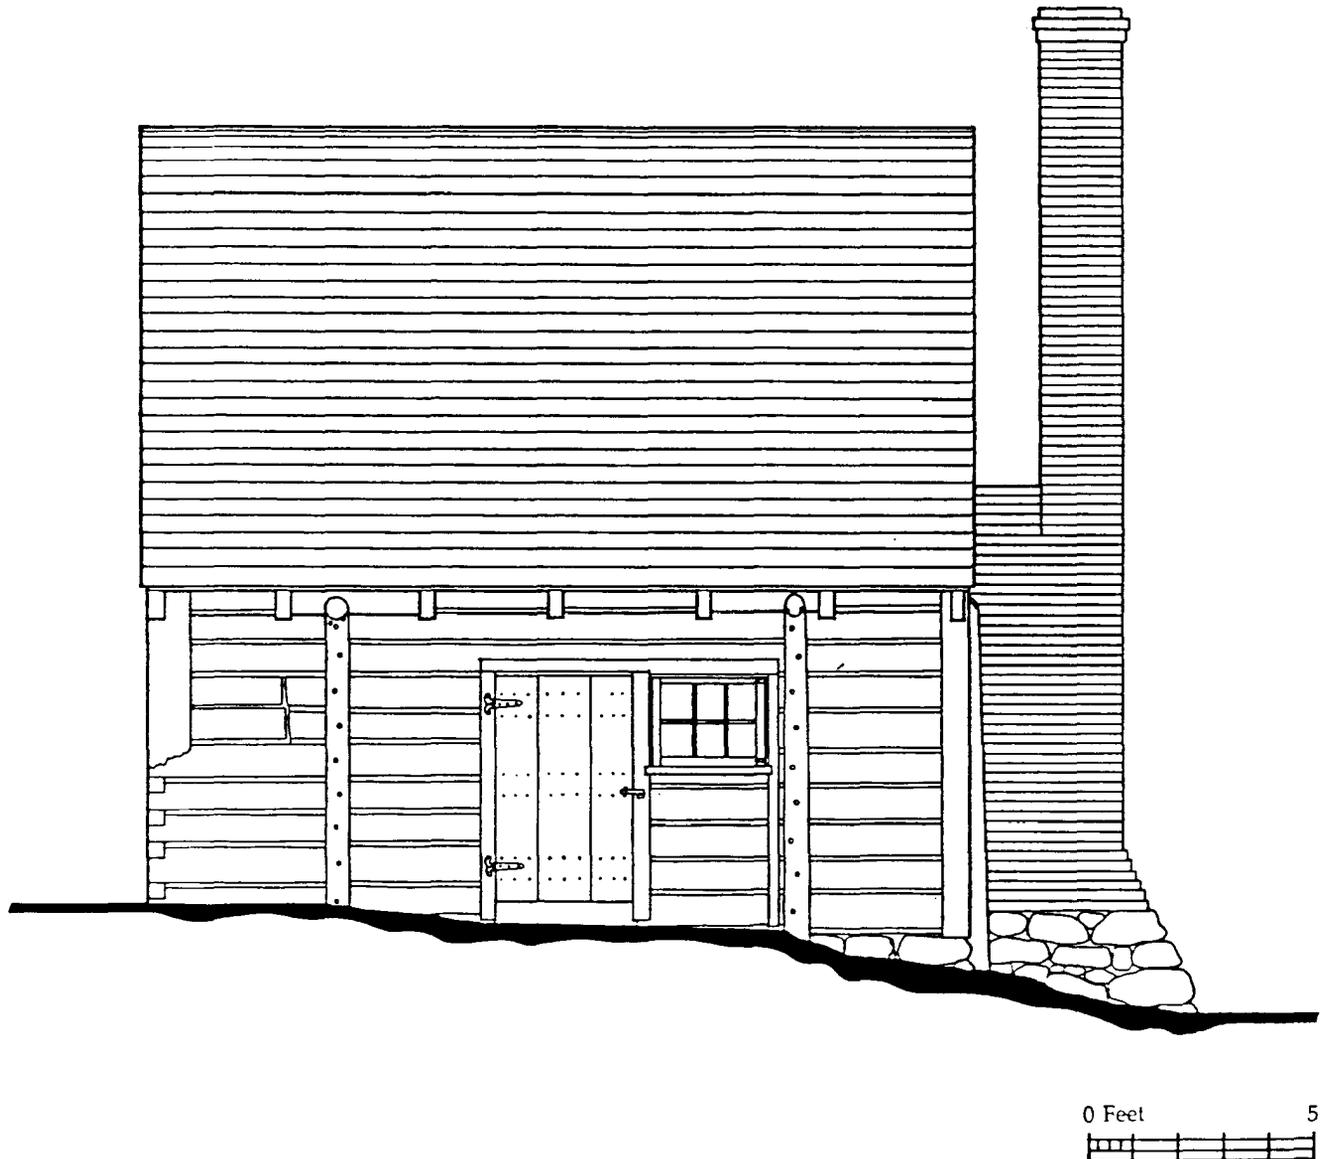
fig. 10. Front (west) elevation.

The west (main) elevation is pierced by a central entrance door measuring 5' X 2'11." The door swings out rather than into the room. The remnants of leather door hinges remain visible. There is an interior wall pocket for the door's original slide bar. Posts which serve as door jambs have been pegged into the ends of the logs where the door opening was cut. A six-light casement window abuts the southern door jamb. Originally shuttered, the plank shutter for this window has been removed and is stored on the interior of the building. The window, like all of those on the first floor, is finishe

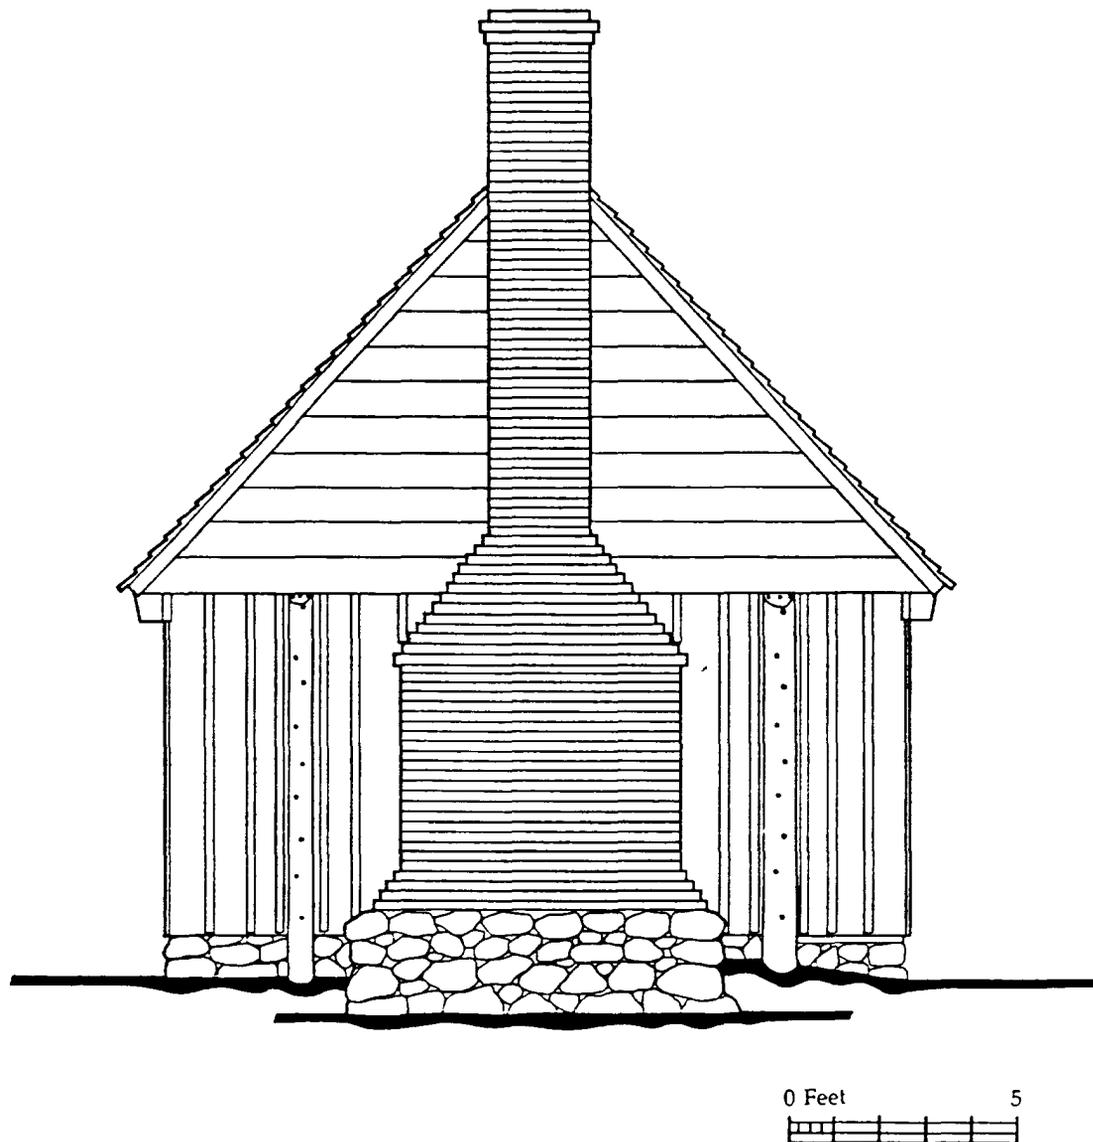
fig. 11. Right (south) elevation.

The first floor of the south elevation is blind. An exterior brick chimney with a field stone base stands against this gable end wall. The brickwork consists of hard-fired red brick laid in four- and five-course American bond with lime mortar in joints that taper back at their base. The brickwork steps out at the base and sits on a wide and rough platform of unworked brown sandstone intended to prevent the chimney from falling down the steep hillside to the south. The brick stack rises free of the gable since there is no attic fireplace.

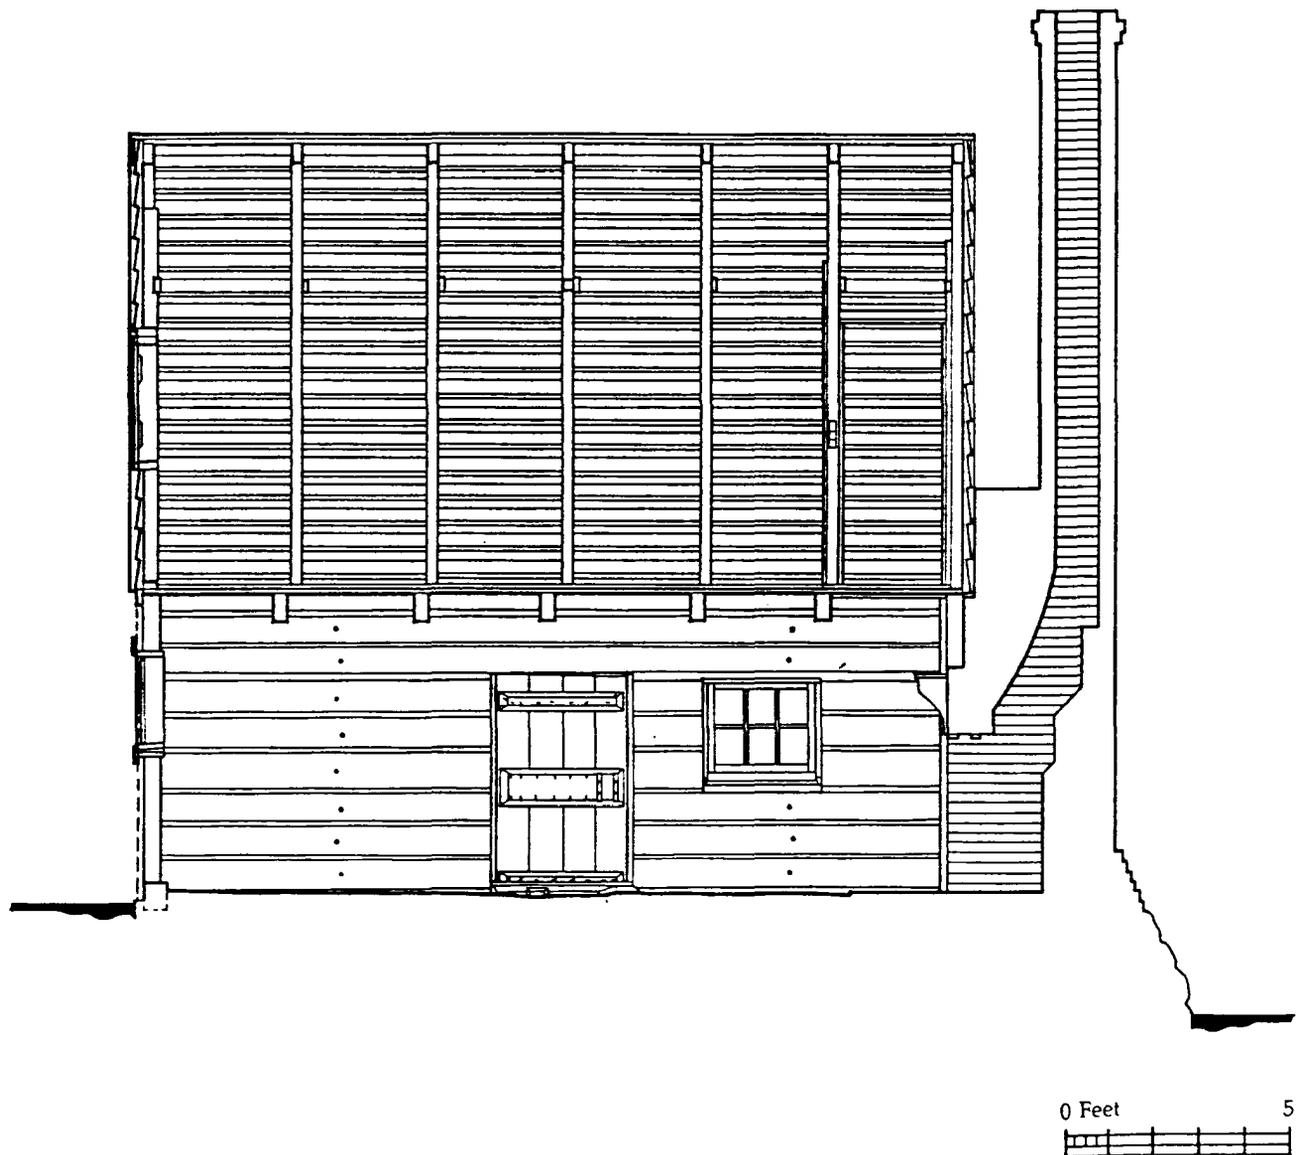
fig. 12. Longitudinal section, looking east.

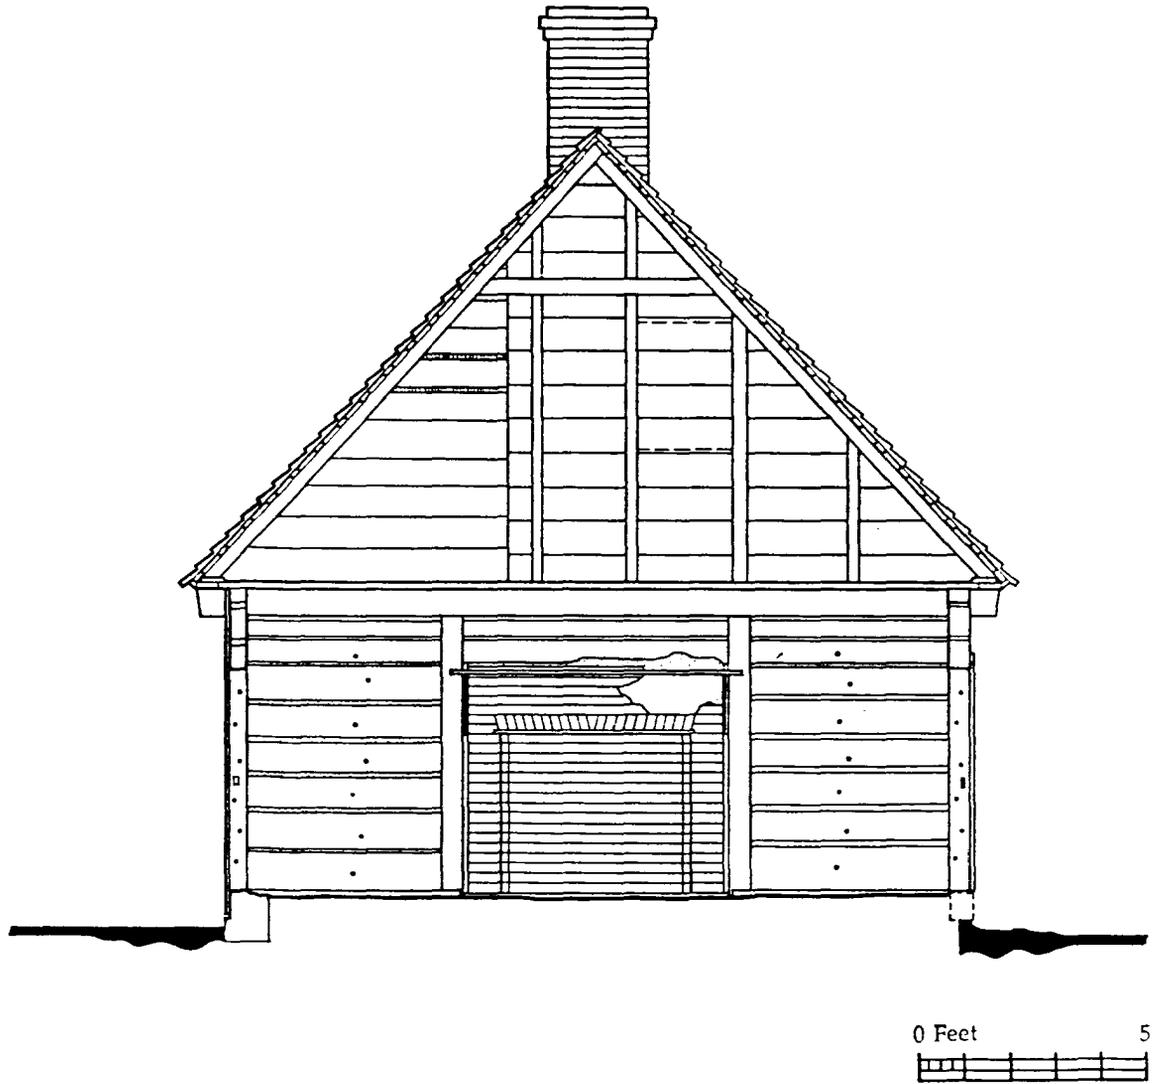
fig. 13. Transverse section, looking south.

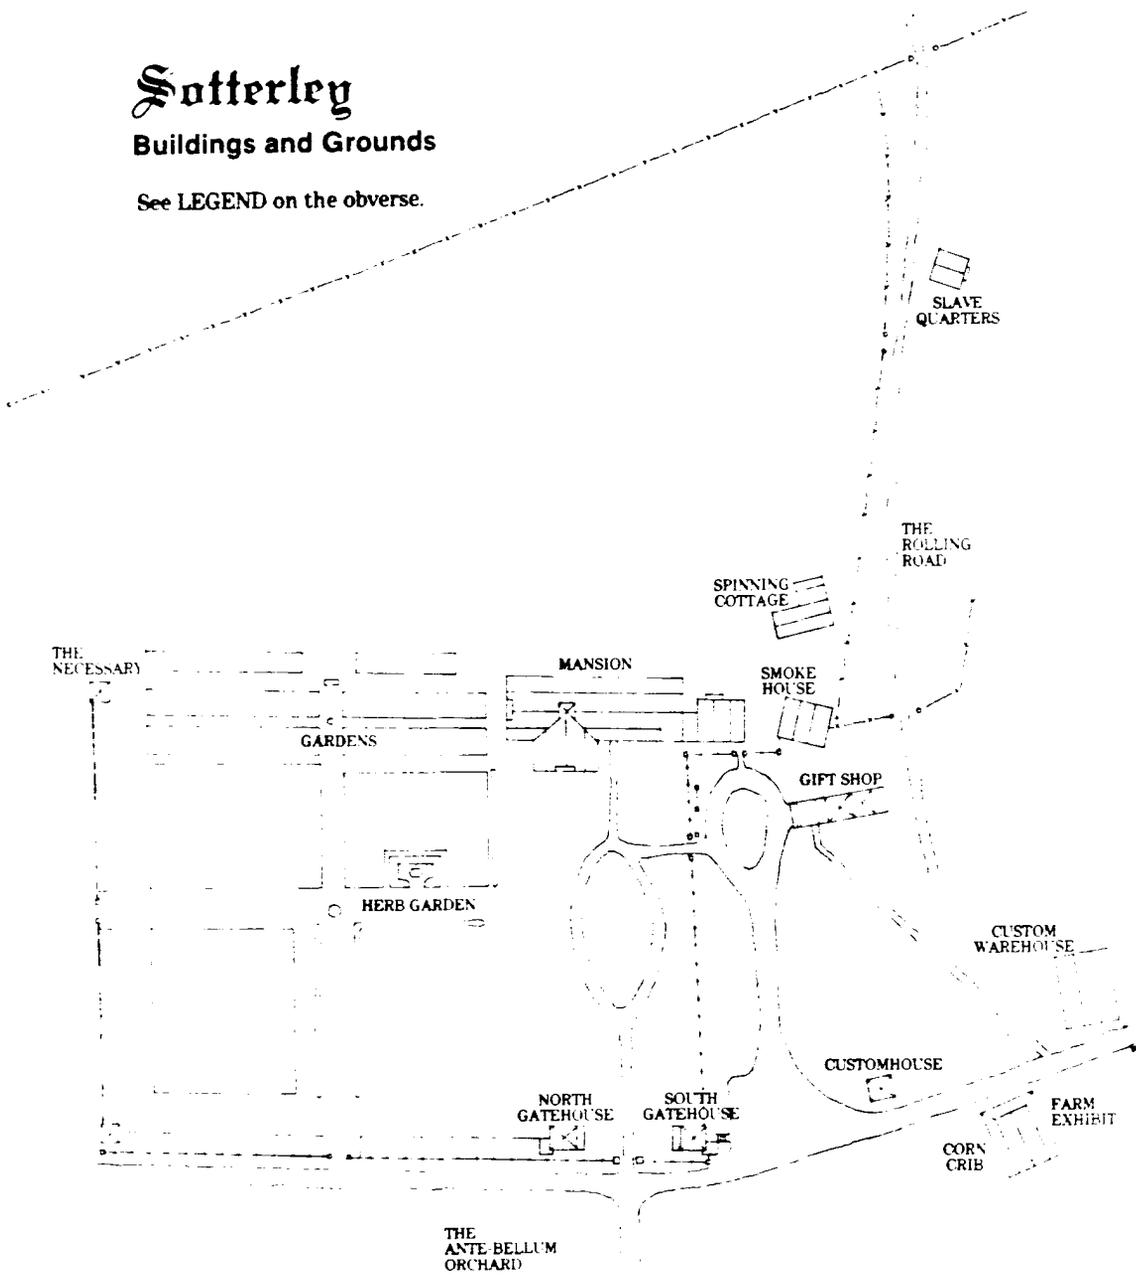
Site plan of the Sotterley grounds showing slave house.
Source: Sotterley Mansion Foundation, Inc.

The Slave House at Sotterley is located south of the main house on a narrow strip of flattened ground between a deep ravine and an old road which extends from the plantation's agricultural outbuildings to the Patuxent River. The Slave House is said to have been one of about five such houses located along the road between this site and the river.

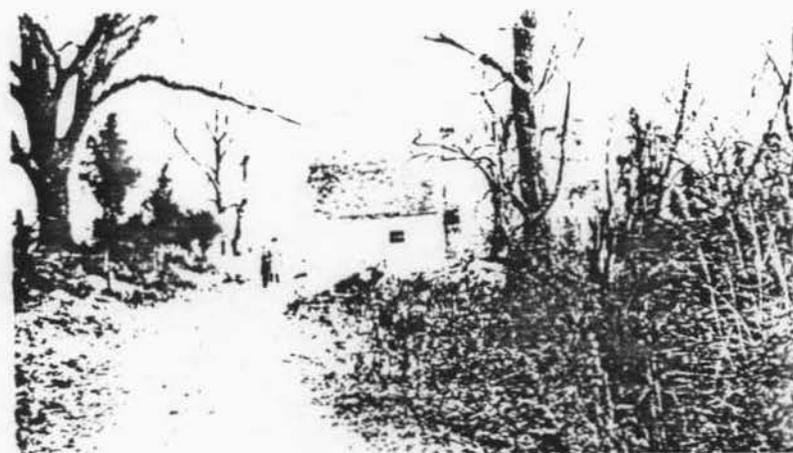
SM-7A, Slave House at Sotterley
Hollywood
7.10 Description

Historic photo of Slave House with caption "Sotterley Thanksgiving, 1936."
Source: Green Photo Album, Sotterley Mansion Foundation Archives.

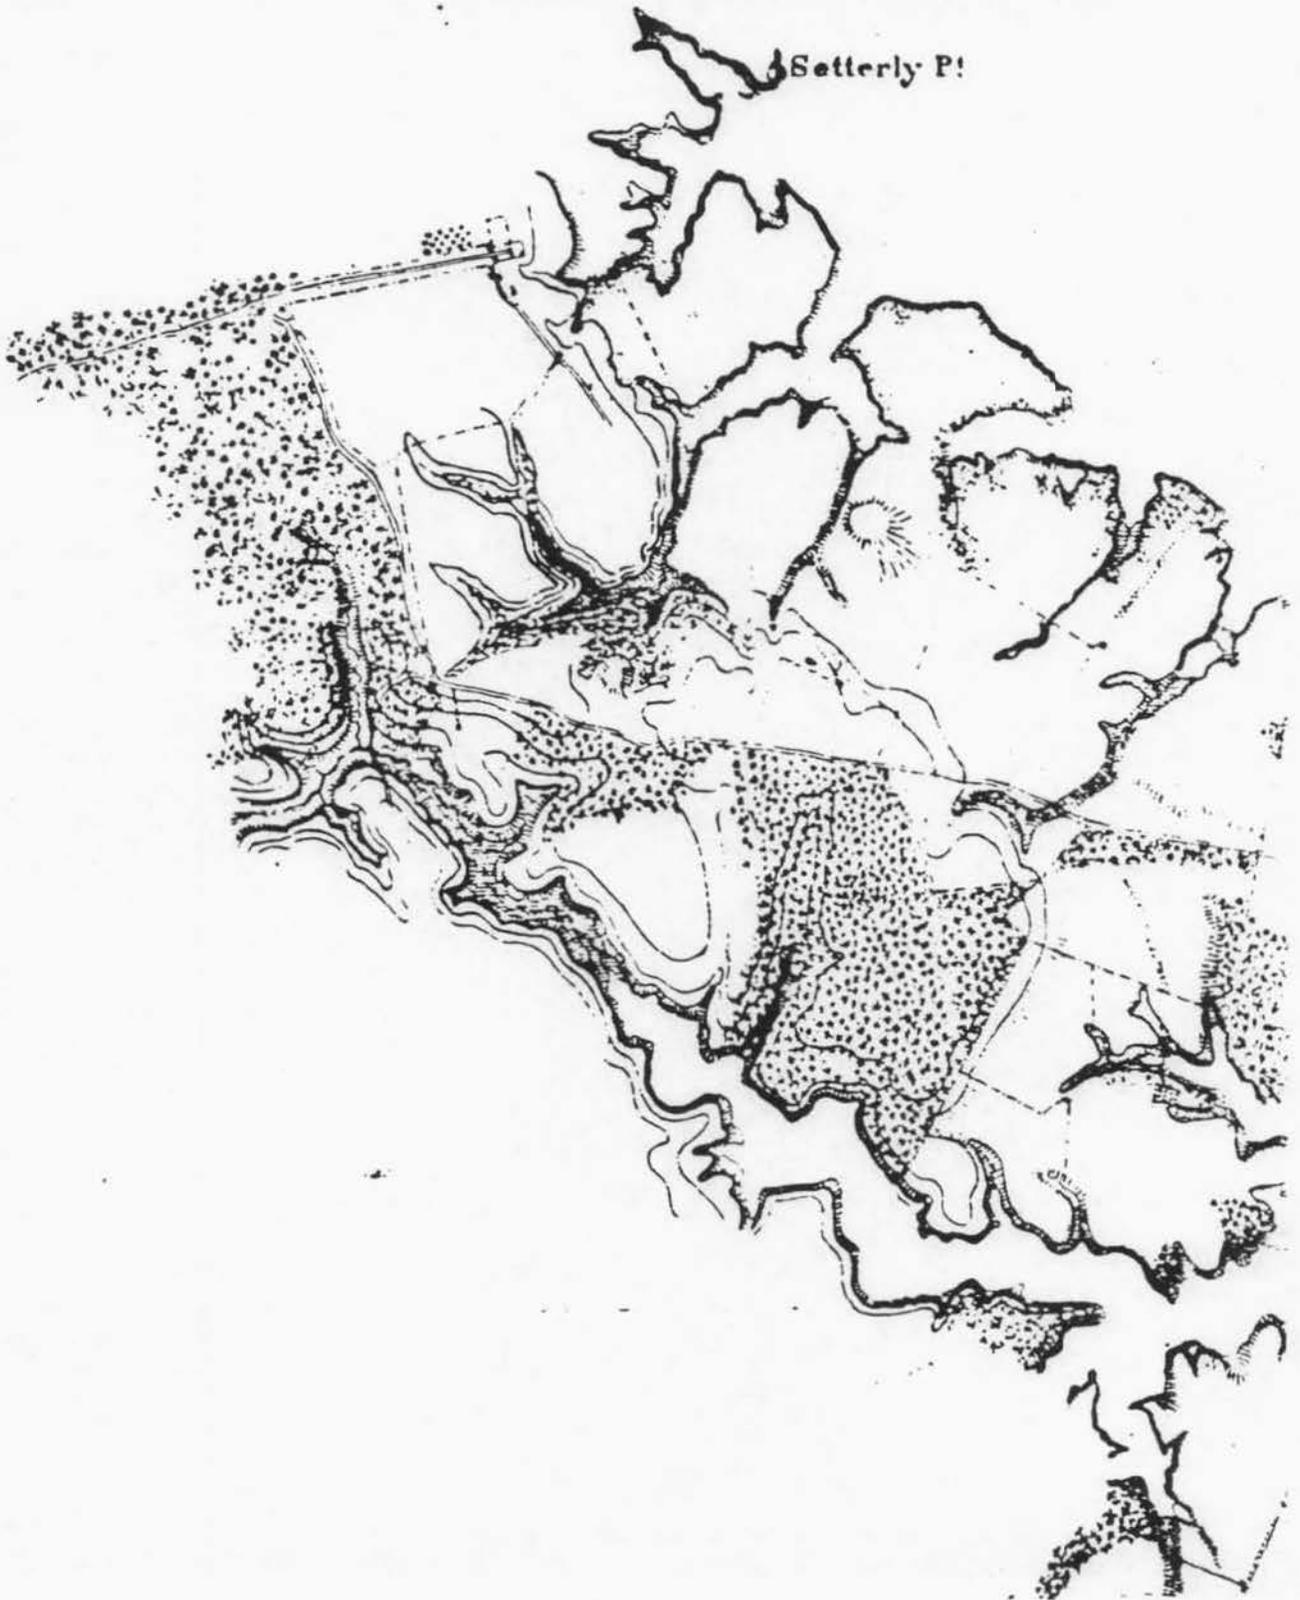
SM-7A, Slave House at Sotterley
Hollywood
7.12 Description

Detail from 1848 U.S. Coast Survey depicting the landscape of Sotterley Plantation.
Source: U.S. Coast Survey, "Mouth of the Patuxent River, Maryland," Sheet #256a.
