St. Joseph's Hall

Maryland Historical Trust Maryland Inventory of Historic Properties Form

Inventory No. SM-862

historic St. Joseph's Hall

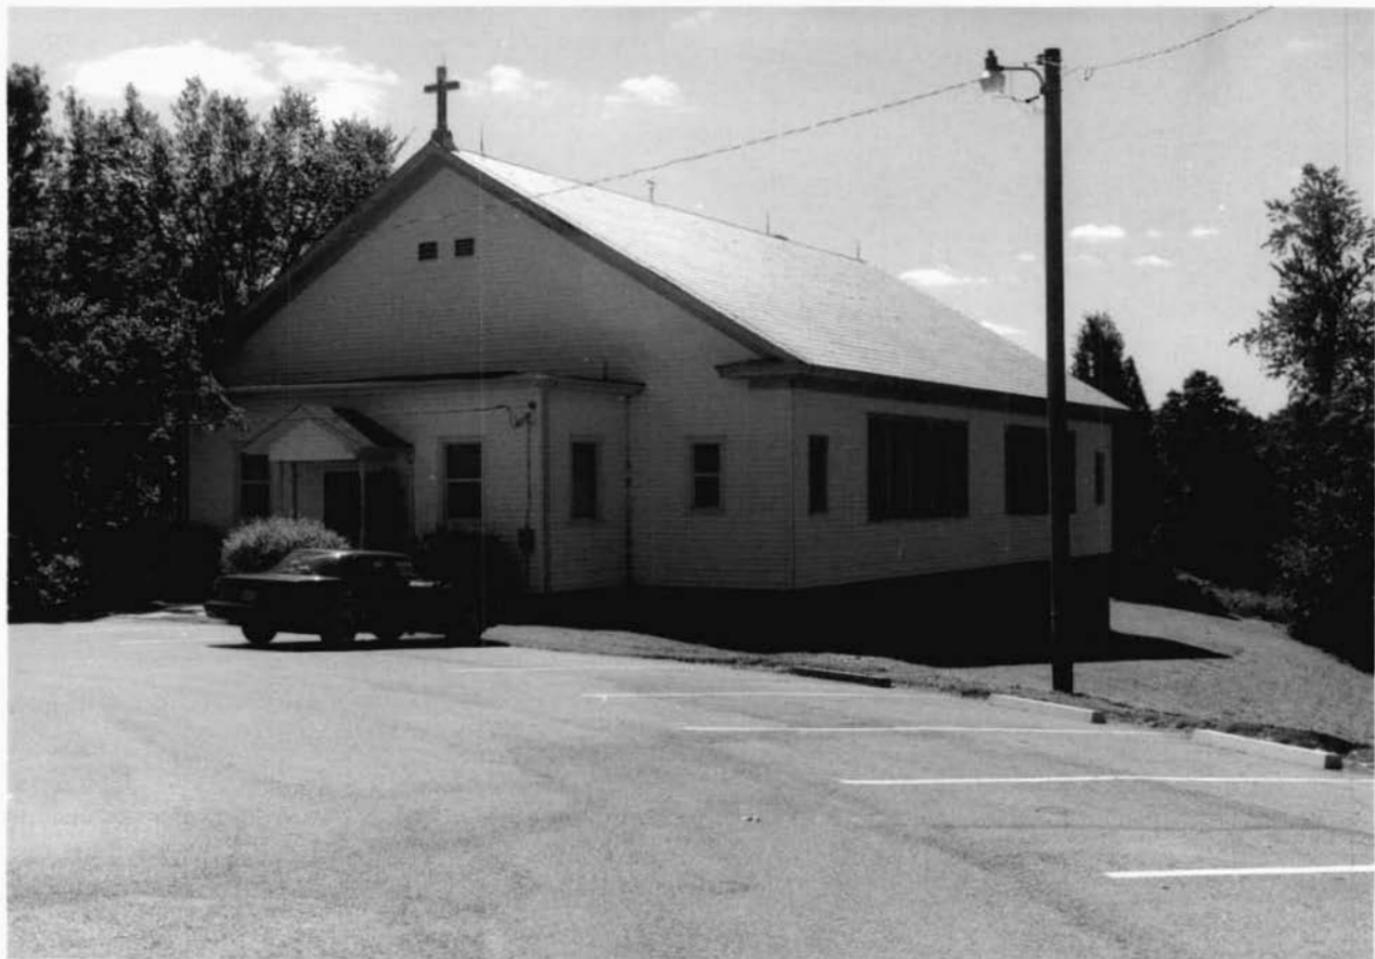
1 of 1

St. Joseph's Hall is a one story, gable-front, frame building with a gable roof. Resting on a concrete foundation, the hall's exterior walls are clad with aluminum siding and the roof is sheathed with decorative pressed-metal shingles.

The primary or north elevation features a flat roofed, three bay extension. The fenestration of this extension includes a set of paired, paneled doors flanked on either side by a modern one-over-one, double-hung sash window. The doors are sheltered by a gable roof portico supported by two turned posts. The main block, meanwhile, features a one-over-one window lying on either side of the extension. The upper portions of the elevation exhibits two louvered openings presumably for the ventilation of the attic. A large cross adorns the peak of the gable front and cornice returns further accentuate the elevation.
