Capsule Summary
SM-886
Oraville Store
Oraville
Private

Maryland Historical Trust Maryland Inventory of Historic Properties Form

Inventory No. SM-886

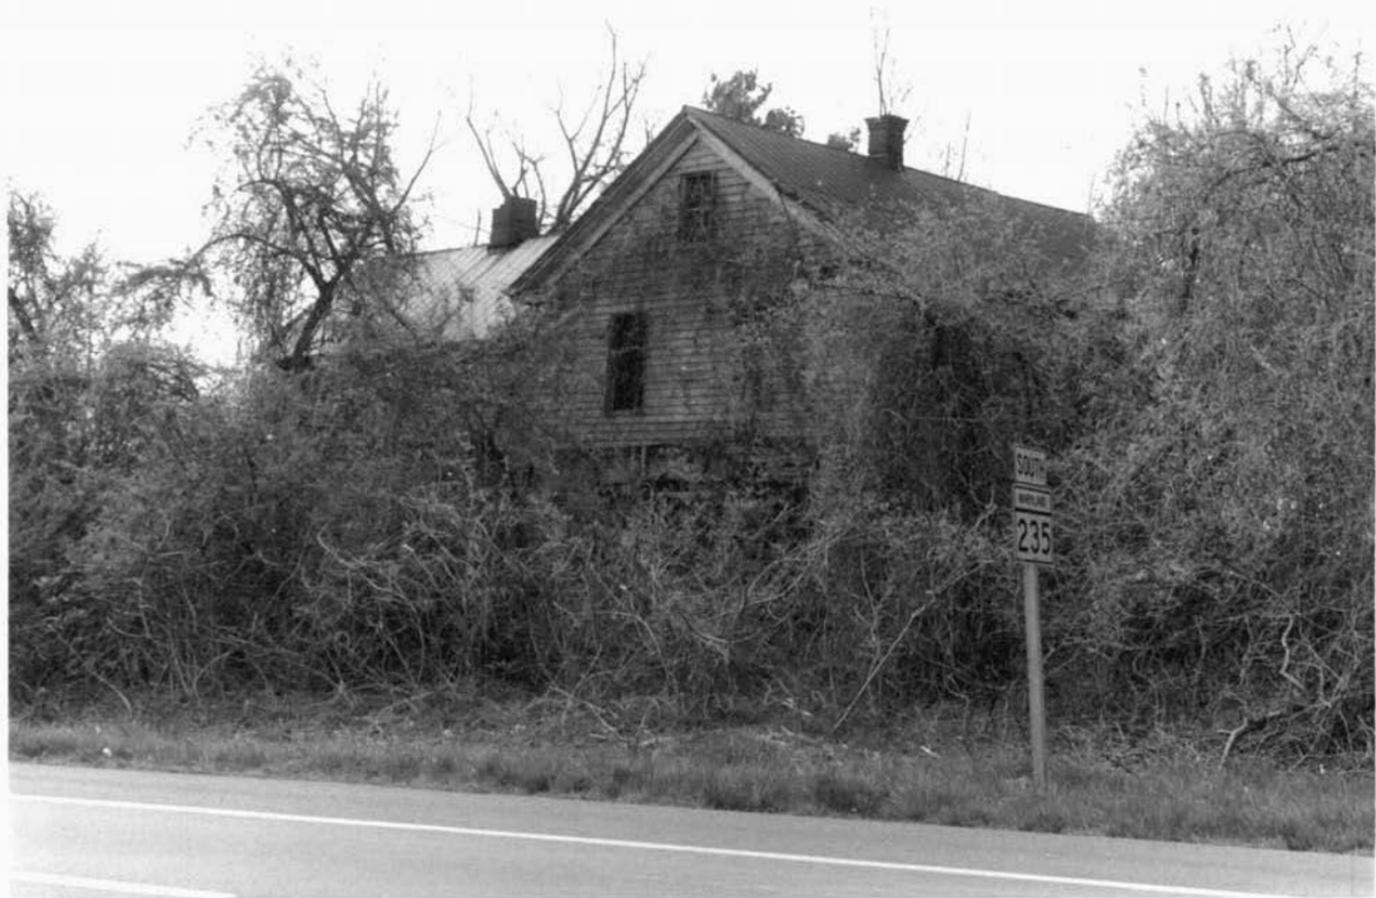
1 of 2

The primary or north elevation is largely obscured by overgrowth. Windows visible on the second floor suggest however, that the main block is pierced by a door and window on the first floor that were once shaded by a now collapsed porch. The second floor fenestration consists of two windows that have lost their sash. The attic story is also illuminated by a window. The gable front of the store is accentuated by cornice returns. No openings on the wing are visible due to foliage.

Looking S

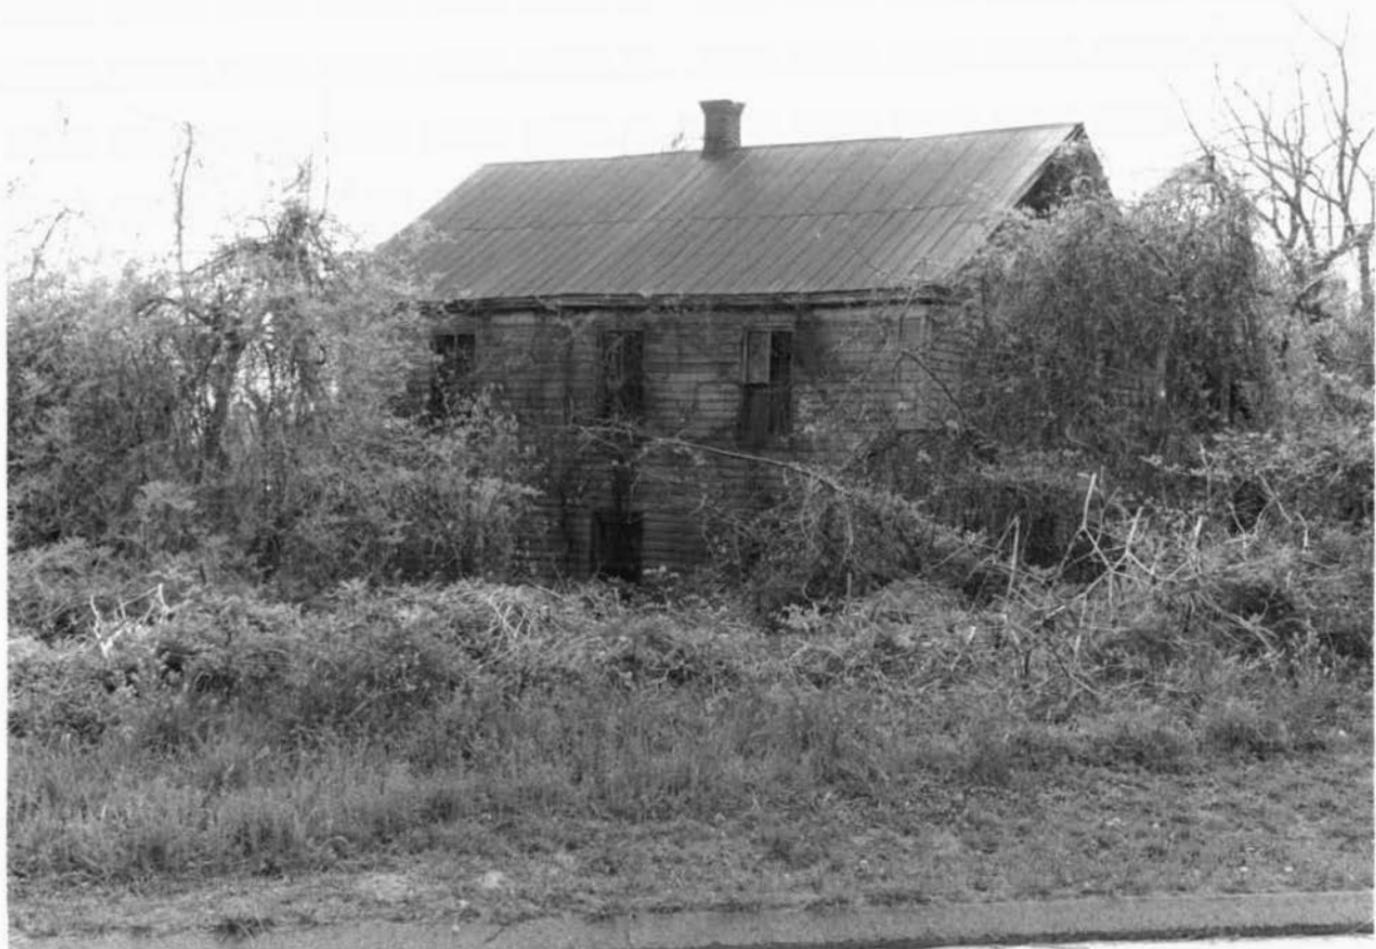
SM-886
Oraville Store
St. Mary's County
Kirk Ranzetta
Sept/00
Md SHPO
Looking E
2 of 2

The west elevation of the main block is pierced on the first and second floors by three two-over-two, double-hung sash windows.
