**MARYLAND HISTORICAL TRUST
NR-ELIGIBILITY REVIEW FORM**

Property Name: Barnwell/Lar Ray Inventory Number: T-1136

T-1136 Barnwell/Lar Ray

Maryland Historical Trust Maryland Inventory of Historic Properties Form

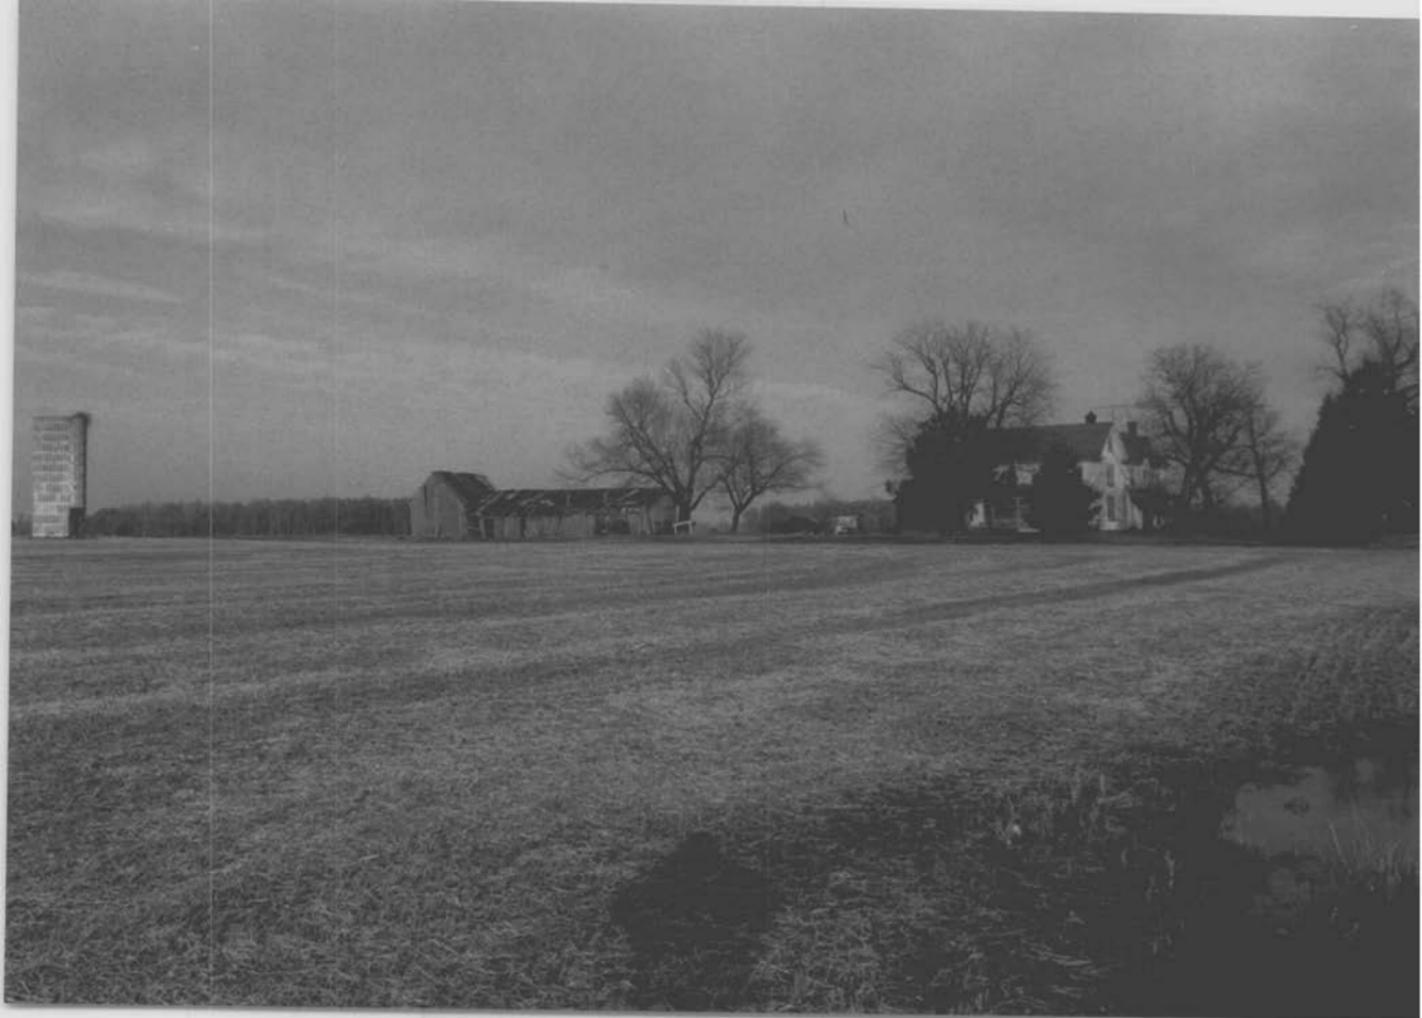
1/7

View of farmstead, to North E. from
Matthewstown Road

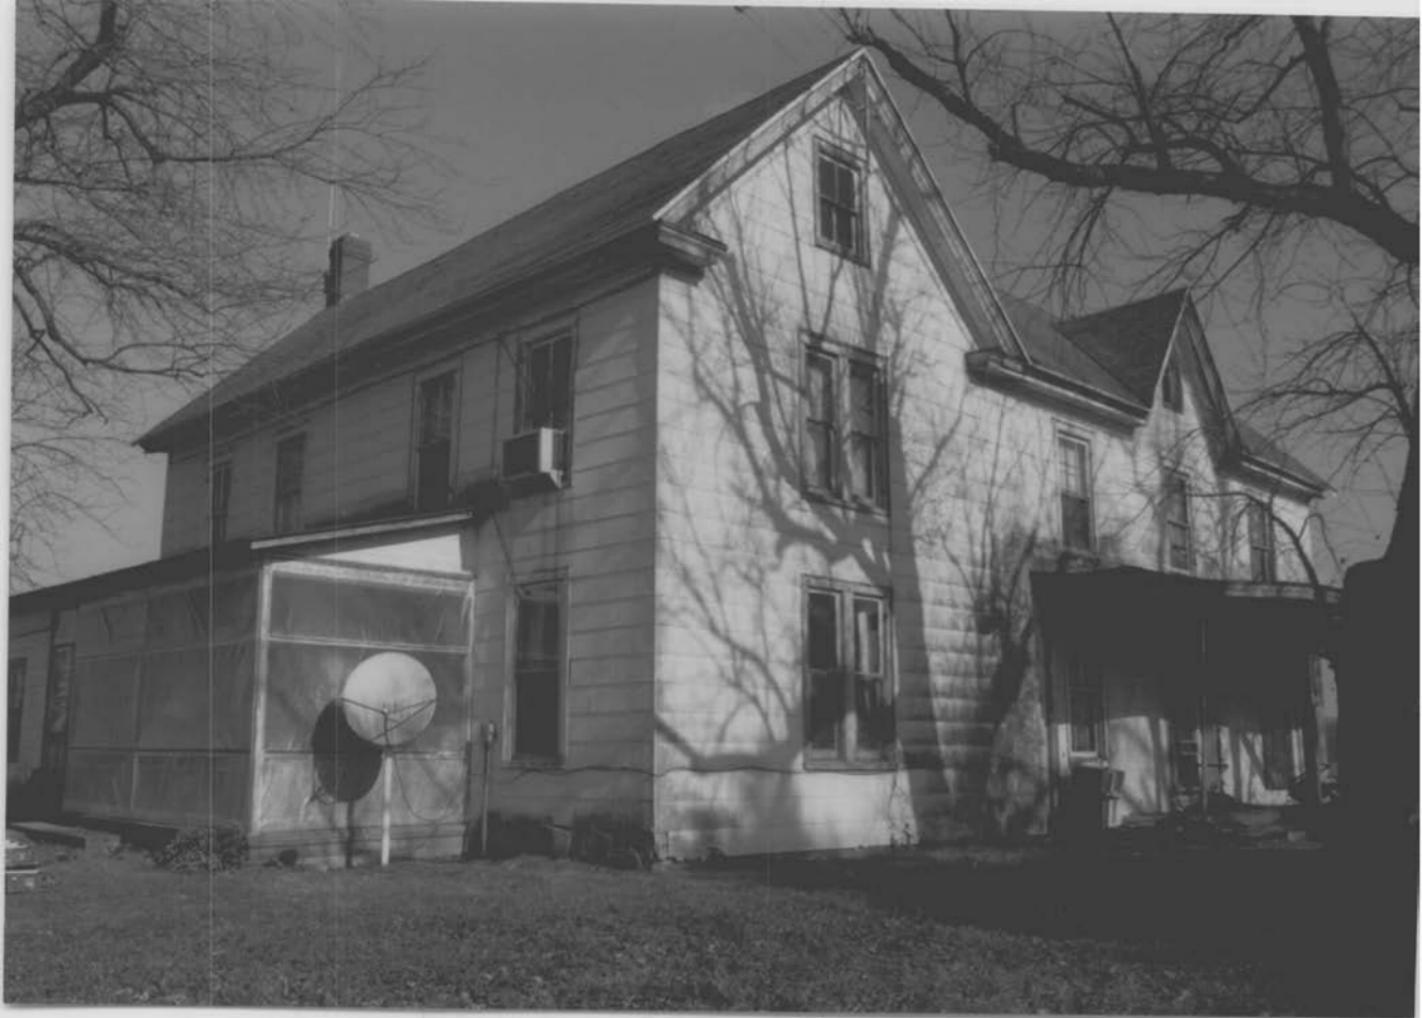
2/7

The house is a 2½ -story wood frame L-plan building. The original block (east) of the house is a rectangular I-house constructed on a continuous brick foundation. The principal (south) façade is three bays wide and has symmetrical fenestration. There is a shed roof front entry porch with wood post supports. The I-house has a central cross gable with a lancet window and there are two internal brick chimneys in the original block. The side-gabled roof is clad by composition shingles and has cornice returns.

View of house, side + front
elevations, to the NE

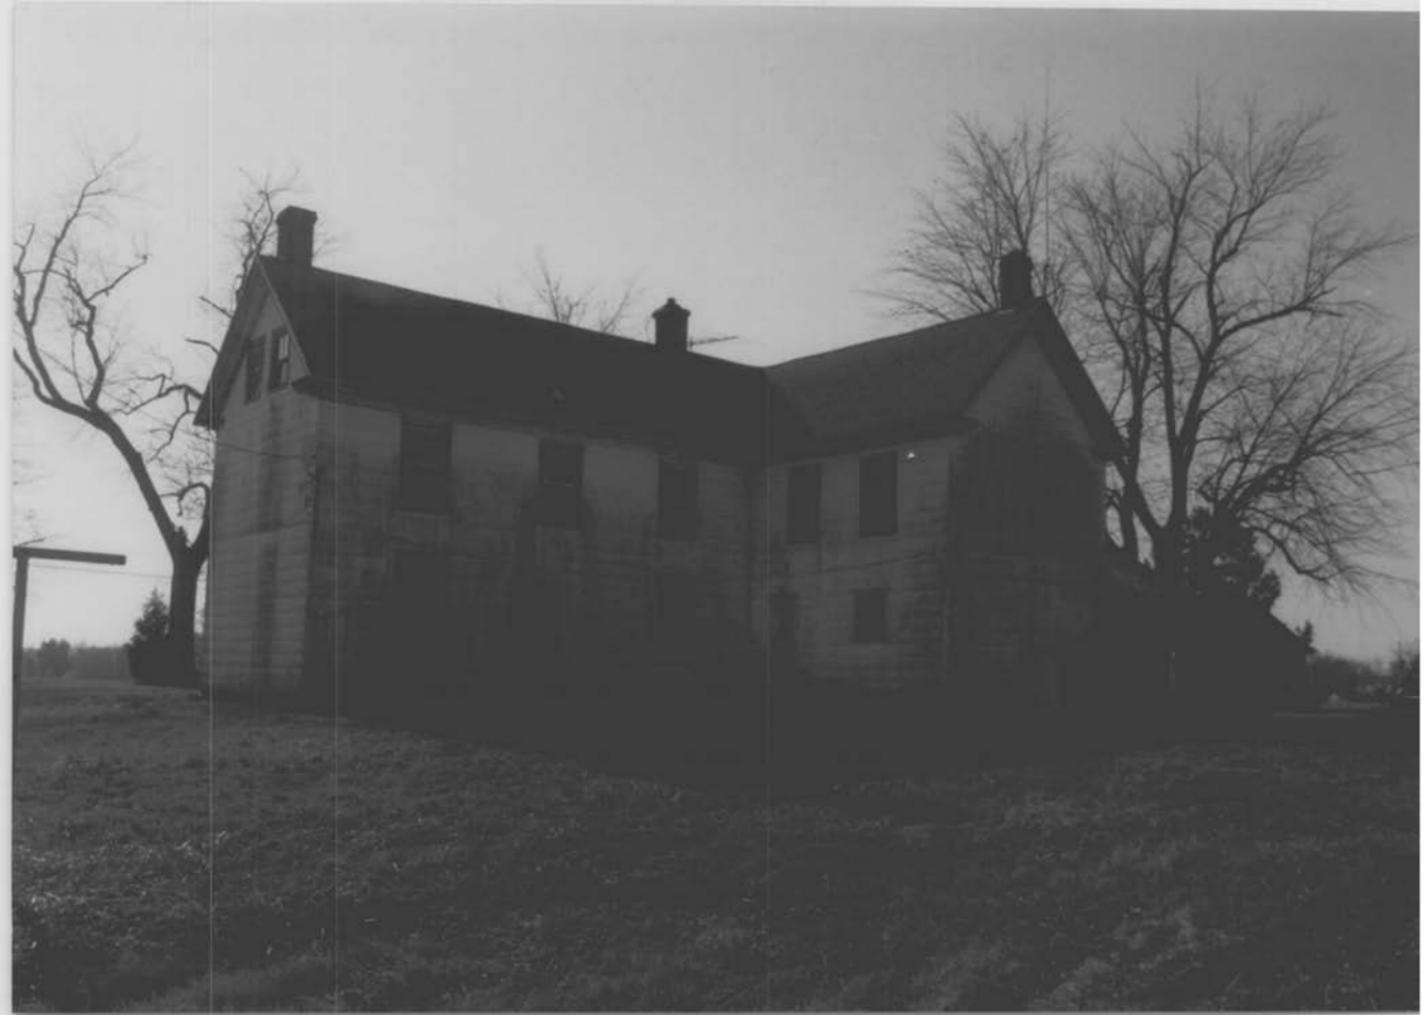
3/7

There is a rectangular 2½-story front-gabled addition to the west side of the I-house constructed on a brick foundation. The addition has an interior brick chimney and its composition shingle clad roof has cornice returns. The house has wood double hung sash (2/2 and 6/6 lights) windows and the building is clad by asbestos shingles. There is an enclosed shed-roof porch on the west (side) elevation.

View of house, rear, to the
SW

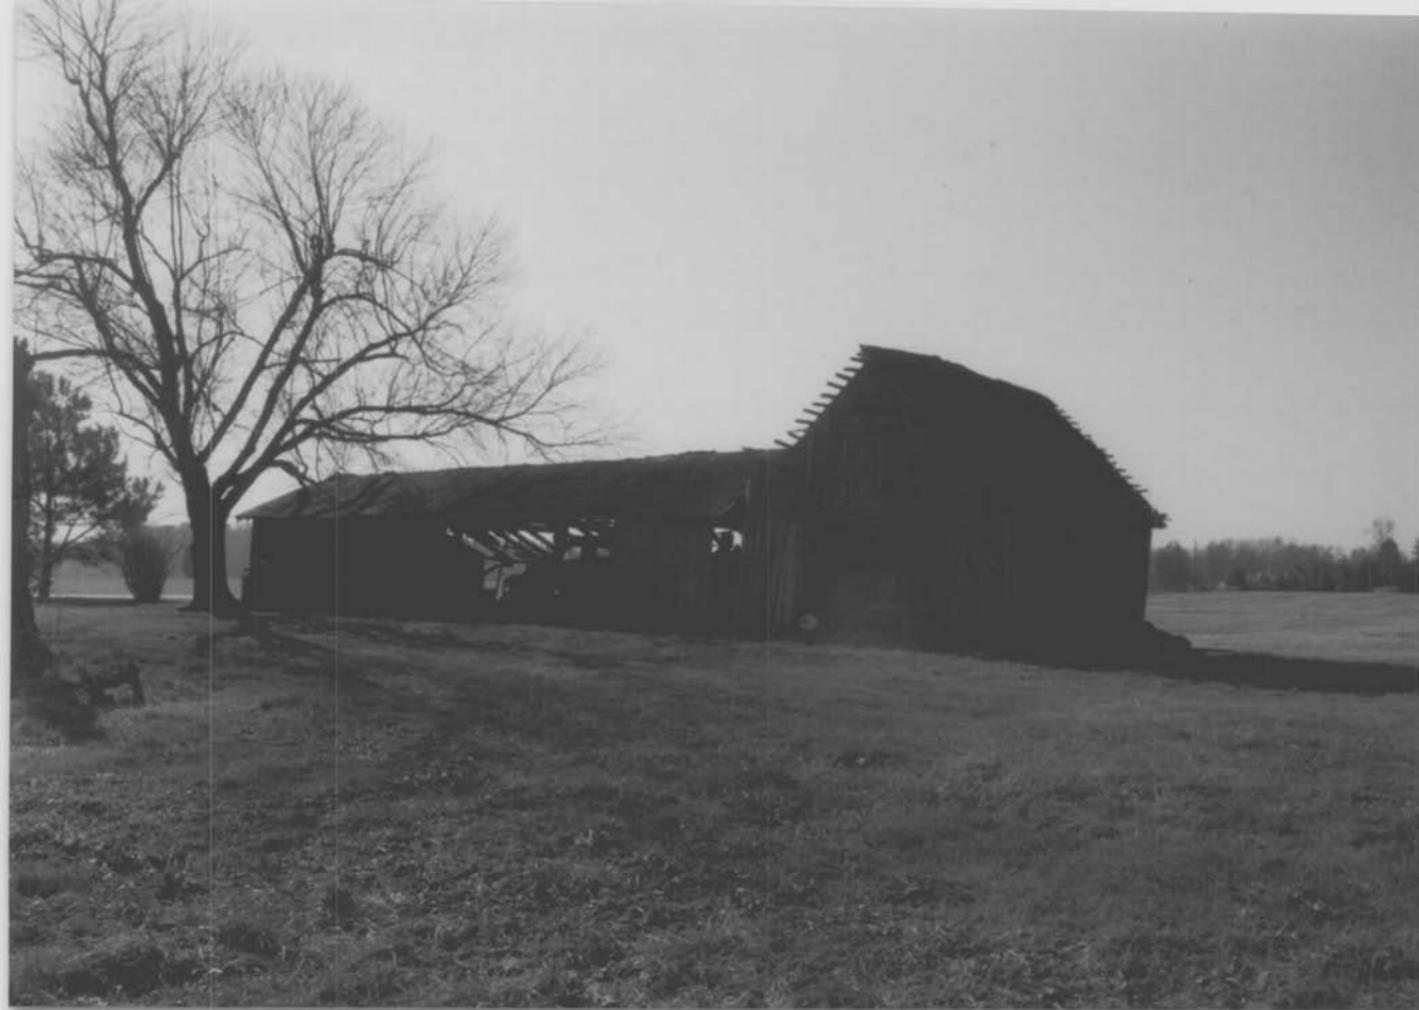
4/7

The storage building/garage is a wood frame building located west of the house. It is a gable-end building constructed of a mortise-and-tenon frame with board-and-batten wood siding. The roof is clad by corrugated metal. The garage is a rectangular extension of the front-gabled building, attached to its southern elevation. The garage is an open, wood frame side-gabled building.

View of shed, garage,
to West.

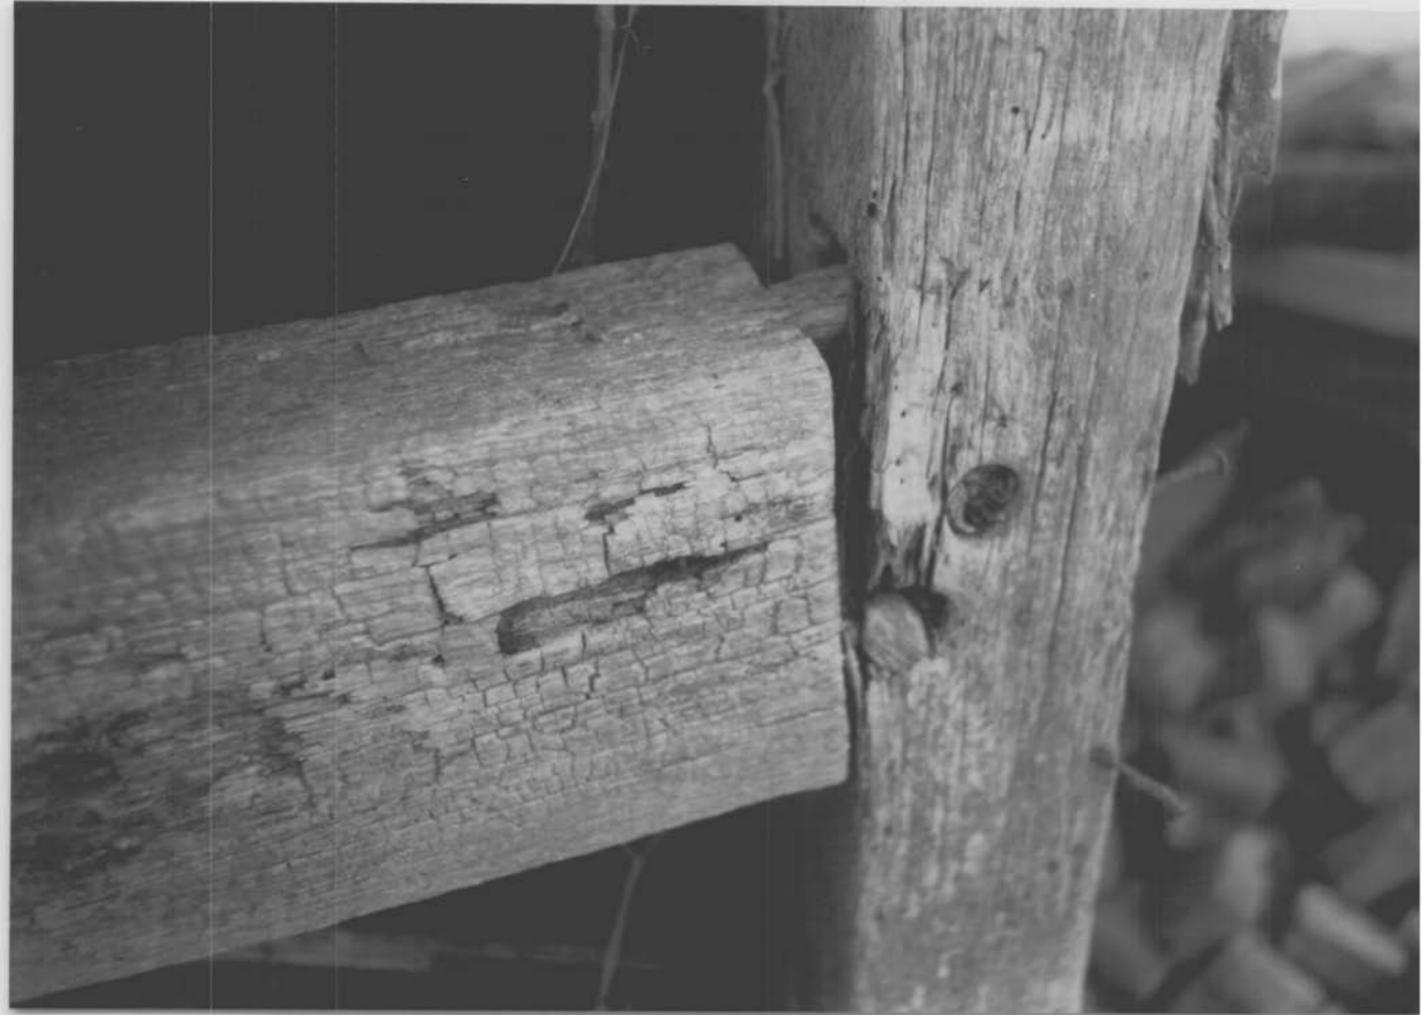
5/7

Construction detail,
Shed, northeast corner.

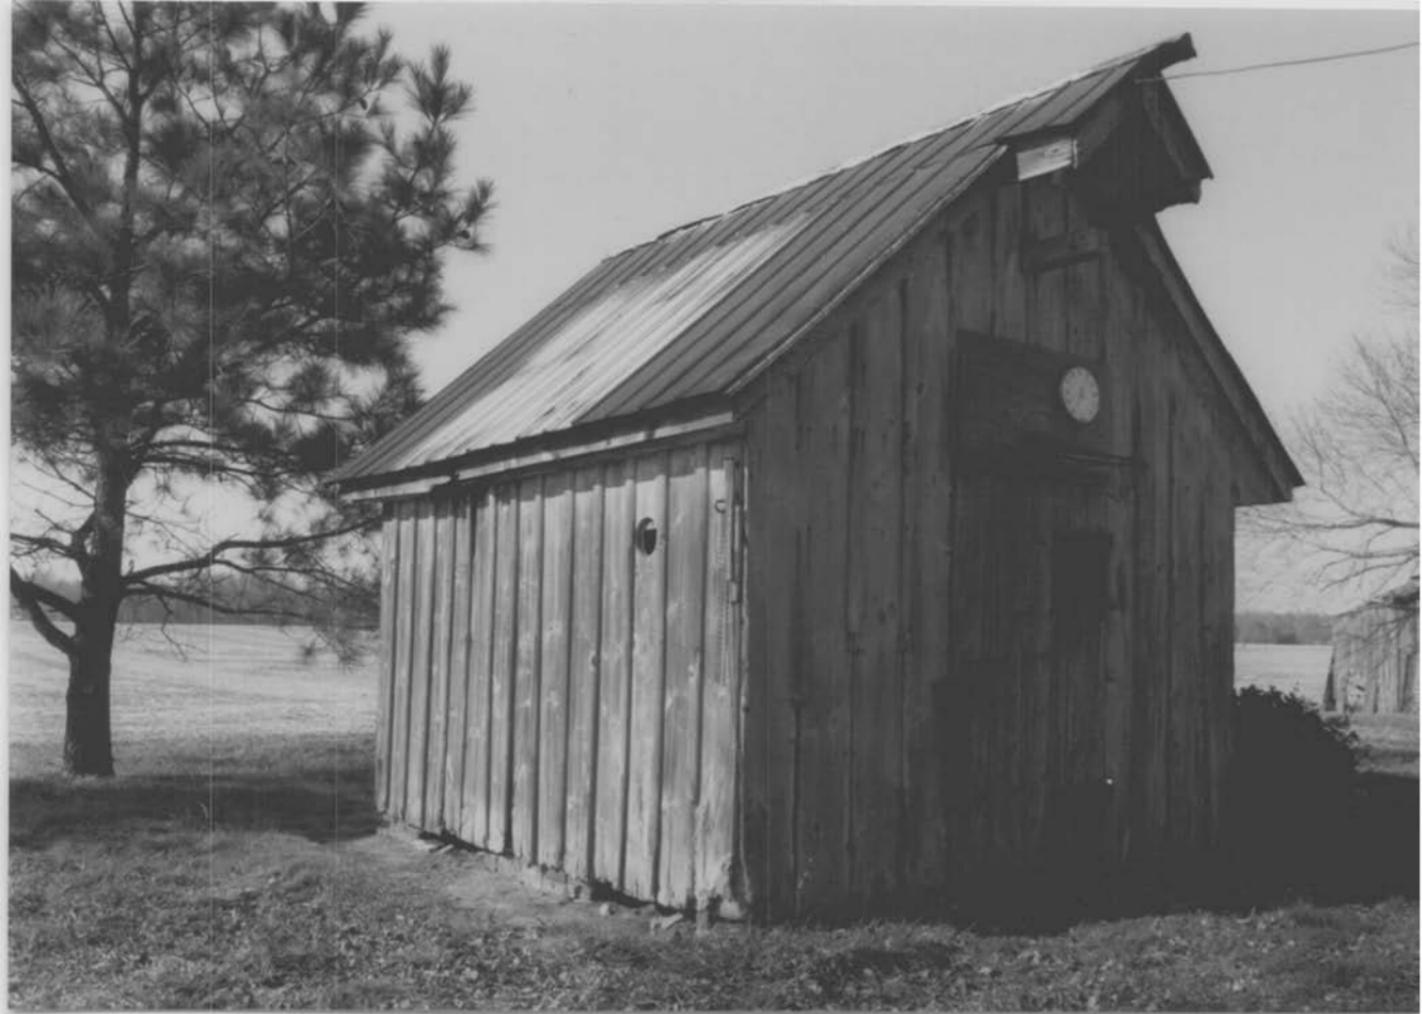
6/7

The third building at the property is a front-gabled rectangular wood frame smokehouse. The smokehouse is a one-story building constructed on a brick pier foundation. It is clad by board-and-batten siding and a standing seam metal roof. There is a hood and joist above the building's single door.

Smokehouse, front and
side elevations. View to
NW.

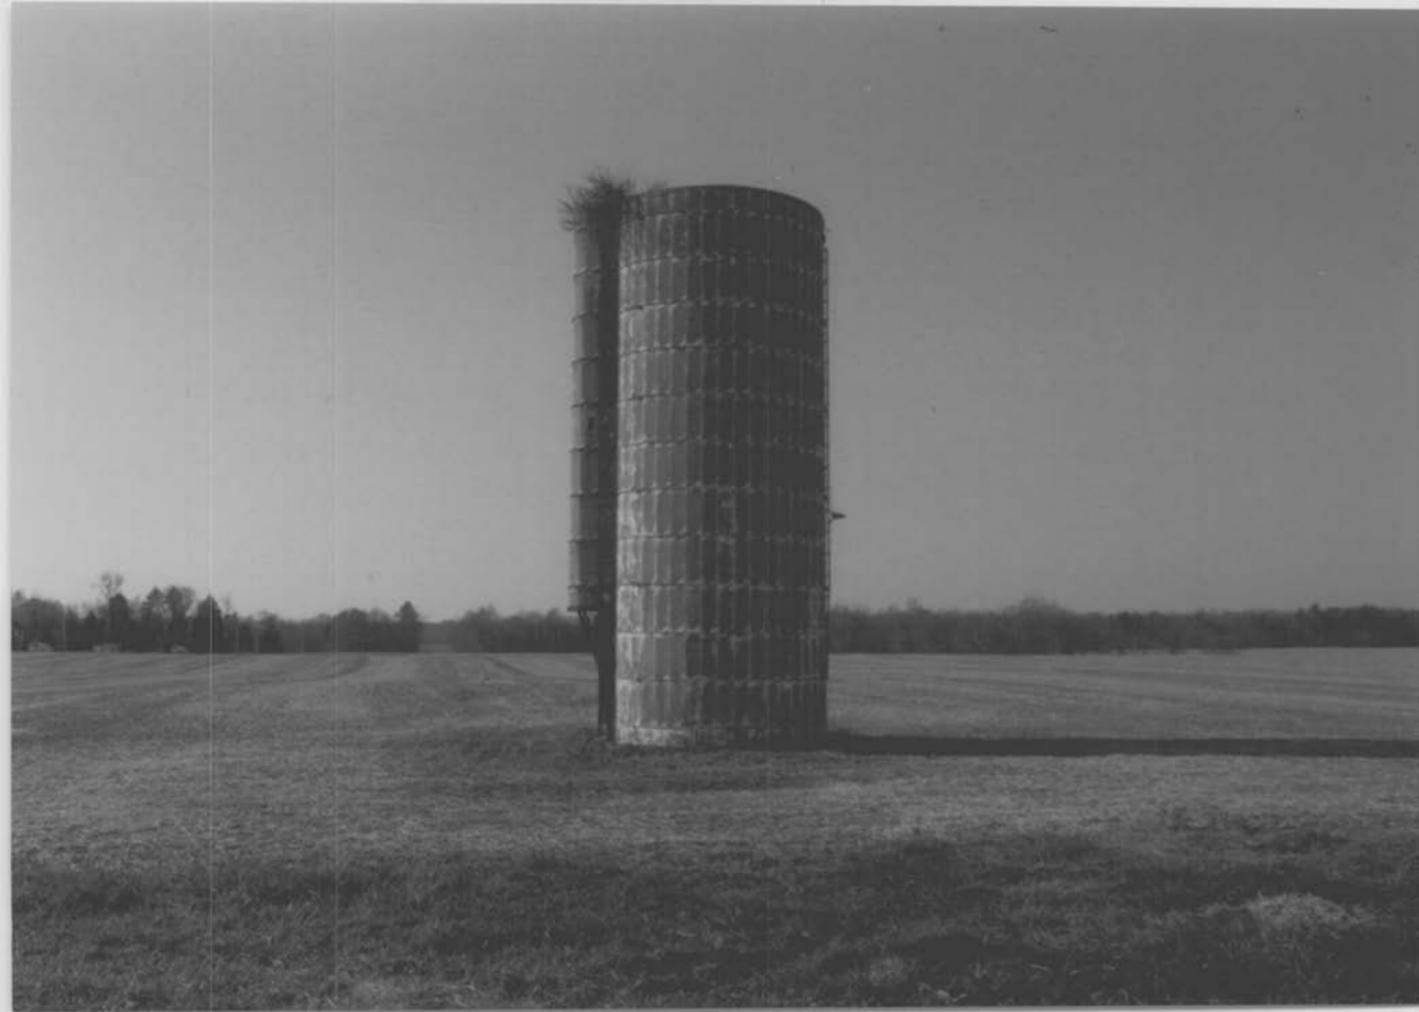
7/7

The silo is located north and west of the storage building/garage. It is a concrete silo.

Silo, view to the
west
