**MARYLAND HISTORICAL TRUST
NR-ELIGIBILITY REVIEW FORM**

Property Name: Knox Farm/Morris Farm Inventory Number: T-1137

Maryland Historical Trust Maryland Inventory of Historic Properties Form

Inventory No. T-1137

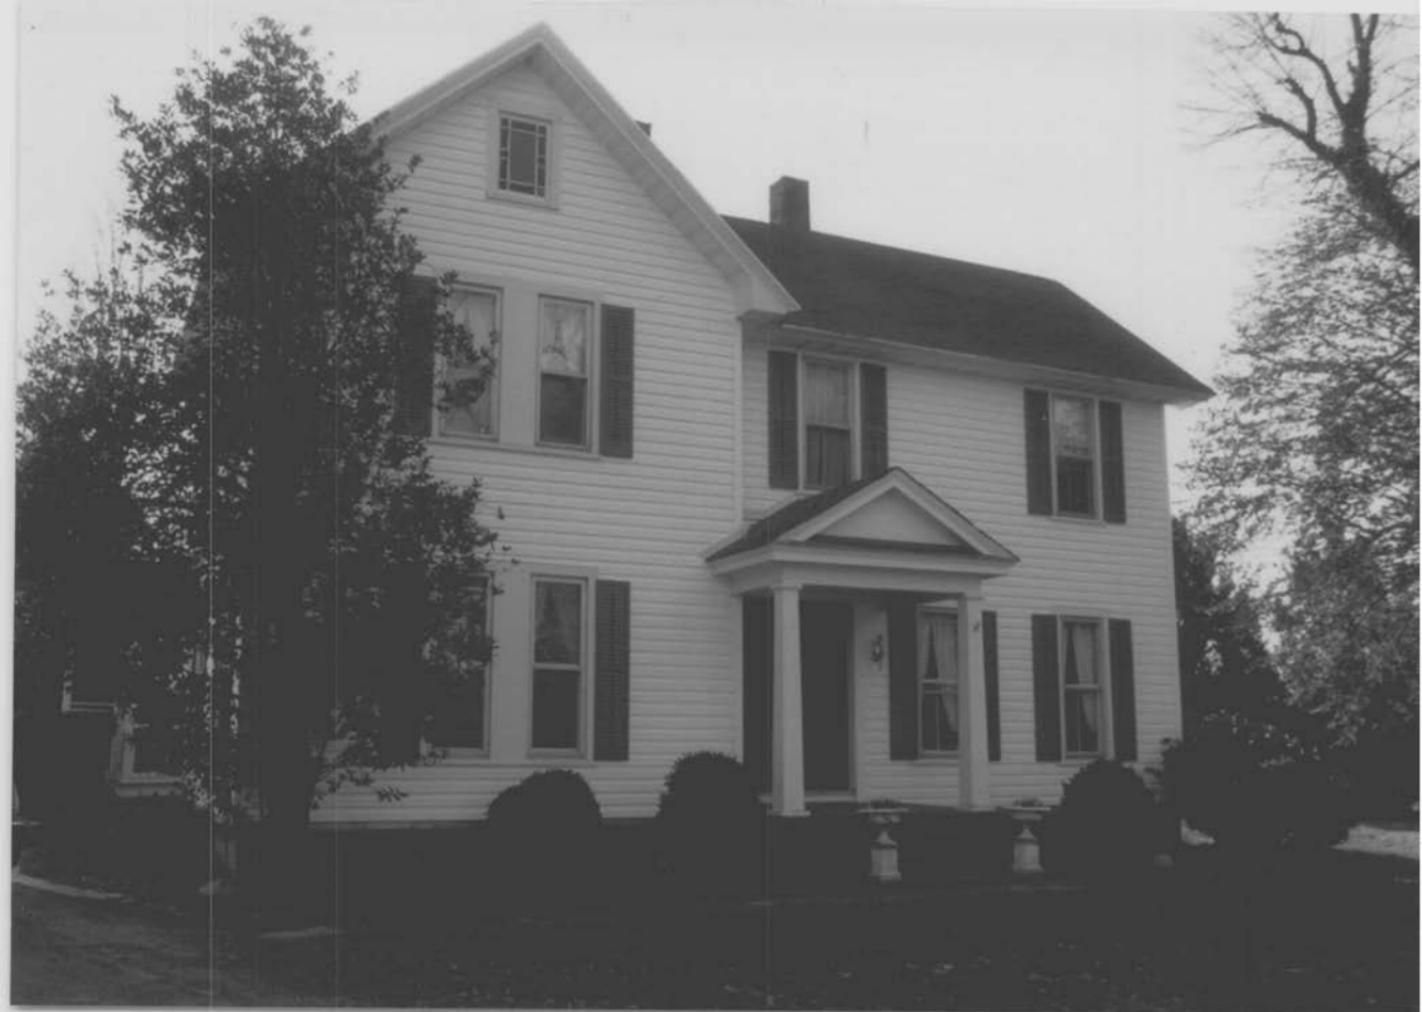
115

House, North elevation

The house at this property is a 2½-story wood frame vernacular building constructed on brick foundation. The house has an irregular plan, the result of multiple additions. Measuring five bays by four bays, there is a front portico situated on the north side of the house and a screened shed-roof side entry porch. The front (north) portico has squared square wood columns and a pedimented gable roof. The cross-gabled house has metal double-hung sash (2/2 lights) windows, and the cross gable block has paired ribbon windows in the north elevation. There also is a gable peak window in the cross gable with a single colorless pane surrounded by smaller stained glass panes.

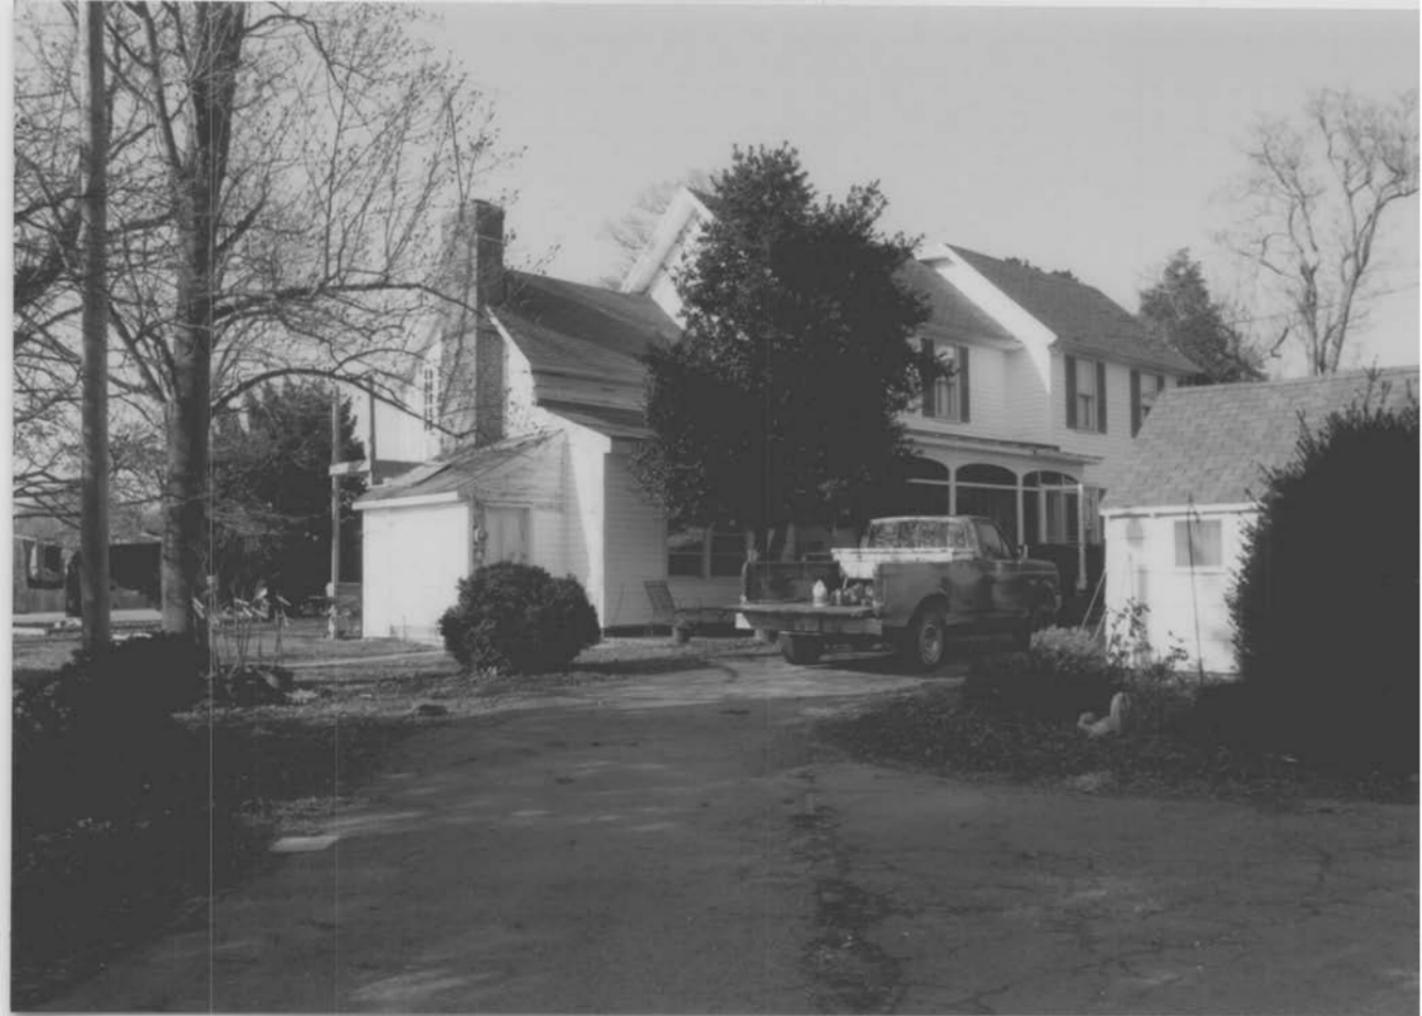
2/5

House, east (side) and
South (rear) elevations

The house extends to the south (rear) by two gable-roof additions and a shed roof addition. There are two interior brick chimneys. The house is clad by vinyl siding and the roof is clad by composition shingles.

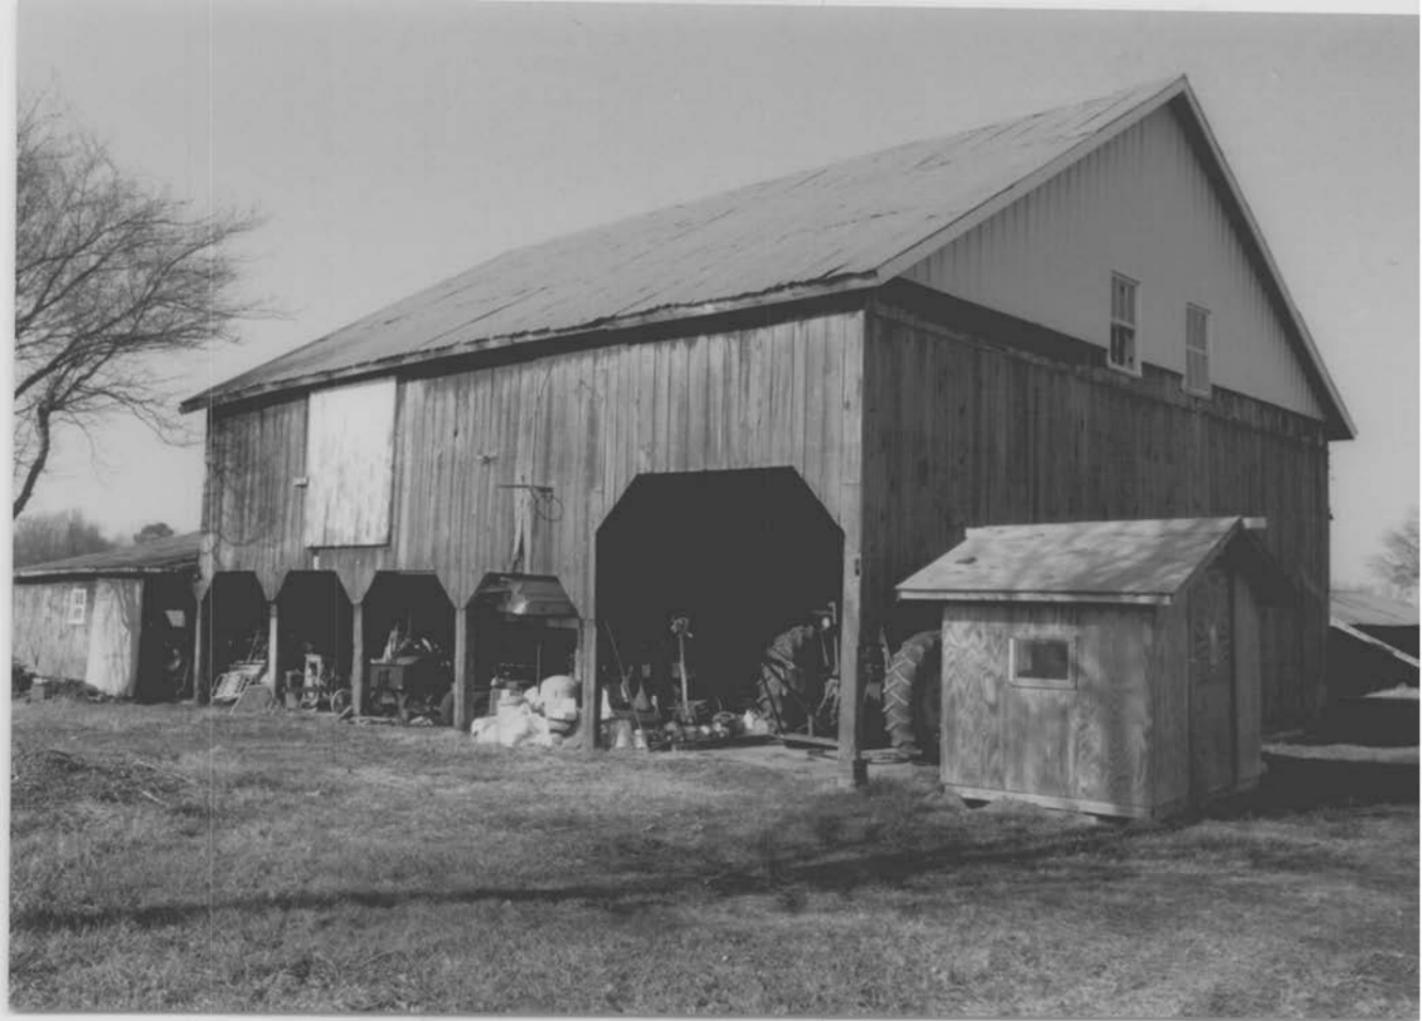
3/5

Barn, view to
the NW

The barn is a side-gabled wood frame building constructed on a post and pier (brick) foundation. The barn rises two stories and there is a one-story shed roof addition to its west side. The barn is clad by vertical planks and vinyl siding (gable end), the roof is clad by corrugated metal. According to the landowner, the barn was built in 1907.

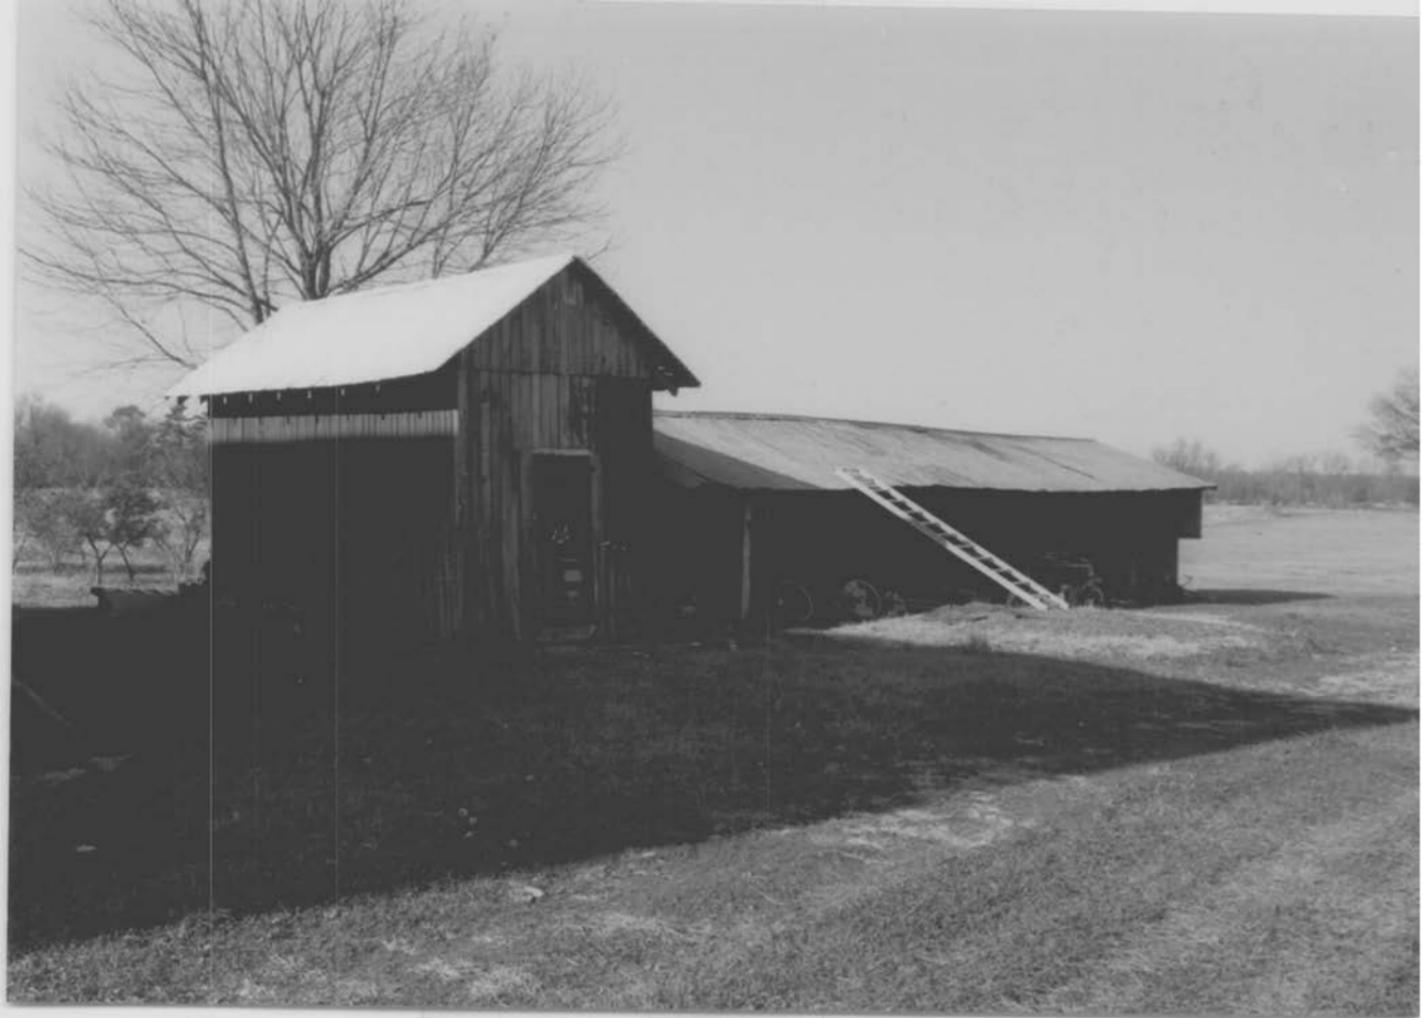
4/5

Corn crib (left) and shed
(right), view to NW

To the north of the barn, there is a gable-roofed wood frame corn crib clad by vertical plank siding and a corrugated metal roof. Adjacent (north) to the corn crib is a wood frame gable roof equipment shed (Figure 4?11). There also is a recently constructed plywood storage building located near the southeastern corner of the barn.

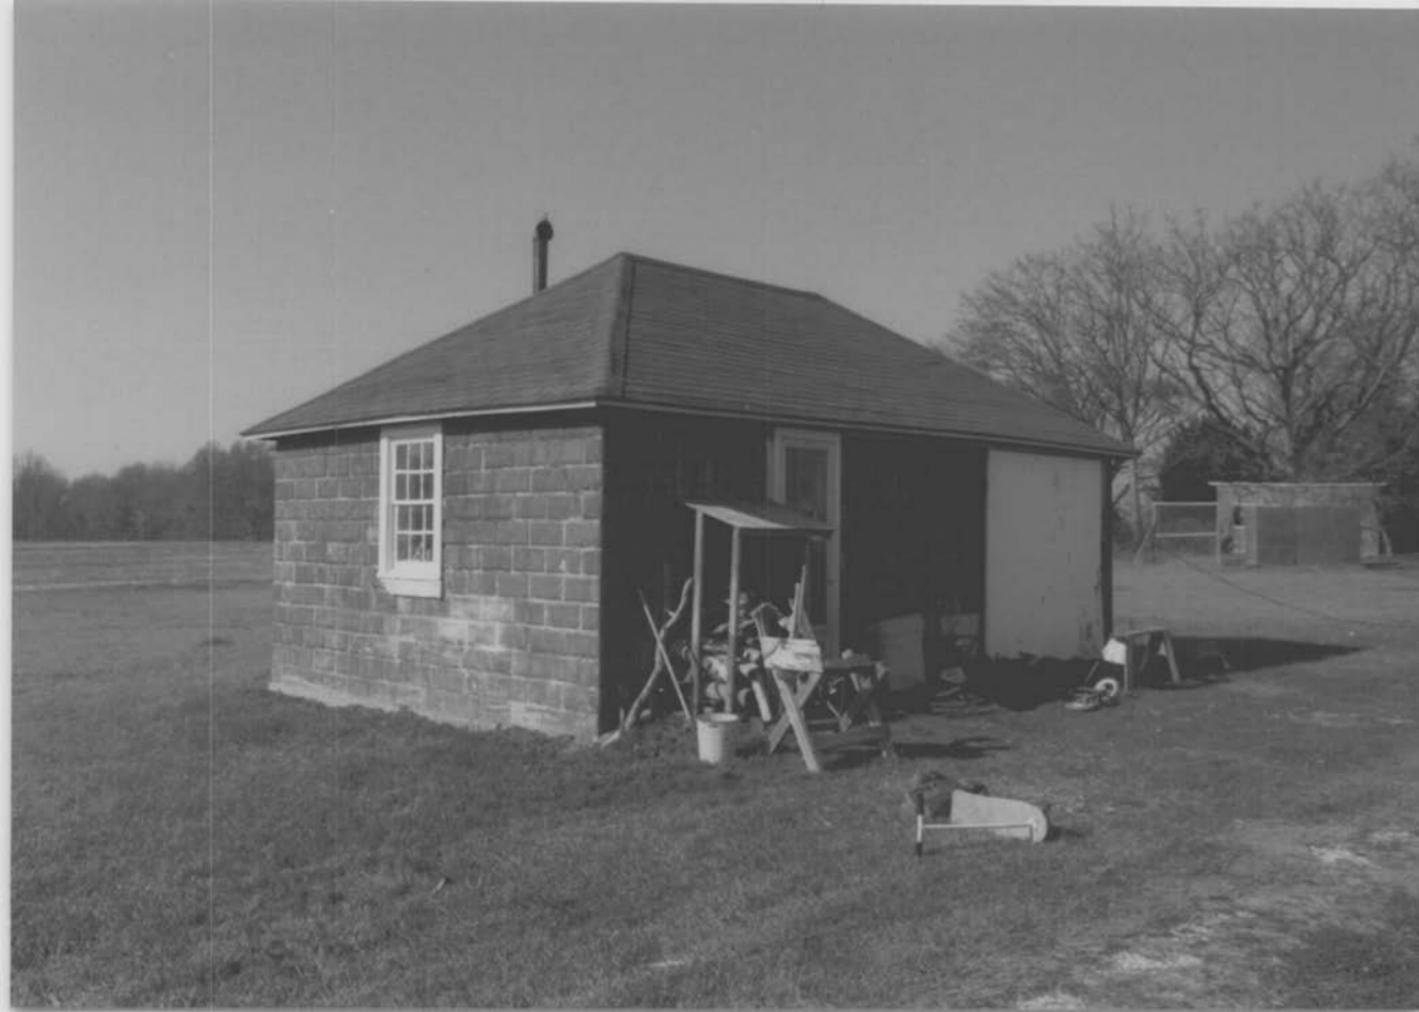
5/5

Concrete block
building, view to
NW

Between the cluster of agricultural buildings (barn, crib, shed) and the house, there is a square concrete block storage building with a hip roof and a wood double-hung sash (6/6 lights) window. The roof is pierced by a metal stove flue.
