**MARYLAND HISTORICAL TRUST
NR-ELIGIBILITY REVIEW FORM**

Property Name: Harrison Farm #2 Inventory Number: T-1140

Project: Harrison Tower Agency: FCC

Maryland Historical Trust Maryland Inventory of Historic Properties Form

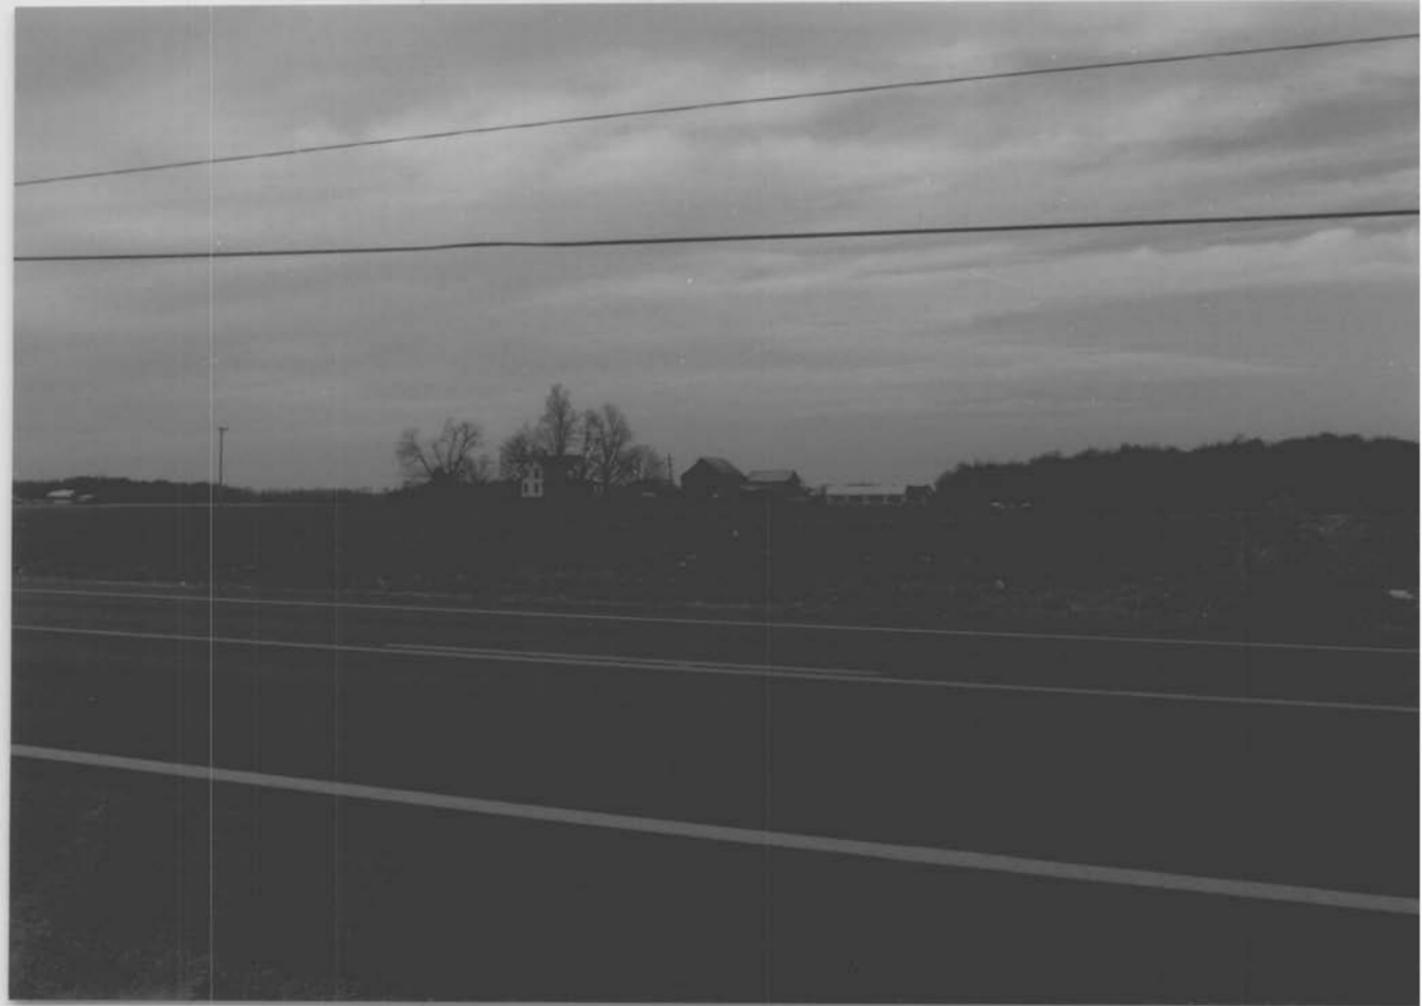
1/4

Farmstead, view
to North

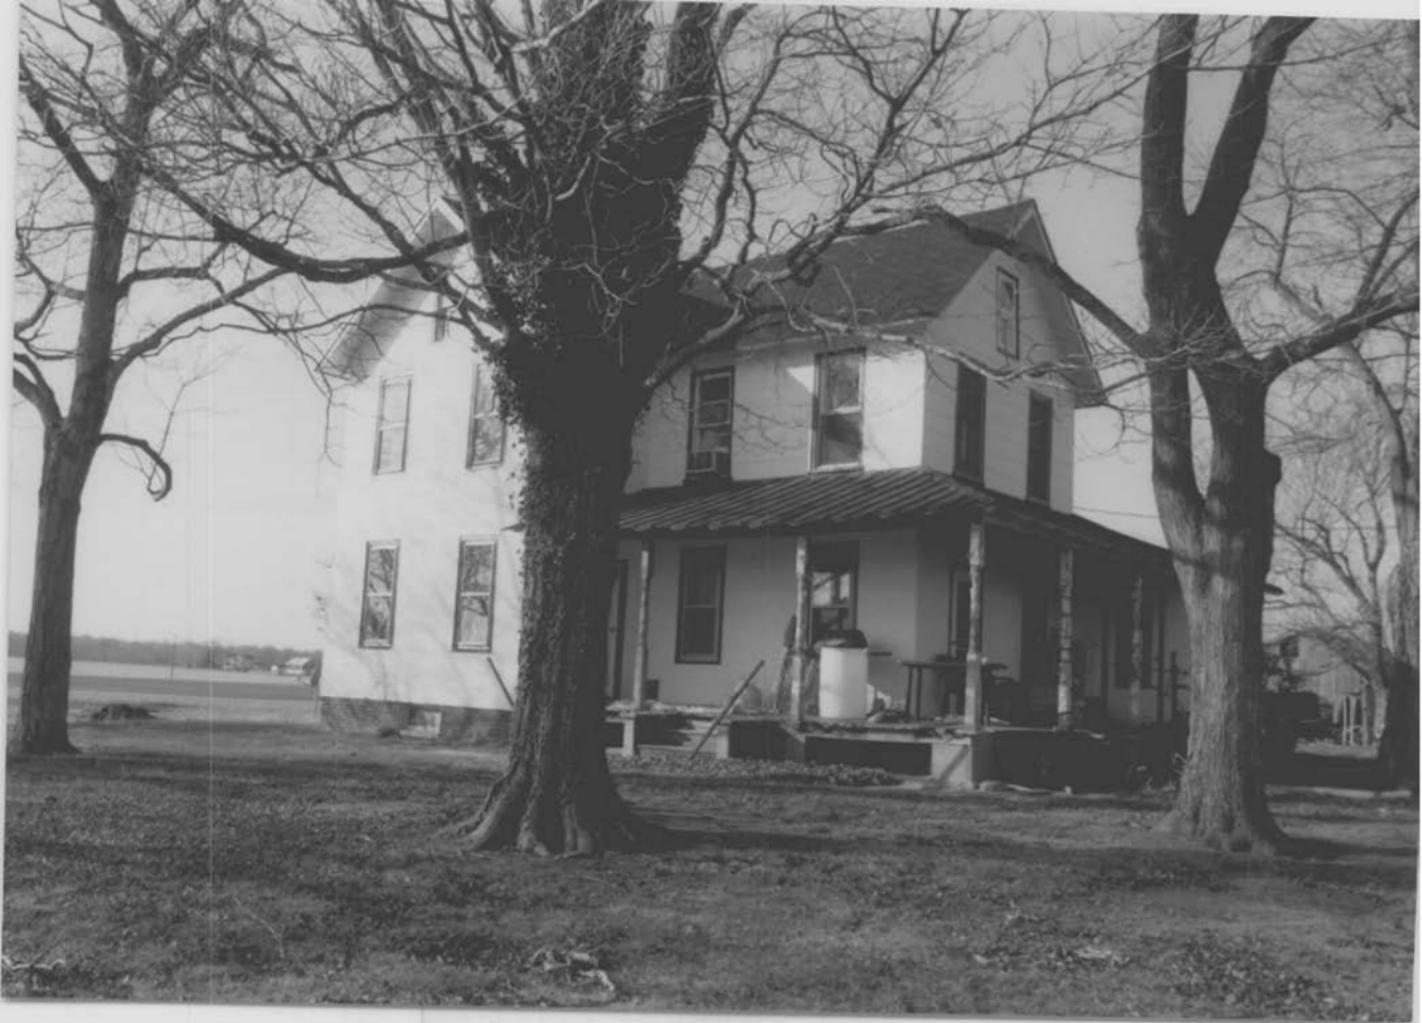
2/4

The house is a 2½-story frame vernacular building constructed on a continuous brick foundation in a T-plan. The house has a wrap-around porch supported by turned wood posts and is partially enclosed; a metal hand pump is mounted on the porch's east side. There is a shed roof concrete block addition to the rear (north side). The house has two brick chimneys: one exterior and one interior. Characterized by irregular fenestration on all elevations, windows in the house include six-light casement windows and metal double hung sash (1/1 lights) windows. The house is clad by asbestos shingles and the roof is clad by composition shingles.

House, South and West
elevations

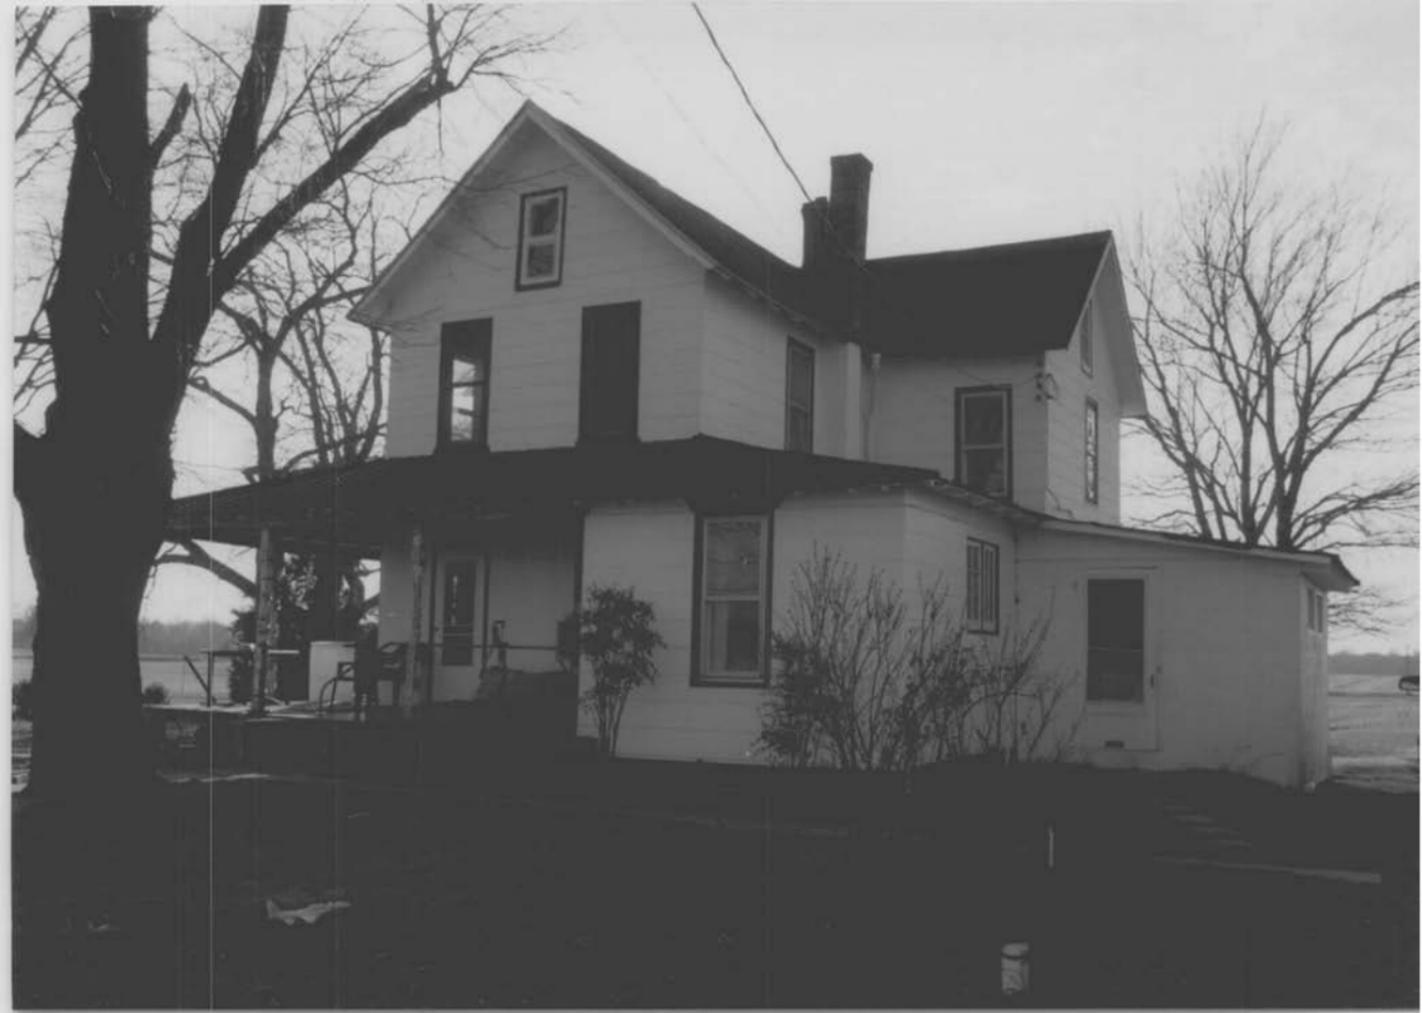
3/4

House, West and North
elevations

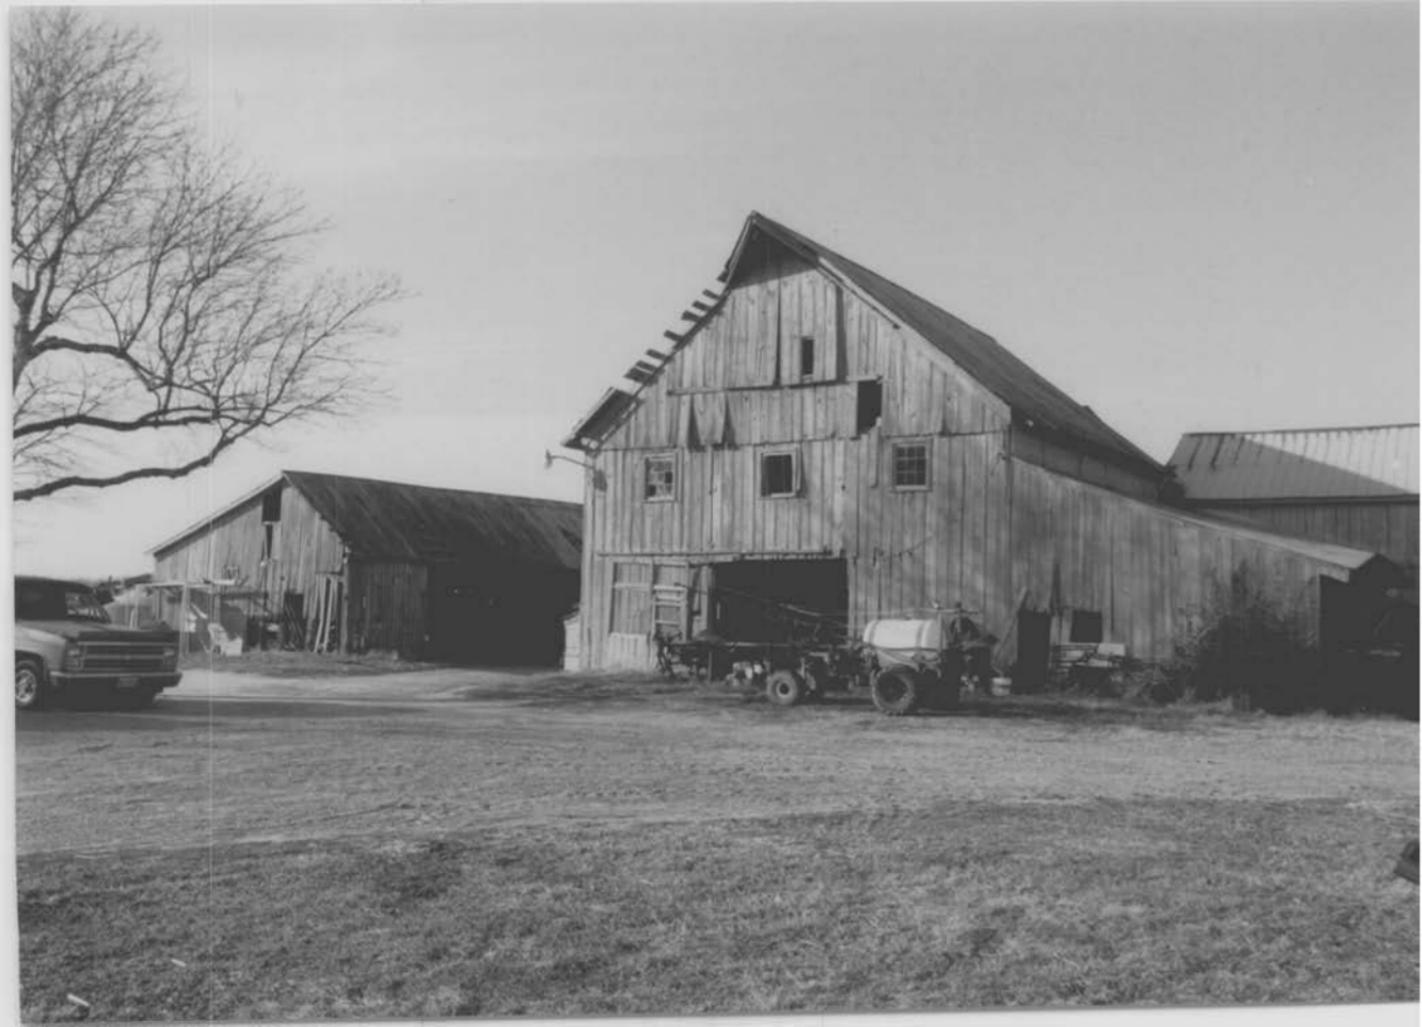
4/4

The agricultural buildings are located north and east of the house and are separated from it by an unsurfaced drive. The barns are wood frame buildings. The southernmost barn is a gable end entry barn with a hay hood and a side (east) shed roof addition. The barn roof is clad by standing seam metal. The second barn is also a gable end entry barn with a standing seam metal roof and it is located immediately north of the first barn.

There is an open, side gabled garage/shed located north of the house and west of the barns. The shed is clad by vertical plank siding and its roof is clad by wood planks. On the eastern margin of the agricultural buildings, there is a concrete block (modern) storage building.

Agricultural Buildings, view
to NW
