**MARYLAND HISTORICAL TRUST
DETERMINATION OF ELIGIBILITY FORM**

Property Name: Pratt Farmhouse Inventory Number: T-116
 Address: 29434 Dutchman's Lane Historic district: yes no
 City: Easton Zip Code: 20601 County: Talbot
 USGS Quadrangle(s): Easton
 Property Owner: Rog G. Brooks Sr. and Margaret W. Brooks Tax Account ID Number: 0410991
 Tax Map Parcel Number(s): 196 Tax Map Number: 34
 Project: Dutchman's Lane over Windmill Branch Culvert Replacement Agency: Talbot County Department of Public Works
 Agency Prepared By: A.D. Marble & Company
 Preparer's Name: Emma Young Date Prepared: 8/6/2009
 Documentation is presented in: Talbot County Recorder of Deeds, Easton, Maryland.
 Preparer's Eligibility Recommendation: Eligibility recommended Eligibility not recommended
 Criteria: A B C D Considerations: A B C D E F G
 Complete if the property is a contributing or non-contributing resource to a NR district/property:
 Name of the District/Property: _____
 Inventory Number: _____ Eligible: yes no Listed: yes no

Pratt Farmhouse
T-116
Easton, Talbot County, MD

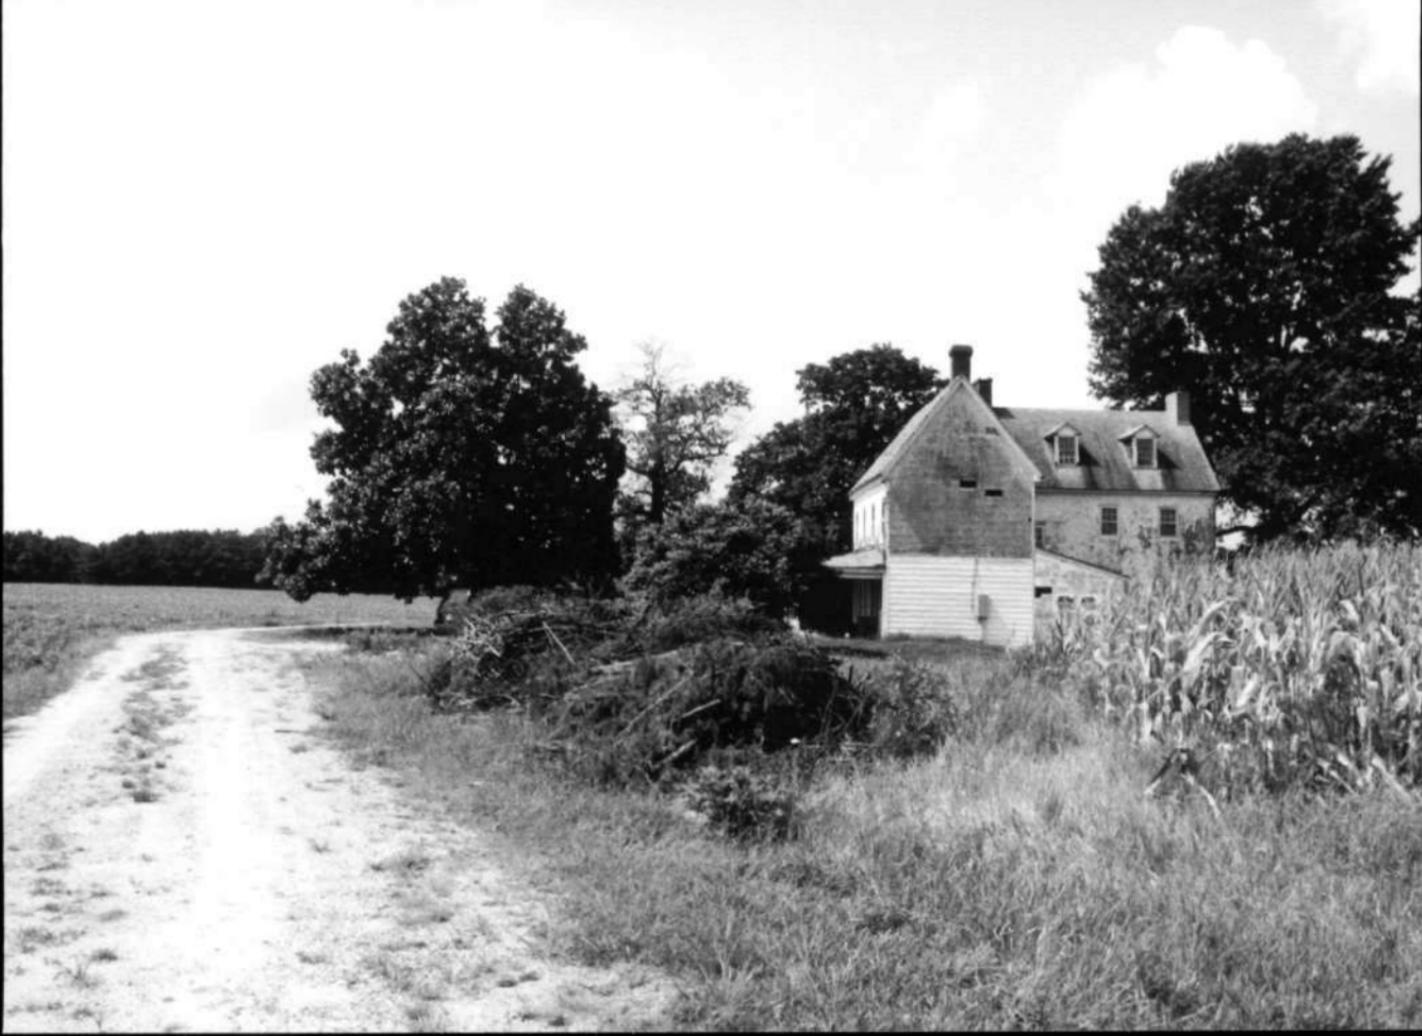
Photo # 1 of 15

Circa-1890 block (to left) and circa-1840 block (to right),
north & east elevations, view to SW

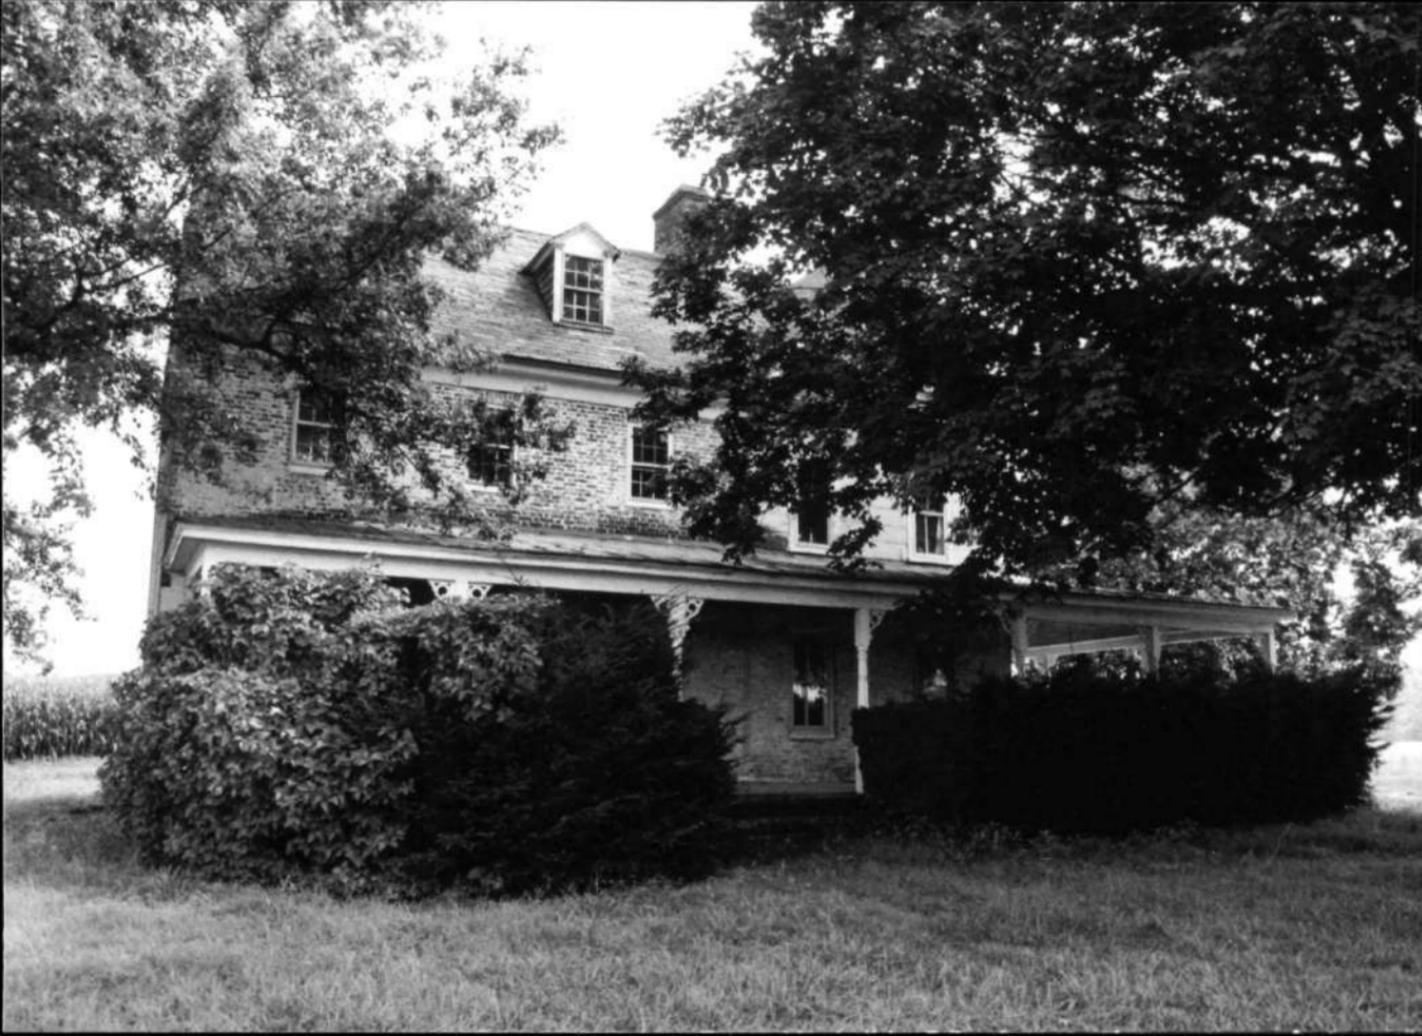
Photo # 2 of 15

The symmetrical south elevation contains a single-leaf, one-light-over-three-panel wood door protected by an aluminum storm door in the easternmost bay. Two window bays are located to the west. The three second-story window openings are aligned above the first-story openings. The west elevation of the ca.-1840 block contains a single-leaf vertical-board door in the southwest corner, near the ground level. The rest of the elevation is devoid of openings. The north (rear) elevation contains two, two-over-two light, double-hung, wood-sash windows in the first story. A three-light, awning, wood-sash window is visible in the basement level, between the first-story openings. A window opening is located between the first and second stories, near the eastern end of the elevation. The second story contains two window openings aligned above the first-story openings.

circa-1840 block, south elevation, view to NE

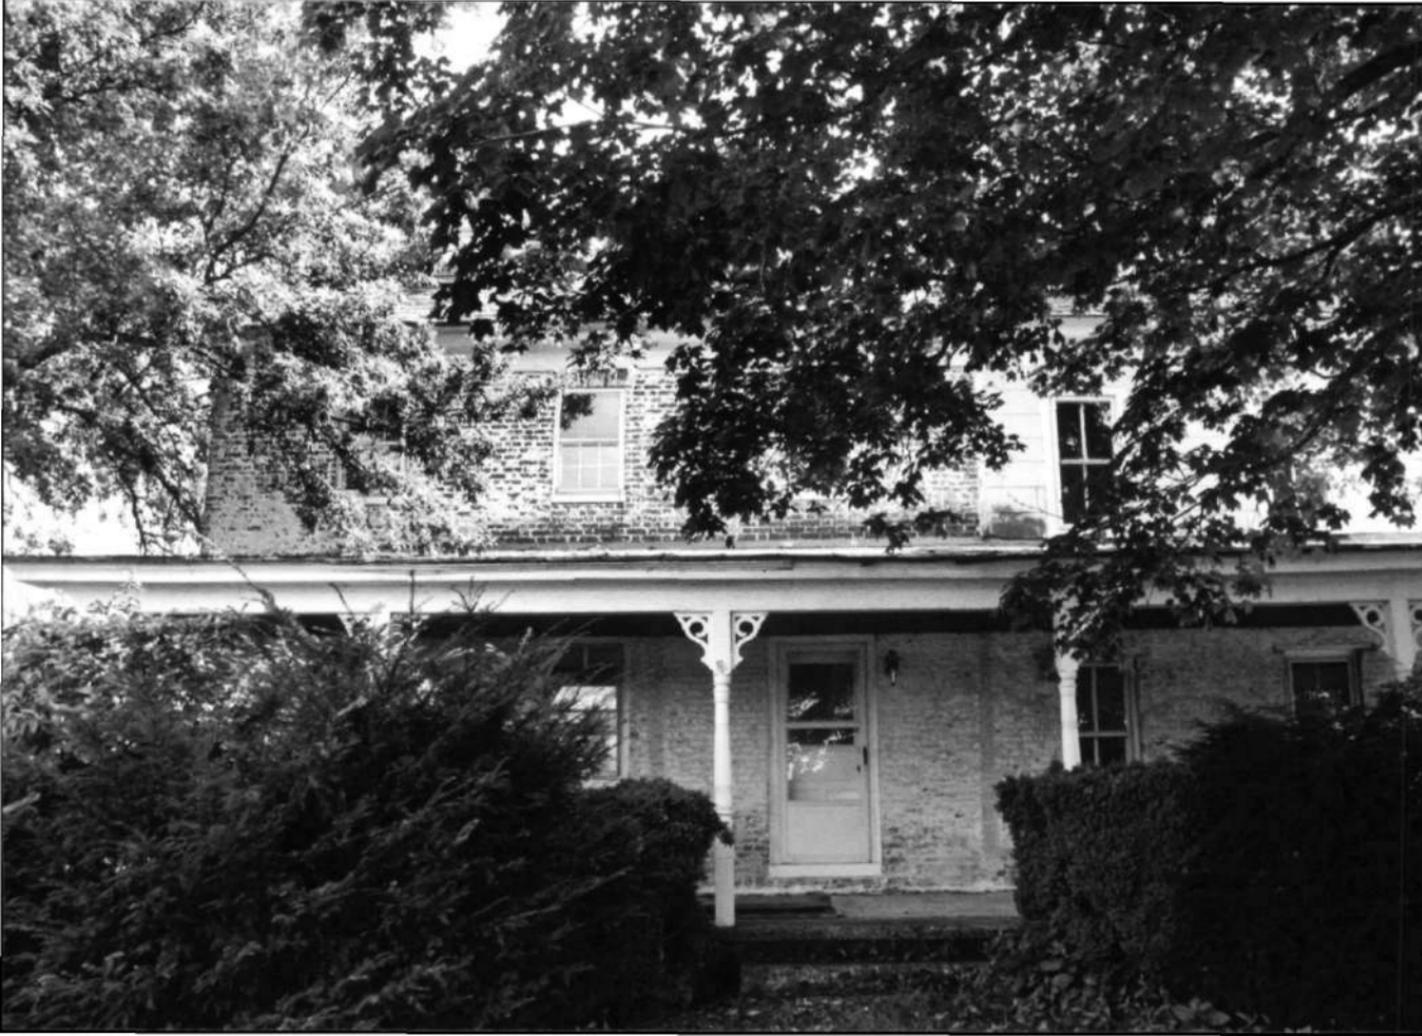
Photo # 3 of 15

circa-1840 block, south elevation, view to N.

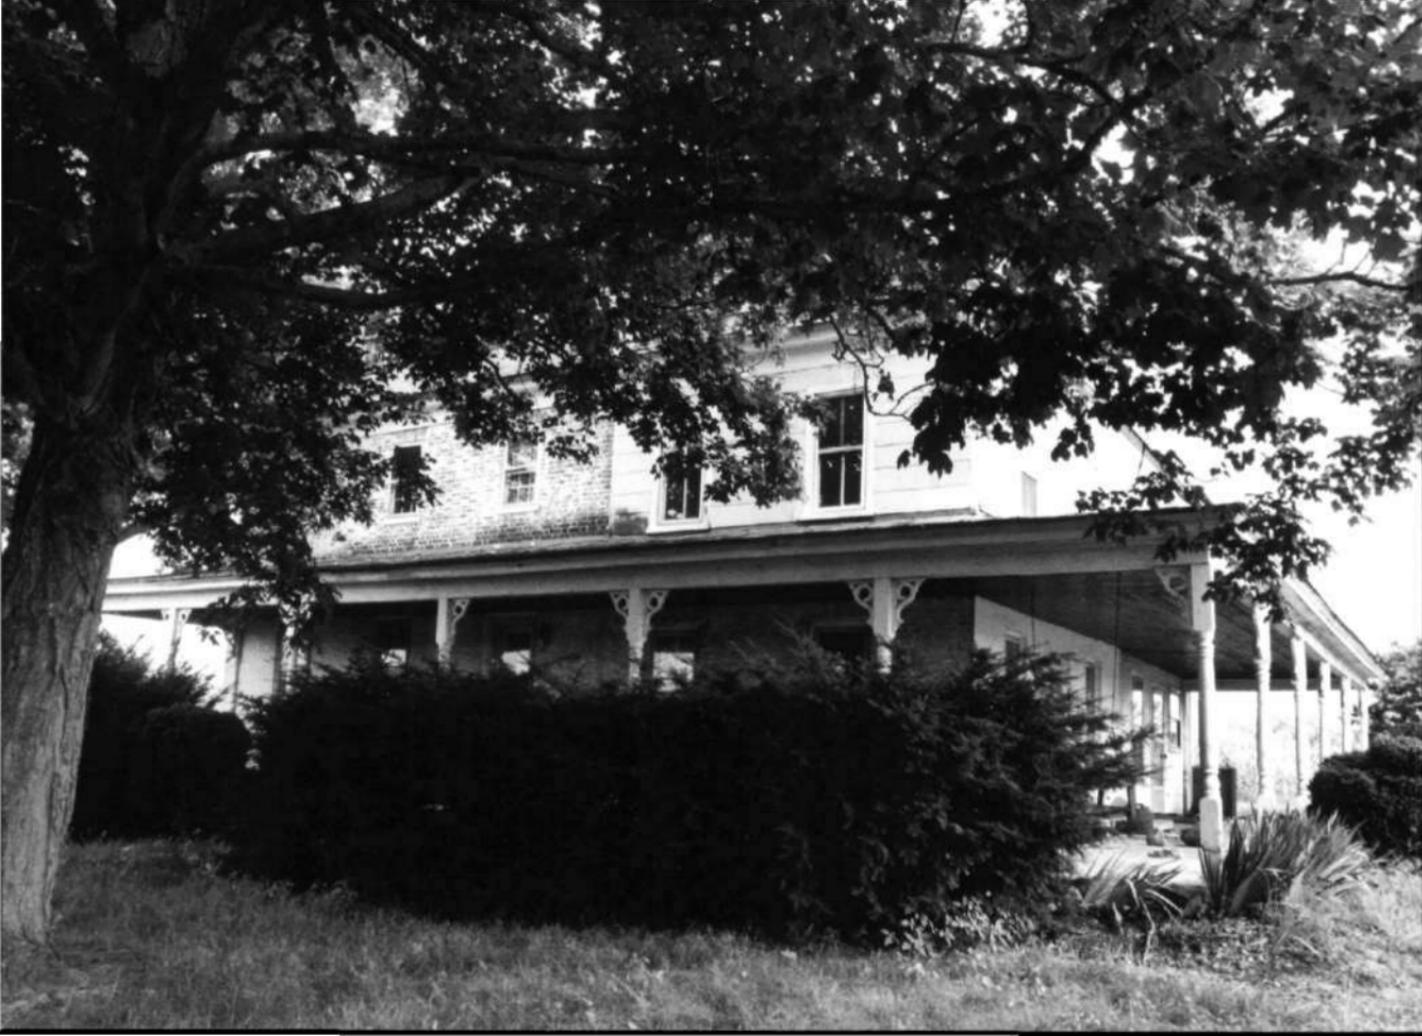
Photo # 4 of 15

circa-1840 block (to left) & circa-1890 block (to right), south
& east elevations, view to NW.

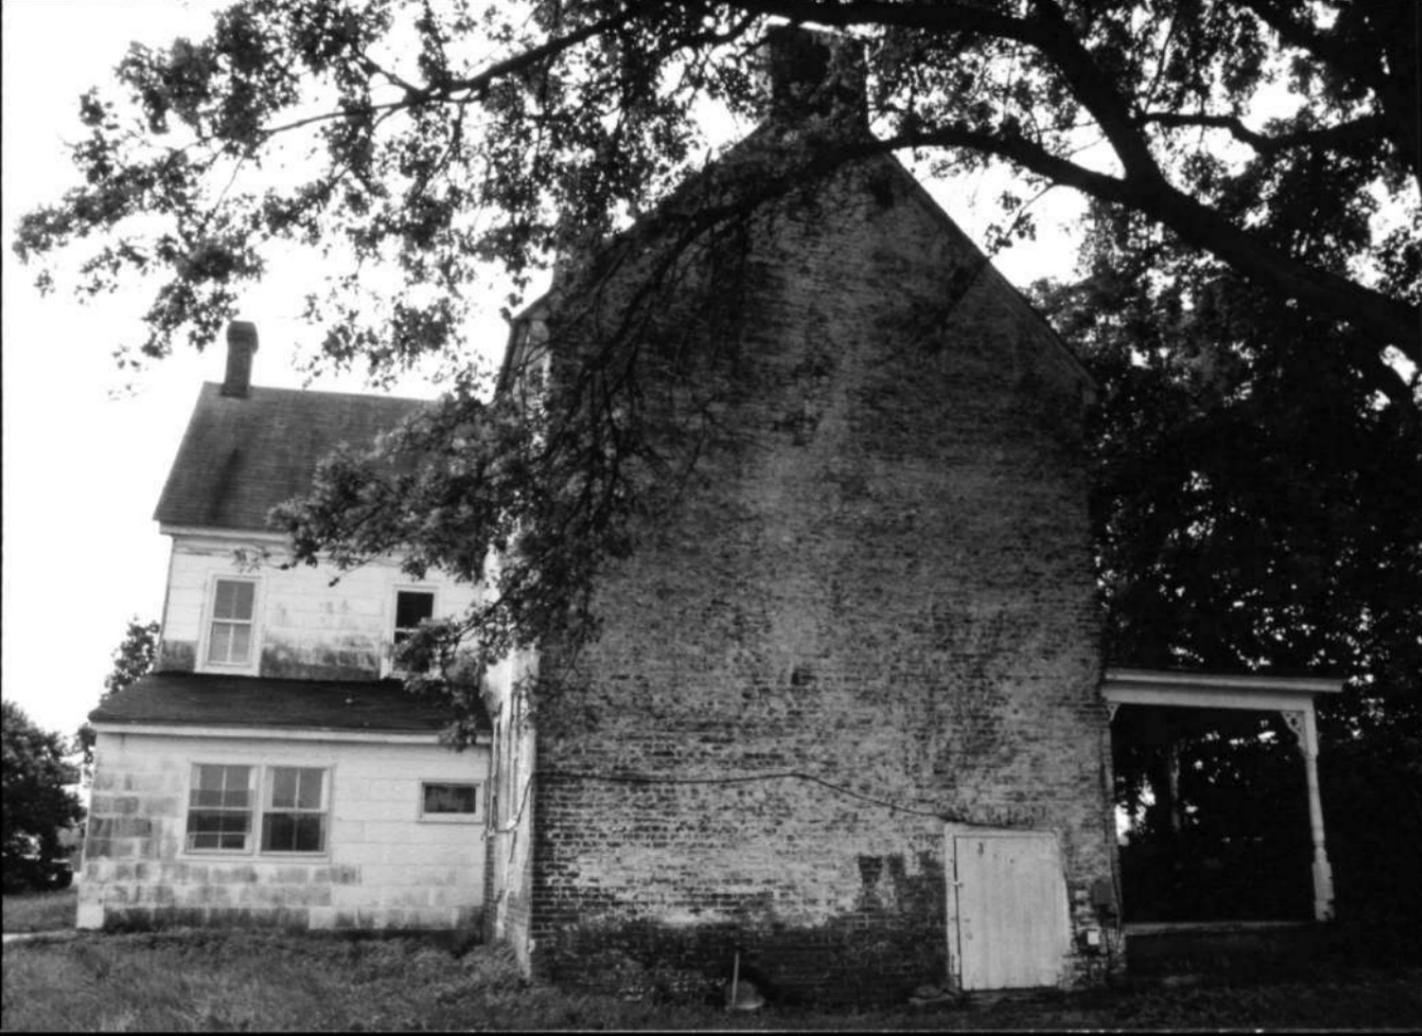
Photo # 5 of 15

circa-1840 block (to right) and circa-1870 block with circa-1950 addition (to left); view elevated slightly to SE.

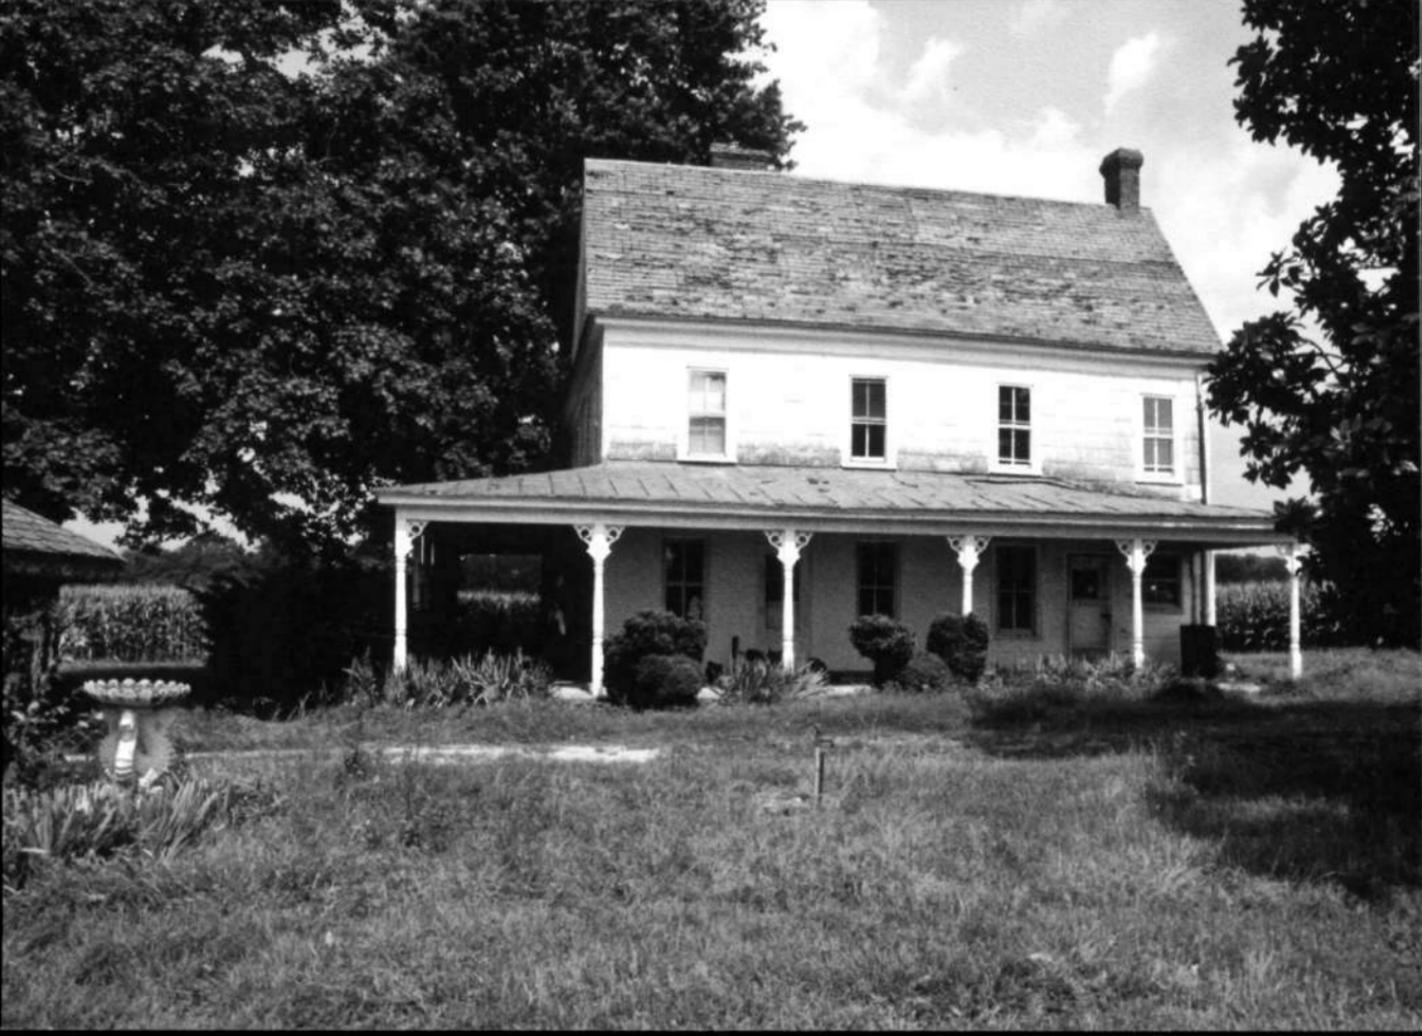
Photo # 6 of 15

The east elevation, which faces the farm lane, measures seven bays wide. The first story features two entries, each consisting of a one-light-over-two-panel, single-leaf wood door. The southern entry features a six-light wood storm door, and the northern entry features a two-light aluminum storm door. Each entry is flanked by a window to the north and south. The northernmost window bay consists of an eight-over-eight light, double-hung, wood-sash window. Four evenly spaced window openings are aligned above the first-story window bays. The north elevation measures two bays wide, with two evenly spaced window openings in the first and second stories. The gable features a centrally located arched, two-over-two light, double-hung, wood-sash window. The south elevation contains the ca.-1950 shed-roofed addition at the first story. The second story contains two evenly spaced window bays; the southernmost window bay is inset with a one-over-one light, double-hung, aluminum-sash window. The north elevation is devoid of openings; however, portions of the asbestos shingles are missing near the second story to reveal the interior lathe.

circa-1890 block, east elevation, view to NW

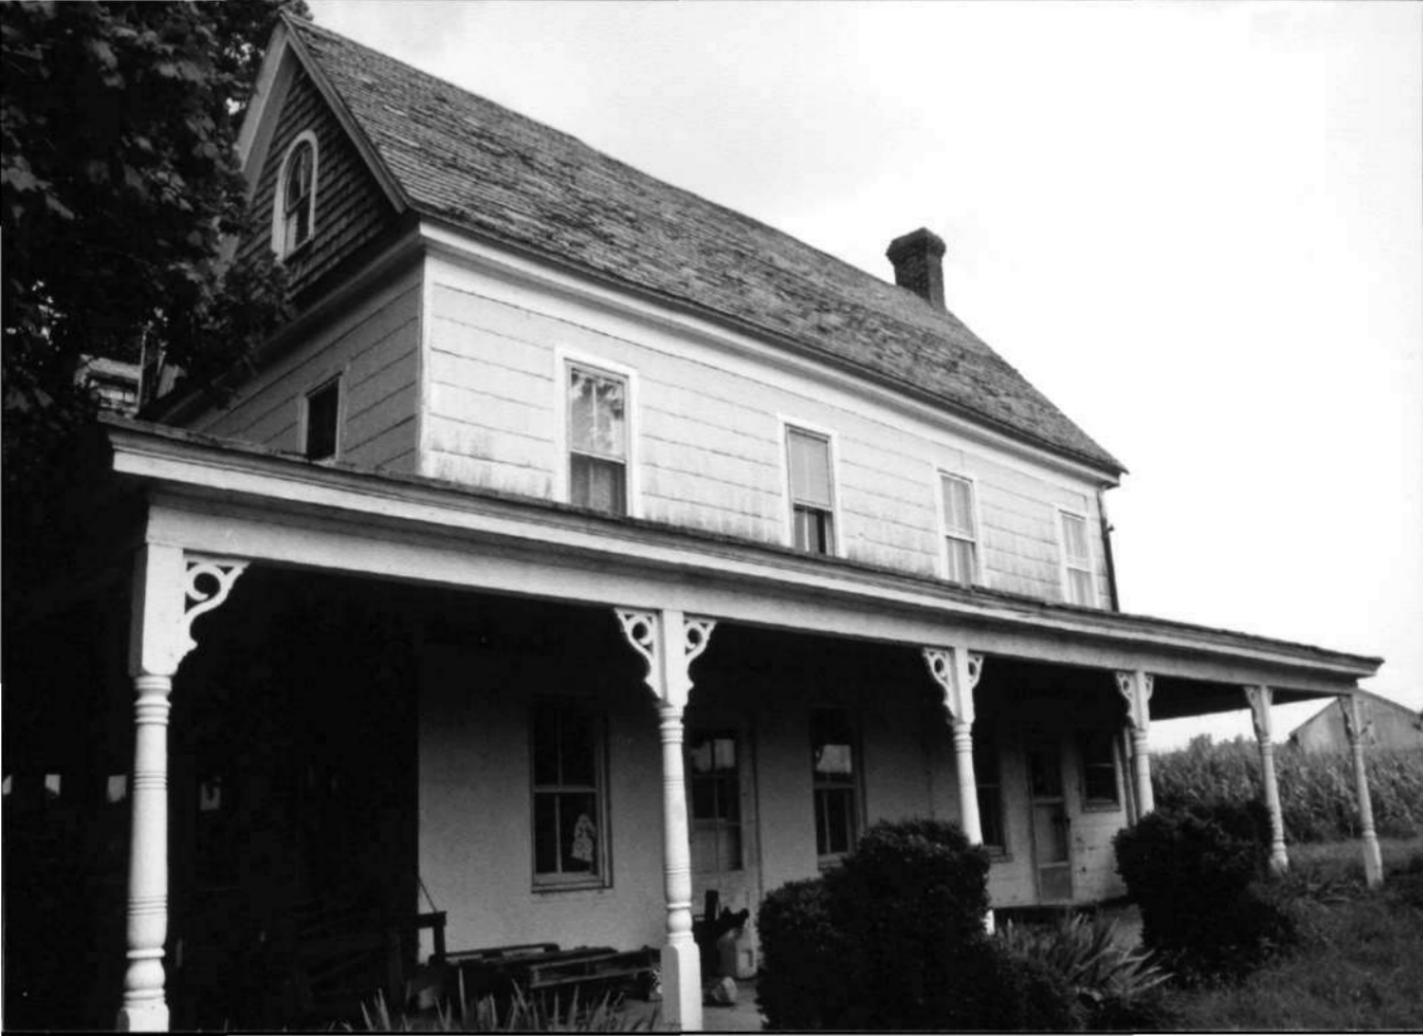
Photo # 7 of 15

circa-1890 block, south & east elevations, view to NW

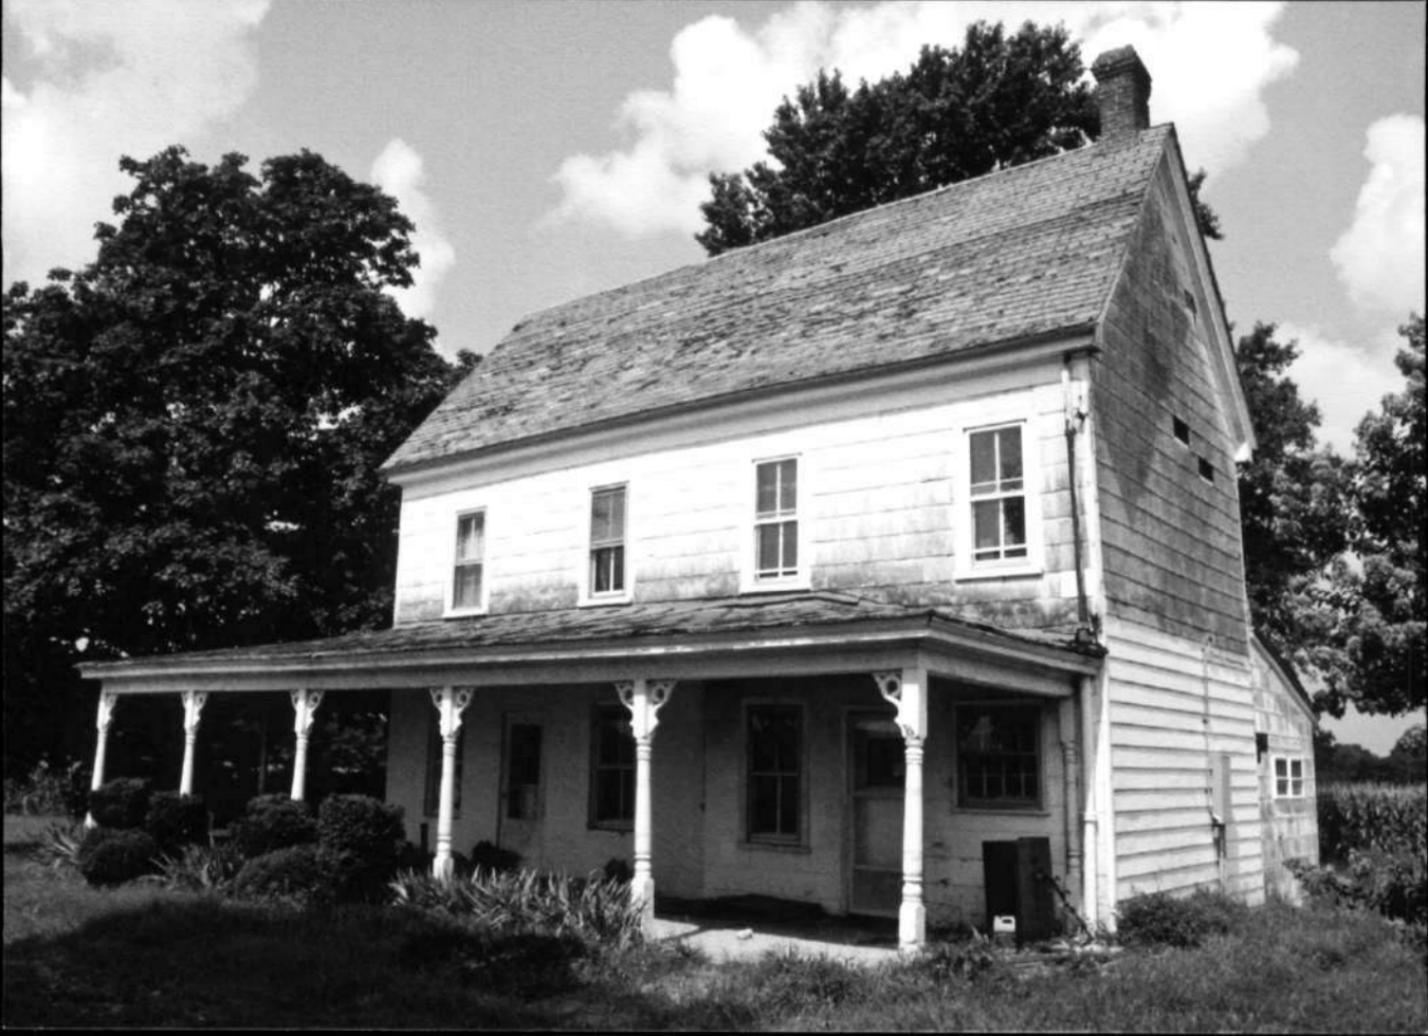
Photo # 8 of 15

NORTH & EAST ELEVATIONS OF CIRCA-1890 BLOCK, VIEW TO SW

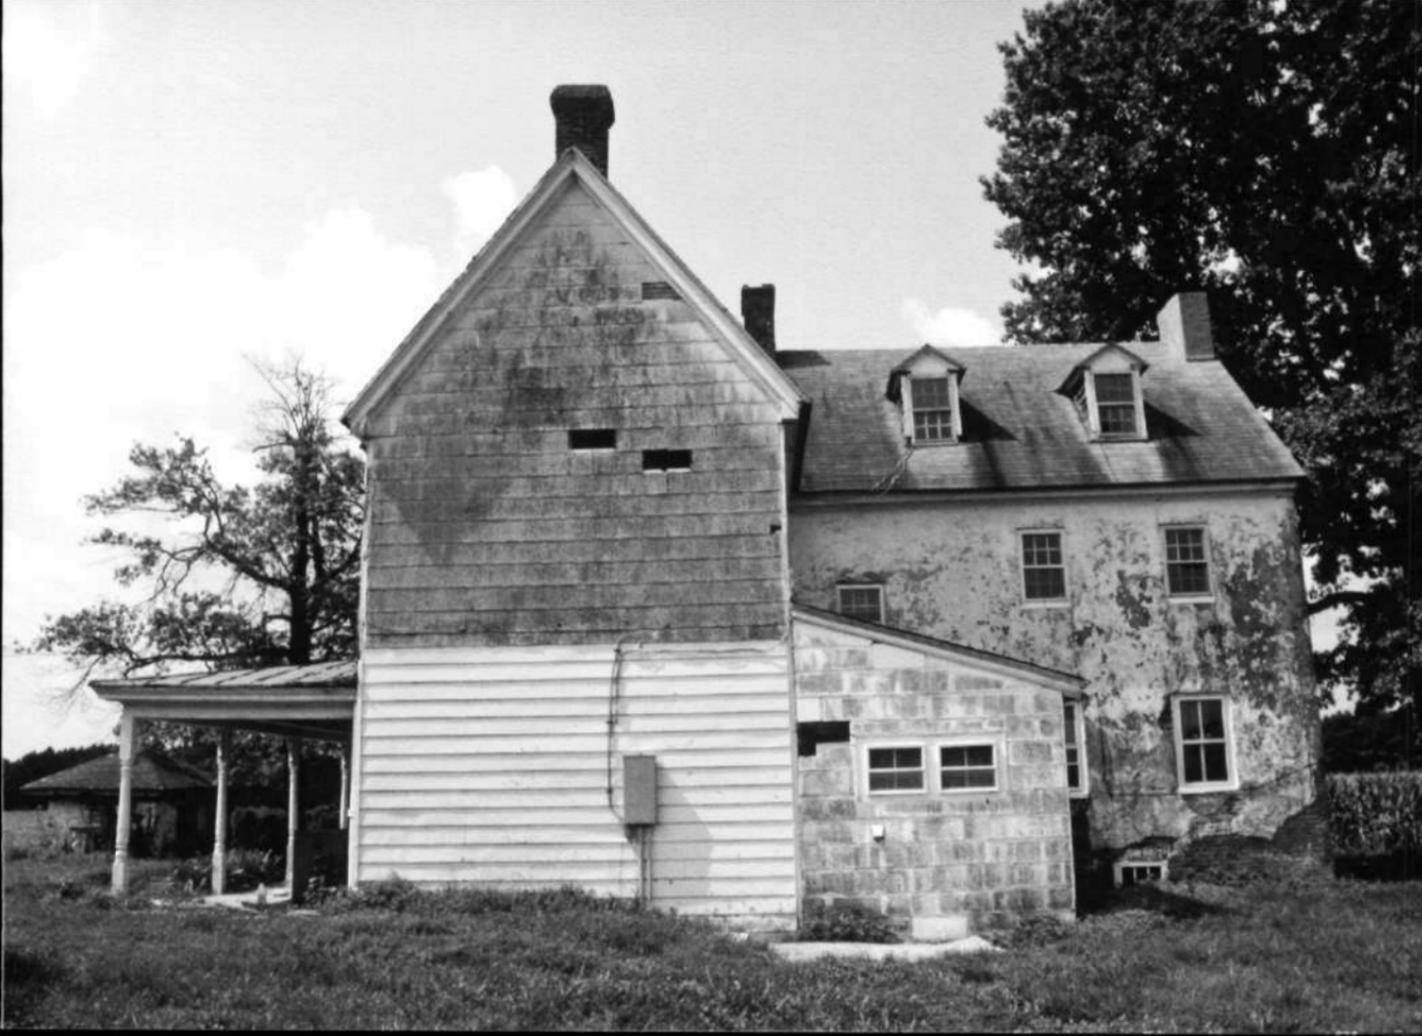
The ca.-1950 shed-roofed addition is clad in asbestos shingles, and asphalt shingles cover the roof. The west elevation contains a set of paired, two-over-two light, double-hung, wood-sash windows in the northernmost bay. A one-light, awning, wood-sash window is located in the southernmost bay. The north elevation contains a set of paired, one-over-one light, double-hung, aluminum-sash windows. The east elevation is concealed by the ca.-1890 block, and the south elevation is concealed by the ca.-1840 block.

North elevation of circa-1890 block with circa-1950
addition (to left) and circa-1840 block (to right), view to S
Photo # 9 of 15

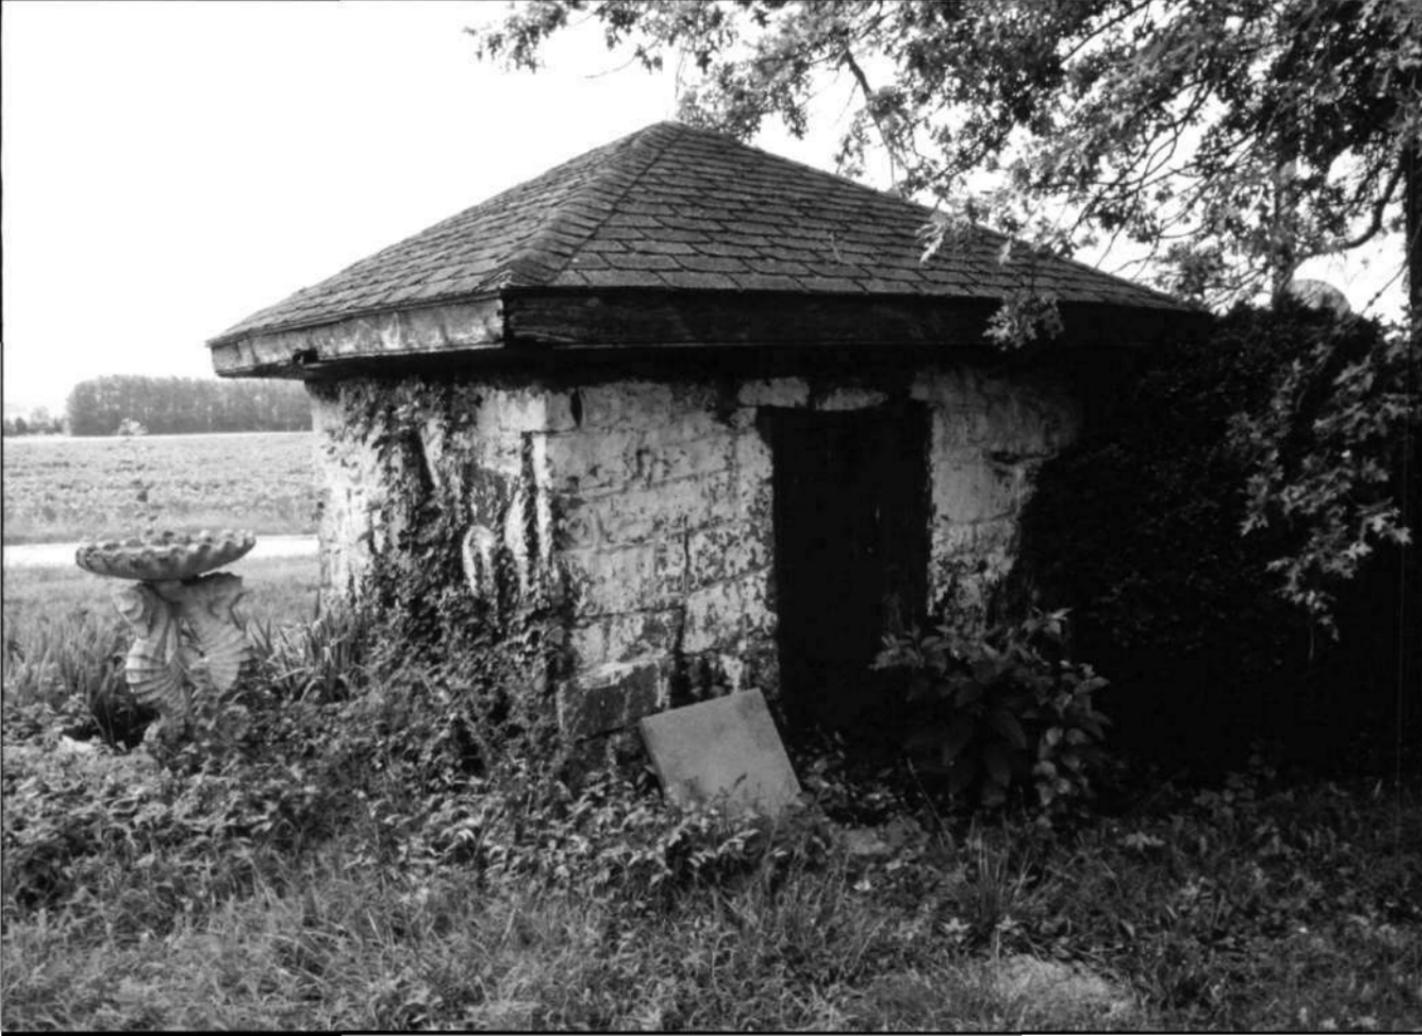
Photo # 10 of 15

The exterior walls of the one-story stone springhouse are covered with stucco. A pyramidal roof, accentuated by a plain, boxed, wood cornice, caps the building and is sheathed in asphalt shingles. The building faces west towards the dwelling. A single-leaf, vertical-board door centrally located in the west elevation provides access to the building's interior. The north and east elevations are devoid of openings. A wood panel covers the window opening in the south elevation.

SPRING HOUSE, North & West elevations, view to SE

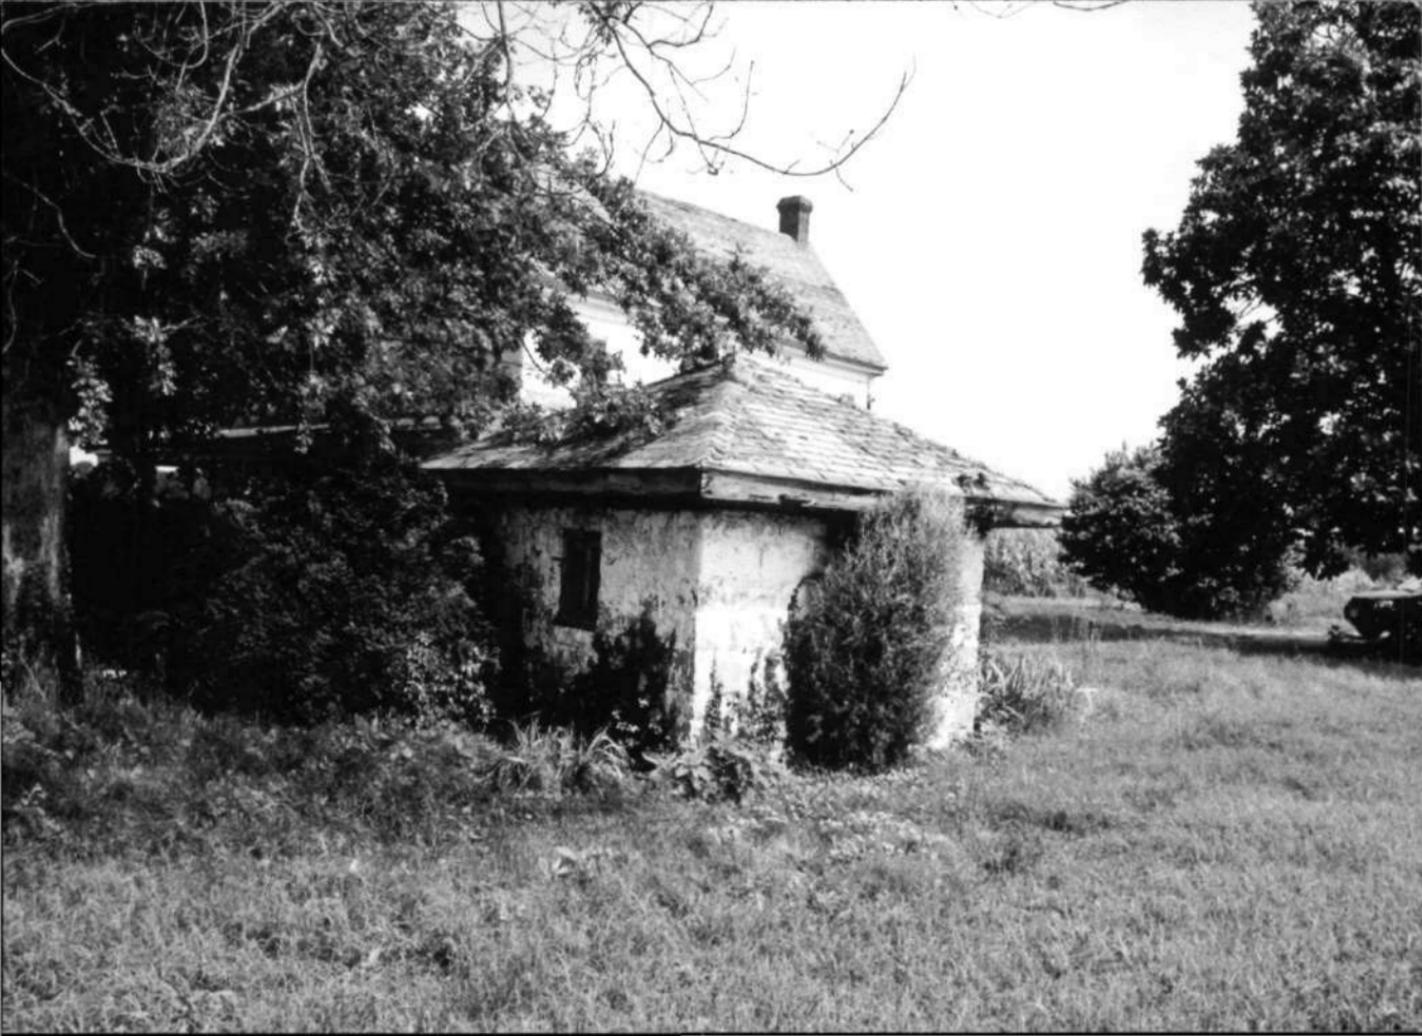
Photo # 11 of 15

SPRINGHOUSE, SOUTH - EAST ELEVATIONS, view to NW

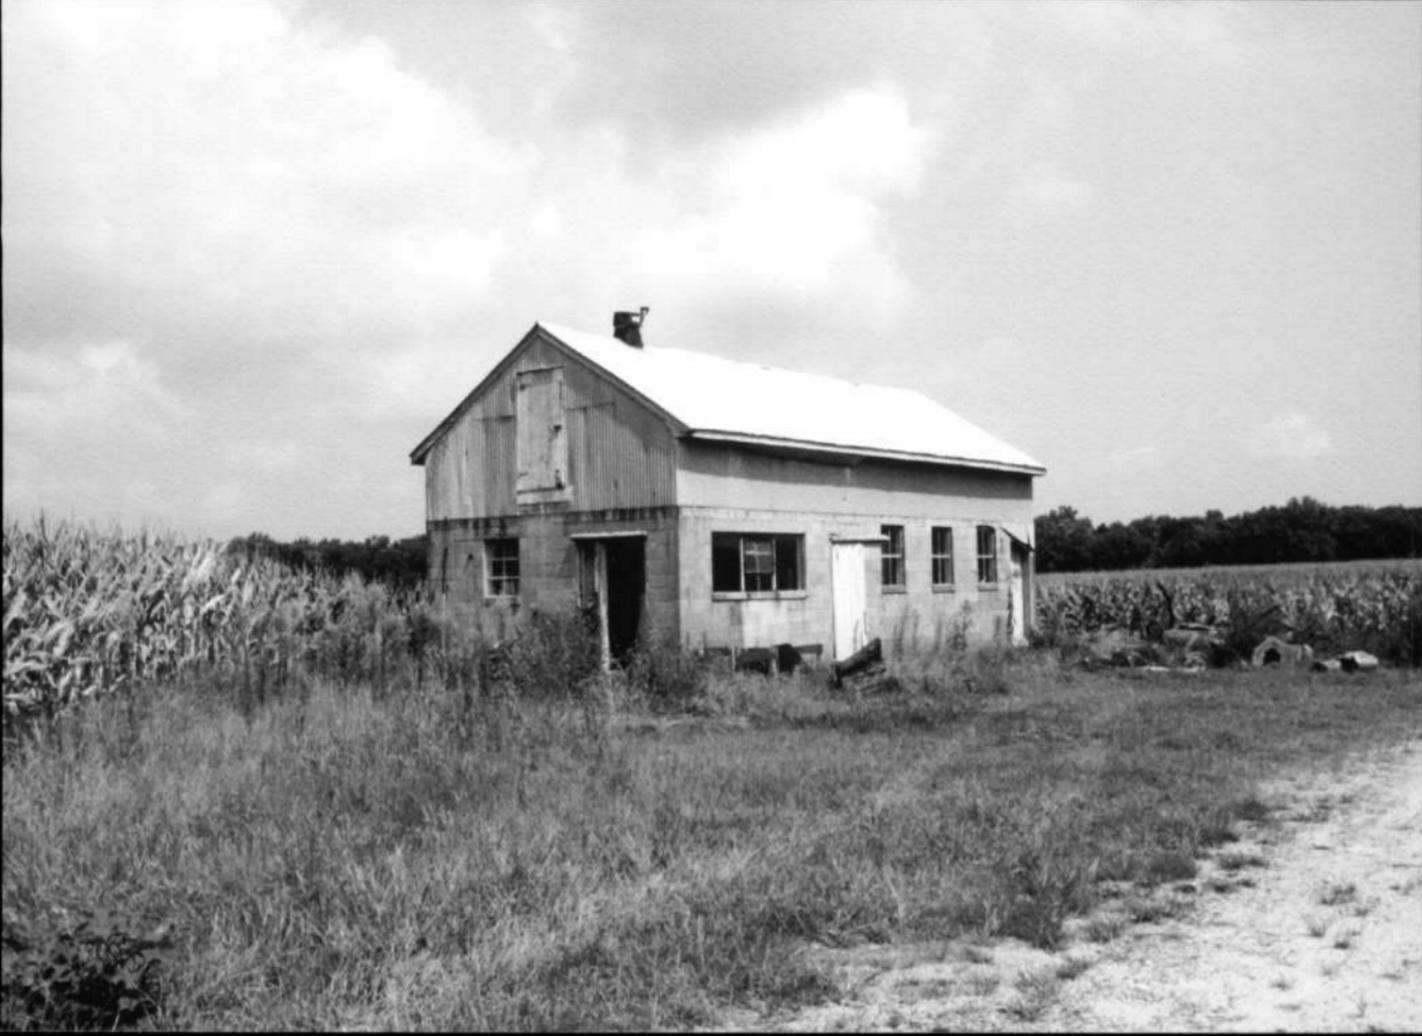
Photo # 12 of 15

A ca.-1950 storage shed is located to the north of the Pratt Farmhouse, adjacent to the west side of the farm lane. The building measures two stories in height. Concrete block comprises the first story, and corrugated metal sheets cover the exterior walls of the second story. The side-gabled roof is covered in corrugated metal and contains a metal stove pipe near the southern end of the roof ridge. The building measures six bays wide on the east and west elevations and three bays wide on the north and south elevations. The windows are comprised of four-light or six-light, fixed, metal-sash types. The doors, hung on overhead metal tracks, consist of vertical-board, sliding types.

STORAGE SHED, SOUTH EAST elevation, view to NW

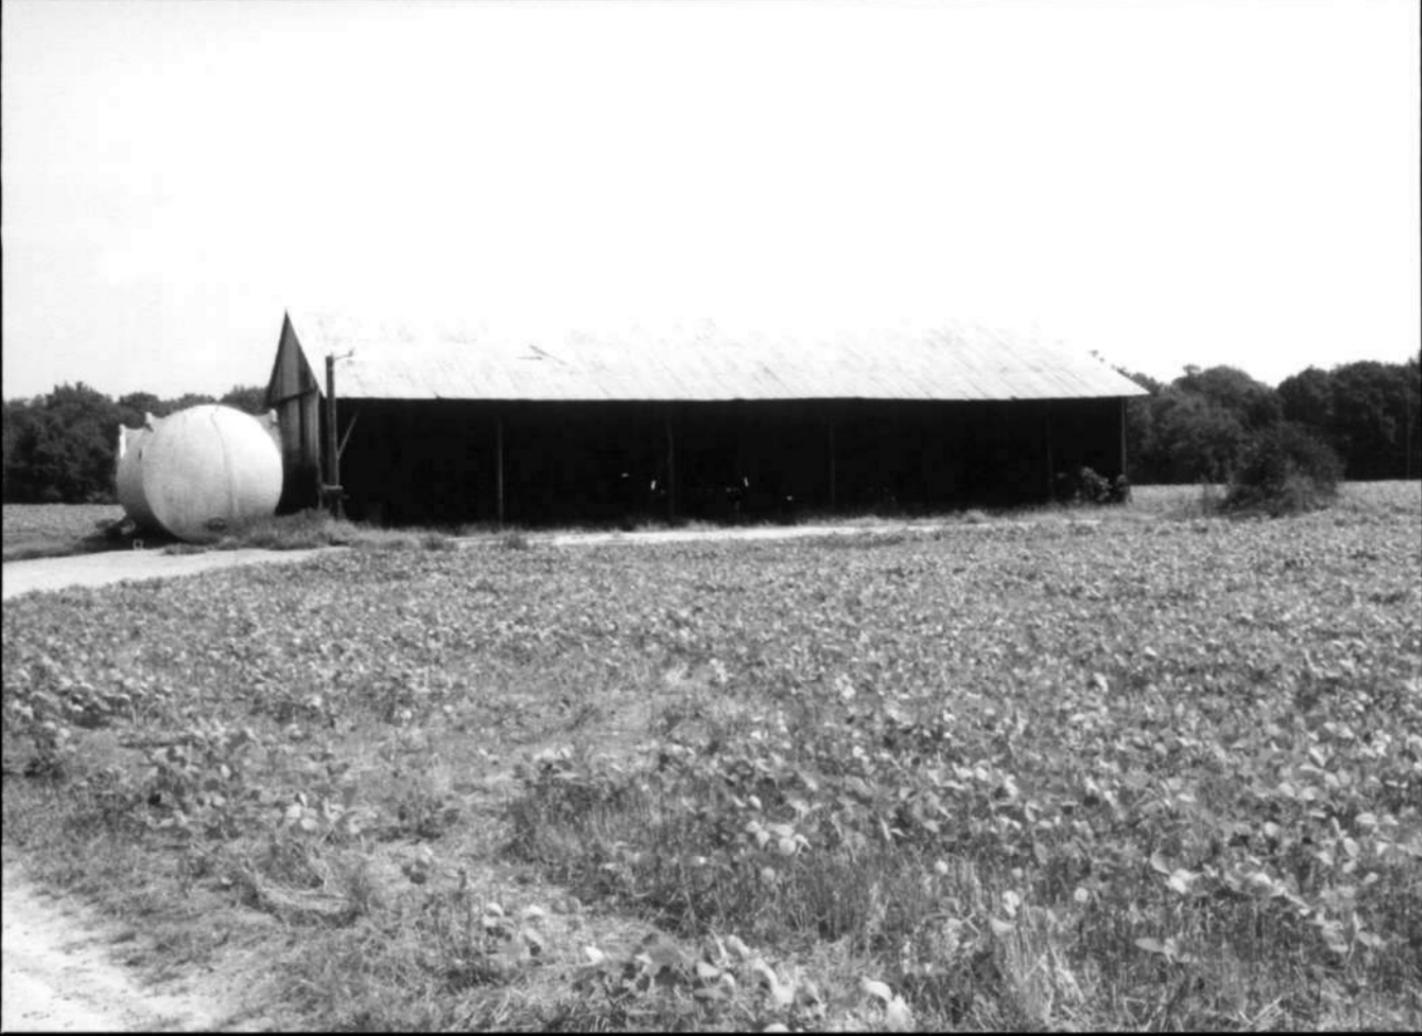
Photo # 13 of 15

A ca.-1930 equipment shed is located to the northeast of the farmhouse. The farm lane curves to the east, to access the south side of the shed. The building is comprised of vertical-board walls and the asymmetrical, side-gabled roof is clad in corrugated metal. Wood poles separate each of the five equipment bays that are accessed via the south elevation. The east, north, and west elevations are devoid of openings.

EQUIPMENT SHED, SOUTHWEST ELEVATIONS, VIEW TO NE
