INVENTORY FORM FOR STATE HISTORIC SITES SURVEY

Katling's Plain

Trappe

T-153

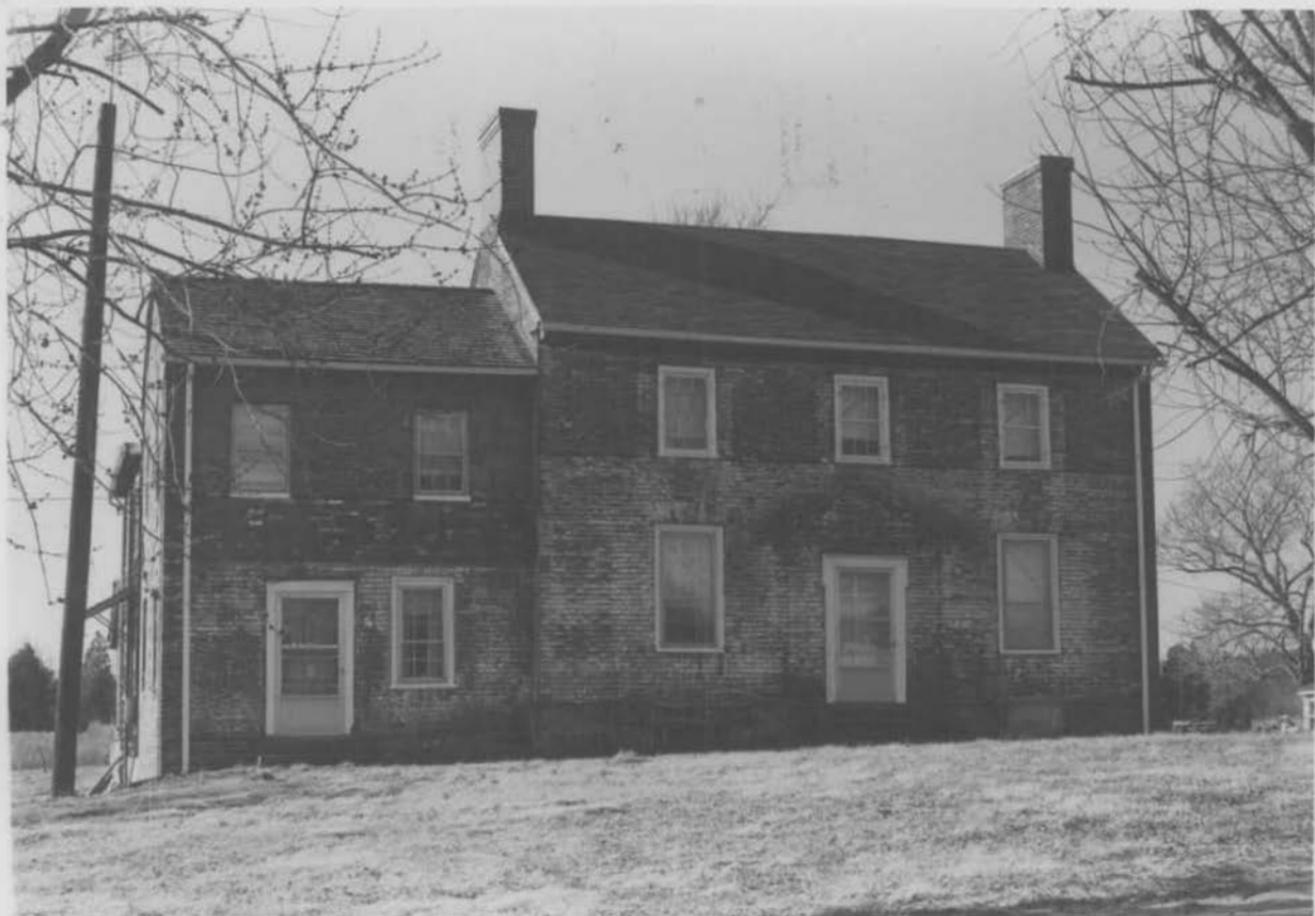
T-153

This late 18th century brick house is unpretentious in appearance yet displays great care and attention to detail by its builder. The original block is two stories high and three bays long by one bay deep. The one story two bay square brick kitchen at the southwest end was later raised to two story.

Both sections have gable roofs running northeast-southwest. The Flemish bond brickwork reverts to 3:1 common bond below the water table and on the gable end above the second floor. The southwest wall of the kitchen has been rebuilt in 5:1 common bond. A water table runs along all sides of the main block and across the southeast side of the kitchen.

Southeast facade

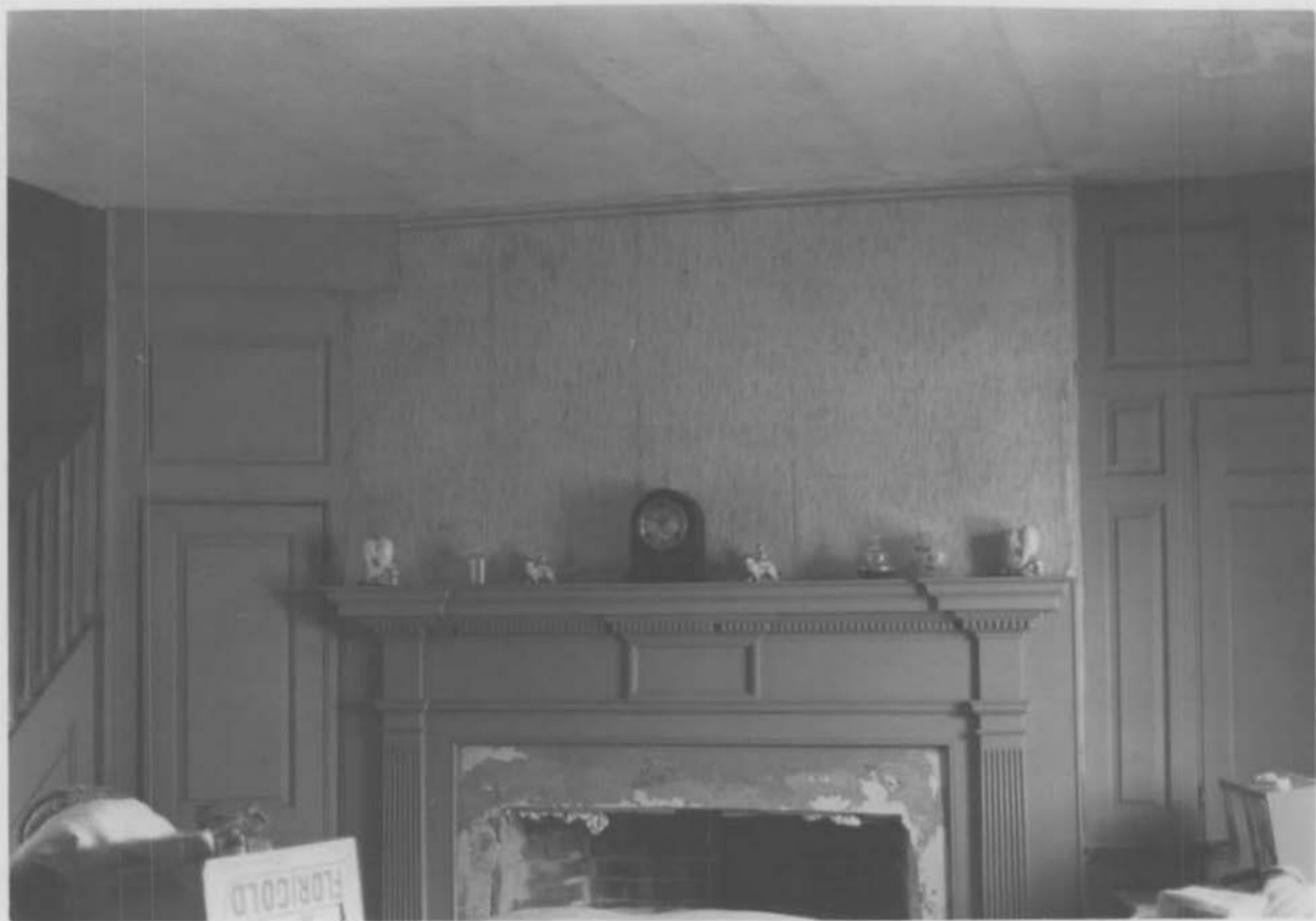
The northeast room is especially well finished. The chair rail, with ovolo and cavette-astragal moldings, doubles as the sills under the windows. Facing the northeast gable end, the stair rises in the left hand corner, followed by a closet, the chimney block with fireplace and mantel, and a large built in cupboard. The stair runs straight before turning 180° in the corner. The side of the straight run is finished with a raised triangular panel. Above this, rectangular balusters support a flattened curve handrail. A handrail is also imbedded in the wall on the other side of the stair, and this rail is fully exposed where it crosses the window's lower corner. The simple square newel has a slightly curved, flattened cap. The boarded backside of one corner tread and riser appear above a rectangular, raised panel, which in turn surmounts the two paneled closet door. The closet is set at a slight diagonal between the stair and chimney block.

The mantel in this room is more elaborate than the others. The shelf, with cyma-recta molding, surmounts a row of dentil work. Below this, centrally located moldings create the illusion of a sunken panel. The pilasters are embellished with gaugework flutings. The adjacent cupboard is framed with three raised square panels across the top, and a short and long rectangular panels on either side. The two lower cupboard doors are constructed with one sunken panel each, while the upper doors each contain a long rectangular panel topped by a small rectangular panel running horizontally.

T-153
Kaitlings Plain
Interior
Northeast room
Merry Stinson
3/1977
Neg-MHT
