INVENTORY FORM FOR STATE HISTORIC SITES SURVEY

Anderton

Rt. 333, .5 miles west of Otwell Rd. (north)

T-155

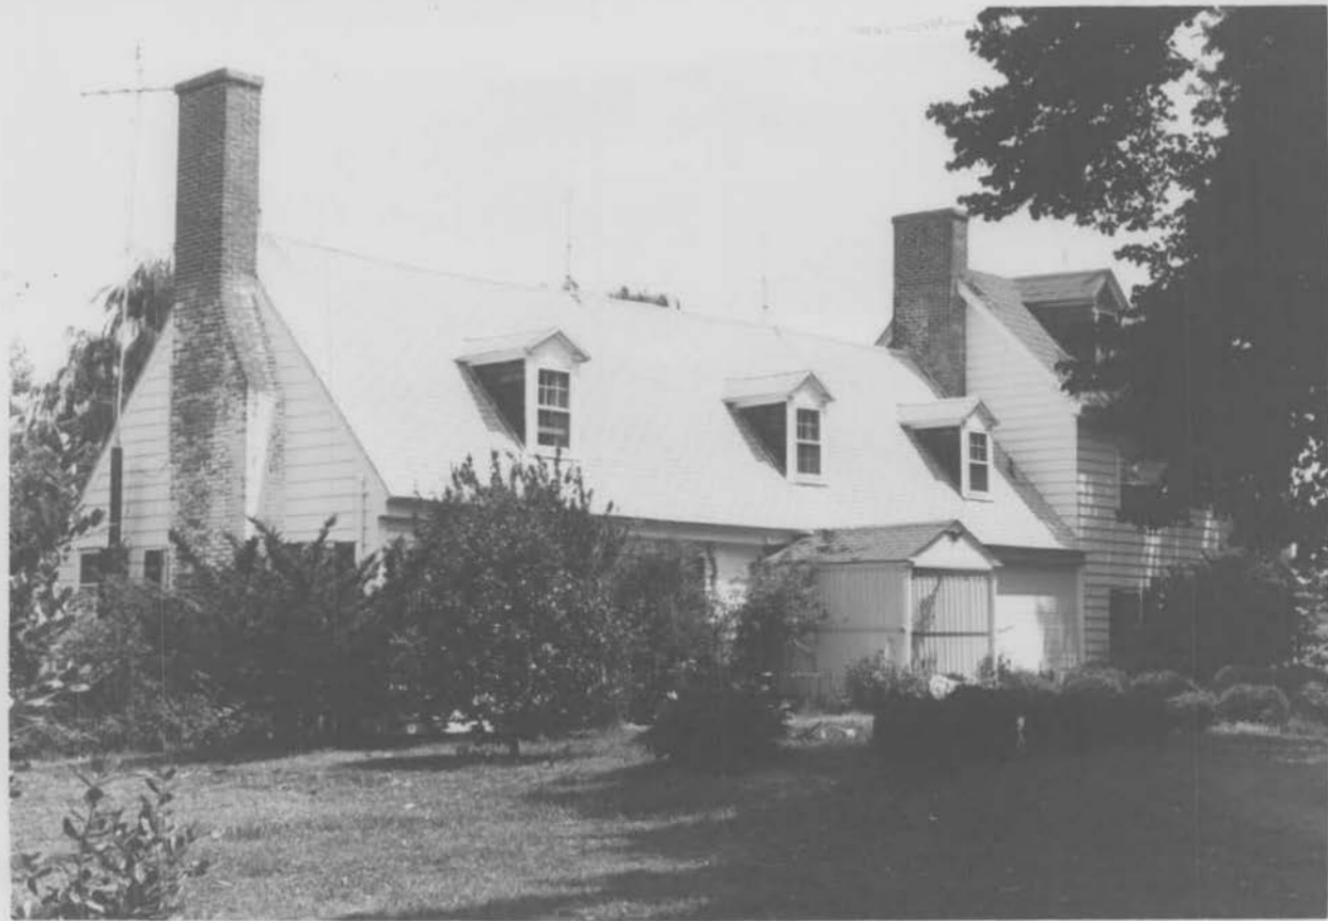
A Anderton T-155

Anderton T-155
Talbot County, Maryland
Neg. located at the Trust, July 1976
Photographed from southwest. 1½-story section
with brick end chimneys. West section built
in 1830.
1 of

1½ story section with brick end
chimneys. West section built
in 1830.

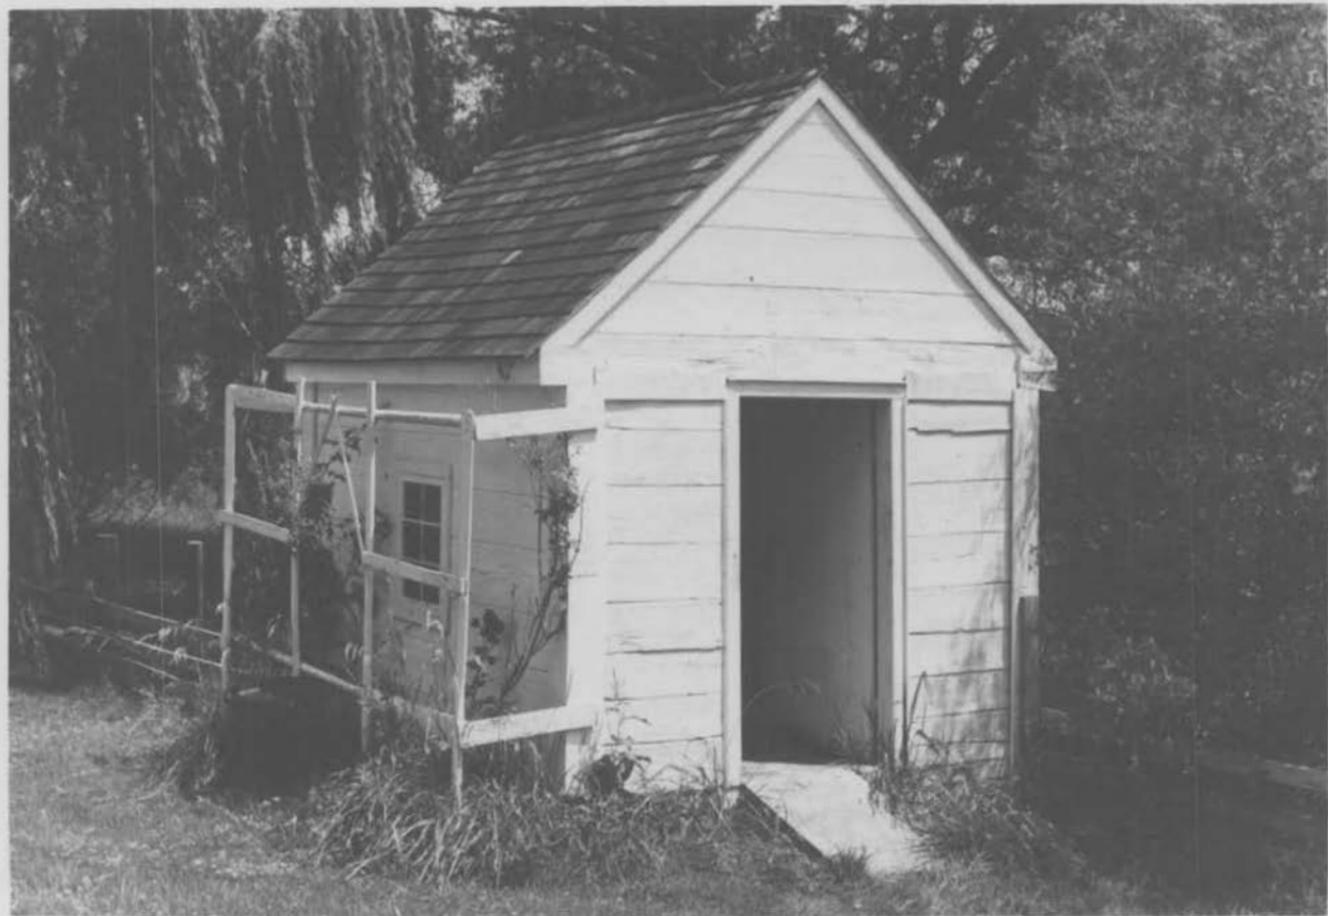
A 1-1-155
Anderton

Small frame outbuilding with gabled roof.
of

#3) Small frame outbuilding
with gabled roof

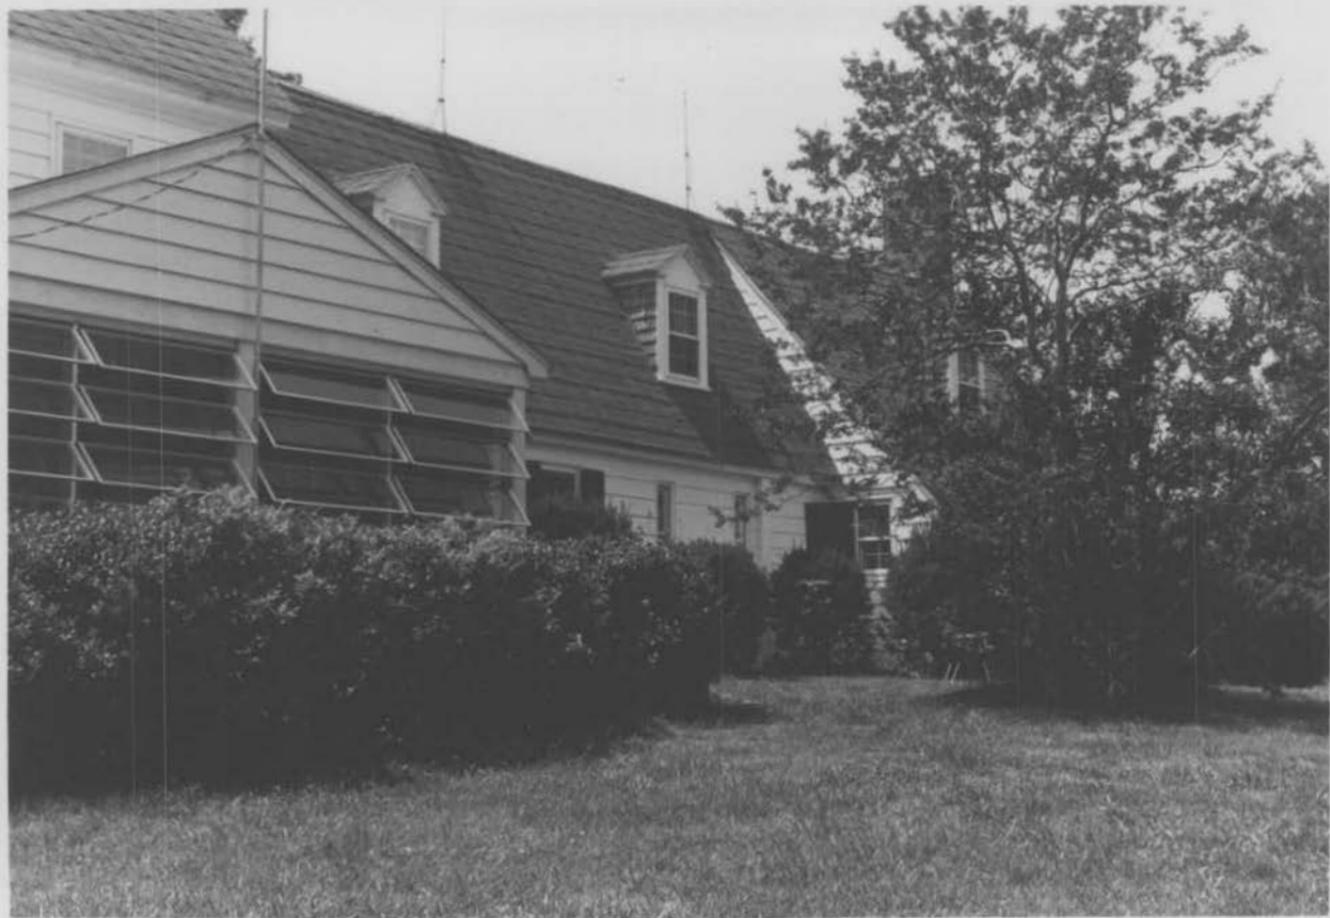
Anderton T-155
Talbot County, Maryland
Neg. located at the Trust, July 1976
Photographed from northeast. South (main)
facade containing central entrance. To the
left of this photo is a small porch
2 of

#2) photographed from North East
South (main) facade containing
central entrance. To the left of
this photo is a small porch.
