**National Register of Historic Places  
Inventory—Nomination Form**

historic Old Bloomfield

Old Bloomfield  
Talbot County  
Maryland

OLD BLOOMFIELD  
EASTON, MARYLAND

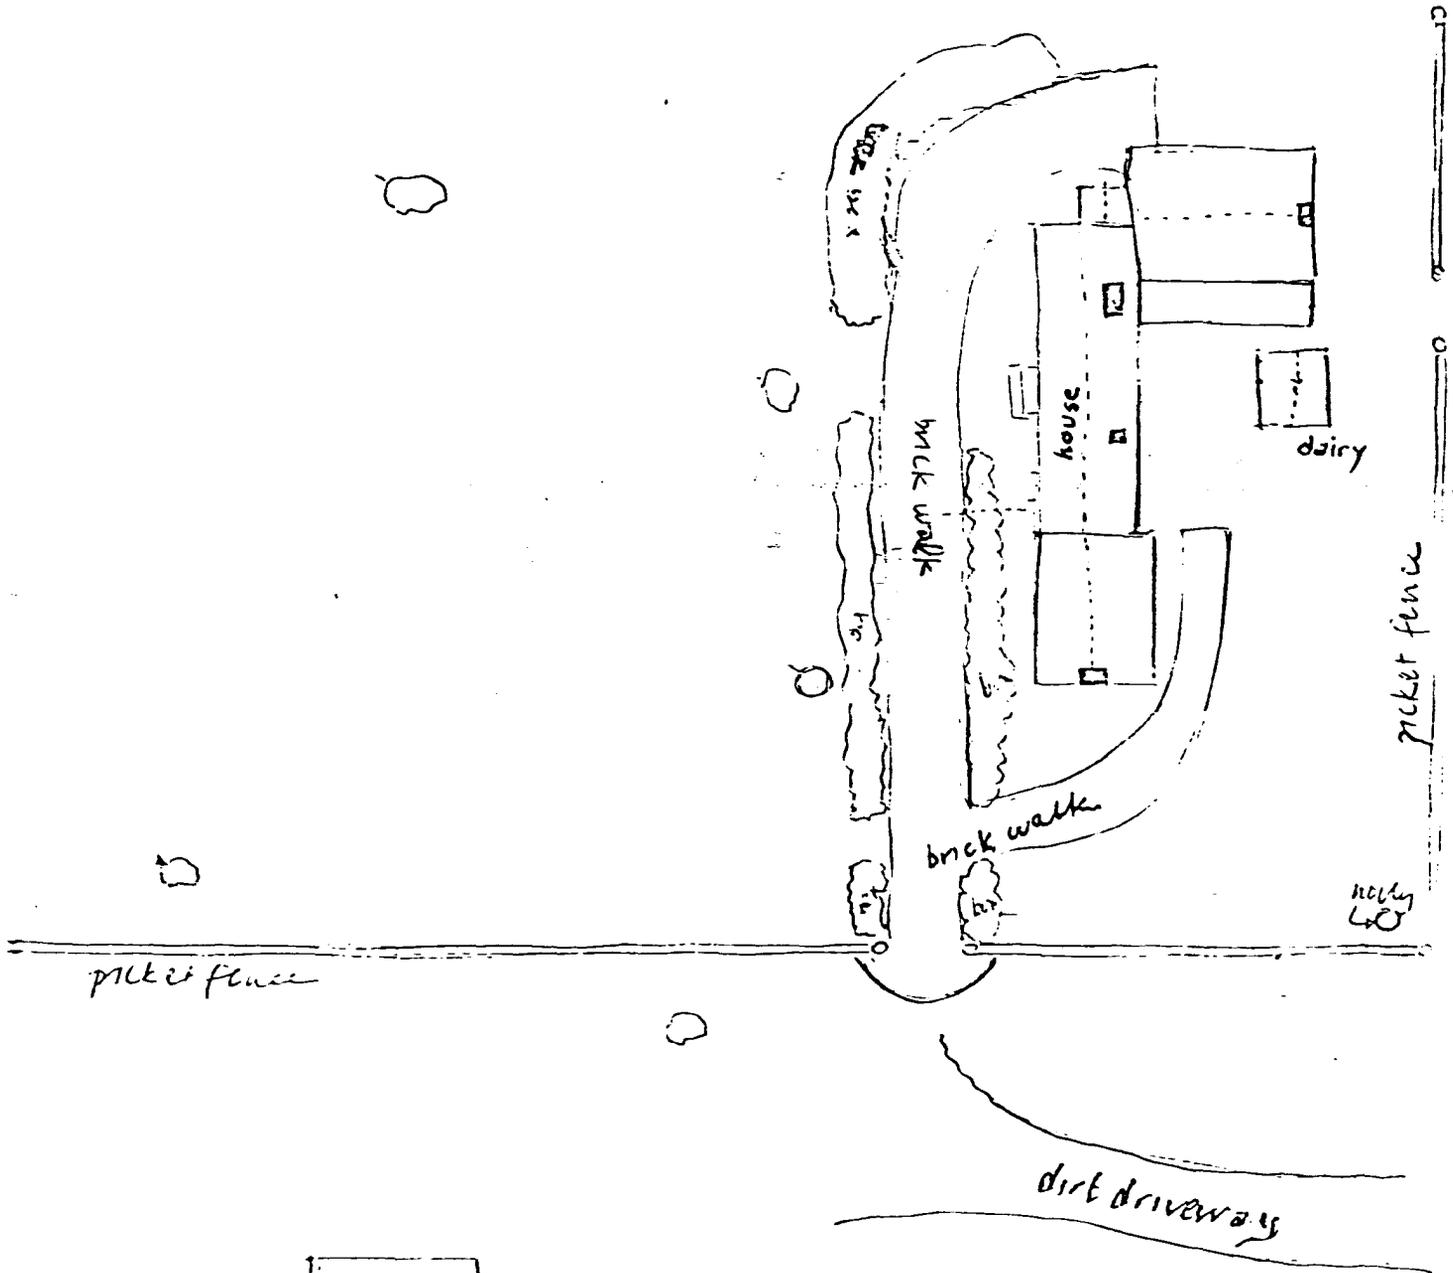
boundary map  
1980

The boundaries for the nomination are shown on the attached section of Talbot County Assessment Tax Map #33.

source: Talbot County Tax  
Map Number 33
