INVENTORY FORM FOR STATE HISTORIC SITES SURVEY

Chance Farm

South side Md. Rt. 33, 1/4 mile west of Md. Rt. 370 in Bloomfield

T-176

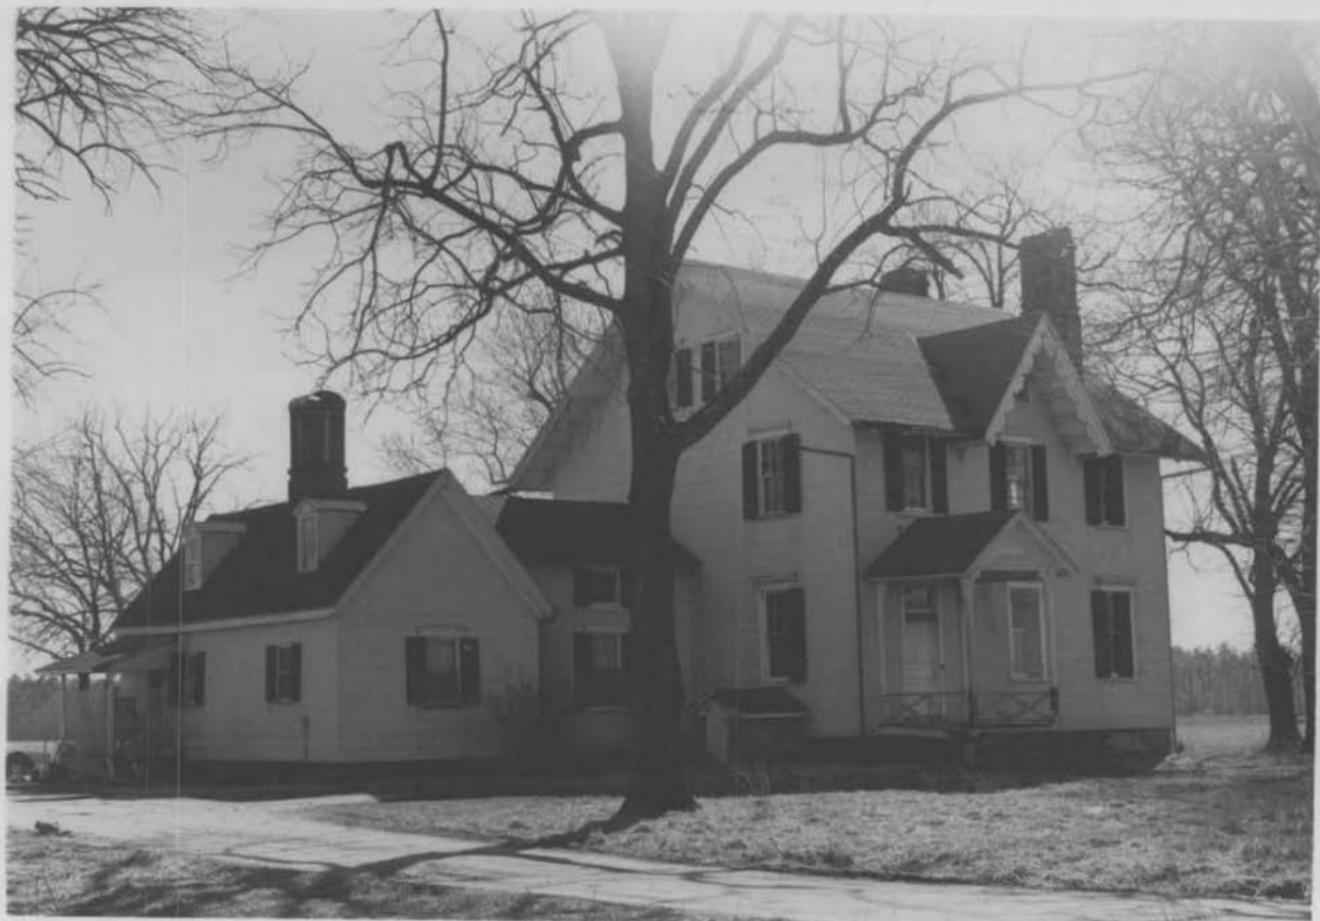
T-176
Chance farm
~~Southwest~~
Northeast

This early 19th century farm includes the main house with a hyphen connecting the kitchen, a two part tenant house, a cemetery, a board and batten barn, and a seven-hole privy. All these buildings are wood frame structures.

The exterior appearance of the house was slightly changed later in the 19th century. The roofline was extended by thin brackets, and low cross-gables with cut-out bargeboard trim were added. The Gothic peak of the cross-gable is reflected in the pointed casement window it accomodates. The chimneys feature channels set into their east and west faces. The two exterior doors are entered through gabled porches. There are several different exterior window frame treatments. Some have pointed segmental arches broken by a keystone, while others have tall window heads topped with either dentil work or a simple bar.
