INVENTORY FORM FOR STATE HISTORIC SITES SURVEY

Woodstock

T-222

Woodstock Farm

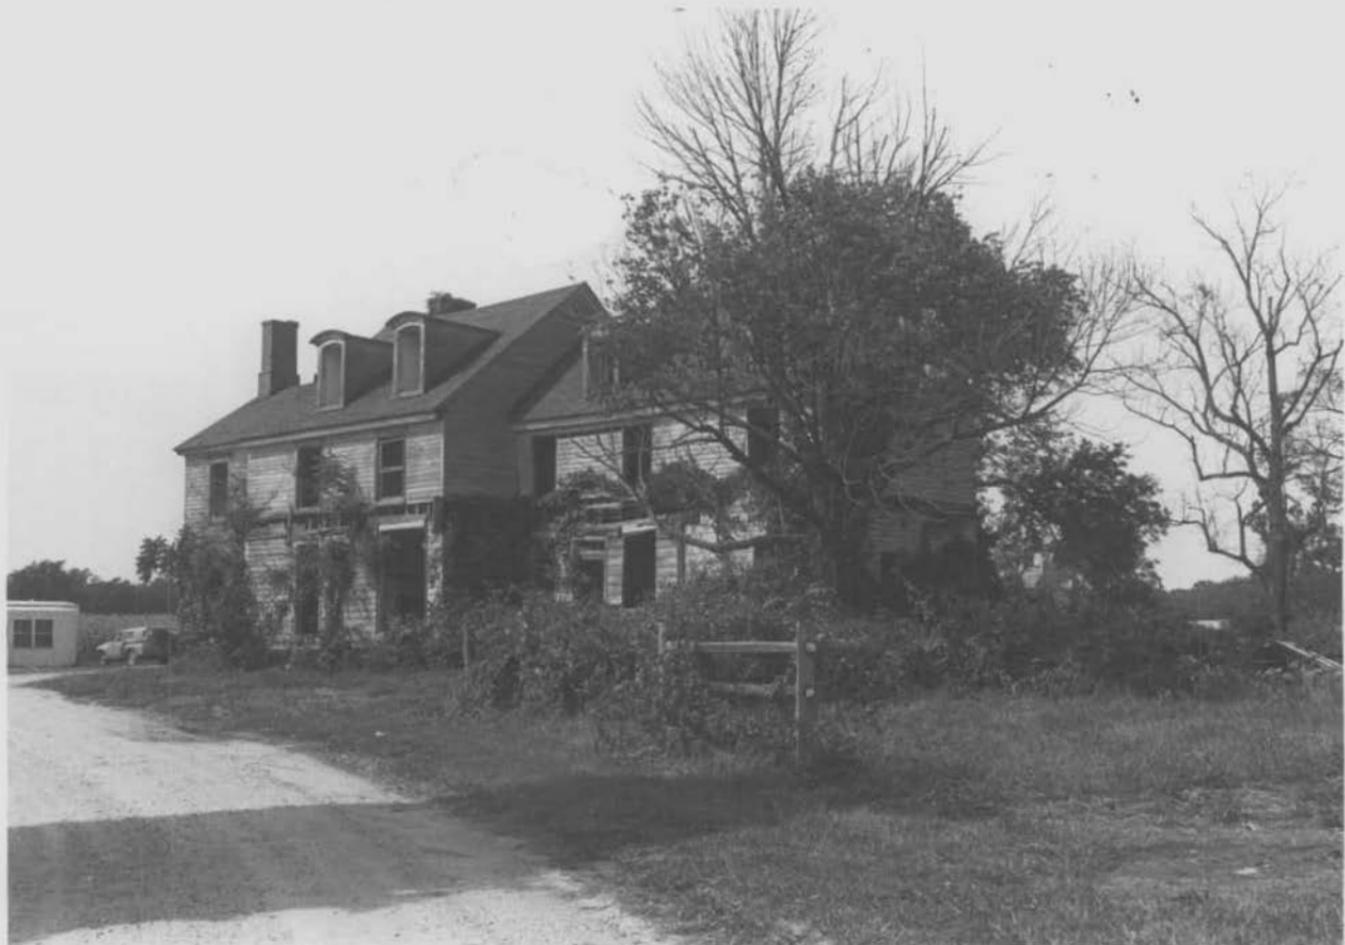
Woodstock is located on the center of a neck of land between Goldsborough Creek and Glebe Creek. It was once a very fine and significant dwelling but it has been allowed to fall into ruin.

The building is a three part frame dwelling composed of a two bay wide by two bay deep, two and one-half story central section with a three bay long two and one-half story section on the east and a two bay long, two story wing on the west. The original section of the building, c. 1835, consisted of the first two sections, the large section having the plan of a townhouse with generous side hall and two parlors. In the wing was a dining room and kitchen, although the original kitchen was in the basement. The addition on the west appears to have been constructed late in the 19th century.

The building is constructed upon a moderate brick basement which is at ground level on the east end. Its walls are covered with plain weatherboard which is absent where the porch was removed. From the few sash which remain the windows apparently had 6/6 sash, but the windows leading onto the former porch extended to the floor and has French doors and in one case a gyb door. The porch appears to have extended across the facade, except for the kitchen wing, and across the entire rear wall, part of which was enclosed behind the kitchen/dining wing. There also appears to have been a porch on the east side of the kitchen, thus having only a section of kitchen facade and the west gable devoid of porch. The dormers on the middle section of the building have segmentally arched sash and roofs. In its west gable rise two large brick chimneys with fire-place on both storys. Another chimney is located in the west gable and another between the kitchen and dining room.
