Bata Shoe Store
14 North Washington Street
Easton, Maryland 21601

T-37
Nineteenth Century,
First Quarter

INVENTORY FORM FOR STATE HISTORIC SITES SURVEY

Bata Shoe Store

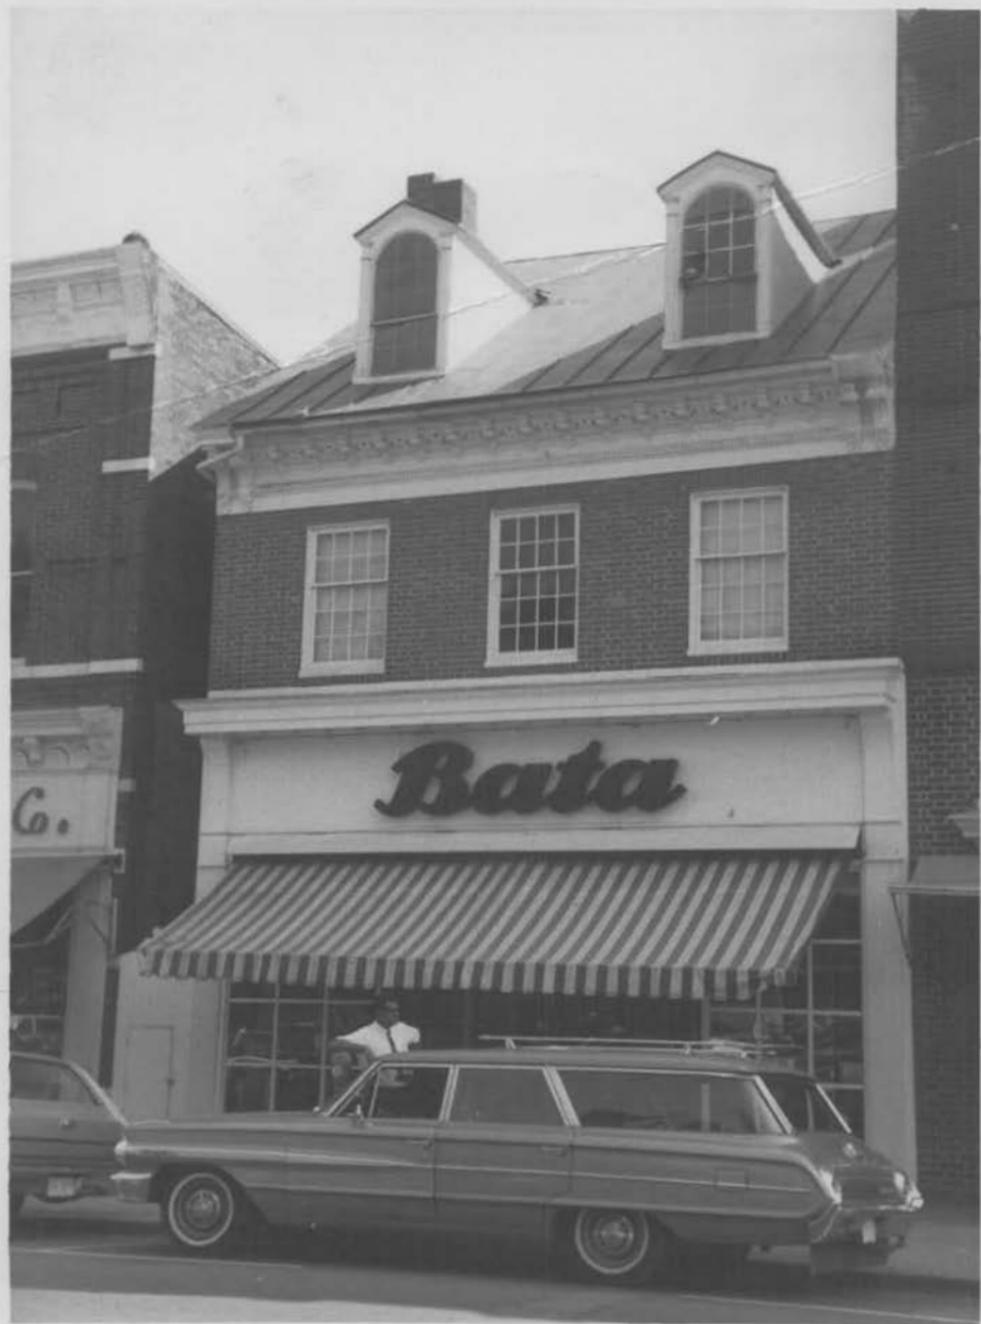
T-37

The building has suffered substantial alterations; a large-scale store front has replaced its entire first floor. A portion of the Flemish bond brick facade remains, however, as do the windows with flat arches and eight over twelve sashes. The trim is a single one inch half round molding. The tall gable dormers have gently pitched roofs and round-headed windows with nine over six sashes. The window opening is flanked by fluted pilasters; there is a cornice and return. Despite needed repairs these features retain their original appearance. The roof is covered with raised seam metal painted green.

Probably added in a mid-nineteenth century renovation, the cornice is the building's most notable feature. The small console-type brackets alternate with stylized pierced-work festoons at the corona. Larger double console brackets with leaf-like feet are found at the corners of the building. A line of tiny half-globes and moldings decorates the frieze. Although added later, the cornice is well-scaled to the building and represents an interesting combination of periods of building. The original cornice remains on the rear facade; it is boxy and plain with original crown and bed moldings.

Bata Shoe Store
14 North Washington Street,
Easton
West Facade

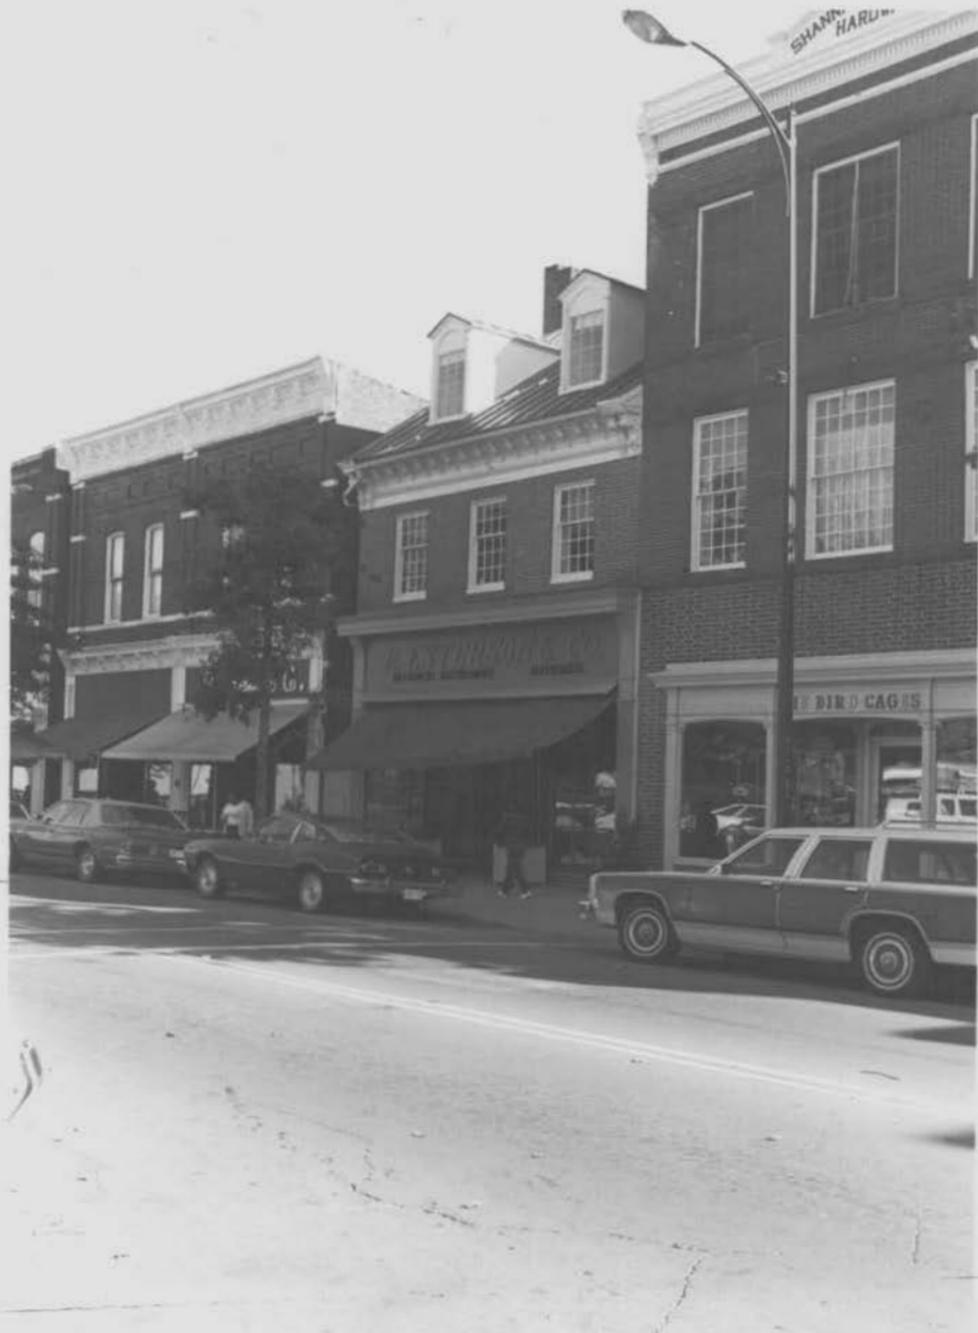
T-37

The building is brick, three bays wide and two-and-a-half stories in height. Its gable roof is taller and somewhat more steeply pitched than the other Federal period buildings on Washington Street. There are two gable dormers on the western slope of the roof; those at the rear of the building have been removed. Three additions form an ell to the rear. They have no distinguishing architectural features and appear to date from the mid-nineteenth century and twentieth century. There are two chimneys at the ridge of the roof. The one at the south wall, a double chimney with a corbelled cap, appears to be original; that at the north wall is modern.

Southwest Elevation

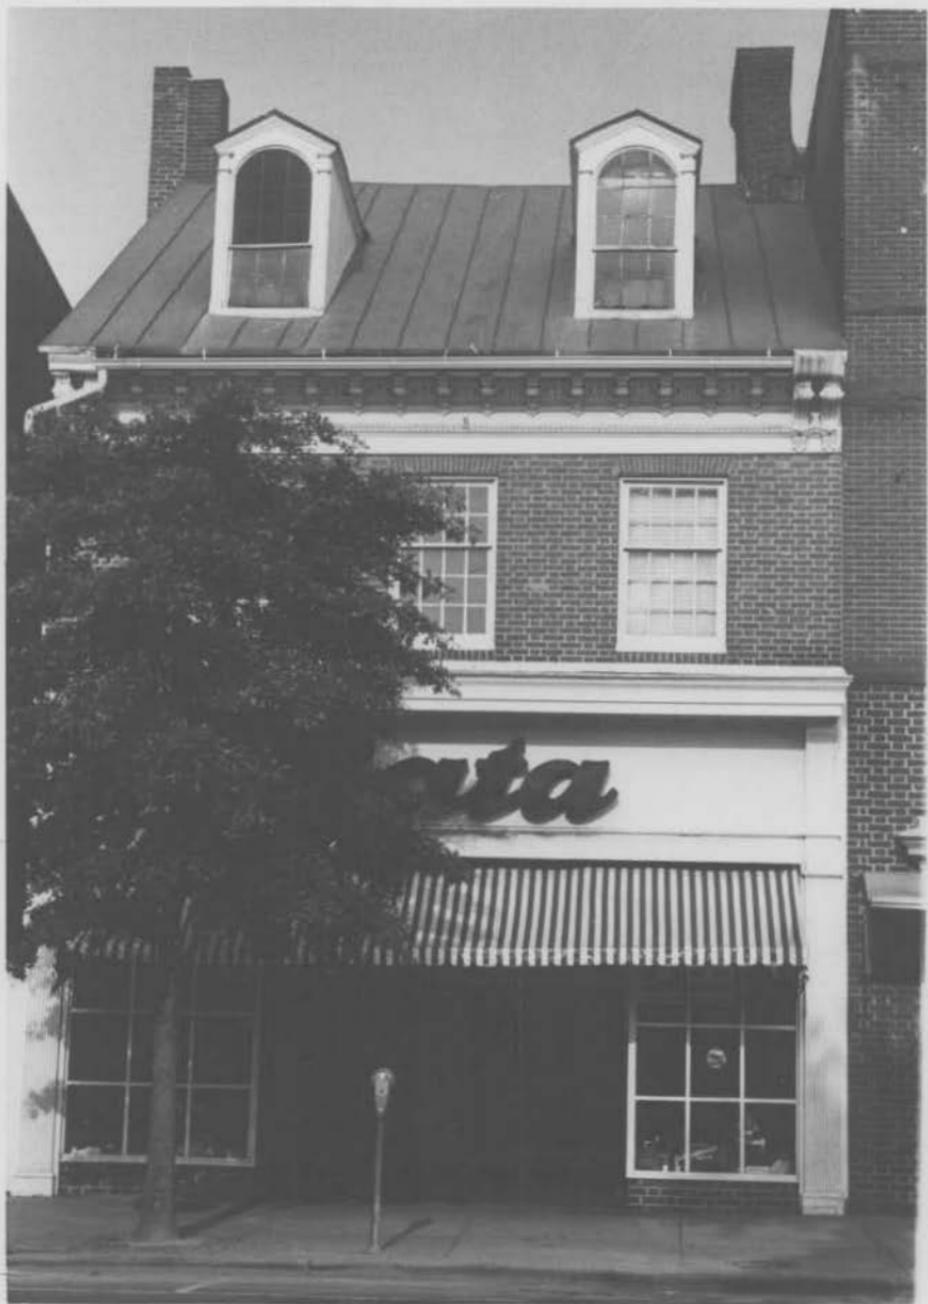
T-37

WEST FACADE
