**Addendum to  
Maryland Historical Trust  
Maryland Inventory of  
Historic Properties Form**

**Name of Property:** Wickersham \ Dawson Baker Farm  
**Location:** 203 Locust Street, St. Michaels (currently)  
vicinity of US 50 and MD 662 (historically)

# Maryland Historical Trust State Historic Sites Inventory Form

historic Wickersham

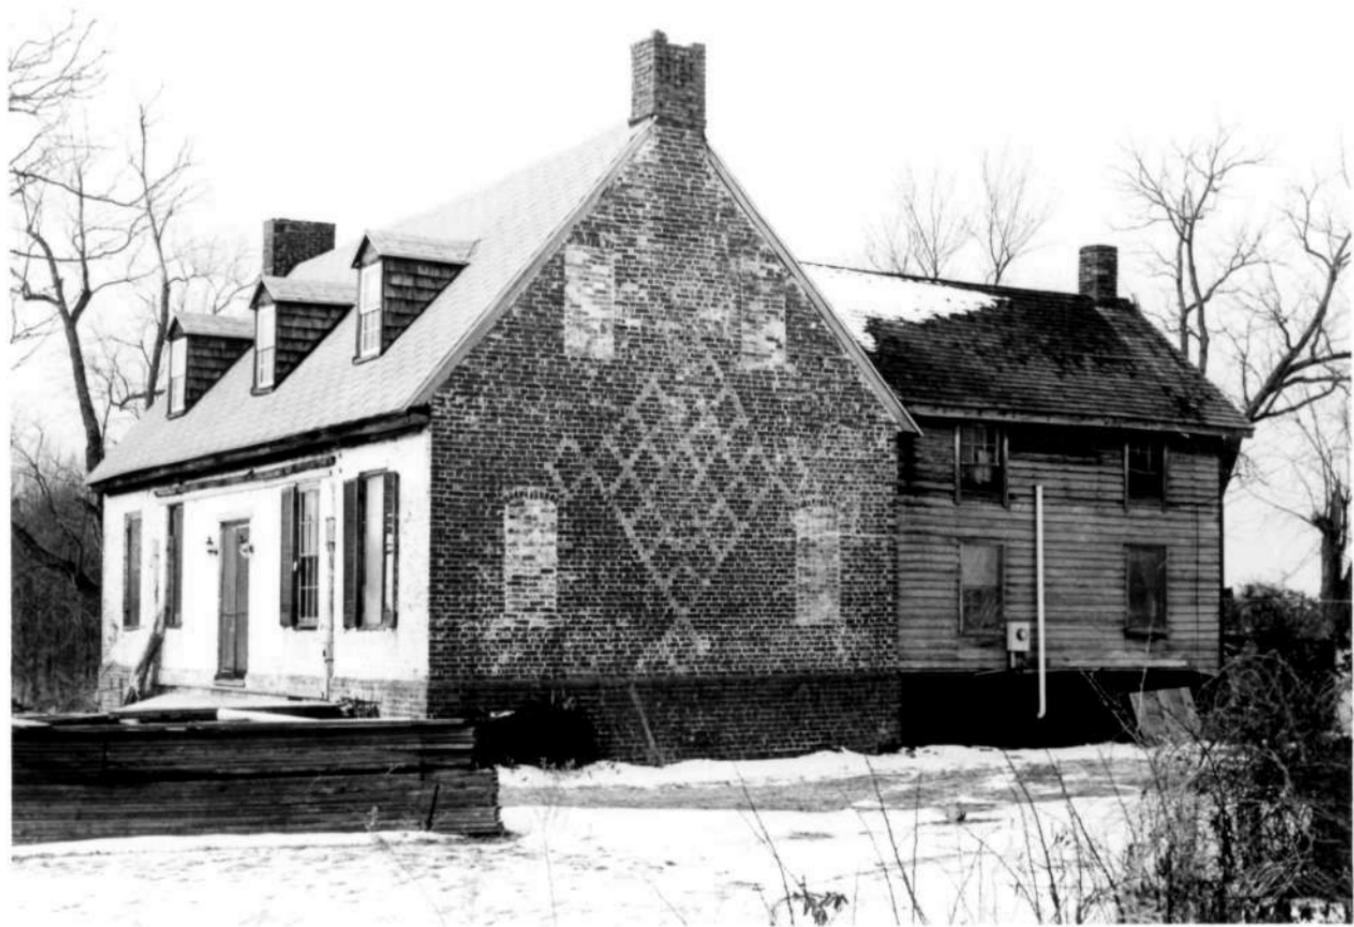
T-56

E. facade (golds)

The east gable originally had two small windows on both storys which have been bricked in. Between the four windows is a large diamond design in glazed headers. It consists of a large diamond composed of sixteen smaller diamonds with a small diamond at top and bottom. Its design is similar to, though more ambitious than, Orem's Delight on Ferry Neck. Wickersham, also, boasts three bricks dated 1750 on the east gable. One reads only 1750 while the other two have June 26, 1750 and R R 1750 respectively.

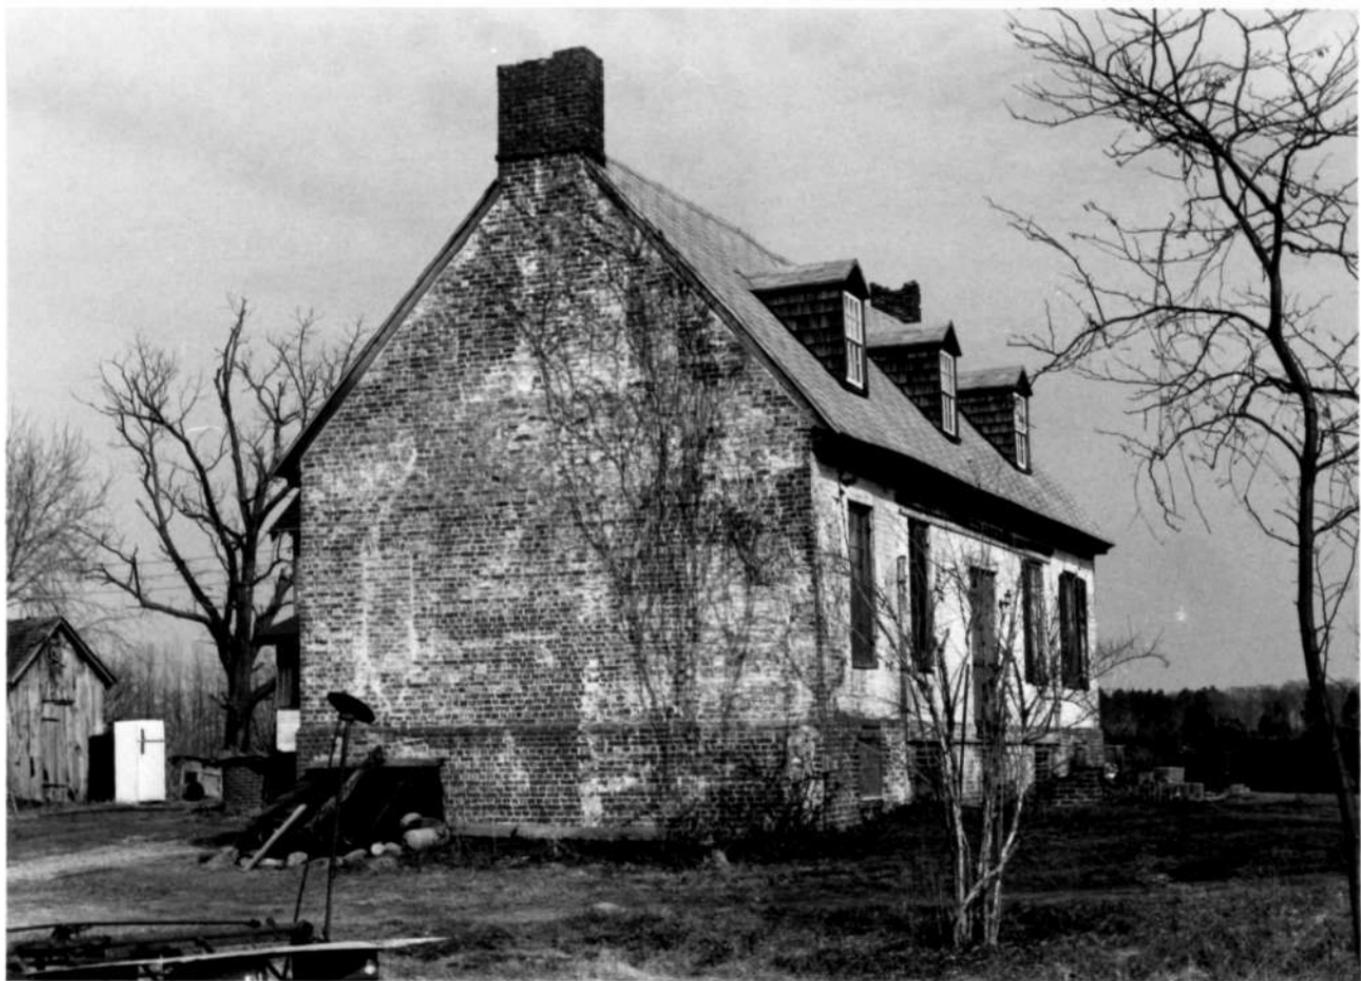
2 of 6

Southwest gable elevation, also

showing south (front) facade.

The brickwork on the west gable facade is laid in English bond above a beveled water table and English bond foundation. The upper gable is laid in three-course common bond. This change in bond is almost certainly original. It is not uncommon for the bonding pattern to change in the upper gable, but this is a particularly early example of the use of three-course bond. A corbeled drip course is carried around three sides of the chimney. The gable eaves are trimmed with beaded and tapered rakeboards.

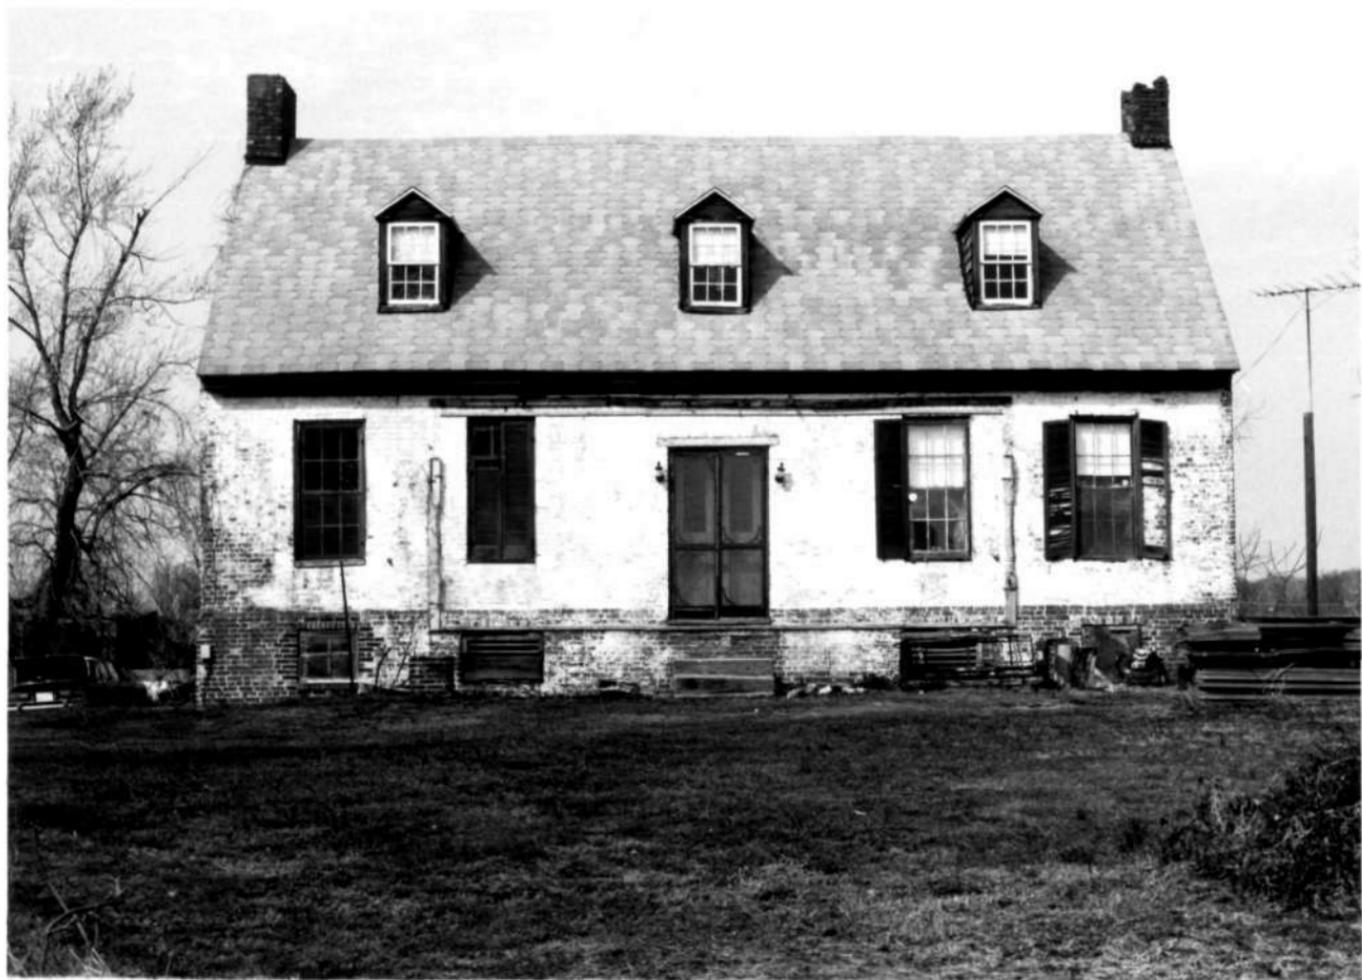
1 of 6

South (front) facade

The front facade, as noted, faces south to the road. A broad, double door is located in the center bay. flanked by two large 6/6 windows on each side. Queen closers are evident on both jambs of the door, and on at least one jamb of each window. The window openings may have been enlarged slightly by cutting them down one or two courses, an alteration implied by the evidence of original interior chairrail above the existing sill level. The dimensions of the original openings are 3 feet 2 inches wide by approximately 6 feet high, suggesting original sash of either 9/9 or 12/12 configuration. There are three 6/6 pitched roof dormer windows on the second story. These date to the Greek Revival period but may replace earlier dormers. Cellar window openings are located below each of the four first story windows; there is no cellar opening below the door. The two cellar window openings flanking the center bay remain undisturbed but the east and west windows have been reduced in size with 20th century brick. The original cellar openings are quite decorative with three-centered brick segmental arches that include alternating glazed headers.

The brickwork on the front facade is laid in Flemish bond above a beveled water table and Flemish bond foundation that changes to English bond for the five courses closest to grade. The cornice is boxed in and trimmed with a complex crownmold applied to a plain fascia and complex bed mold applied to a beaded frirze board. The cornice appears to be constructed with machine nails and probably was rebuilt during the Greek Revival renovation of the interior. The dormer windows are sheathed with wood shingles and trimmed with simple Greek Revival details; the roof of the house is covered with asphalt shingles. Louvered wood shutters dating to the 19th century survive on three of the first story windows. They are hung on standard manufactured hinges and are fitted with simple hand forged shutter dogs. Two half-columns survive from a late 19th century porch that extended across the center three bays of the house until a few years ago.

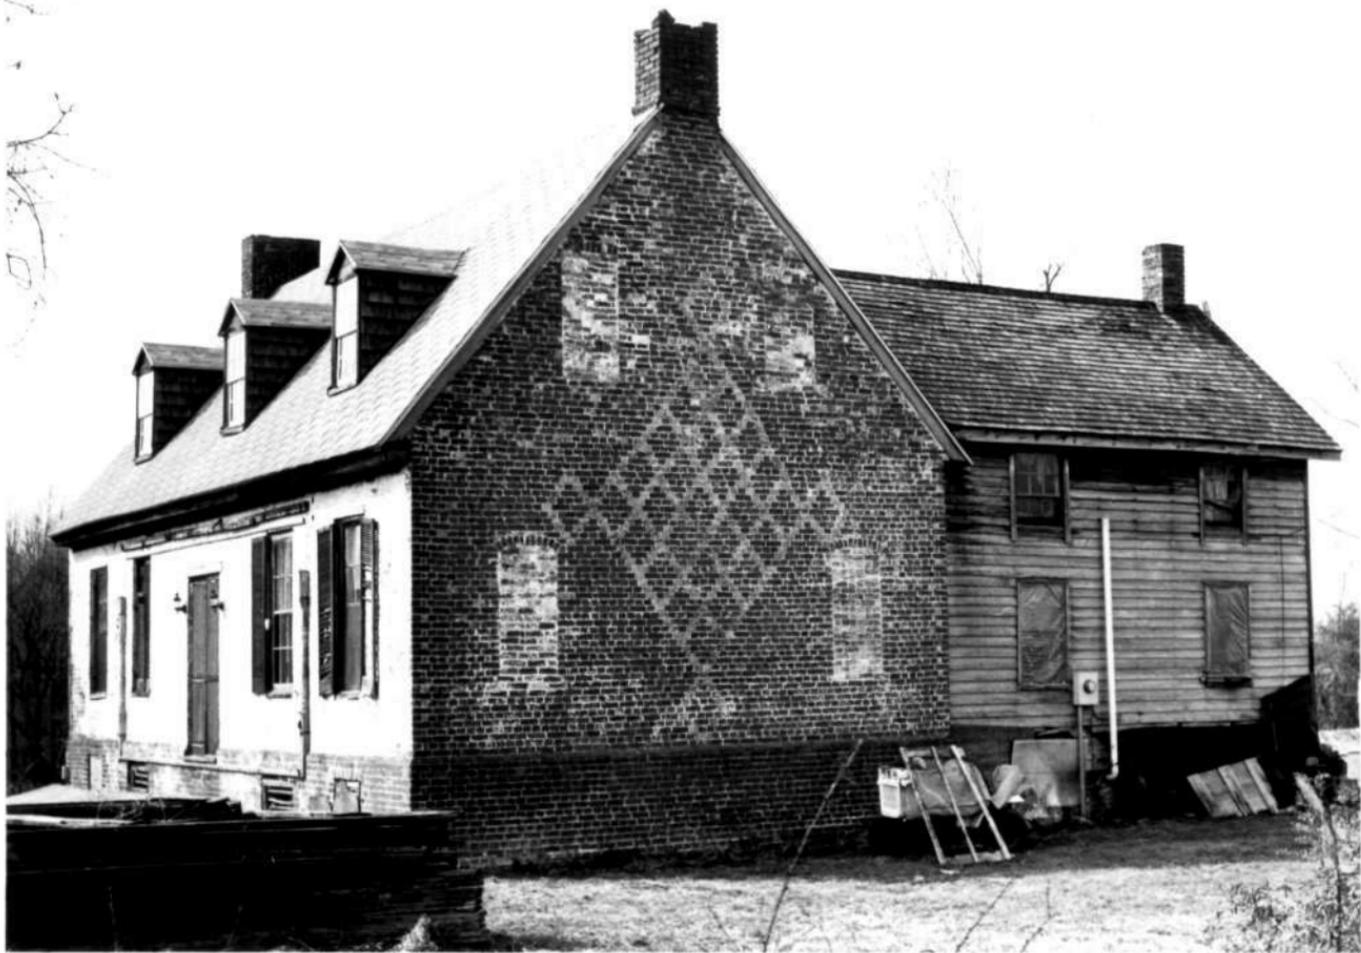
3 of 6

Southeast elevation, also showing  
east facade of frame addition.

The rear wing measures 16 feet wide by 20½ feet deep. It rests on a continuous brick foundation and is covered with plain weather-board siding secured with wire nails. The pitched gable roof is covered with wood shingles; the eaves oversail and are boxed in. On the east facade, there are two 6/6 windows on the first story and two 6/3 windows on the second story. A brick stove chimney is centered on the interior of the north gable wall. A door at the extreme east end of the first story is the only opening in the north gable. The next facade is similar to the east facade except there is a door in the south bay, opening into a one story lean-to porch that extends across most of this facade of the wing.

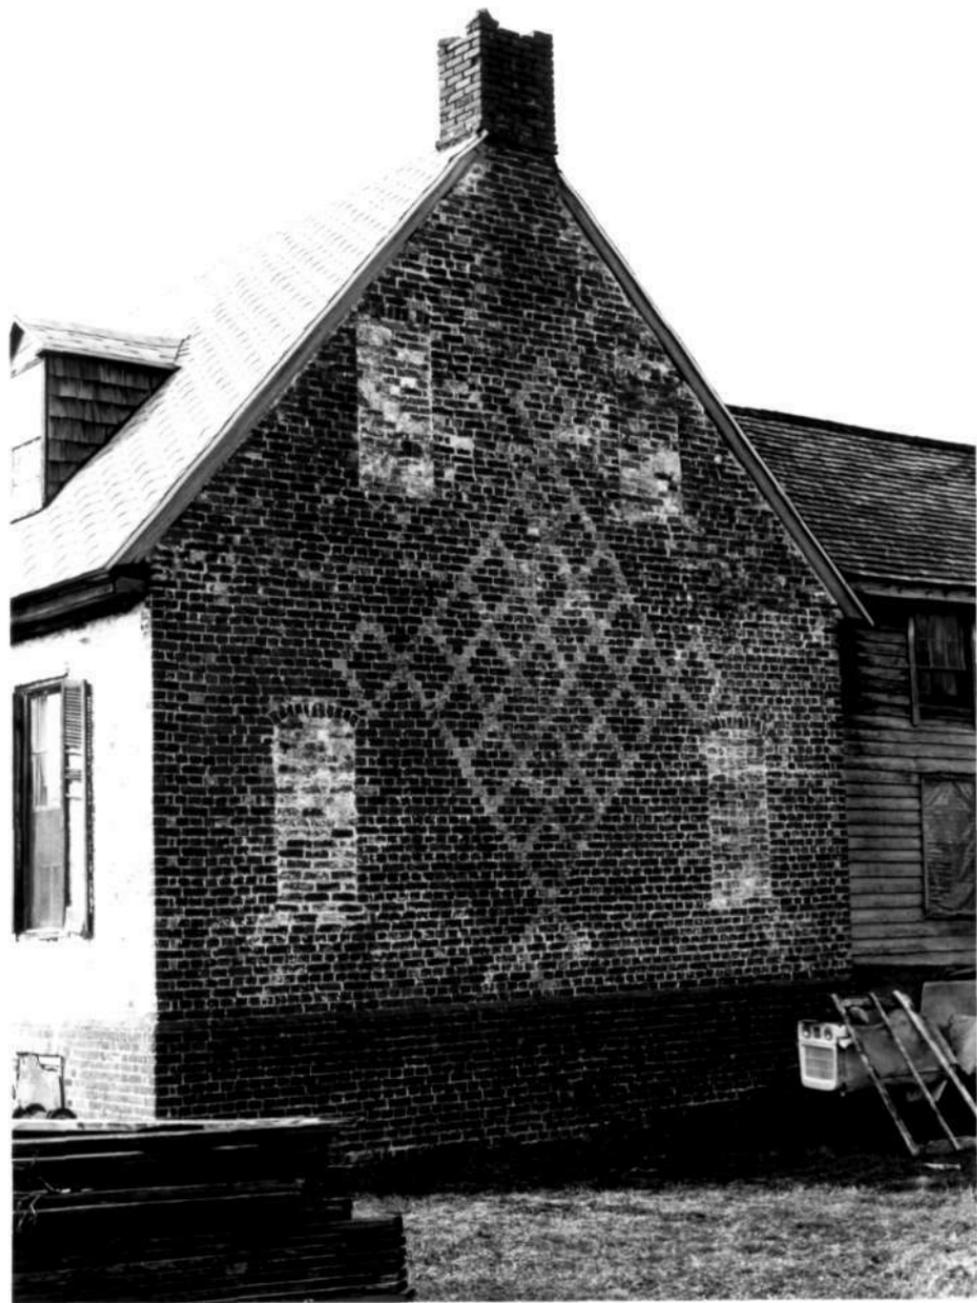
4 of 6

Detail of glazed header diaper

pattern

The east gable wall of the house is embellished with a handsome pattern of interlocking diamonds executed with glazed header bricks. This pattern consists of 29 small diamonds arranged so that 25 of them form a single large diamond with one additional diamond at each corner. This diamond pattern is flanked by a pair of window openings on the first story and a record pair in the upper gable. These window openings are similar to the west gable, having segmental lintels on the first story and flat soldier course lintels on the second story. The brickwork on this facade is laid in English bond above and below the beveled water table; the upper gable is random bond. The chimney on this gable is only a single flue in contrast to the larger double flue chimney on the west gable. The eaves are trimmed with beaded and tapered rakeboards.

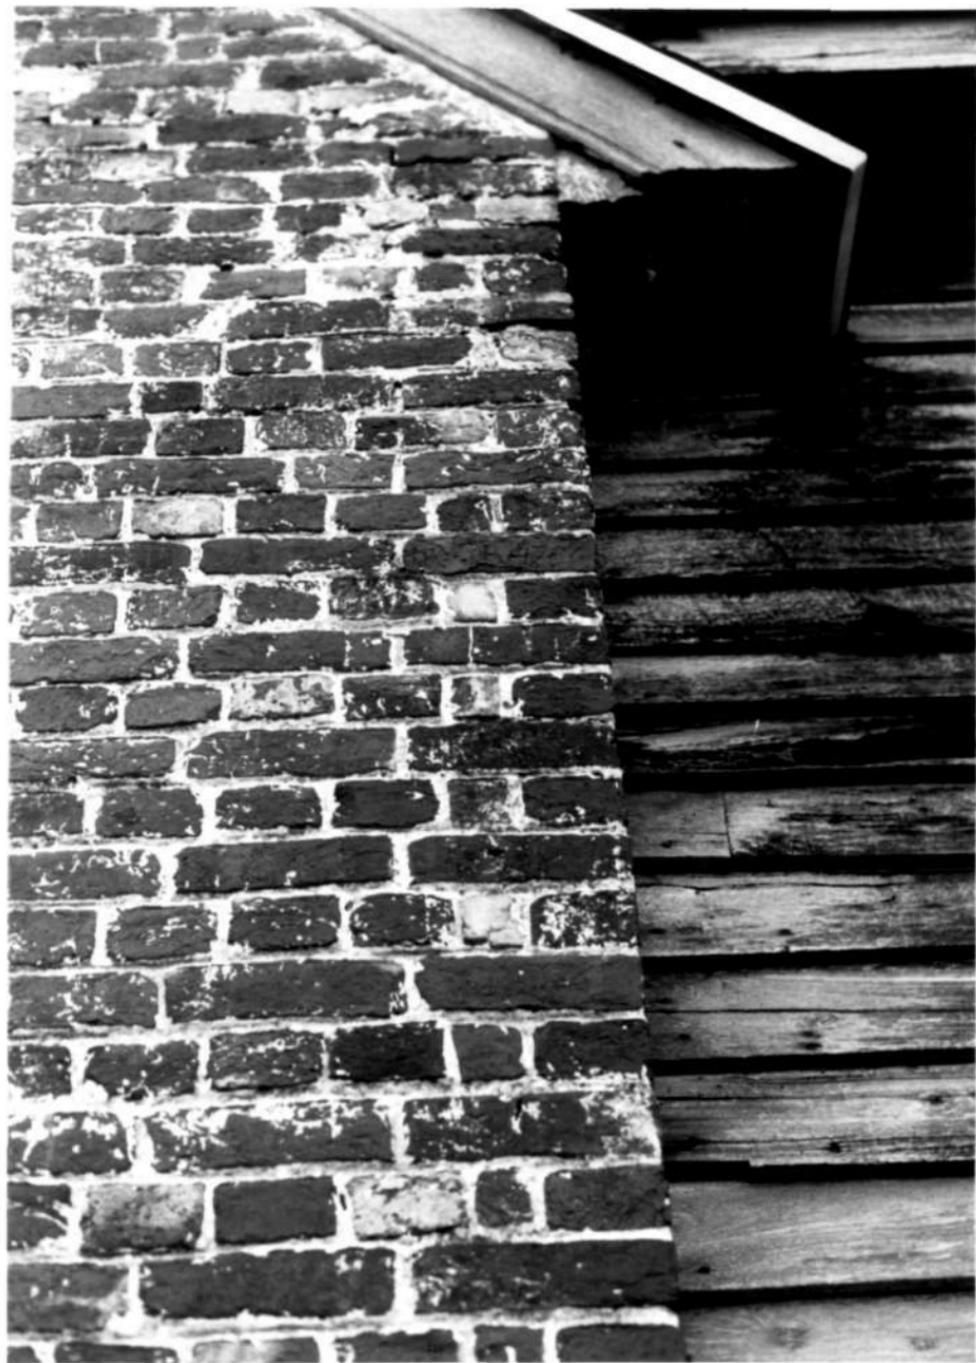
5 of 6

East gable end, detail of cornice at  
northwest corner, showing dated and  
inscribed brick: "HRR 1750"

Of particular significance are three inscribed bricks found in this gable end of the house. One, dated June 26, 1750 is located within the small diamond at the base of the larger overall pattern. A second, dated 1750, is located in the next diamond up and to the right. A third brick inscribed

H  
R R 1750

is located on the north corner, 35 courses above the water table. The initials are assumed to stand for Robert Harwood, who acquired the property from his father in , and his second wife, Rachel, whom he married in .

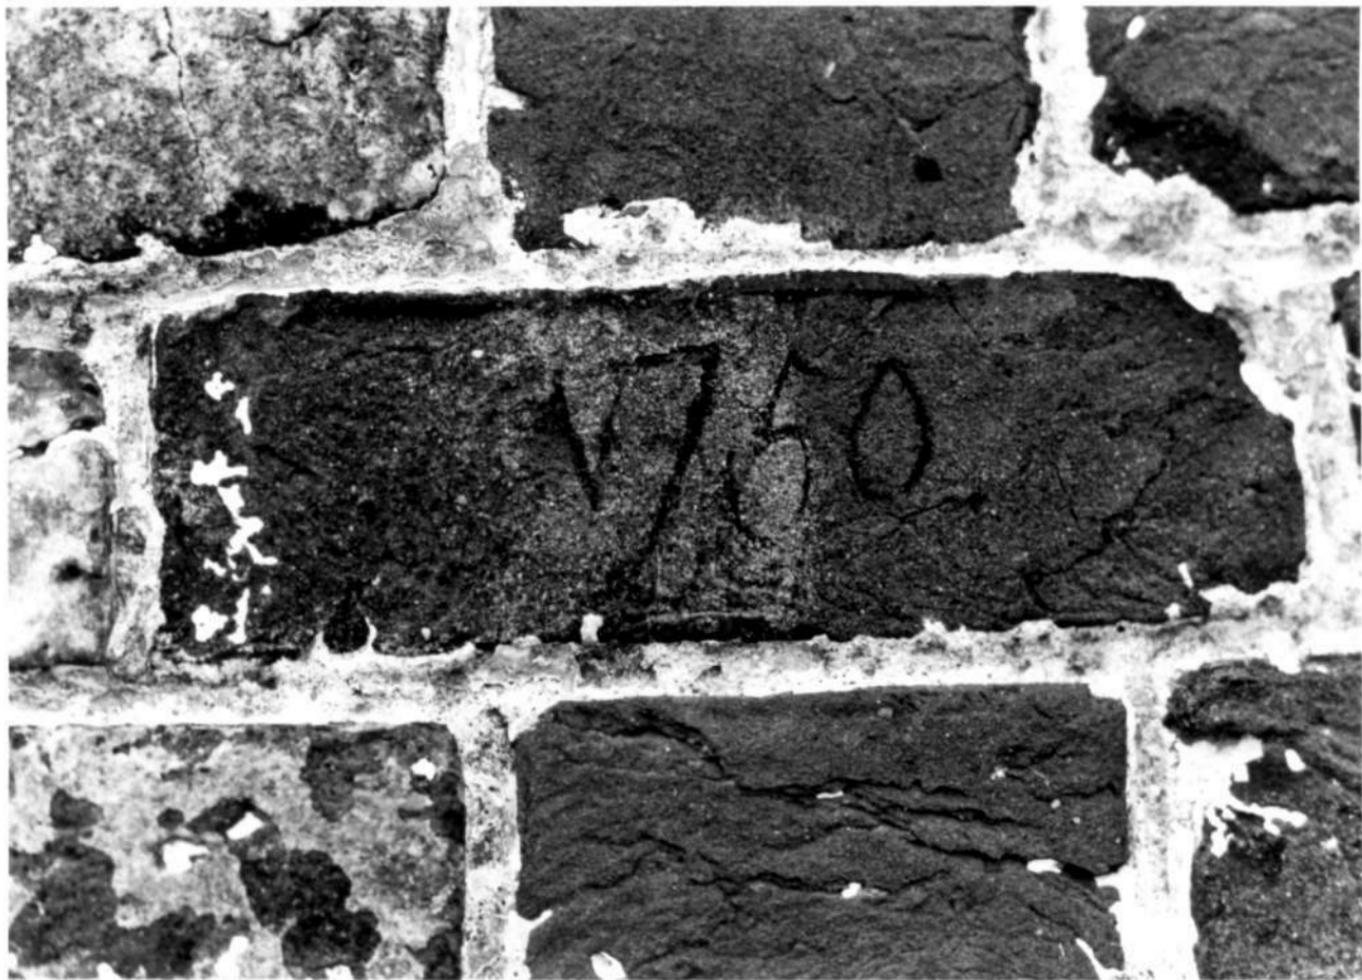
6 of 6

One (of three) dated bricks: "1750"
