William S. Turner House
Bellevue
Private

Maryland Historical Trust State Historic Sites Inventory Form

Survey No. T-783

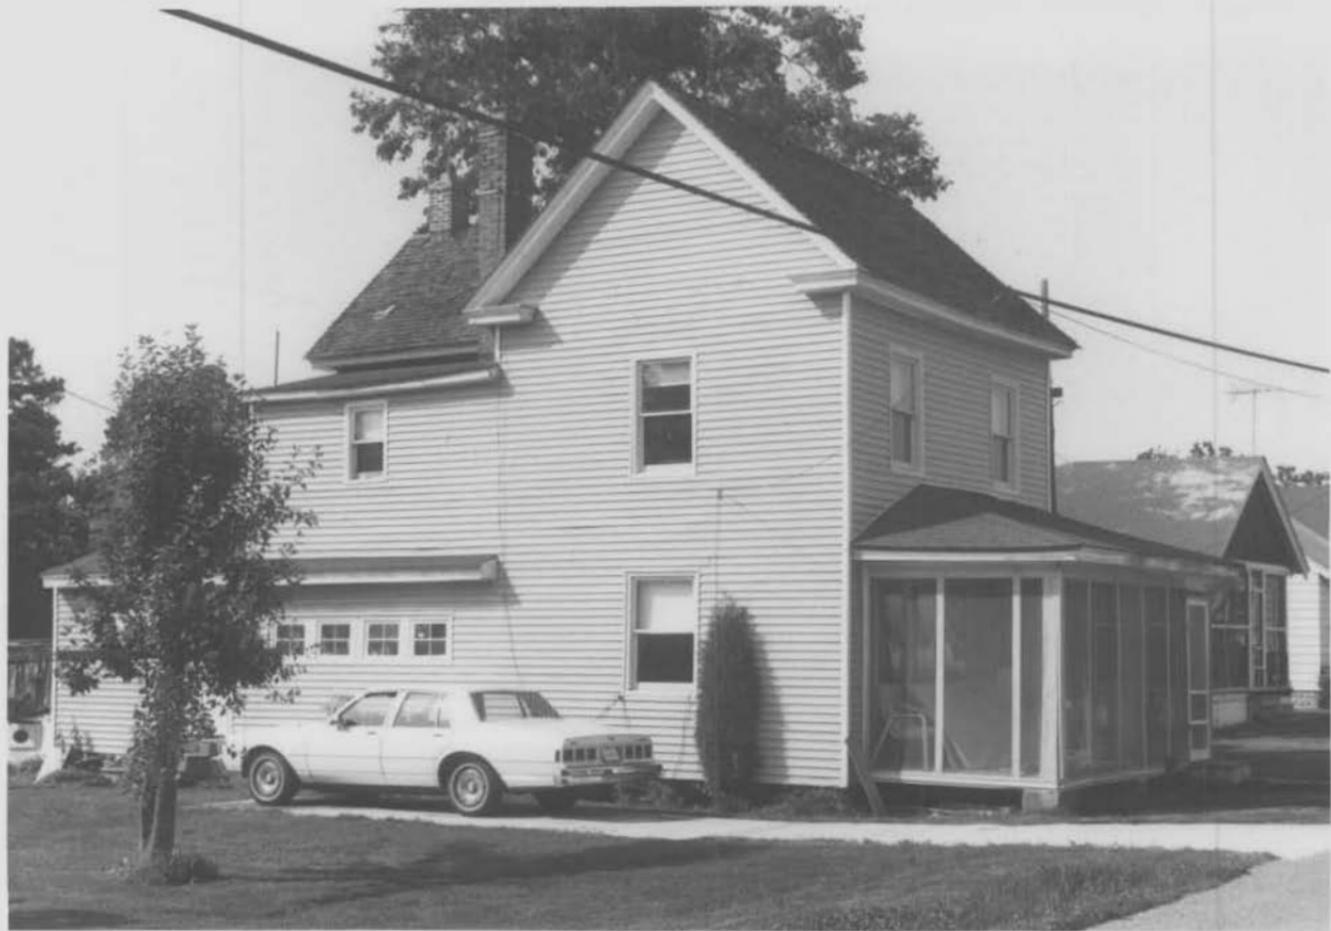
Southwest elevation

The northeast and southwest gable ends follow along similar finishes with single-pane sash windows lighting the first and second floors. A slightly extended eave is trimmed with short returns at the base of the roof. Rising against the northwest corner of the house, now within the shed addition, is a brick chimney stack.
