# Maryland Historical Trust State Historic Sites Inventory Form

historic Black Walnut Point Farm

and/or common Black Walnut Point Inn

Survey No. T-815

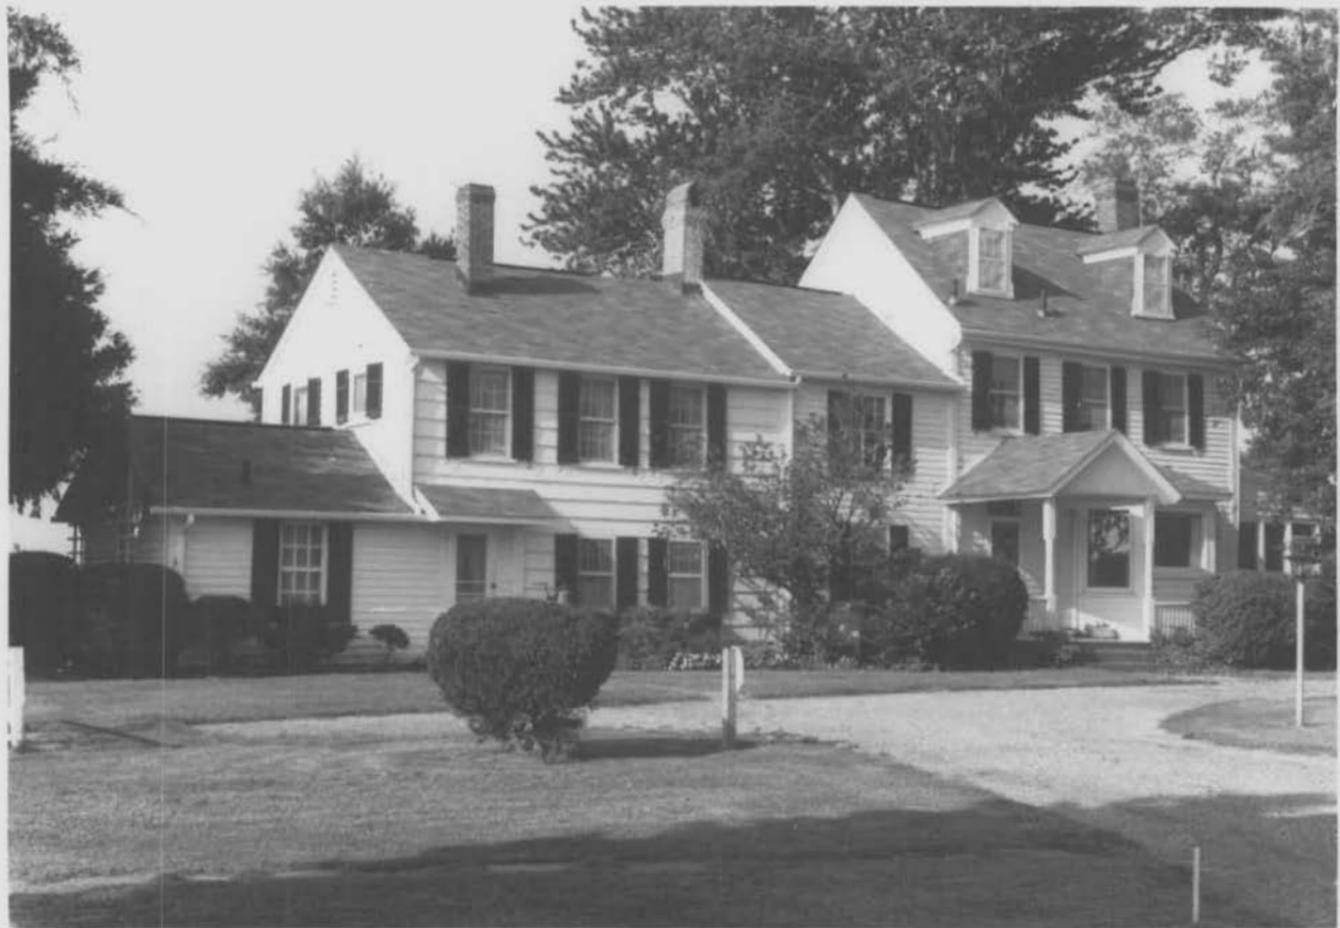
NORTHEAST ELEVATION

The northwestern three-bay structure of the northeastern 'main' facade is covered in white weatherboard. The symmetrical facade has an eight-paneled door as the eastern bay which is sheltered by a small gable roofed portico and flanked by a bay window. The door has a three-light transom, and the portico, a later addition, has turned supports and a square post balustrade which wraps around to the south side of the building. Three six-over-six sash windows with green, louvered shutters light the second floor. Two dormers with six-over-six sash windows pierce the roof of the upper half story.

A single bay, two-story structure covered in German siding is the first addition on the southeastern end of the earlier three bay section. The first floor of this addition is lit by a six-over-six sash window. The second floor has one twelve-light window. A two-story, three-bay structure covered with wide weatherboard planks telescopes southeast from this first addition. This section has a side door flanked by two six-over-six sash windows. The second floor is lit by three six-over-six sash windows. There is an interior chimney stack both on the northeast roof slope of this addition and between this addition and the one to the northwest. A one-story, gable roof structure covered in plain weatherboard is attached to this second addition and is lit by one six-over-six sash window.

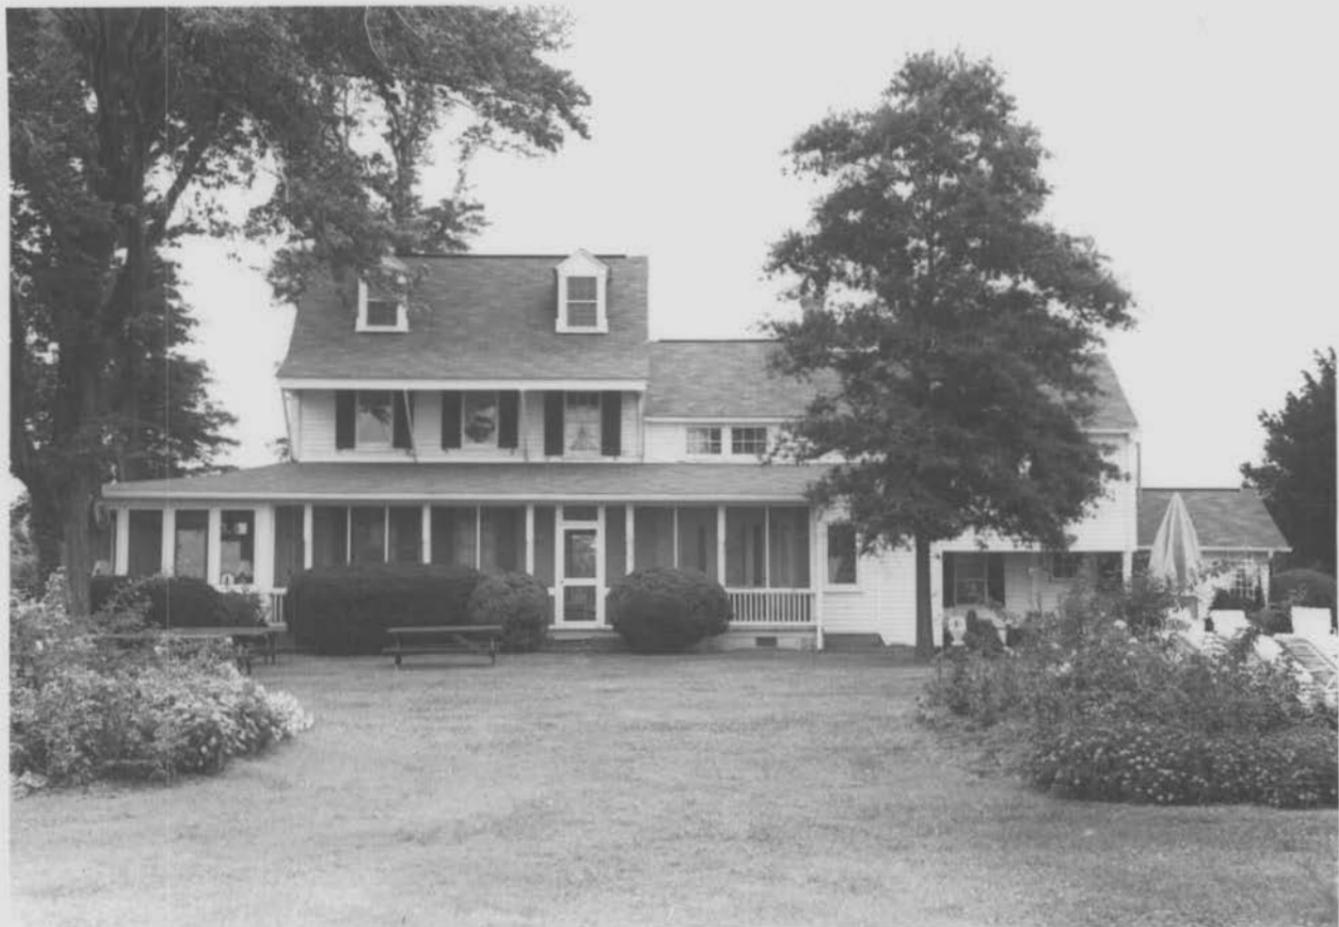
SOUTHWEST ELEVATION

The southwest (rear) elevation of the primary wing's first floor has a screened porch supported by turned posts which wraps around the building to the west gable end where it is enclosed. There are two six-over-six sash windows and an eight panel door on the first floor, and two casement windows and one six-over-six sash window on the second floor. The windows have green, louvered shutters. The roof of this primary wing extends out over the second floor creating a two-story porch. This porch was probably originally supported by large posts set into the ground. Today it is supported by braces connected to the main wall. The underside of the overhang is gracefully finished with curving wood work. Two gable roof dormers with six-over-six sash windows pierce the roof of the upper half story.

The screened porch extends across the first floor of the first addition which is lit by one six-over-six sash window with green, louvered shutters. The second floor of this addition is lit by two six-light casement windows. The wide plank second addition has an entrance door and one six-over-six sash window with green, louvered shutters. The second story extends out over this first floor, sheltering the first floor entrance. The one-story, gable roof third addition is lit by one six-over-six sash window.
