Maryland Historical Trust State Historic Sites Inventory Form

and/or common Frank Fairbanks House

Survey No. T-827

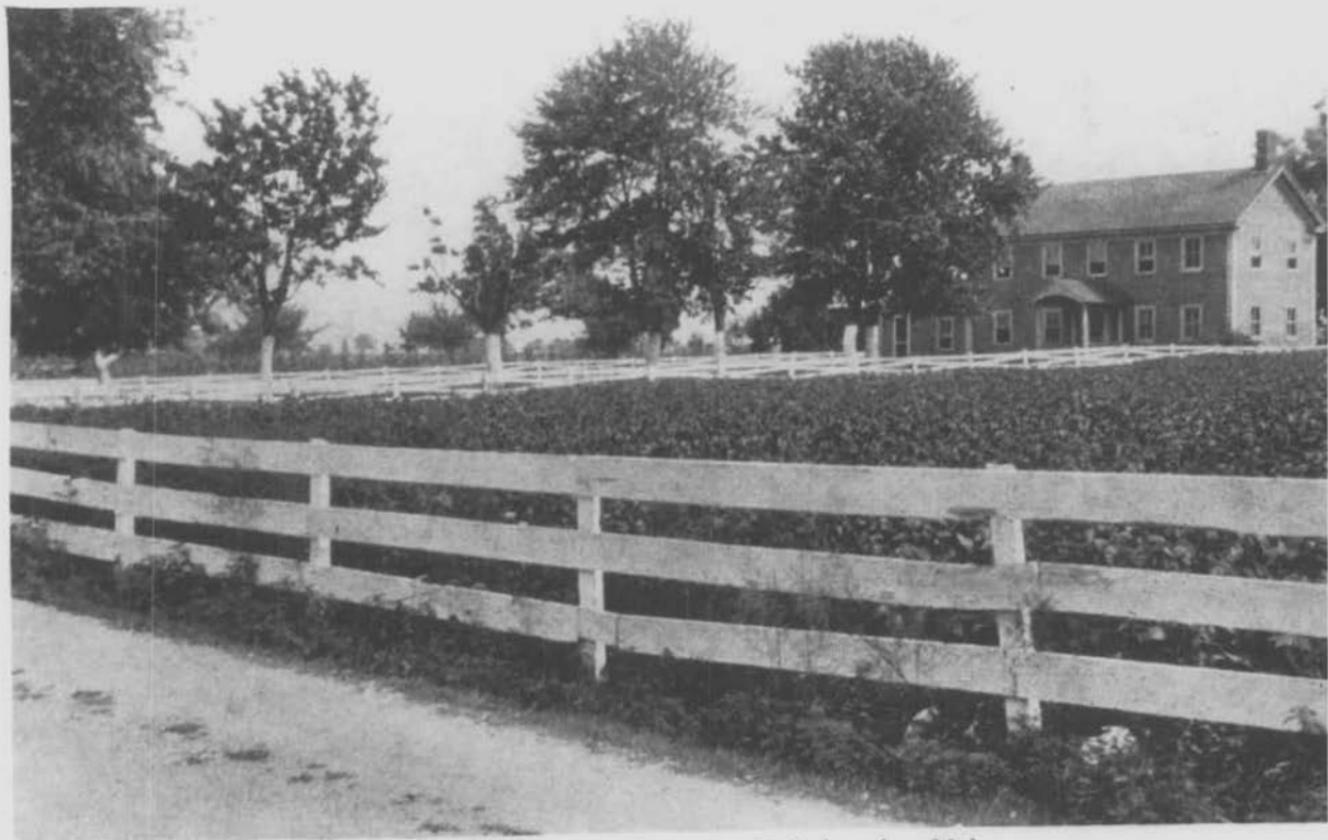
FRANK FAIRBANKS HOUSE T-827

The north (main) facade has a central door flanked by a pair of two-over-two sash windows. The windows on the eastern bays have wide surrounds, while the windows on the western bays have narrow surrounds and are inset at a lower point in the wall. A gable-roofed portico shelters the door. While the supports for this portico are new, the roof and tongue in groove platform are original. The second story has five two-over-two sash windows. The three western bay windows have narrow surrounds, while the two eastern bays have wide surrounds. The house has cornerboards and a boxed cornice.

The two bay west elevation has two-over-two sash windows on the first and second floors with narrow surrounds. A centrally placed interior chimney rises above this west gable.

NORTHWEST ELEVATION

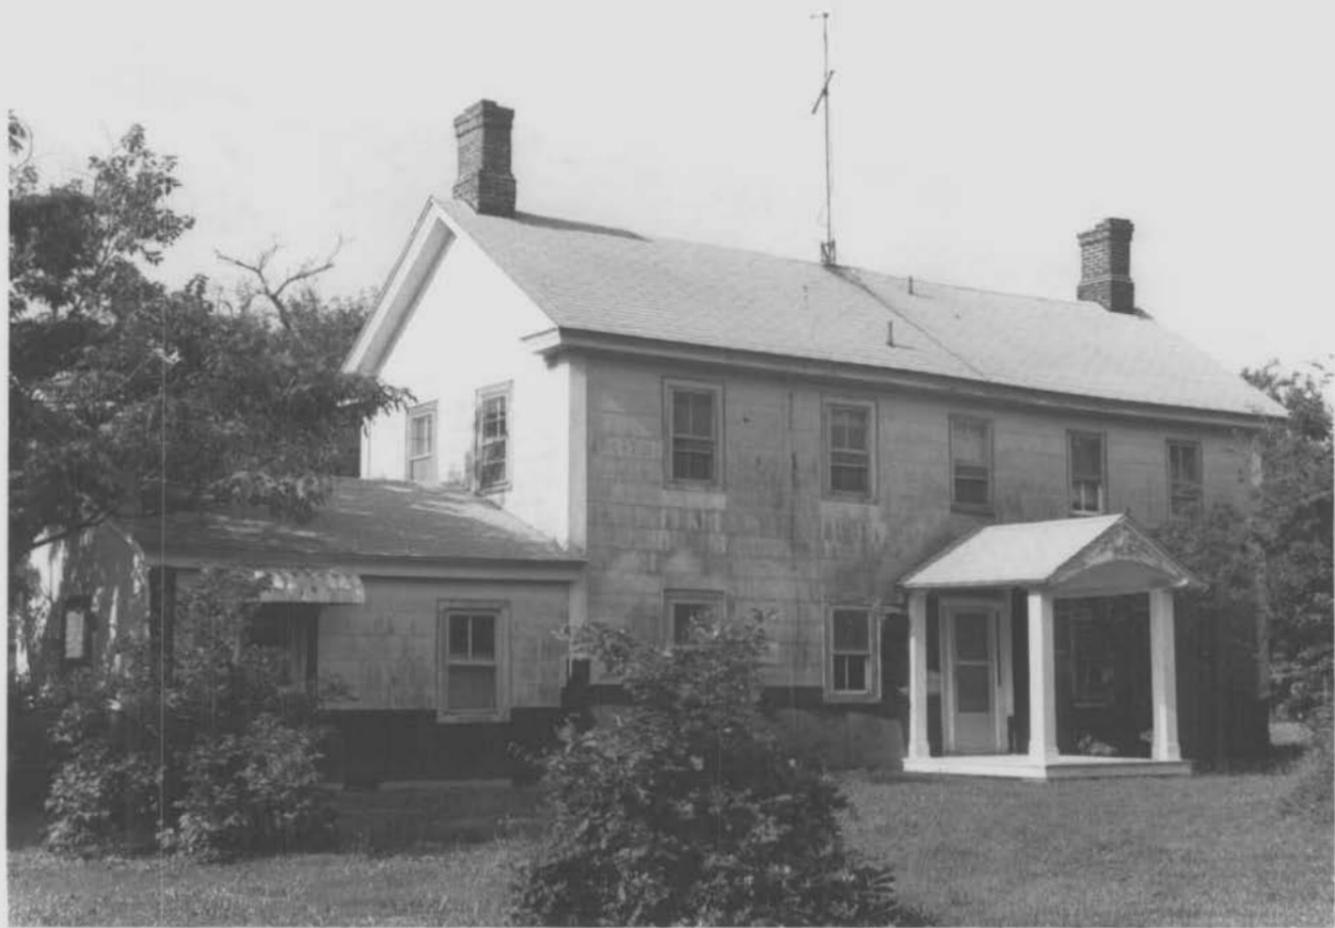
T-827

The east elevation has a one-story, gable roof addition across the first floor. There are a pair of two-over-two sash windows with wide surrounds on the second floor. An interior brick chimney sits at the east gable end which has shallow cornice returns.

NORTHEAST ELEVATION.
