Maryland Historical Trust State Historic Sites Inventory Form

historic St. John's Methodist Episcopal Church, South

and/or common The Southern Church

Survey No. T-829

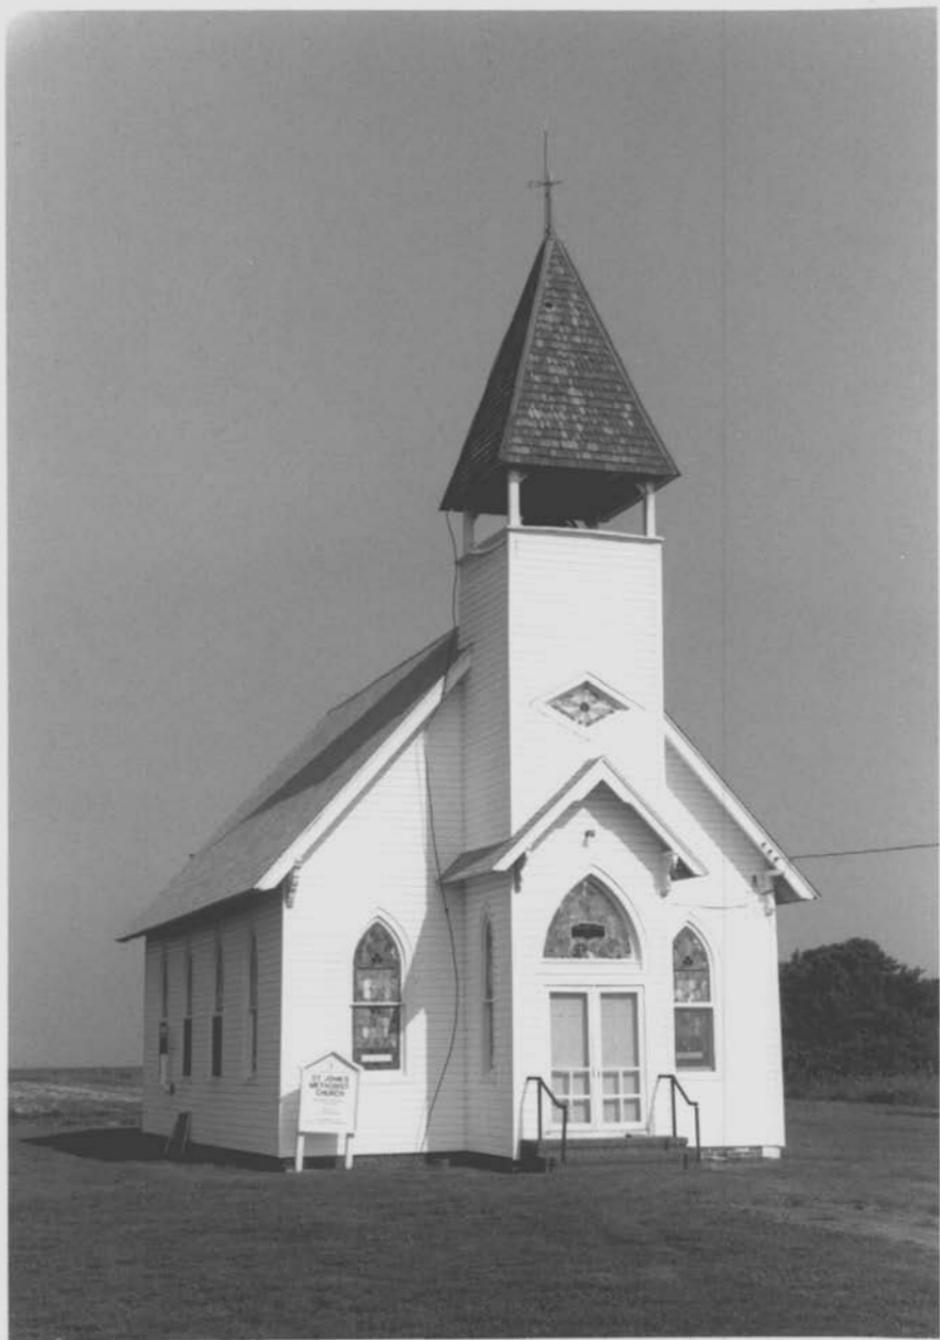
SOUTHEAST ELEVATION:

The three-bay east (main) facade has a projecting bell tower as its central bay, flanked by double hung, pointed-arch, colored glass windows. Smaller versions of these windows light the projecting bay vestibule. The double door entrance through the bell tower has a pointed-arch, colored glass inset above it which reads "St. John's M.E. Church Presented by J.V. Harrington and Family."

A gable roof divides the bell tower in half and forms a sort of shallow portico above the entrance. A diamond pane, colored glass window is inset above this portico. The pyramidal roof of the bell tower is covered in alternating square-cut, fishscale, and sawtooth, green shake shingles. The bell tower roof is supported by plain posts with spindle work brackets, and the open eave has exposed rafter feet.

The four-bay north and south elevations are marked by four double-hung, pointed-arch, colored glass windows. The eaves of the roof are slightly extended with the tips of the rafter feet exposed.
