Maryland Historical Trust State Historic Sites Inventory Form

and/or common Bayshore Cottage

Survey No. T-843

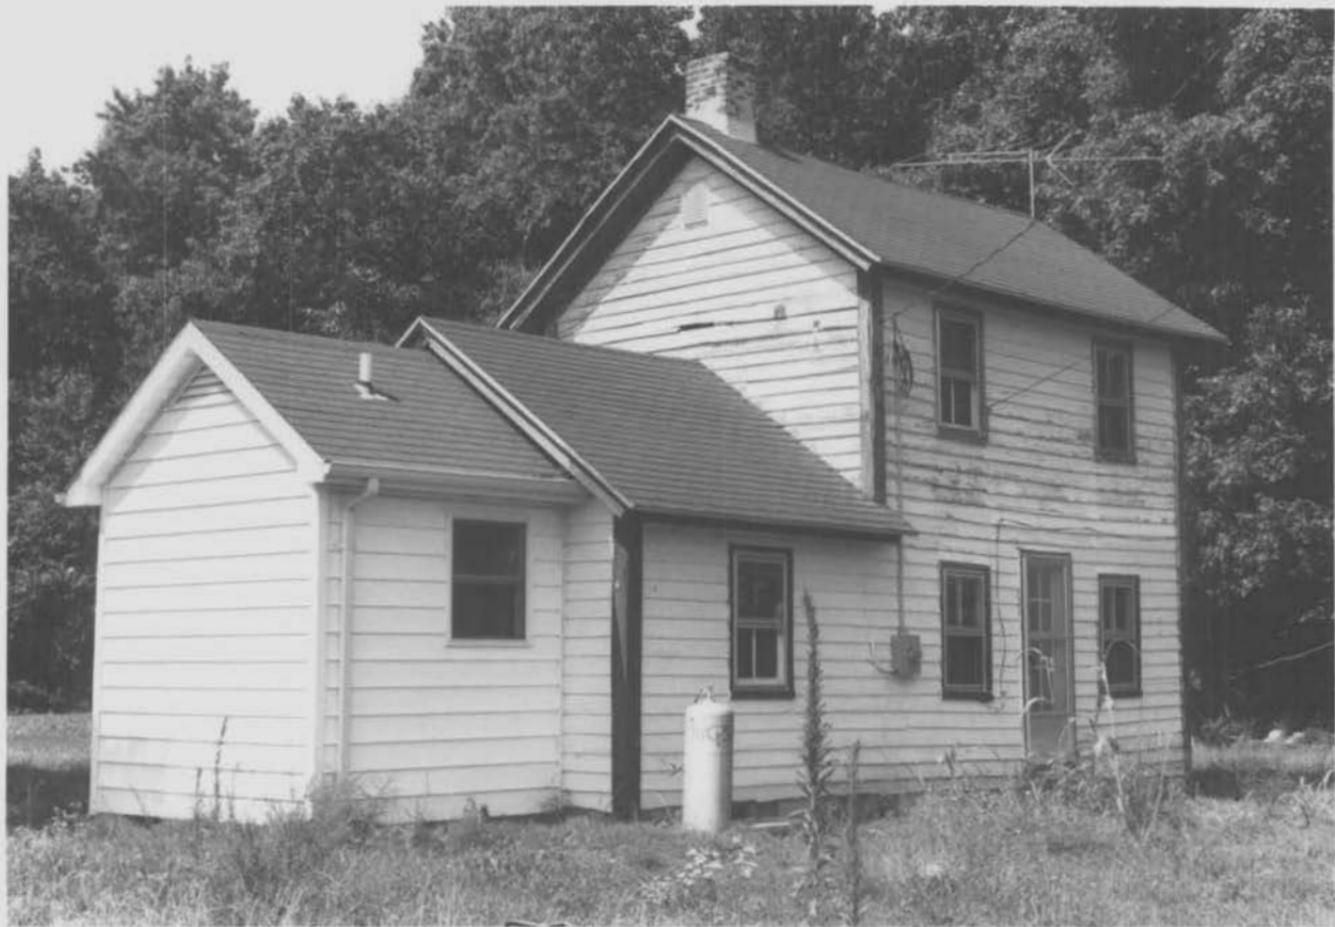
NORTHEAST ELEVATION

The north (main) facade has three bays with a central door flanked by two-over-two sash windows. There are two two-over-two sash windows on the second floor. A one-story, gable roofed addition is attached to the east end of this structure and has one two-over-two sash window on the north side. A second and more recent addition clad in aluminum siding and covered with a gable roof is connected to this first addition.

The east elevation is blind with an interior chimney stack piercing the gable roof of the main structure.
