Maryland Historical Trust State Historic Sites Inventory Form

and/or common Jackson House

Survey No. T-856

The Jackson House is located on the southeast corner of Rt. 33 and Mission Road in the village of Tilghman on Tilghman Island, Talbot County, MD. The house faces west, with the principal gable oriented on a north/south axis.

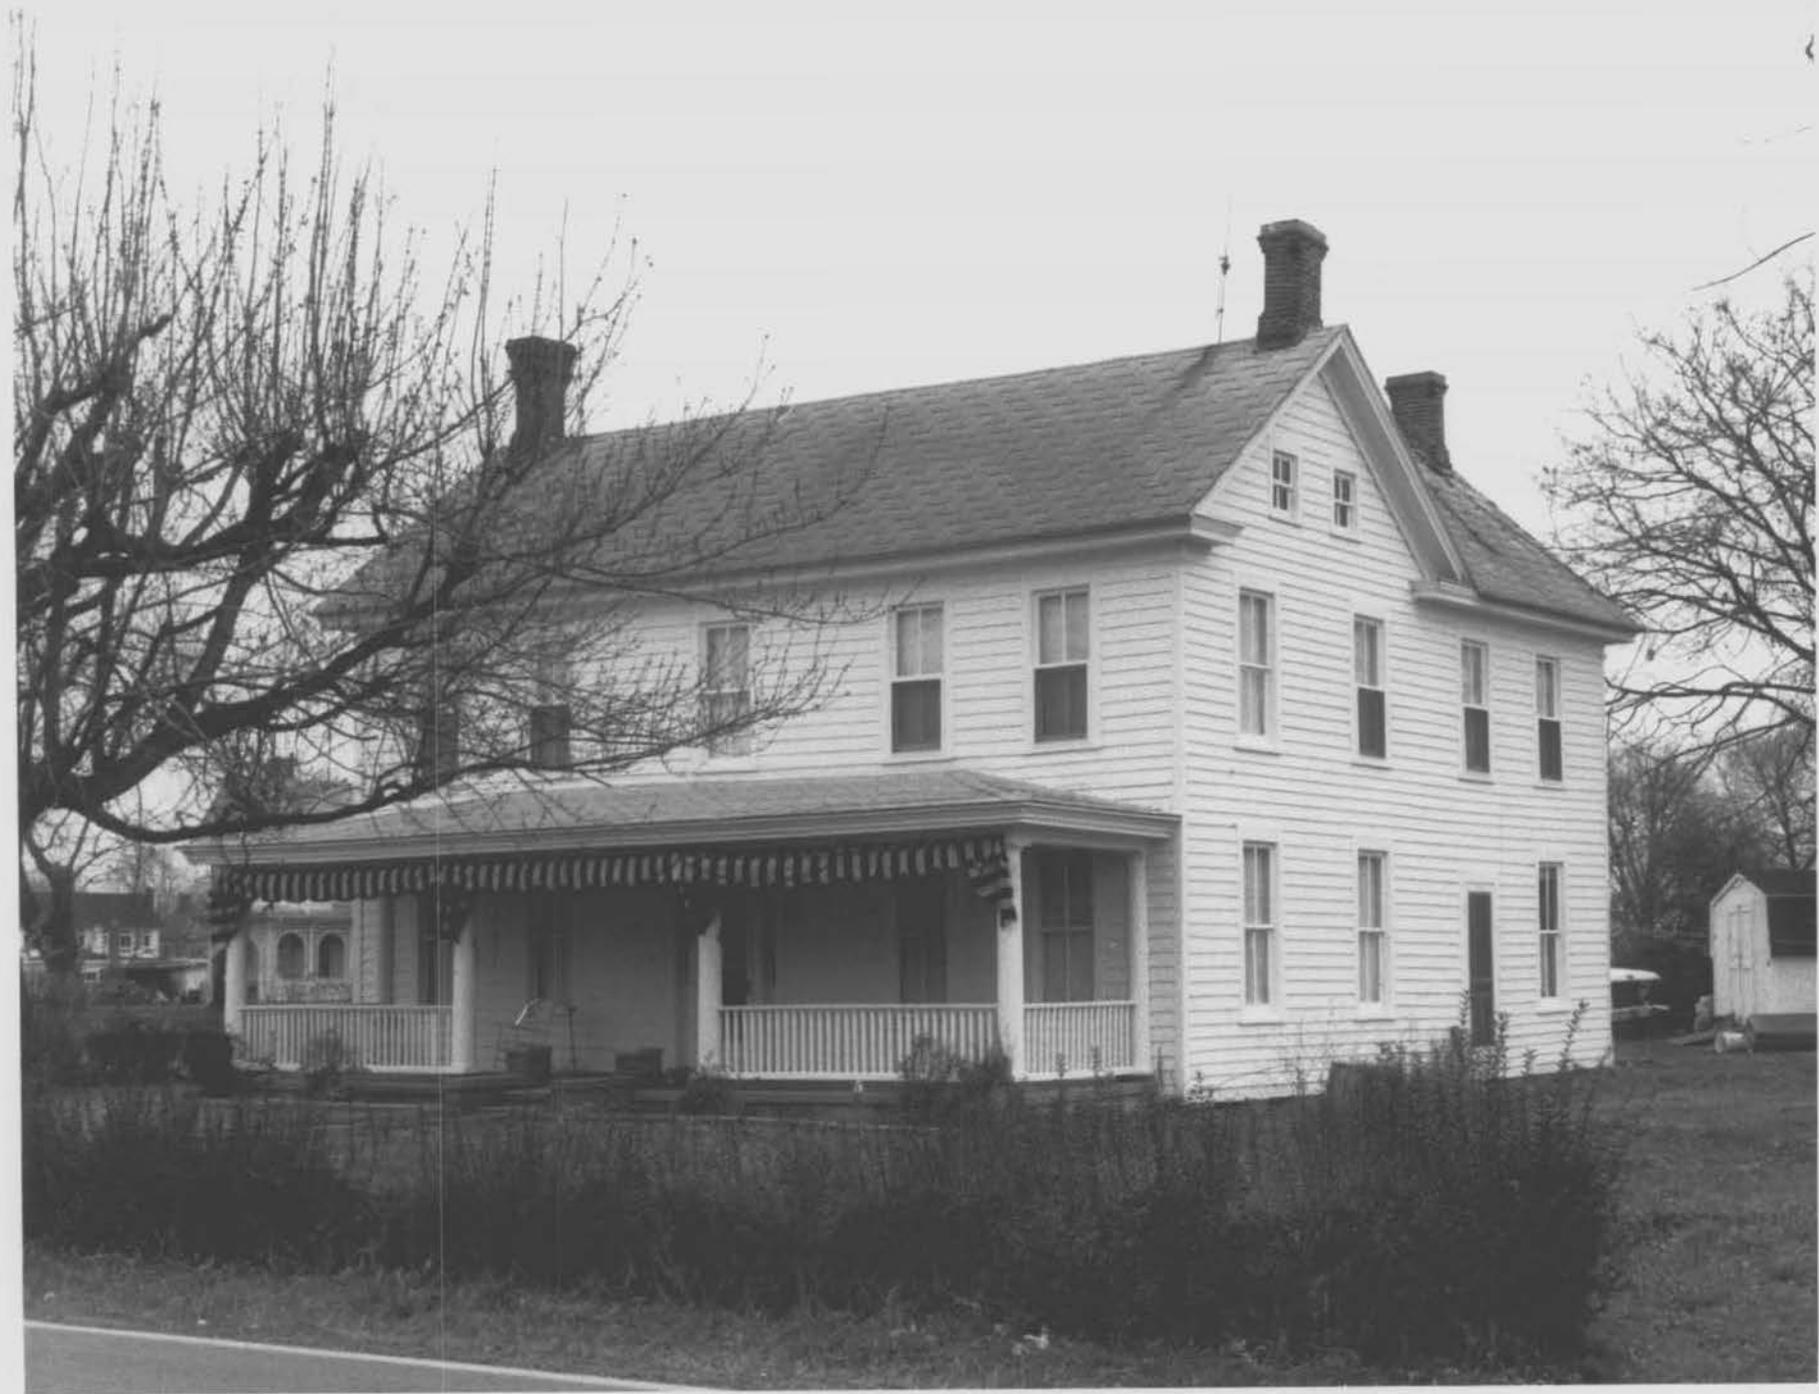
SW ELEVATION

The west (main) elevation has five bays with a central door flanked by two two-over-two sash windows with wide surrounds. The door has a three light transom and sidelights. There is a full-width porch across the first floor supported by doric columns with a square post balustrade. The porch cornice has a sawtooth moulding and black and white striped awnings. The second floor is lit by five two-over-two sash windows with wide surrounds.

The south elevation is a two bay gable end with shallow cornice returns and pilaster cornerboards. There are two two-over-two sash windows on the first and second floors of this elevation and two square windows in the attic story. There is an interior, brick chimney at the south gable end. A two bay, two-story wing extends to the rear with a door and one two-over-two sash window on the first floor and two two-over-two sash windows on the second floor.
