110-112 North Potomac Street  
Hagerstown  
Washington County, Maryland

circa 1890

WA-HAG-37  
22045346-11

INVENTORY FORM FOR STATE HISTORIC SITES SURVEY

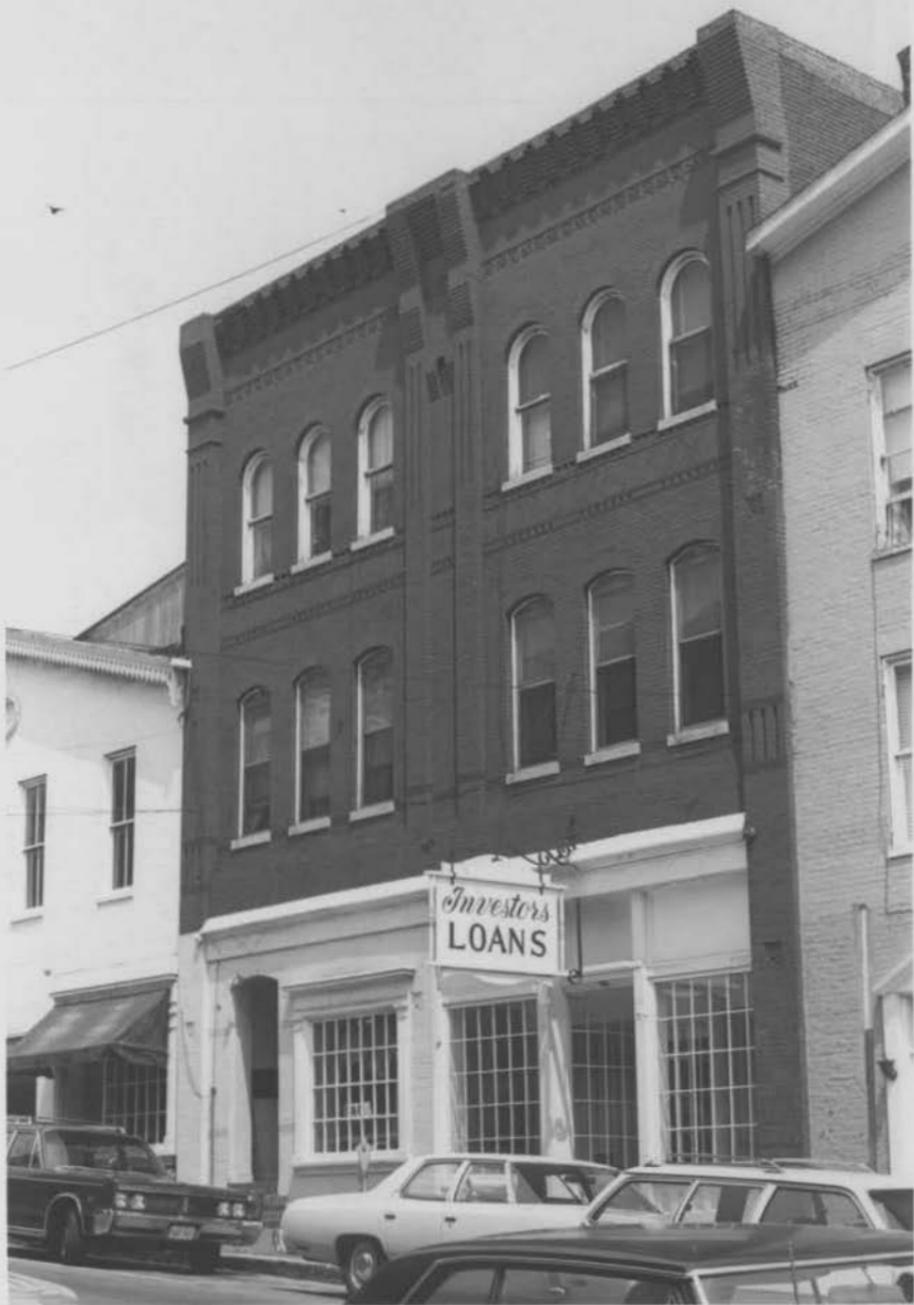
west elevation

The principal or street elevation (west side) is fairly original in condition and is primarily significant for its decorative brickwork. Rectangular in shape, the facade is divided into two sections by a pair of flat pilasters running the height of the upper two stories. It is also flanked by single end flat pilasters extending from the ground level to a corbeled brick cornice at the top.

The first or street level of the facade has two shop fronts which are adaptations of earlier fronts. The southern front has a recessed central door and large display windows which were recently given the multi-light look with the addition of false mullions. The basic framework appears to be original because of the decorative detailing (fluting and circular designs in 1890s fashion) on it.

The north front has a segmental entranceway leading to two recessed doorways into the interior. To the south of the entranceway is a multi-light display window with a large trabeated surround. This window is of recent vintage. The original arrangement of this section, as shown in a photograph published in 1896 (Baltimore American Illustrated), was the opposite of the present arrangement, a doorway to the south and a segmental arch window in the present entranceway. The present segment arch doorway, however, appears to extend higher than the original window. The surface of the bricks in this section are painted a cream color.

The second and third stories of the facade elevation have six windows each divided into groups of three corresponding to the sections formed by the pilasters. All of these windows are of the double-hung, wooden sash type with narrow frames and one-over-one lights but differ with segmental arch tops on the second story and round arch tops on the third level. The top sashes correspond to the shape of the arches. The sills may be molded masonry.

The entire facade is highly decorated with brickwork. The bricks are red and laid in Stretcher bond with decorative reeded banding delineating the story levels. The pilasters have small patches of fluting. A wide band of

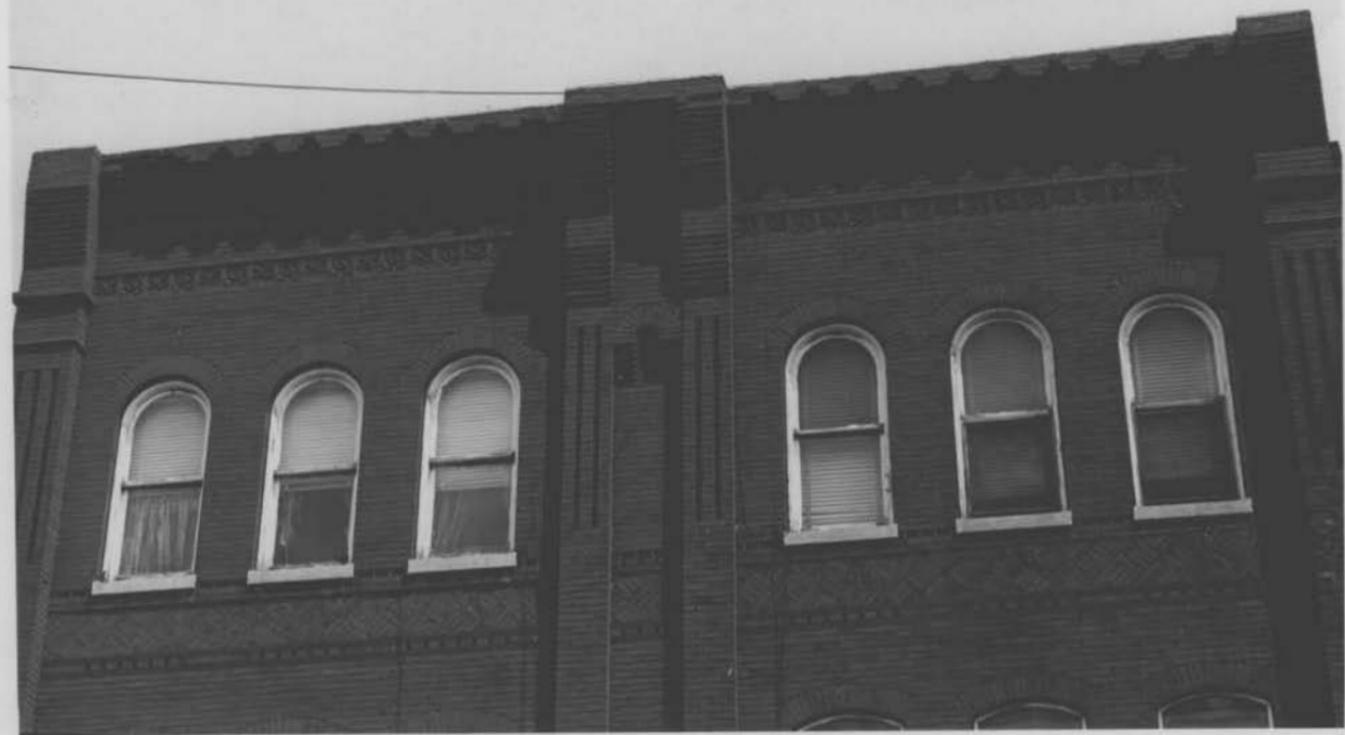
west elevation - detail

brickwork laid in diamond pattern and bordered on the top with bricks set at a diagonal stretches the width of the facade below the third story windows. The division between the centered double pilasters is terminated at the top, being about the top of the third story windows, by a round arch below the corbeling of the cornice. The facade appears to have once been painted red, the same color as the bricks.

The most interesting of the brickwork are the square decorative bricks positioned along the end pilasters and forming two rows of banding below the cornice. The bricks on the pilasters are located two in the upper third of the first story and two about the height of the top of the second story windows. The bricks are decorated with round flower designs. Another of these bricks is located near the center of the street level and is visually connected to those in the end pilasters by reeding stretching across the north store front.

The two square brick bands below the cornice consist of alternating round flower designs of the type on the pilasters and a Greek cross design. The top band is immediately below the cornice and the other band, more easily visible, is located about two feet below, about where the cornice corbeling begins.
