32-48 West Washington Street

Hagerstown

HISTORIC SITE
SURVEY INVENTORY

1. Name of property: ROUTZAHN BUILDING

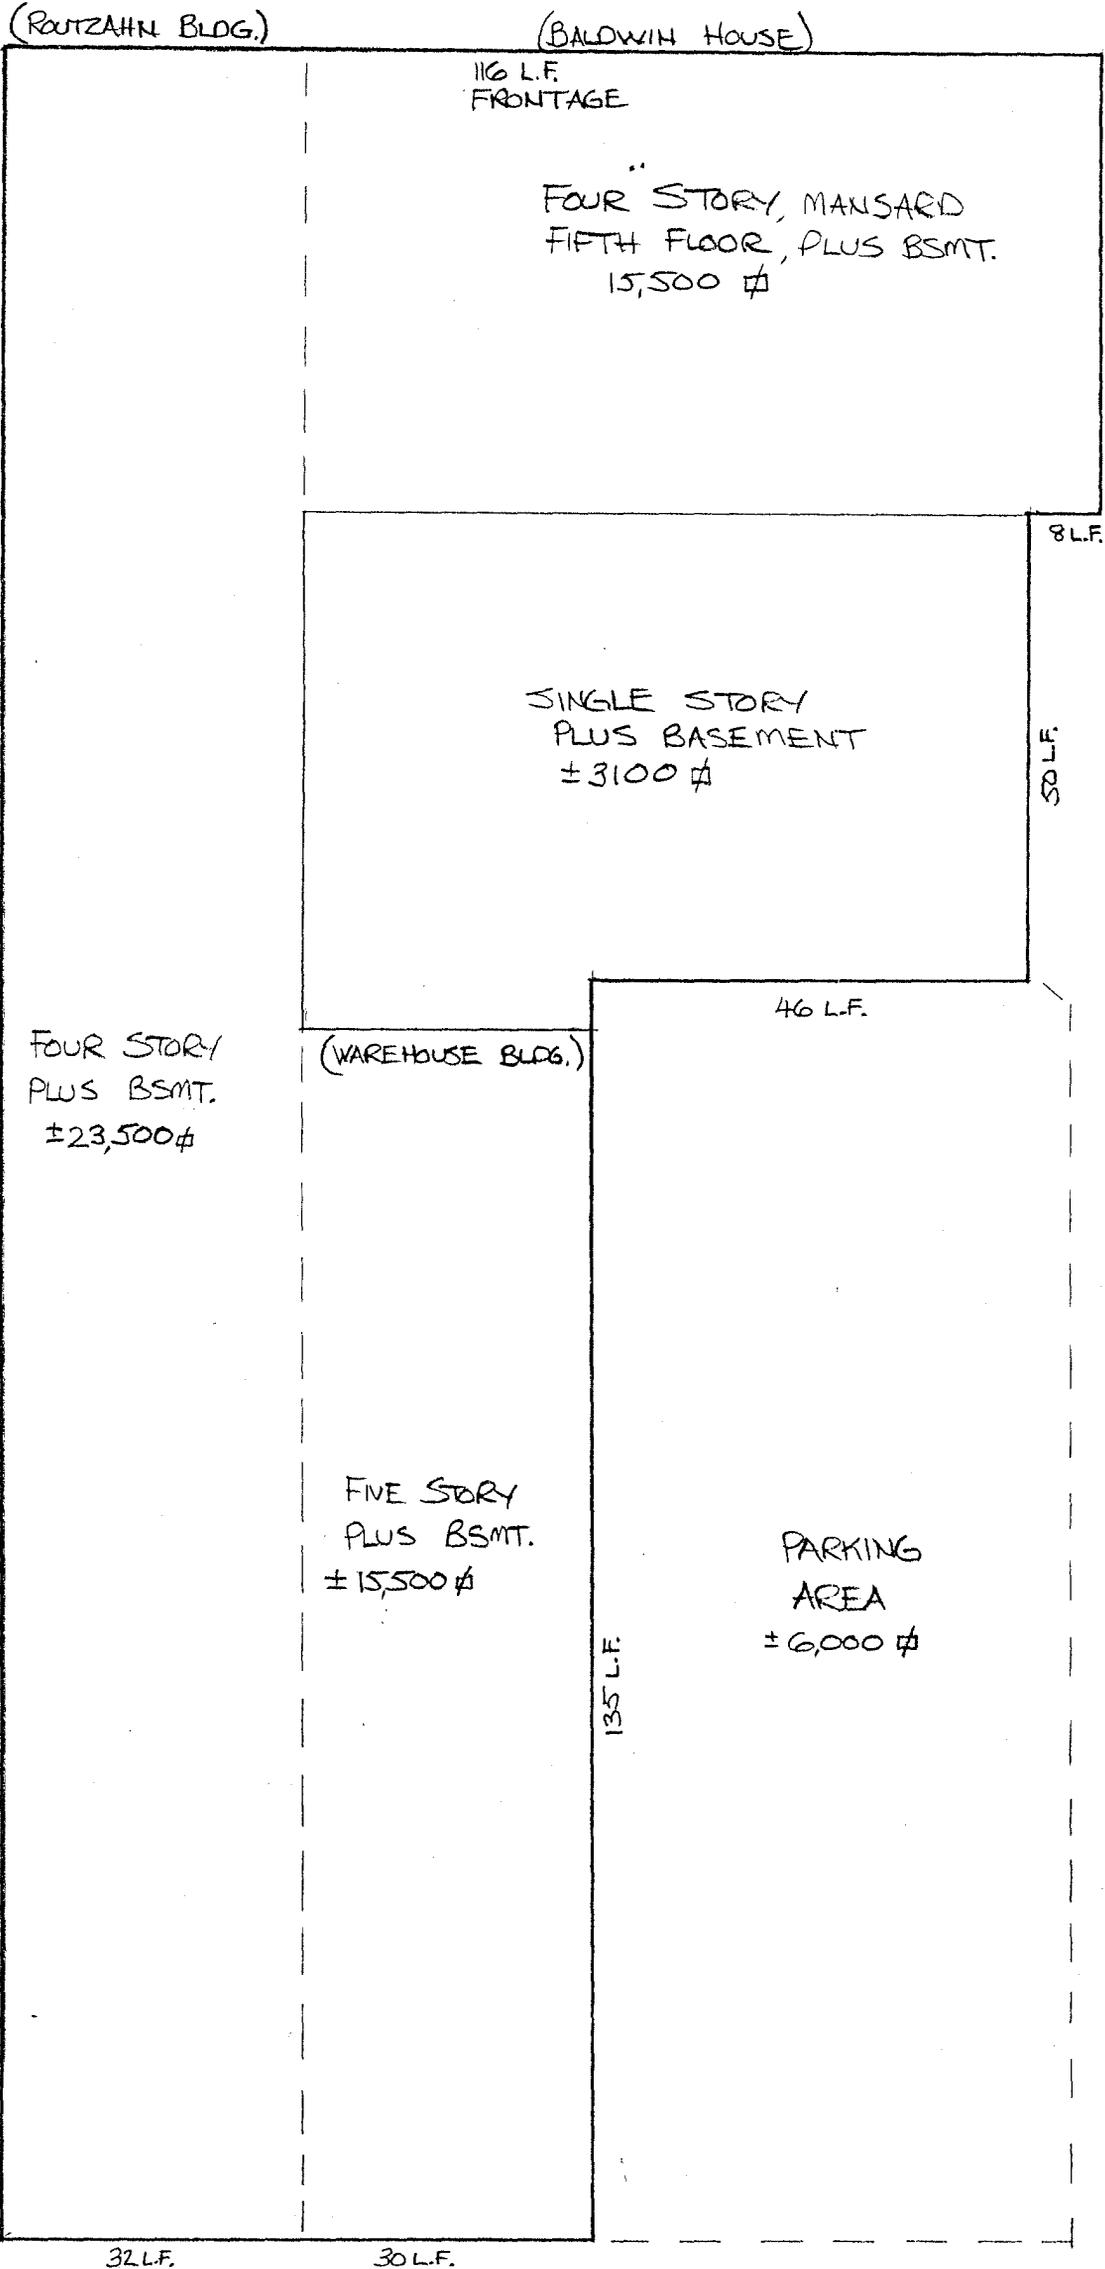
← W. WASHINGTON ST. →

SCALE 1" = 20'

ASSUMES 80% OF EXT. DIMENSION AS SHOWN ABOVE

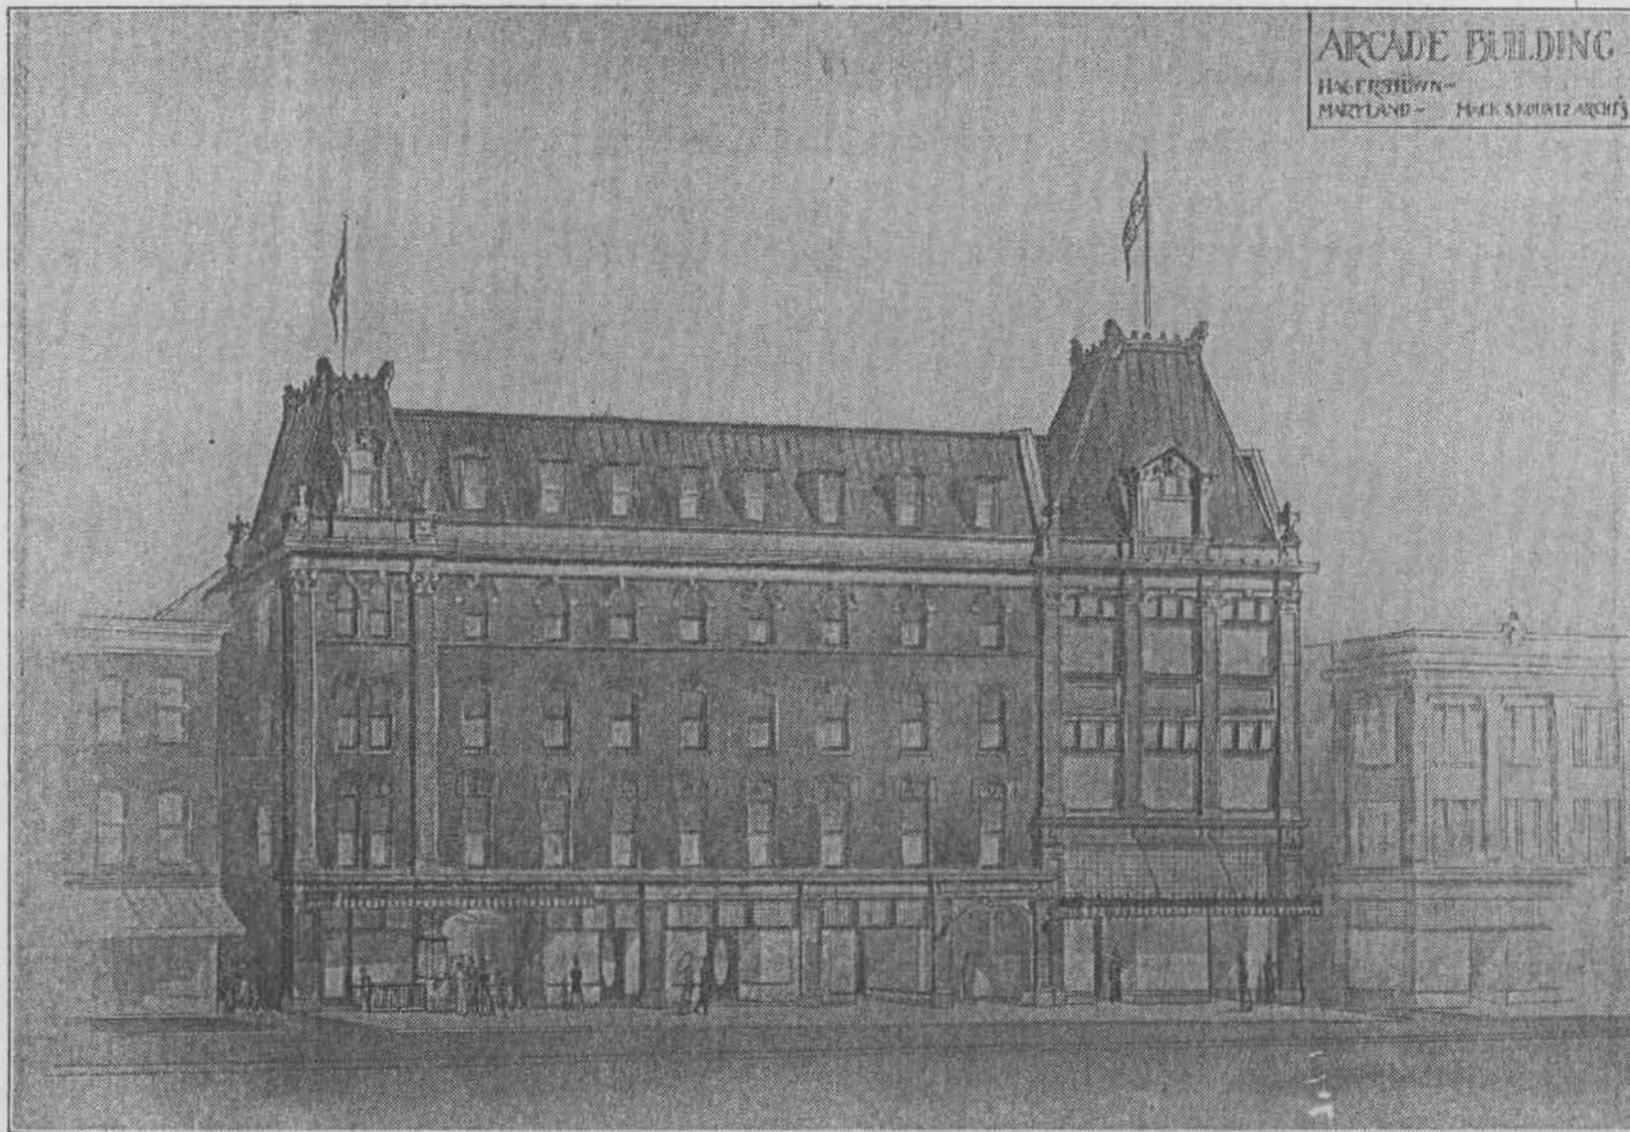
ARCADE BUILDING
HAGERSTOWN -
MARYLAND - HICK AND OWENS ARCHTS

THE ARCADE BUILDING, SHOWING THE NEW ACADEMY ENTRANCE ON THE LEFT

The building has been known by various names since it was renovated in 1915. Among these names are Arcade Building, as shown on the 1915 architect's perspective for the renovations, and Academy Theater Building. The western section is identified in recent deeds as the Industrial Building.

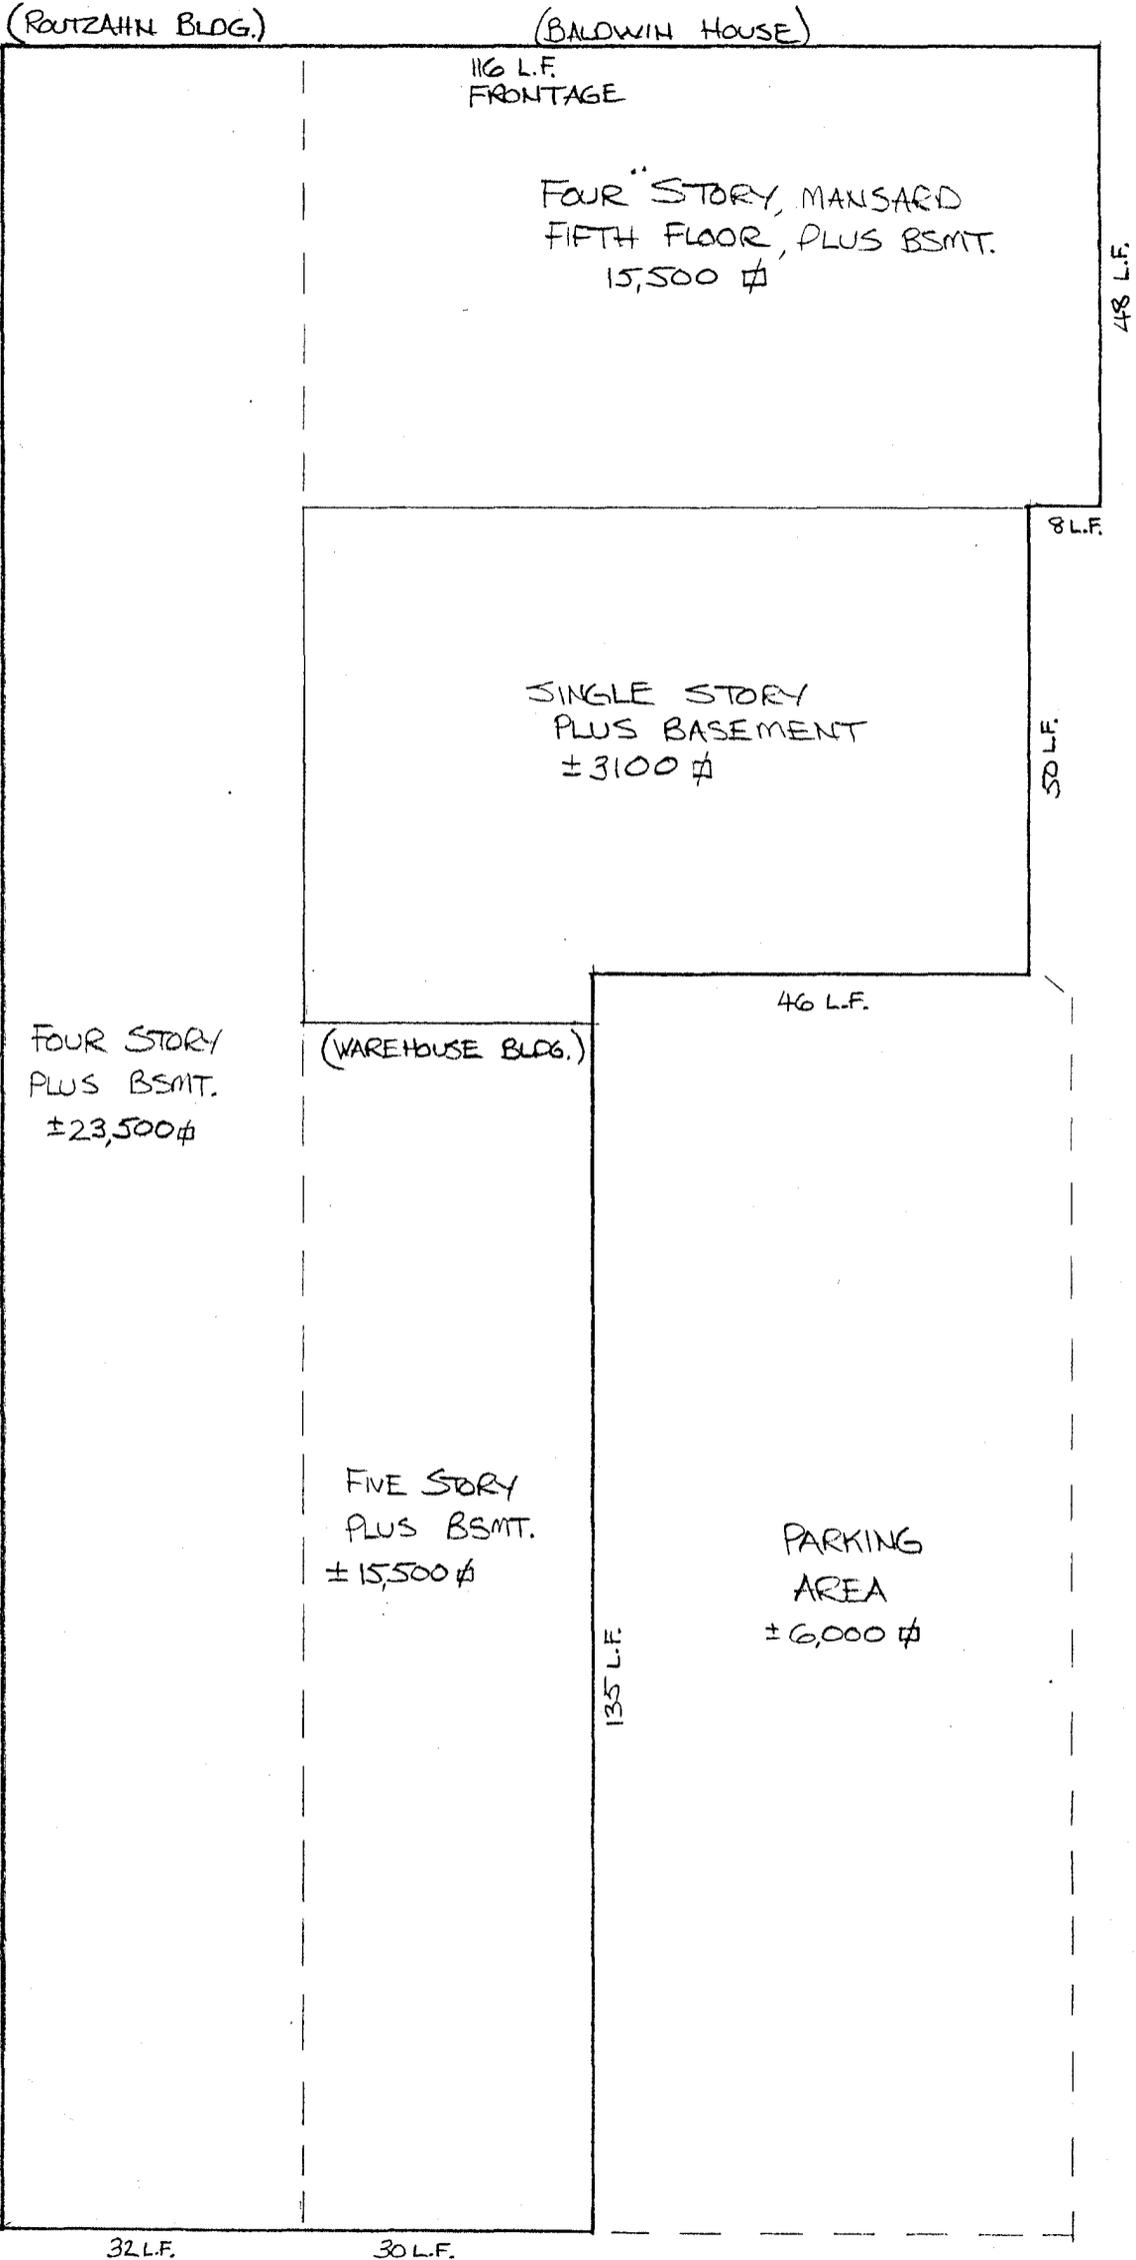
← W. WASHINGTON ST.

SCALE 1" = 20'

ASSUMES 80% OF EXT. DIMENSION AS SHOWN ABOVE

TOTAL SQ. FTG. EXCLUDING ALL BASEMENT AREAS = 57,600 + 6,000 SQ. FT. OPEN AREA
