INDIVIDUAL PROPERTY/DISTRICT
MARYLAND HISTORICAL TRUST
INTERNAL NR-ELIGIBILITY REVIEW FORM

Property/District Name: Shafer Farm Survey Number: WA-I-264

Project: Downsville Pike at I-70 Agency: FHWA/SHA

ABSTRACT
WA-I-264
Shafer Farm
Hagerstown Vicinity
private

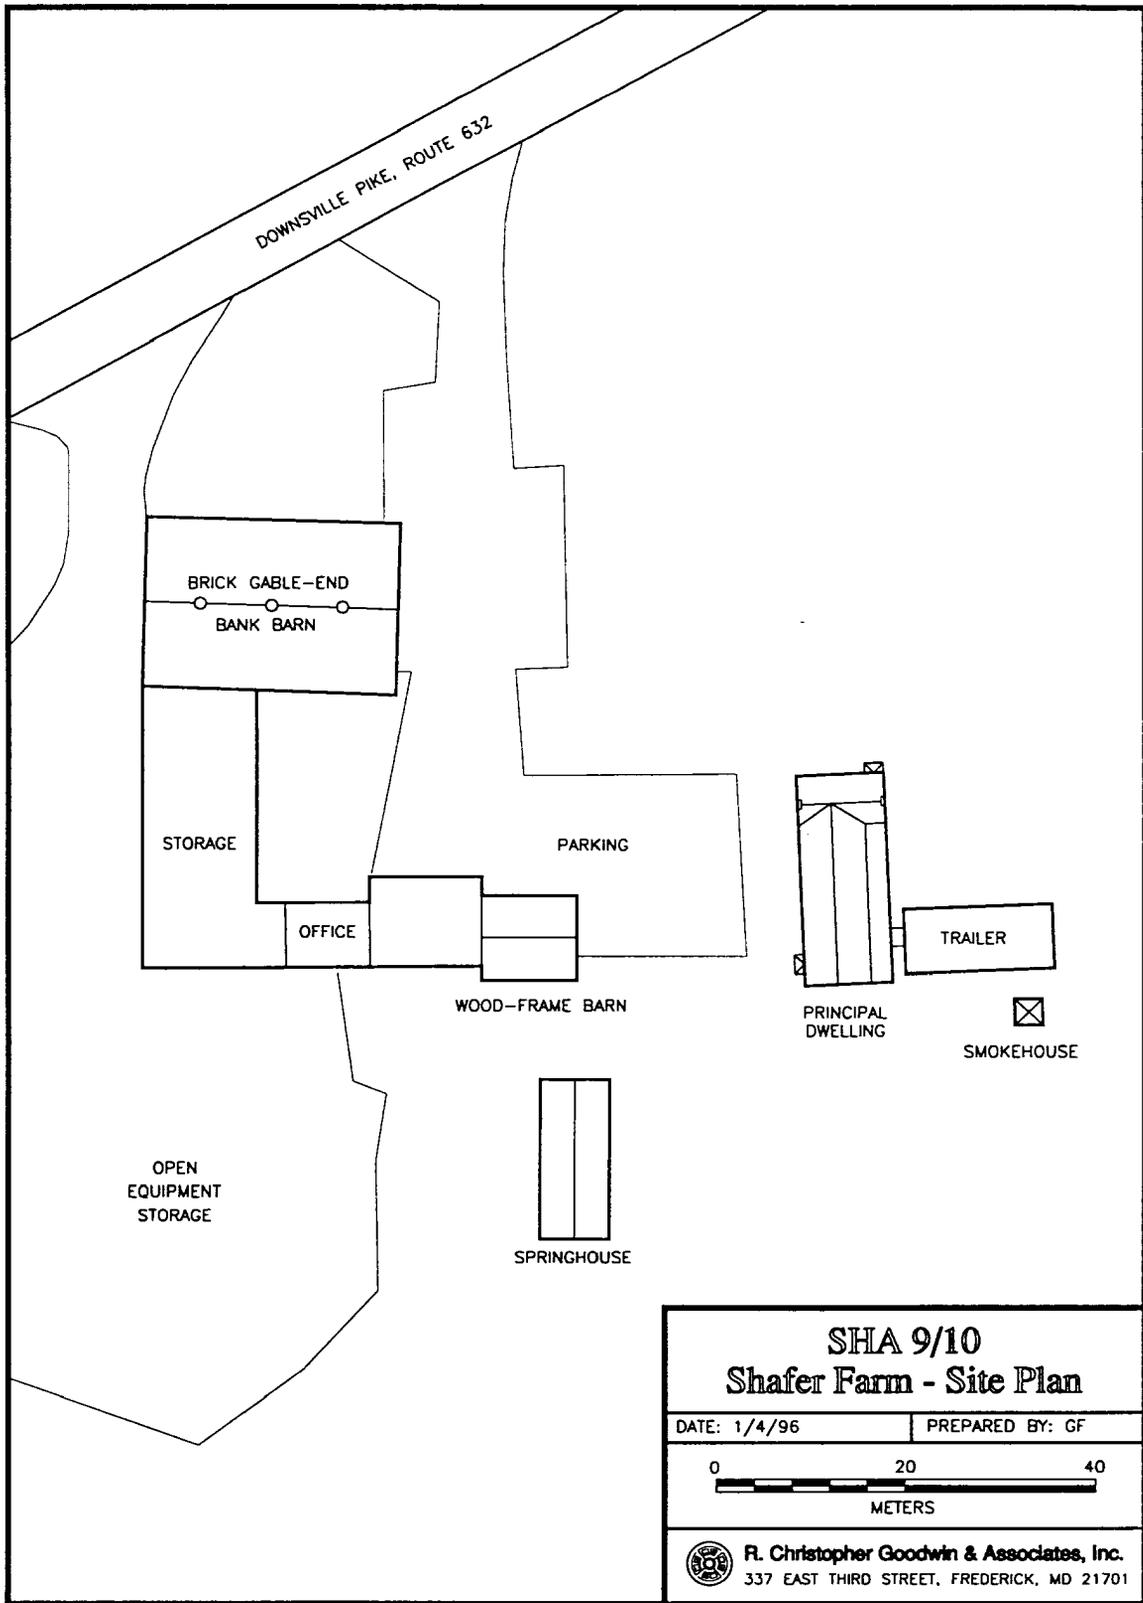
WA-I-264

The farm complex is comprised of five buildings: a brick dwelling, a brick-end bank barn, a stone springhouse, a wood frame barn, and a wood frame smokehouse. The former farm complex occupies a site on the east side of Downsville Pike (Route 632). The complex buildings are oriented towards the west overlooking agricultural fields that historically were part of the Shafer Farm. The brick dwelling and bank barn dominate a low rise that slopes toward the tributaries of Marsh Run; outbuildings are sited east of the barn and south of the dwelling. A paved driveway provides access to the complex from the Downsville Pike. A parking area and storage yard is located between the main dwelling and bank barn.

Sketch Plan of Shafer Farm.

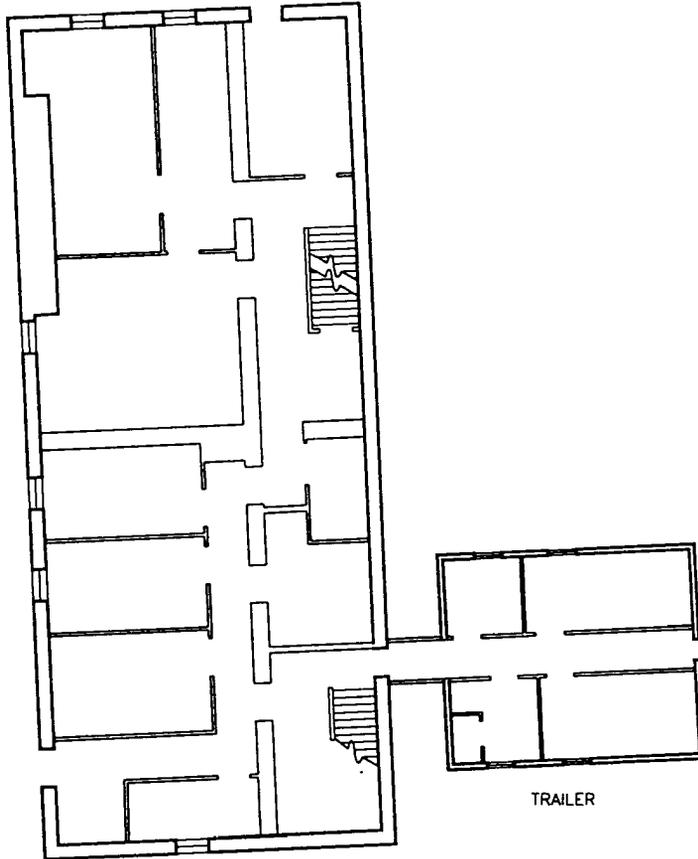
The principal block of the house is three bays wide and two bays deep. An ell extends east from the principal block. The ell is three bays wide and one room deep.

First Floor Plan of Principal Dwelling

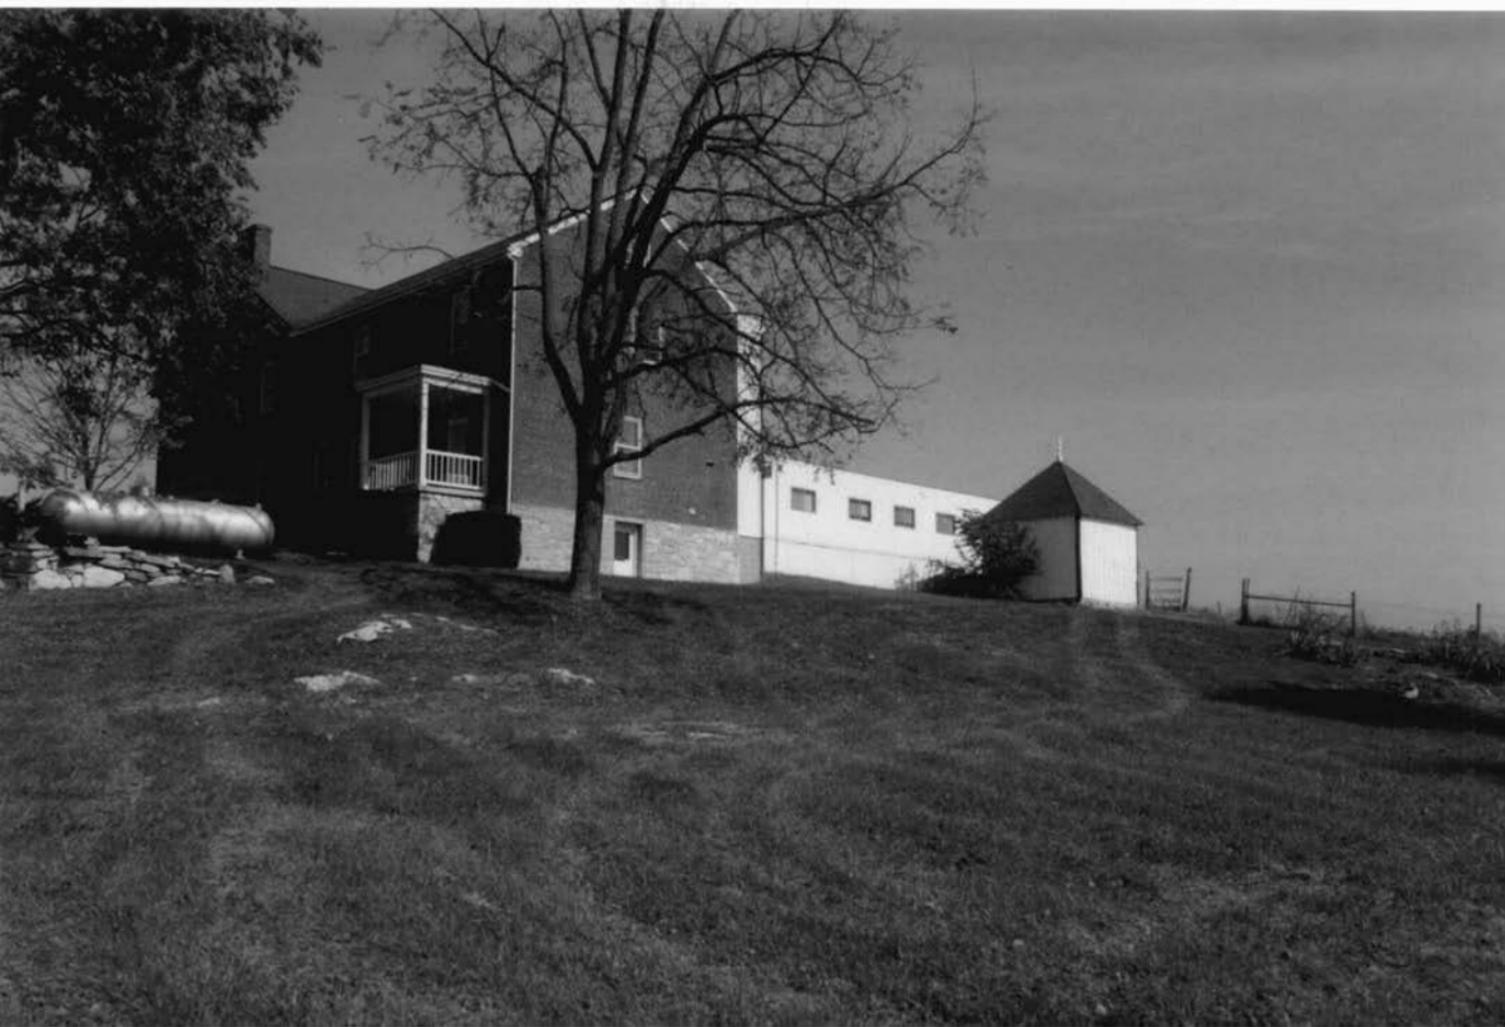
3 of 9

View Northwest, Southwest Rear Ell, Principal Dwelling, including Smokehouse

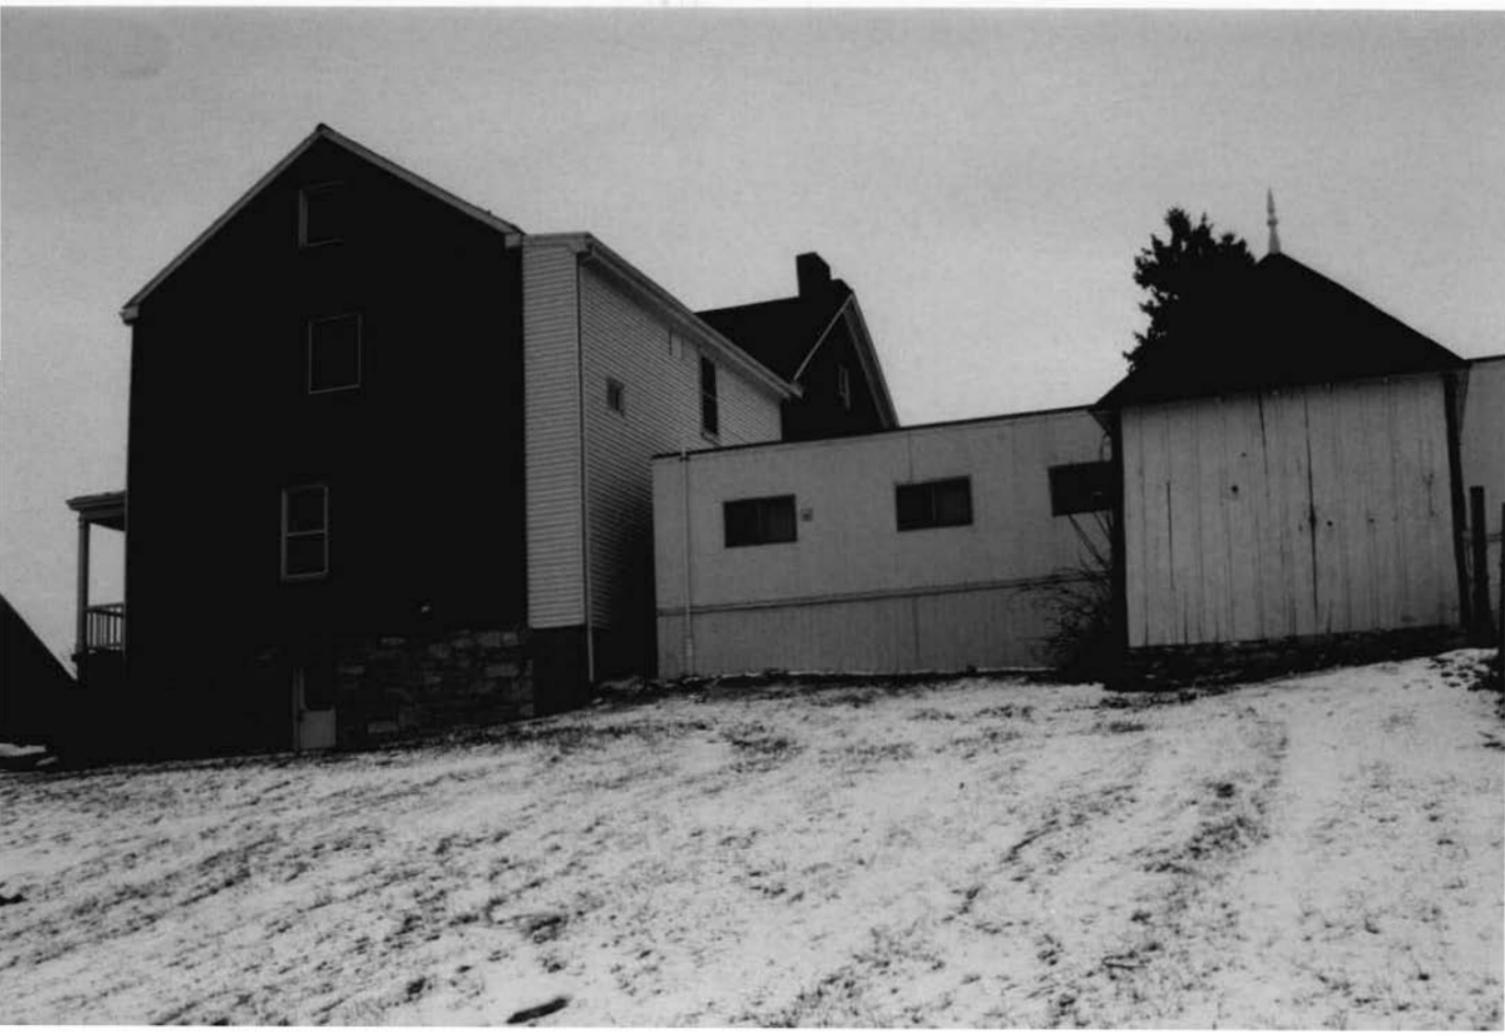
4 of 9

A narrow, two-story, shed-roof addition extends from the north elevation of the ell. The addition is supported by a concrete block foundation and is sheathed in aluminum siding. Two, one-story, office trailers are connected to the addition.

View Southwest, Rear Ell, Principal Dwelling, including trailer

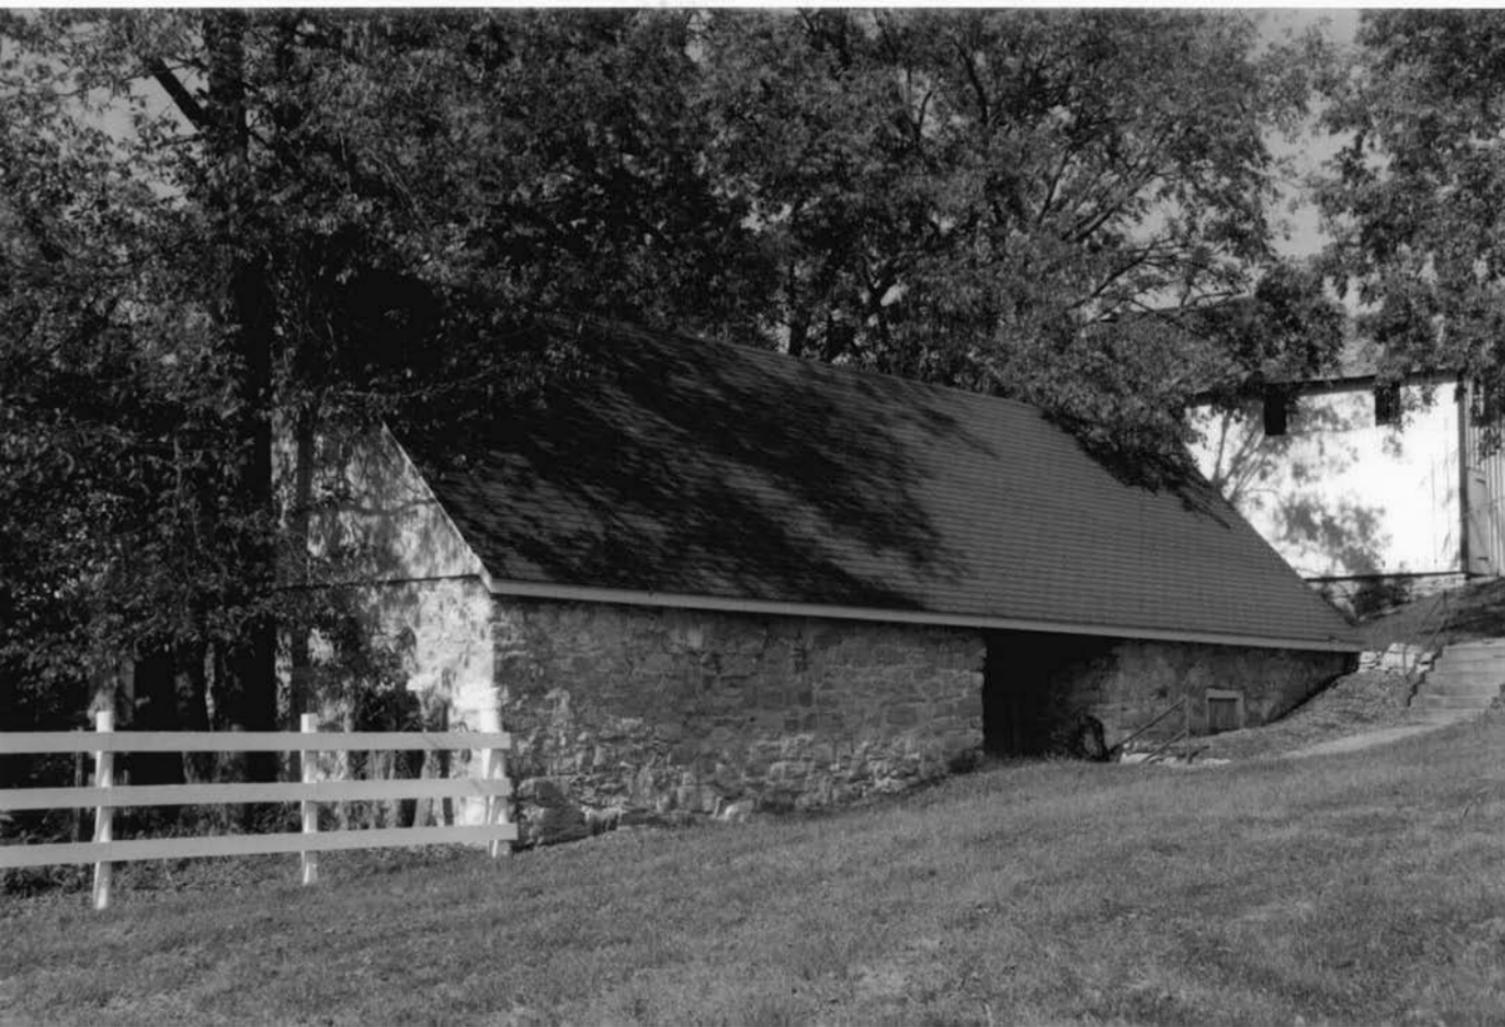
5 of 9

Springhouse (ca. 1800). A stone springhouse is located approximately thirty feet southeast of the principal dwelling. The springhouse is constructed of rough-cut, random course stone; larger stones supporting the building corners. The exterior walls are painted white. The spring house is a rectangular, one-and-one-half story structure consisting of two rooms connected by a central breezeway. This dog trot ground plan is an unusual configuration for a springhouse (Dickey:1976). The opening created by the central breezeway is supported by two large wooden beams. The building is banked into the slope of the hill creating a partially exposed ground floor. Each room of the building is accessed by doors located in the breezeway. The doors to each room are located off center; both retain their original pegged framing. The building terminates in a replacement steep side-gable roof clad with asphalt shingles. An earlier roof was slate. Simple wood boards mark the eave the gable ends. The south elevation features a two window openings that are centered in each room. The east elevation includes a stone chimney with a brick stack. The east, gable-end elevation features vertical board siding. The west elevation is bermed into the hillside providing grade-level access to the attic level through a wooden vertical board door.

New Southwest, North Principal Elevation Springhouse

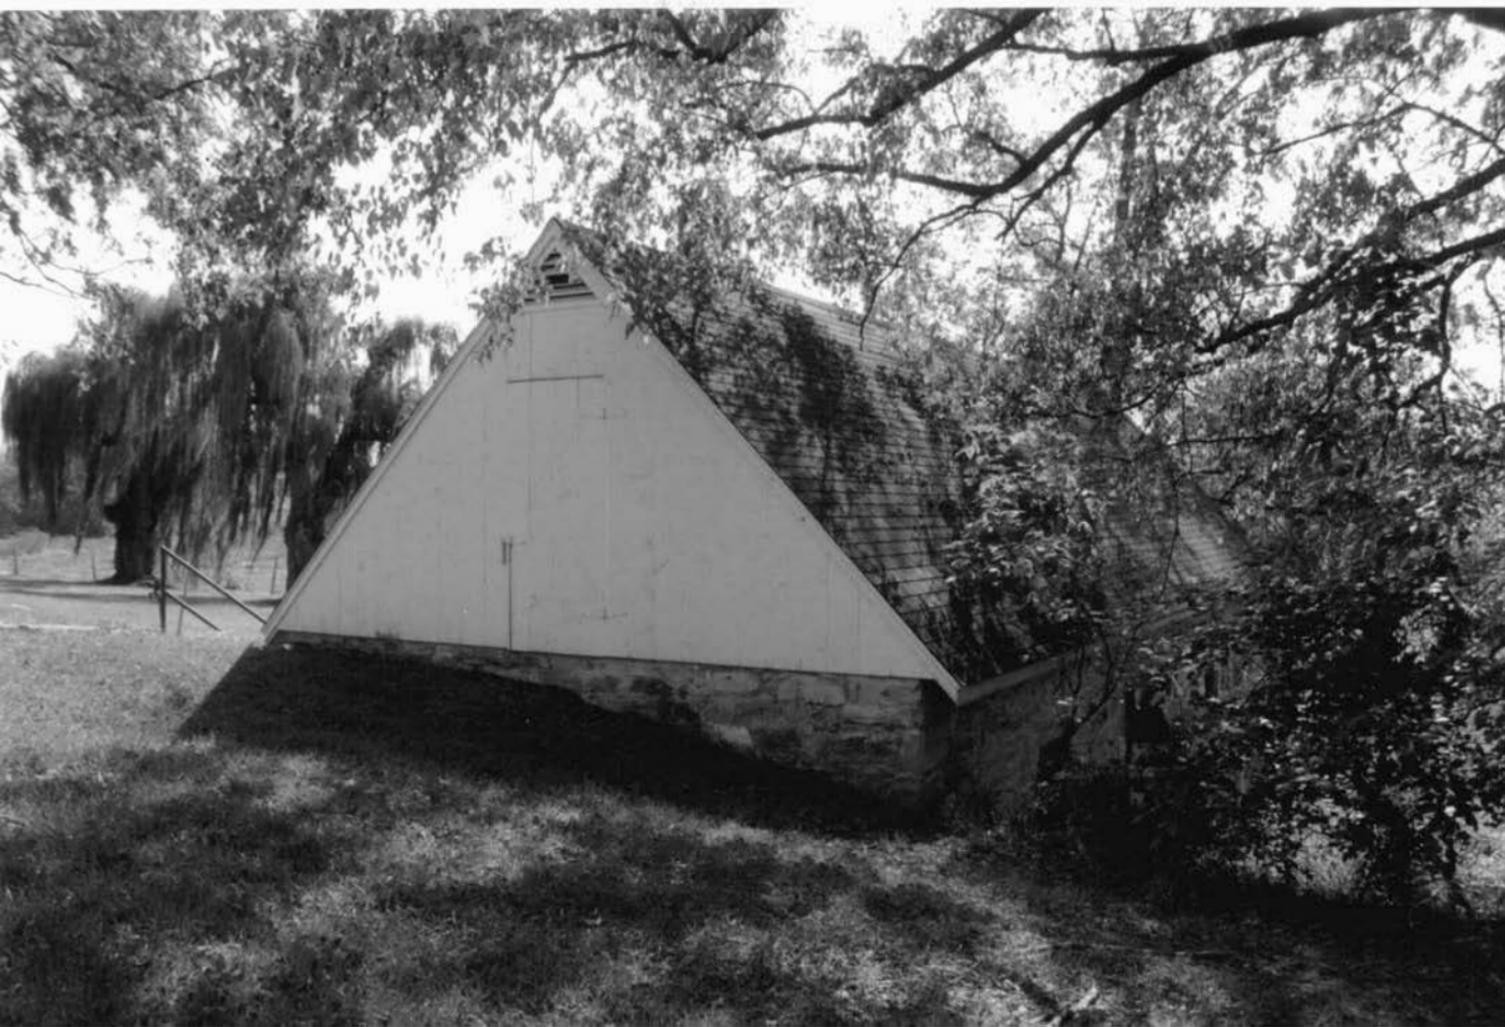
6 of 9

The interior of the building is utilitarian and lacks interior finishes. The west room of the ground floor features a poured concrete floor and mechanical water pumping system. The southern end of the room includes a stone spring-fed cooling trough. The east room of the ground floor contains a fireplace on the east wall. A rough opening was added to the east wall as an animal door.

View Northeast, West Elevation, Springhouse

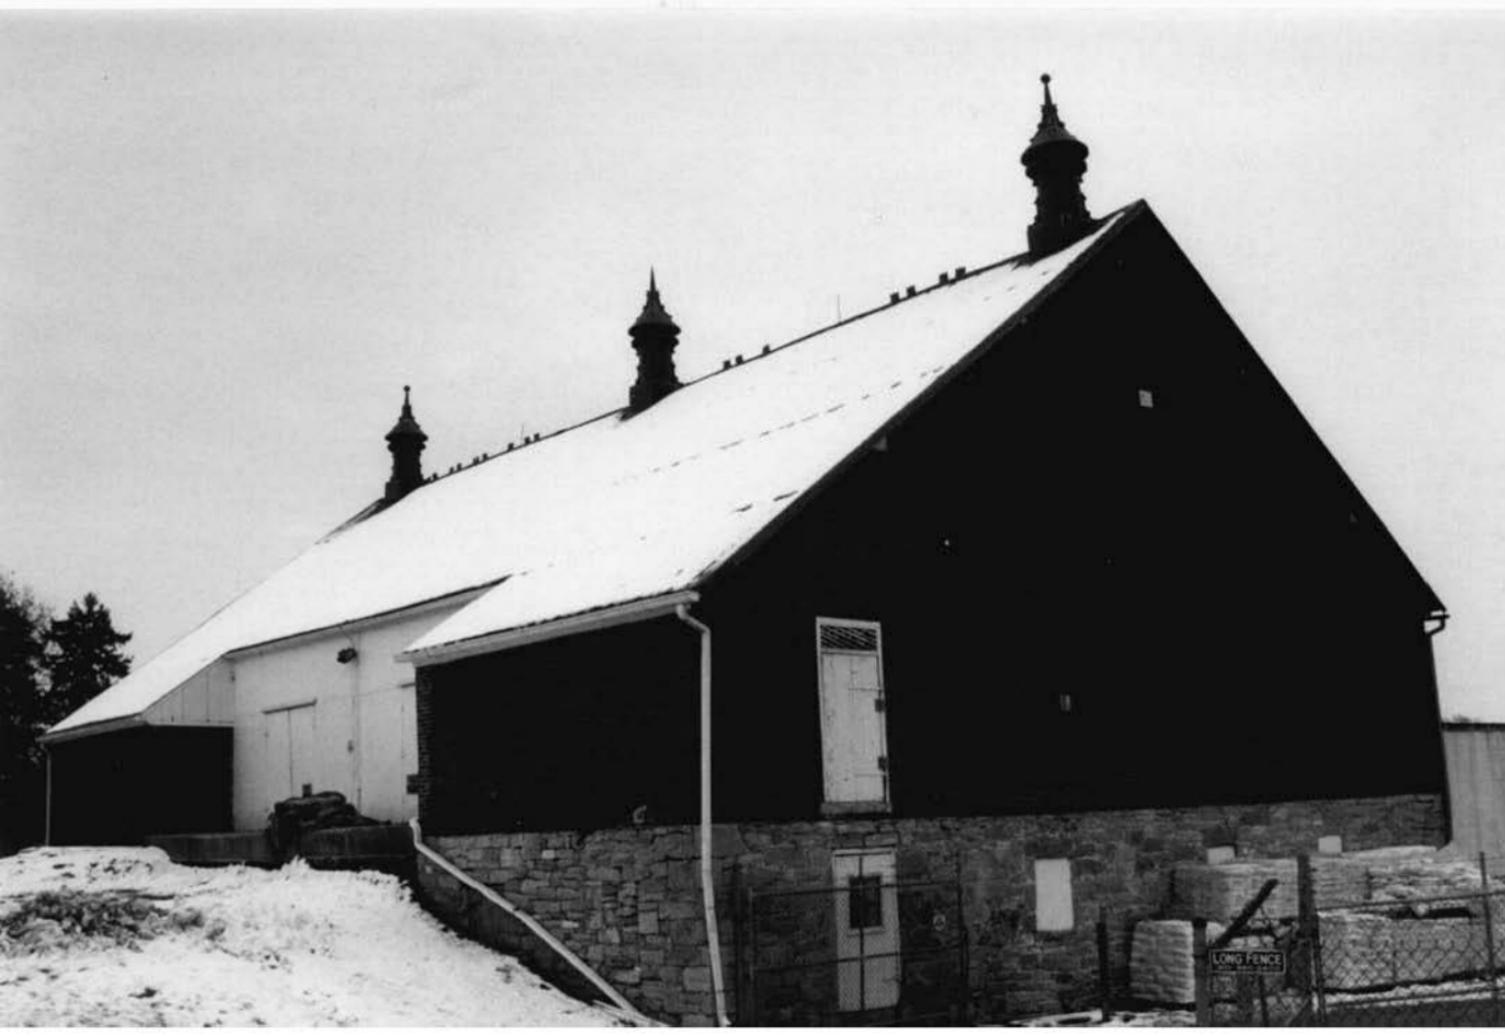
7 of 9

The primary (west) elevation is defined by projecting brick bays that flank the banked earth entrance ramp. The two bay entrance is sheathed in plywood and houses two sets of hinged double doors. The hinged double doors are plywood units supported by wood frames. A concrete loading dock occupies the central recess created by the projecting brick bays.

The building's decorative gable-end brickwork consists of a series of four rows of repeating motifs: diamond, sheaf, hour glass, and diamond. The upper gable includes an elaborate design of triangles that create a stylized lily.

View Northeast, West Elevation, Brick Gable-End Bank Barn

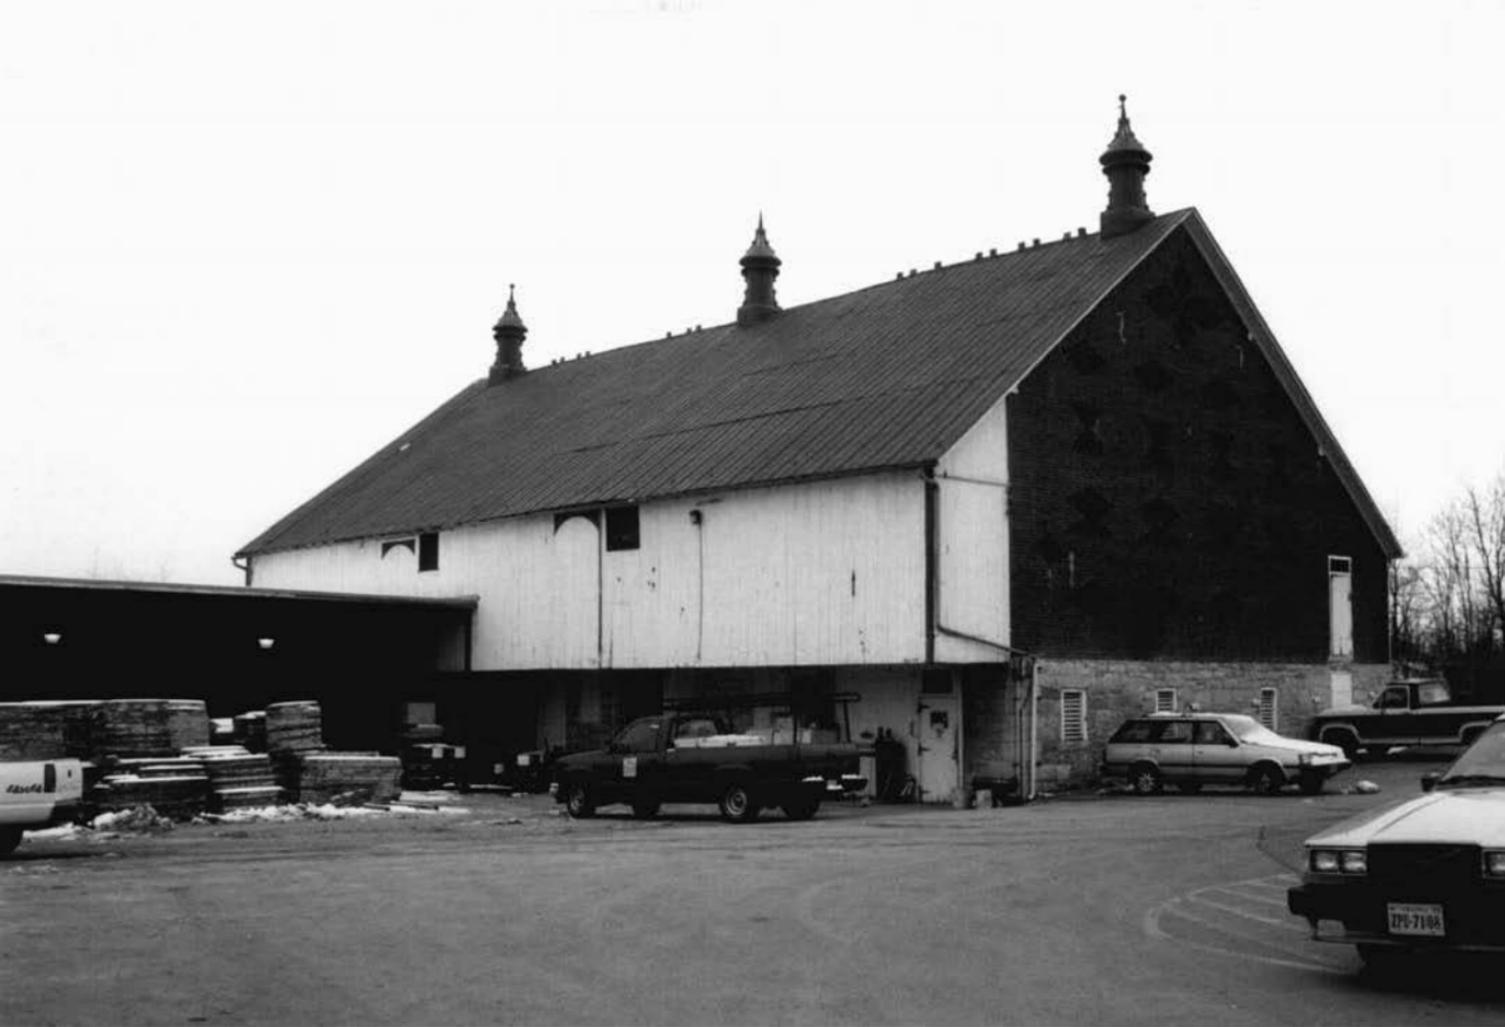
8 of 9

The rear (east) elevation features a stone ground level that was used originally to house livestock. The majority of the original stall doors and windows have been infilled with concrete block. As is characteristic of bank barns, the rear elevation includes a covered barnyard created by the projecting forebay. The forebay is cantilevered approximately six feet and is framed with large hand-hewn beams. The upper portion of the forebay exhibits a central wooden overhead sliding doors clad with vertical boards. Two, six-light, fixed-sash, wooden windows are located near the eave line of the roof. An open storage yard extends to the rear of the barn.

A one story, concrete block storage shed has been added to the east elevation. The storage shed terminates in a shed roof that is sheathed with a corrugated metal. The shed is enclosed on three sides and is open towards the former barn yard. The concrete storage shed forms is connected to the wood barn that is located northeast of the bank barn.

View Southwest, East Elevation, Brick Gable End Bank Burn
