ABSTRACT
WA-I-270
Martin Farm
Cearfoss Vicinity
private

INVENTORY FORM FOR STATE HISTORIC SITES SURVEY 579

Martin Farm

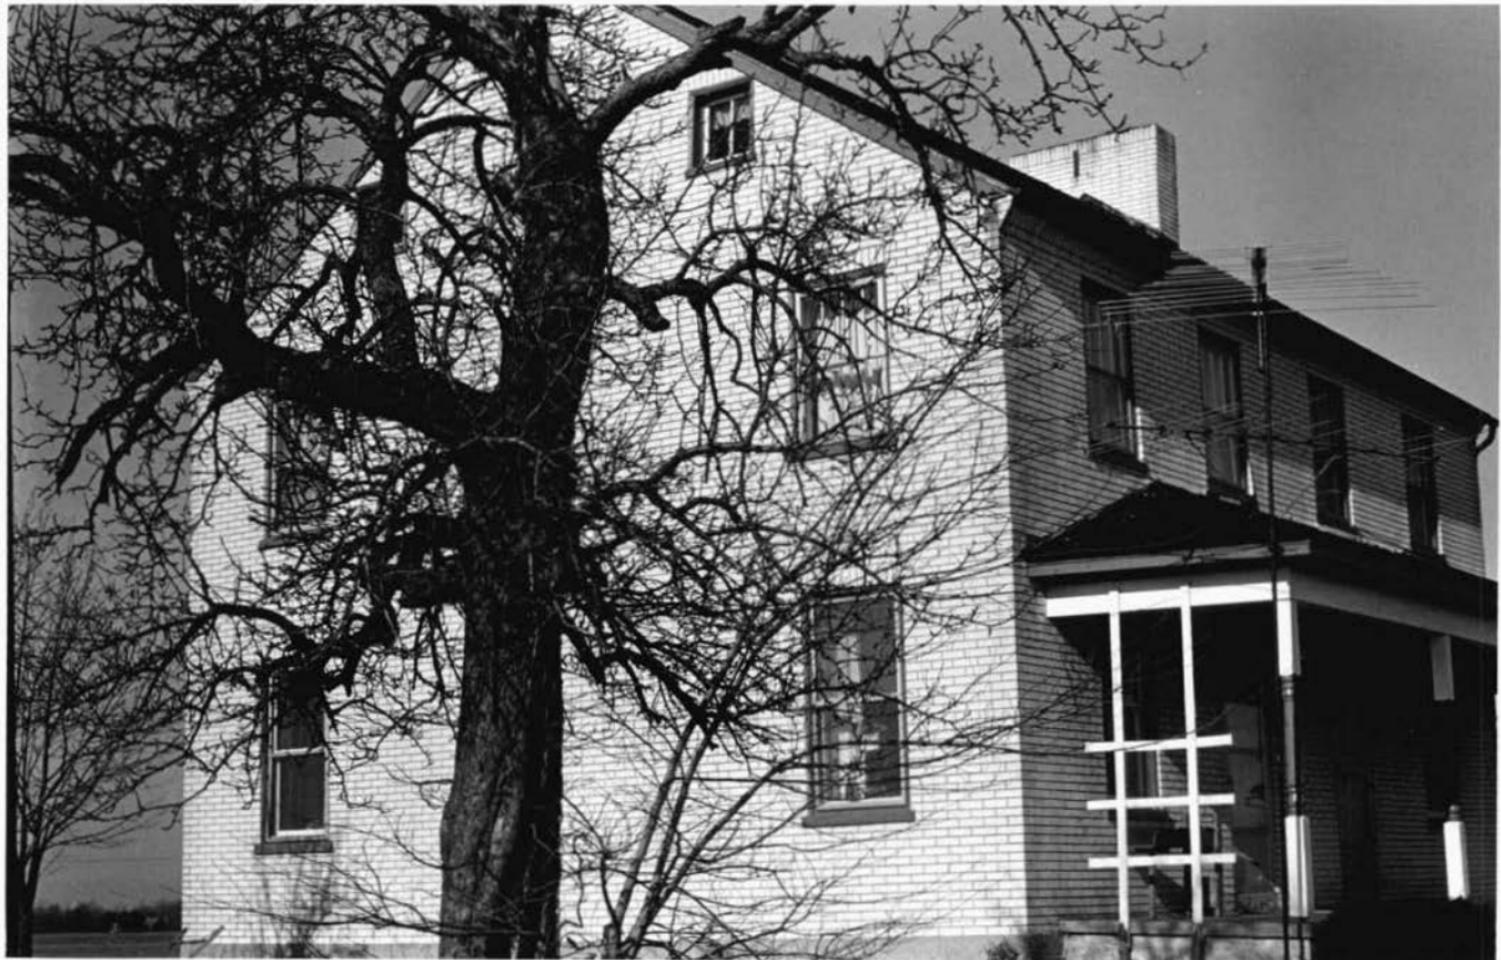
MARTIN FARM

The house is a two story, four bay brick structure sheathed with white imitation brick siding. The foundations have been covered with concrete. Windows and doors appear to have been arranged symmetrically in the front elevation. The window frames which are probably original are narrow and finished with a bead at the inside edge. Single pane double hung sashes are used at the first story while the second story has upper sashes with four vertical panes. The house has two front doors which are centered, side by side in the east wall. Both doors are treated similarly having paneled jambs and transoms. Extending across the front of the house is a one story hip roof porch supported by heavy turned posts.

The roof is sheathed with sheet metal and terminates with barge boards set directly against the end walls. Chimneys are located inside each gable end, the larger being at the north wall.
