**MARYLAND HISTORICAL TRUST
DETERMINATION OF ELIGIBILITY FORM**

Property Name: L. Miller House Inventory Number: WA-I-501
 Address: 11602 Greencastle-Williamsport Pike City: Hagerstown Zip Code: 21740
 County: Washington USGS Topographic Map: Mason Dixon Quadrangle
 Owner: Martin, Dale and Rebecca Is the property being evaluated a district? No
 Tax Parcel Number: 20 Tax Map Number: 48 Tax Account ID Number: 02-002809
 Project: Proposed Baer Property Cell Tower Agency: FCC
 Site visit by MHT Staff: no yes Name: _____ Date: _____
 Is the property located within a historic district? yes no

historic L. Miller House

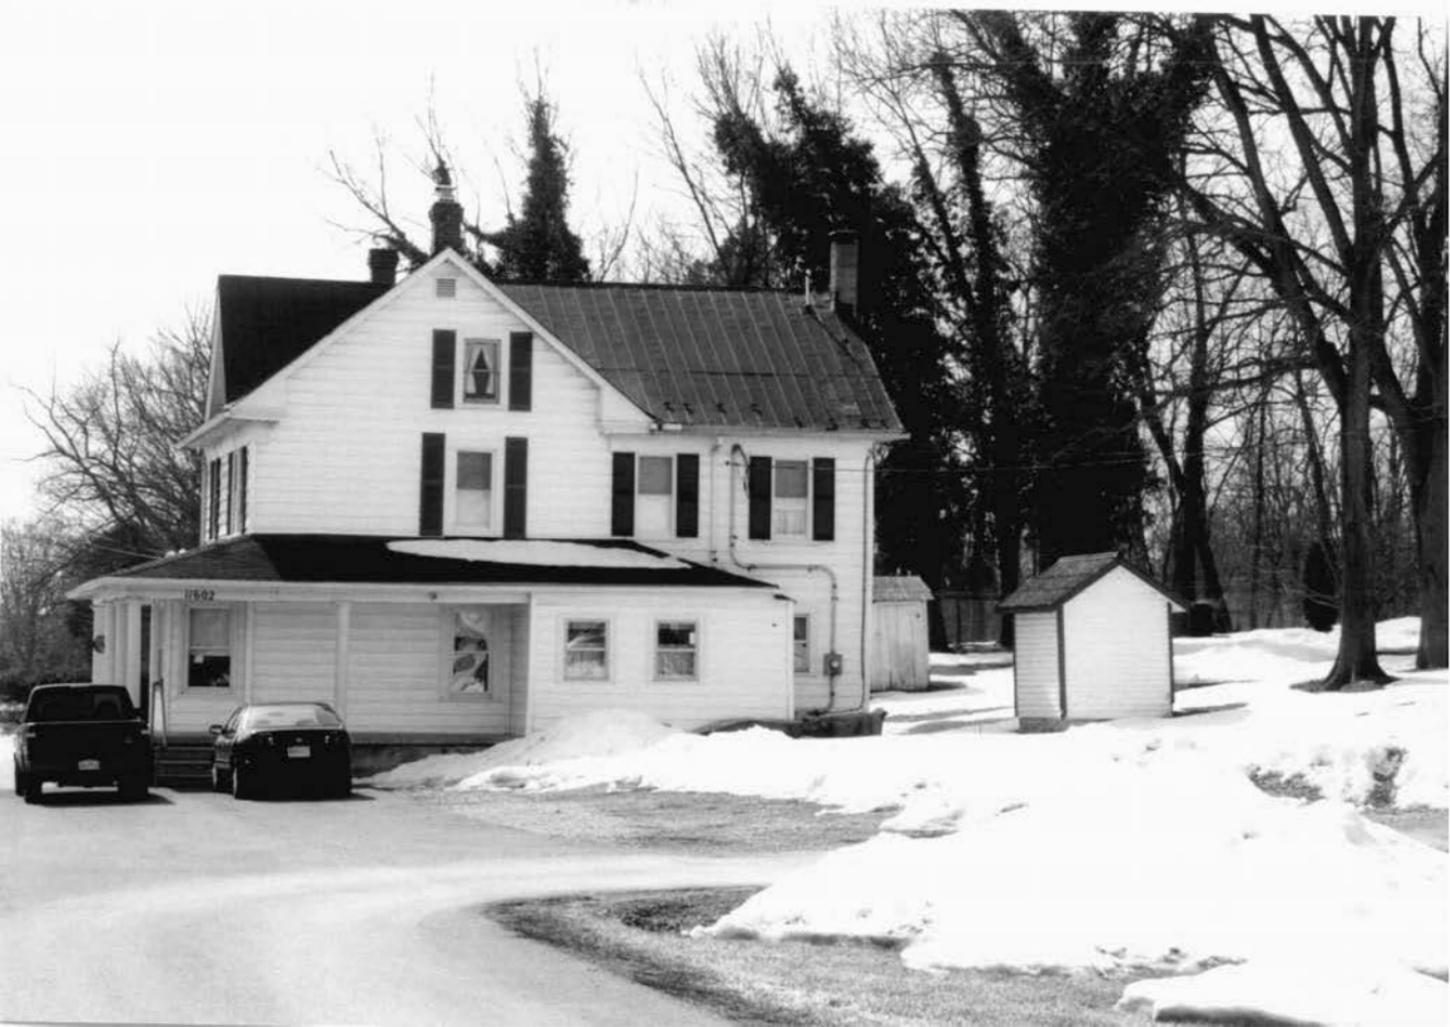
① of 3~~4~~

South side facade

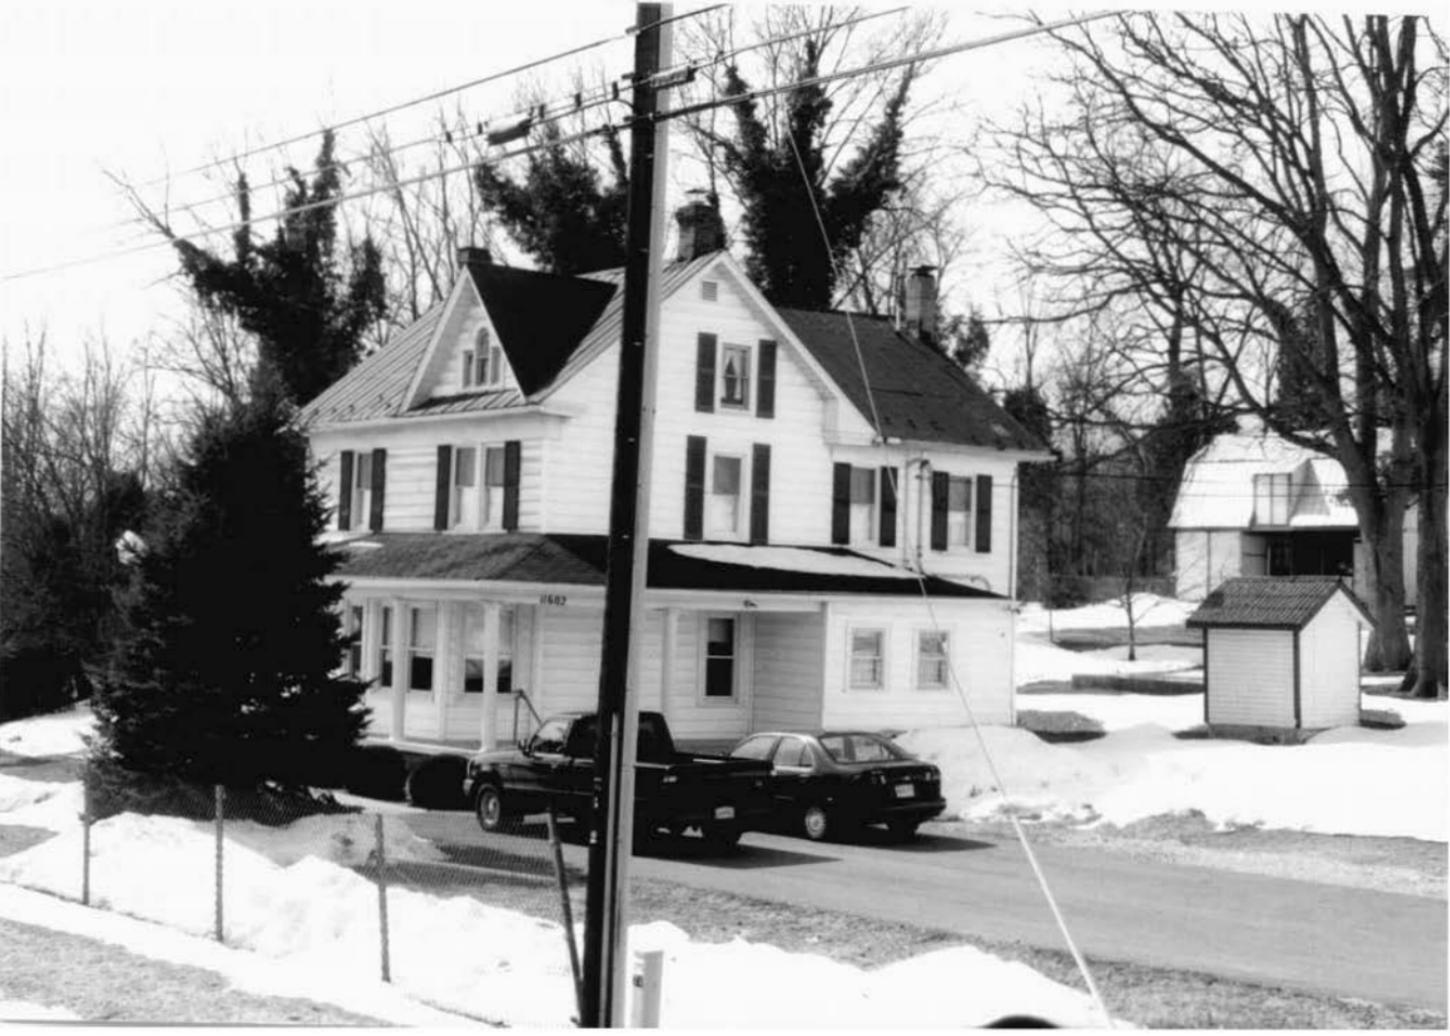
(2) of 3

The principal (east) facade features a variety of window arrangements in the northern bay of each floor. The first floor has a projecting multi-sided unit in its north bay. A one story porch covers this facade and continues along the north gable end wall where it is partially enclosed. The north bay of the second story has a different type of window arrangement; here, there is a pair of windows.

front elevation ^(east) and north side
elevation
