WA-I-503 Frame Bungalow

Hagerstown Vicinity

Maryland Historical Trust State Historic Sites Inventory Form

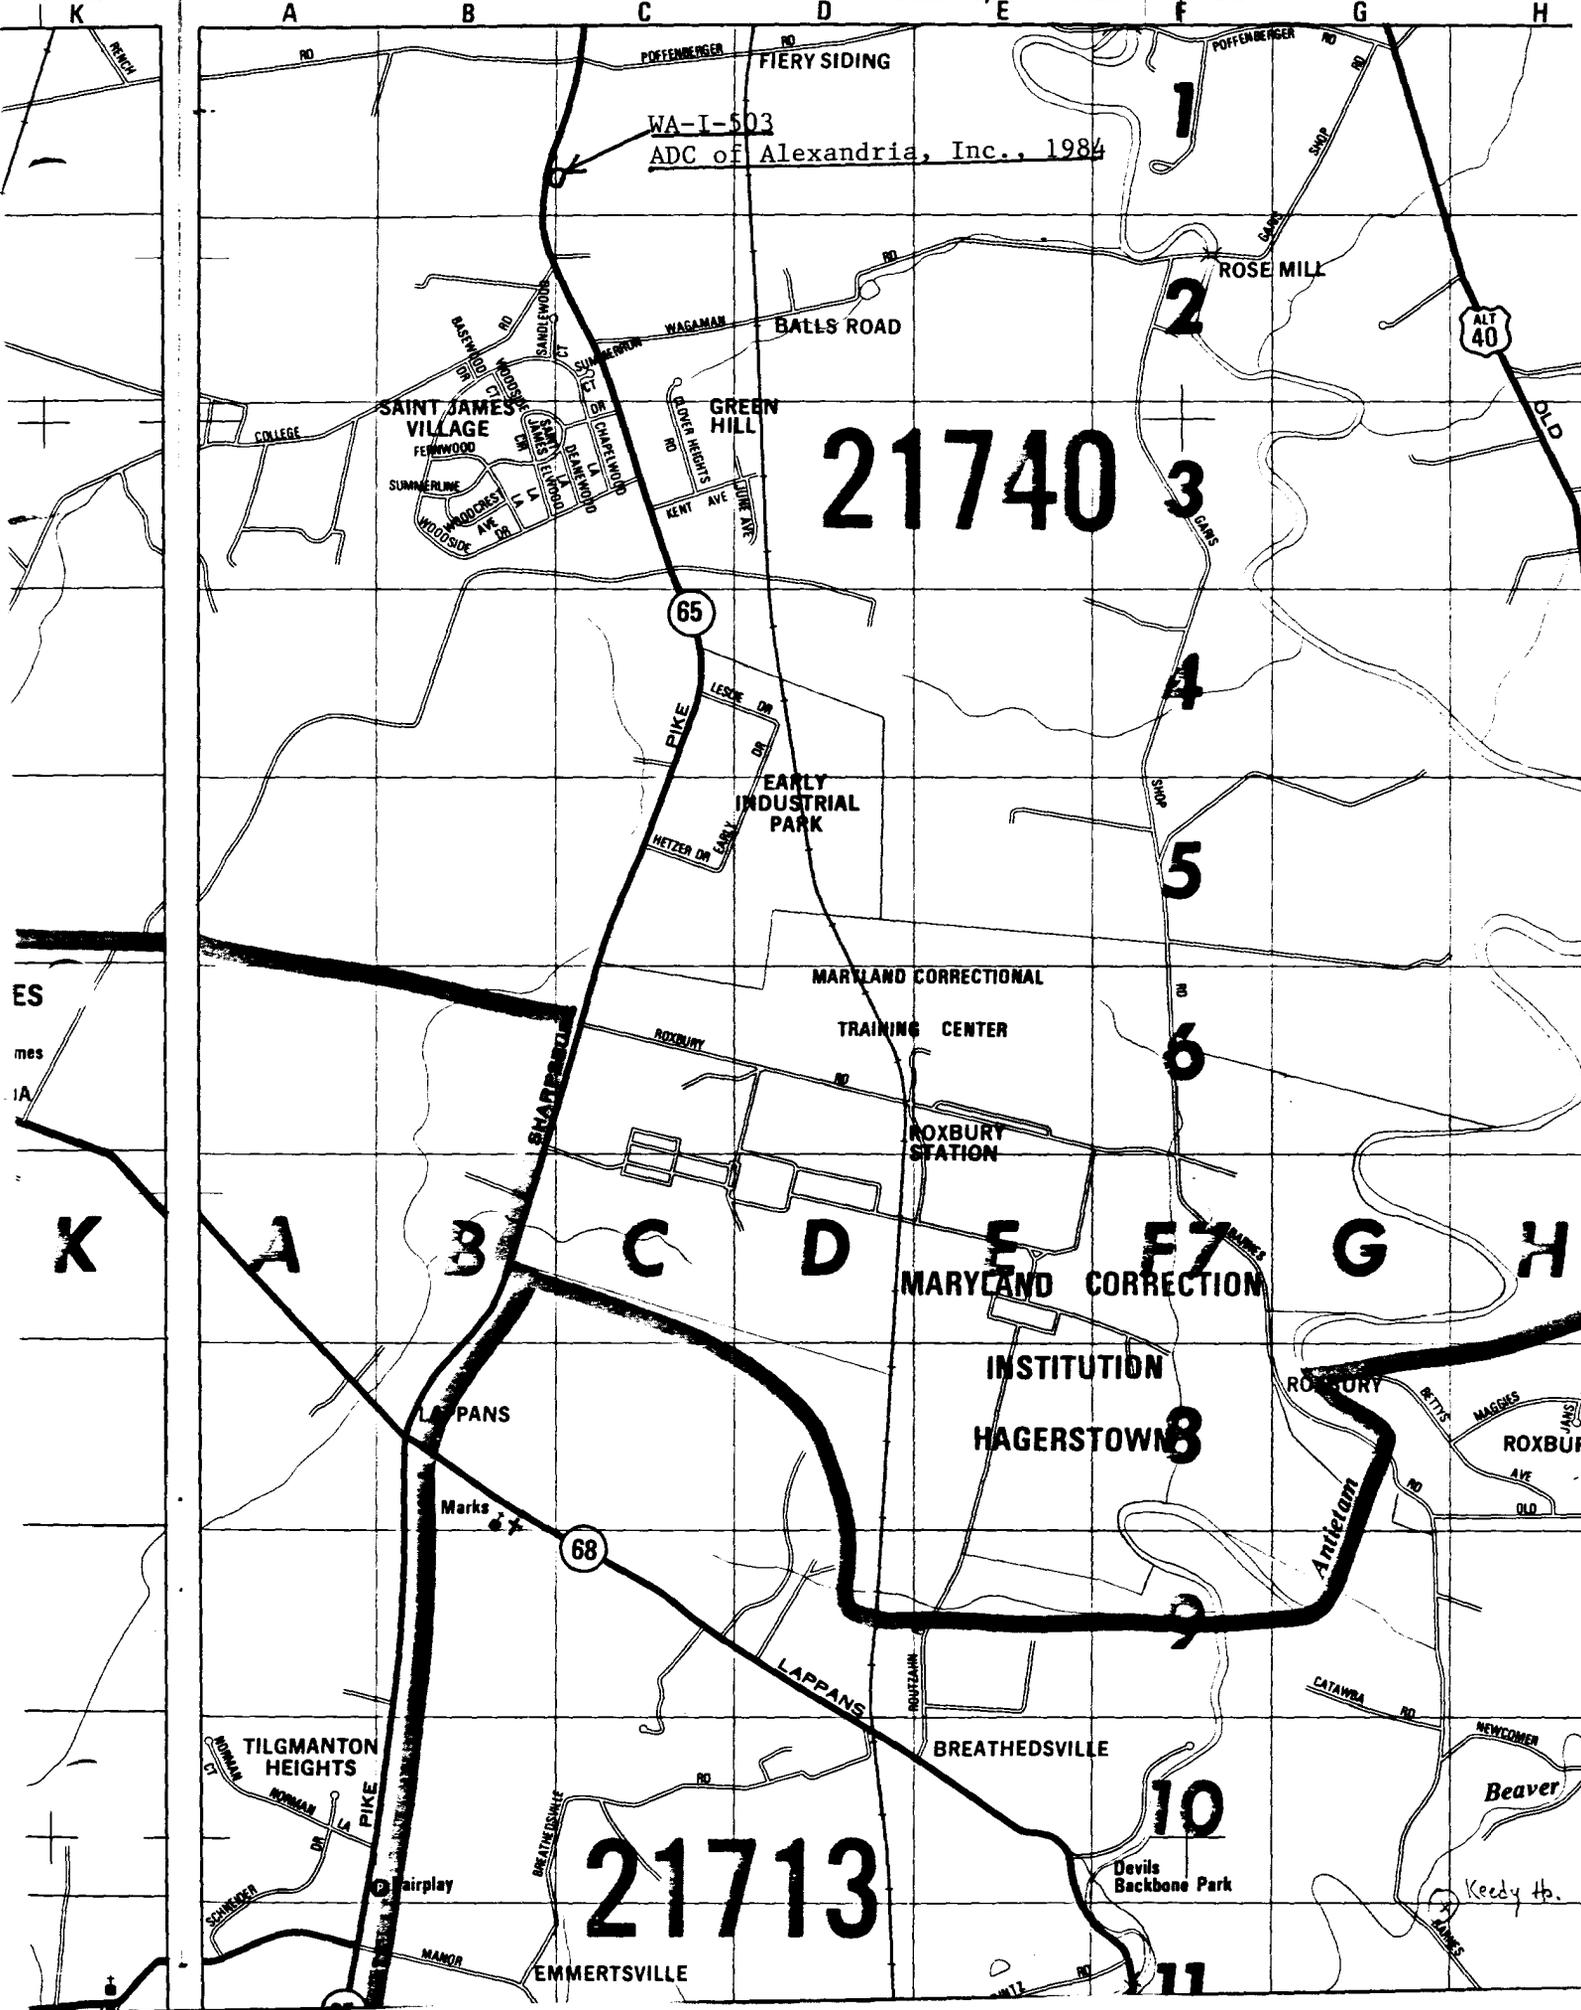
1. Frame Bungalow WA-I-503
2. Washington County, Maryland
3. Joe Getty
4. May 1983
5. Maryland Hist. Trust, Annapolis, Md.
6. West elevation; camera facing east
7. 1/1
