WA-I-506 Brick Bungalow

Maryland Historical Trust State Historic Sites Inventory Form

and/or common Brick bungalow

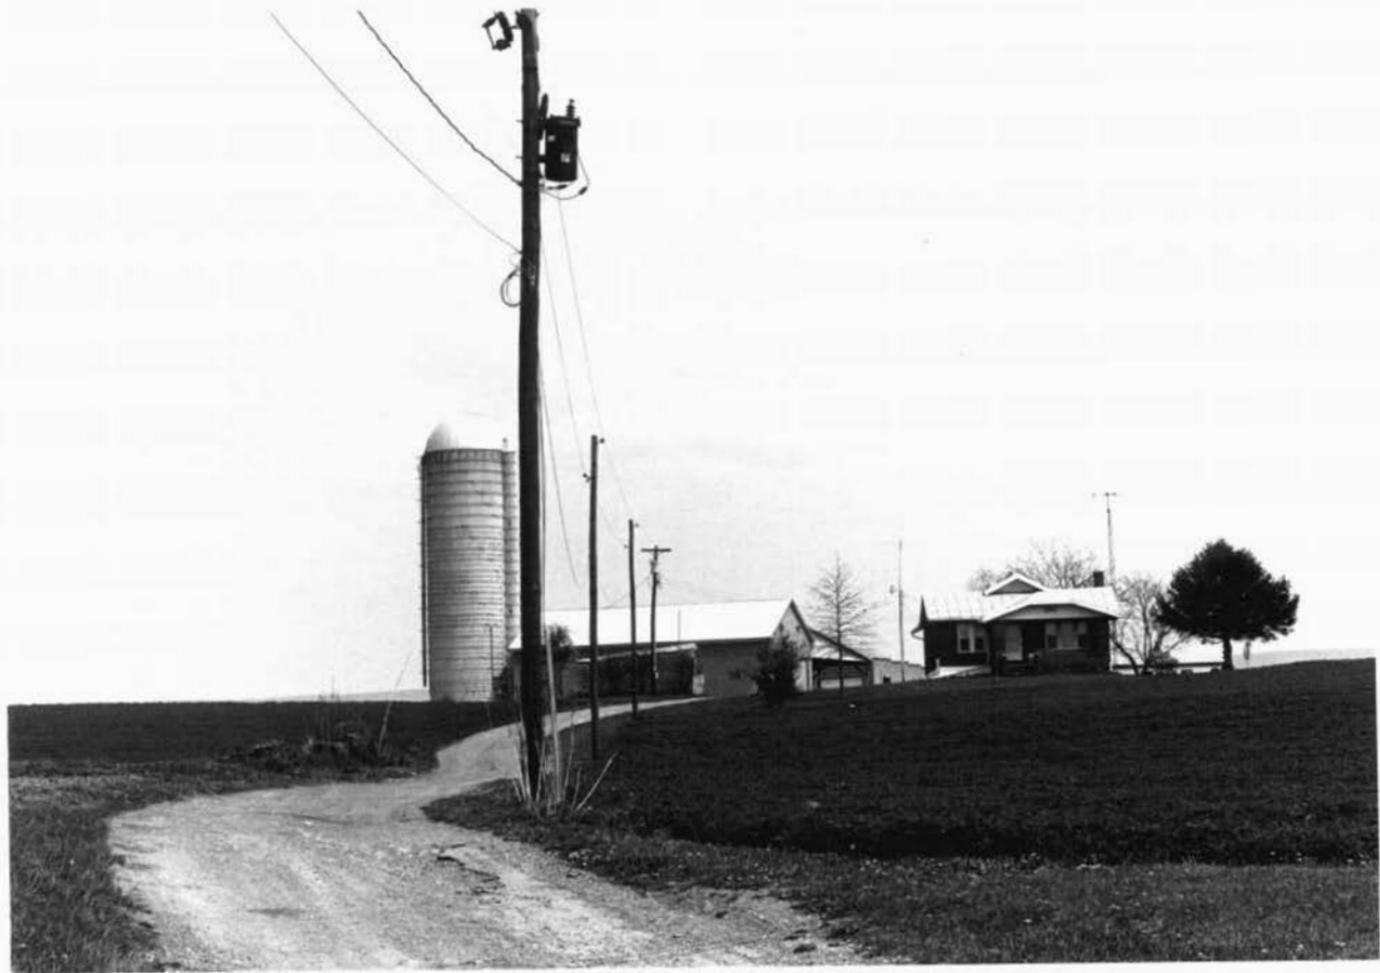
1. Brick Bungalow WA-I-506
2. Washington County, Maryland
3. Joe Getty
4. May 1983
5. Maryland Hist. Trust, Annapolis, Md.
6. West Elevation; camera facing east
7. 1/1

The brick bungalow is a one and one-half story, three-bay by two-bay house. It has a gable roof with a central dormer. The main facade has a central entrance with a two-bay porch in the southernmost bays. The date of construction is early 20th century.

The brickwork is stretcher bond. The main facade has a three-section window in the southernmost bay and a two-section window in the northernmost bay. The porch has a hipped roof covered in sheet metal. An interior-end chimney rises from the south gable end.
