WA-I-522      Foursquare House

# Maryland Historical Trust State Historic Sites Inventory Form

and/or common Foursquare house

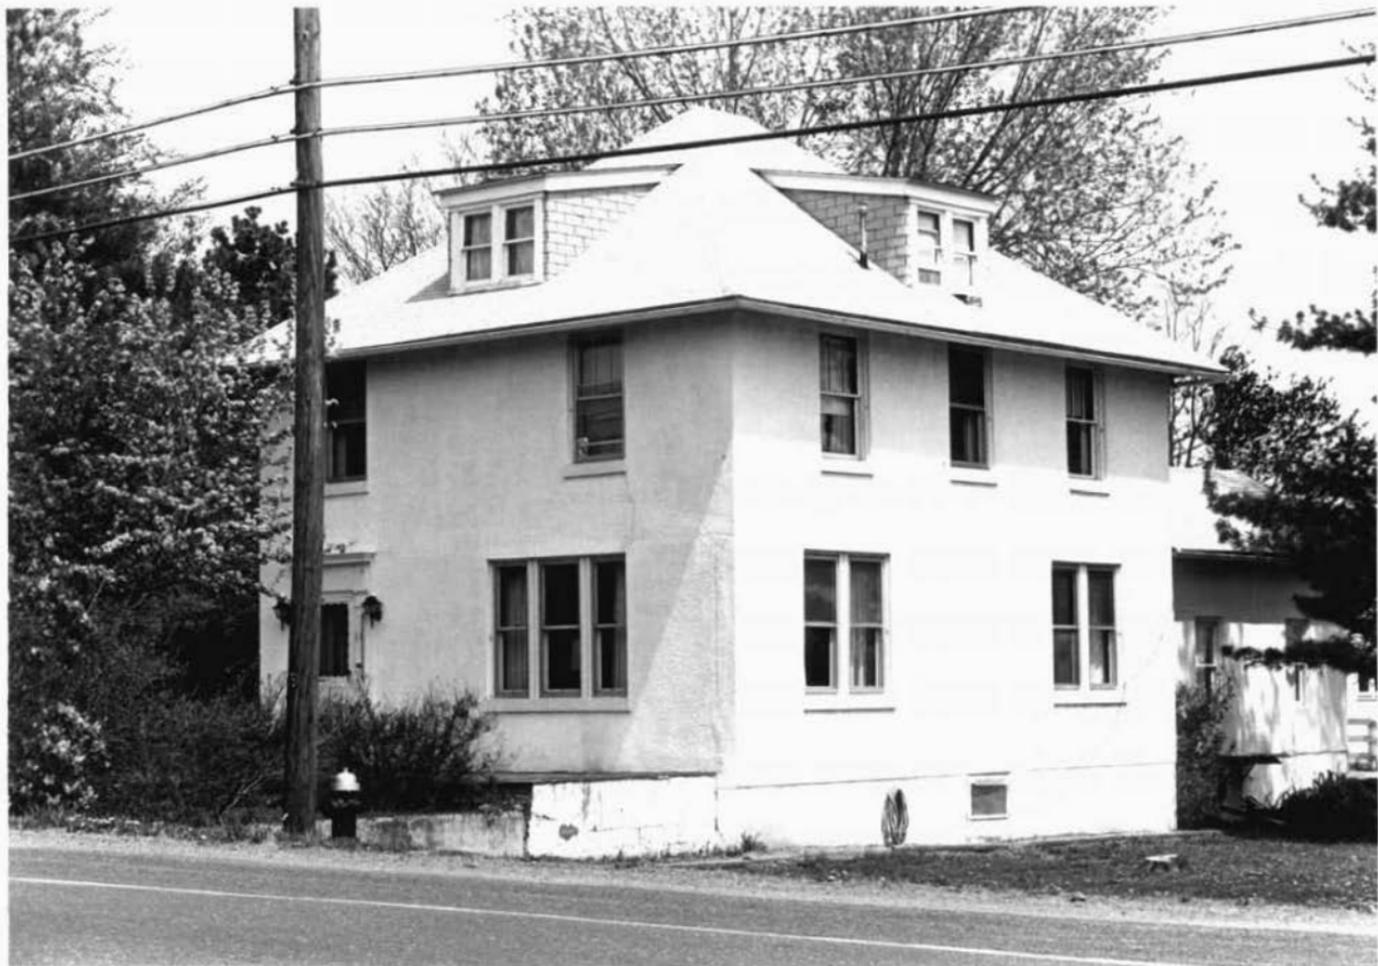
1. Foursquare House WA-I-502 522
2. Washington County, Maryland
3. Joe Getty
4. May 1983
5. Maryland Hist. Trust, Annapolis, Md.
6. West elevation; camera facing east
7. 1/1
