**MARYLAND HISTORICAL TRUST
DETERMINATION OF ELIGIBILITY FORM**

Property Name: George and Margaret Garis House Inventory Number: WA-I-886
 Address: 19202 Poffenberger Road Historic district: yes no
 City: Hagerstown Zip Code: 21740 County: Washington
 USGS Quadrangle(s): Funkstown
 Property Owner: Claggetts Mill LC Tax Account ID Number: 10-006465
 Tax Map Parcel Number(s): 103 Tax Map Number: 58
 Project: US 40 ALT at Poffenberger Road Agency: State Highway Administration
 Agency Prepared By: EHT Tracerics, Inc.
 Preparer's Name: Laura Trieschmann Date Prepared: 4/12/2011

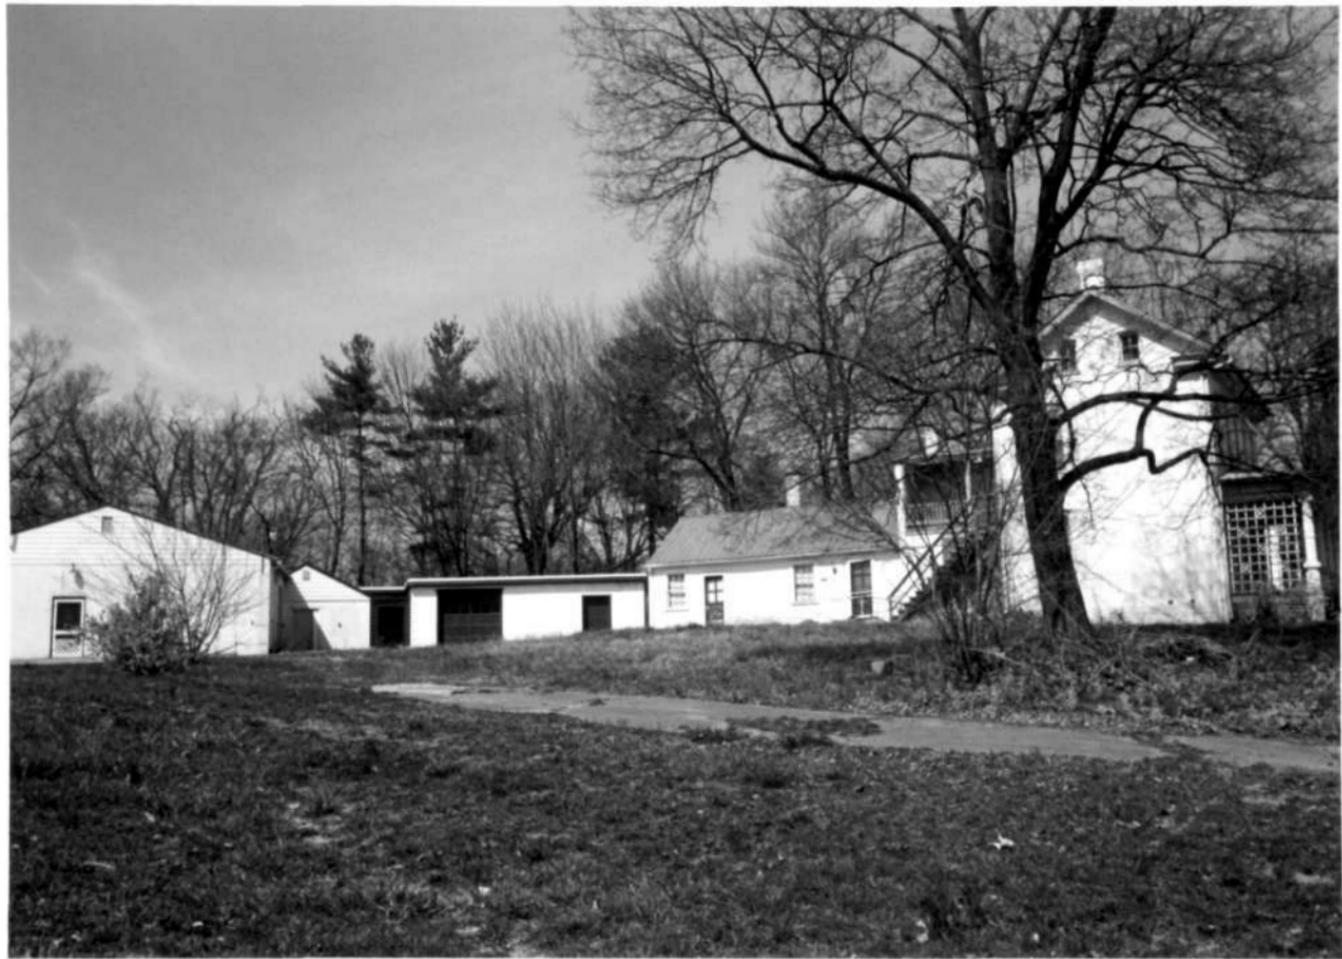
3 OF 17

Dwelling Exterior Description: The main block of the Garis House stands two-and-one-half stories in height, set on a coursed, uncut stone foundation that is raised slightly and dressed at the corners of the façade. The structure is constructed of brick laid in seven-course American bond; many layers of paint remain on the exterior. The I-house presents a façade extending five bays wide with a central entry; it is one room deep with an original two-story ell occupying the northern end of the west elevation. Capped by a side-gabled roof of standing-seam metal, the roof of the main block has nailed beams, false plates, and lacks a ridge board. The wide overhanging eaves are ornately finished with an ogee-molded cornice of wood, scrolled modillions, ogee-molded bed molding, raking cornice, and returns. Interior-end brick chimneys with ornately corbeled caps pierce the ends of the ridgeline.

The symmetrically fenestrated façade holds five standard-sized window openings on the first and second stories, each with a 2/2 window. The openings have wood sills—some covered in metal to slow deterioration, shallow ogee-molded surrounds, and rowlock brick segmental arches. Shutter hardware remains on many of the surrounds. The centrally placed single-leaf entry of the main block has a wood sill, shallow ogee-molded surrounds, rowlock brick segmental arch, paneled reveals, one-light fixed transom, and Italianate-style door with semicircular-arched panels. A metal screen doors secures the entry. The side elevations are similarly pierced on the first and second stories with 2/2 windows. Each story has a single opening in the western end bay. The upper gable ends are pierced by shallow segmental-arched openings that flank the chimney stack. Four-light operable wood-sash casement windows, set in shallow ogee-molded surrounds with wood sills, are contained in these small openings. Rowlock bricks highlight the segmental arches. Additional fenestration consists of small window openings in the foundation; some of the openings are located under the front porch. The openings are finished with wood surrounds and segmental brick arches. The rear elevation of the main block has window openings in the southern end bays of the first and second stories; a window opening pierces the central bay of the second story, under the shed roof of the inset porch. The rest of the elevation is obscured by the original two-story ell. The foundation level has segmentally arched window openings, each holding two-light awning windows with square-edged surrounds. A metal bulkhead door is located in the southern end bay at the foundation of the west elevation.

MAIN HOUSE, LOOKING NW

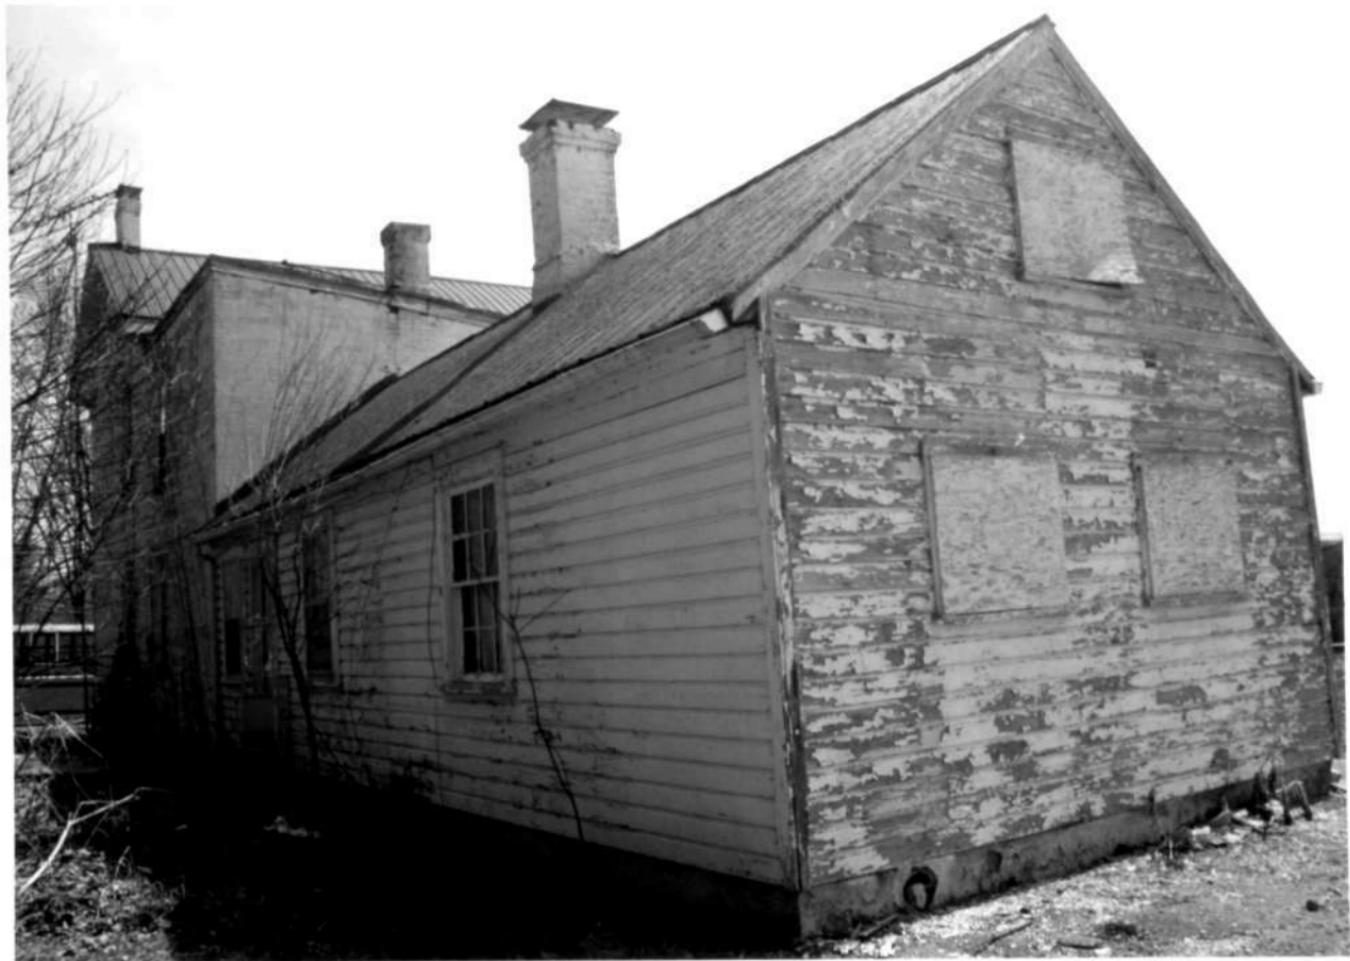
7 OF 17

MAIN HOUSE/ADDITION LOOKING SE

Based on physical survey, the one-and-one-half-story addition is an alteration, located on the west elevation of the ell. The construction of the addition seems to have occurred in the mid-twentieth century, possibly when a modern kitchen and family room

were needed. The addition is set on a concrete foundation, which exhibits signs of deterioration. Clad in wood German siding, this wood-frame addition has a side-gabled roof of standing-seam metal. Nailed rafters and the omission of a ridgeboard suggest that it was constructed prior to the turn of the twentieth century, but the structure itself implies otherwise as the surrounds, windows, chimney, doors, and concrete foundation speak to the mid-twentieth century. The slightly overhanging cornice, created by the false plate, is boxed with square-edged bed molding. The cornice is obscured by metal gutters, which are heavily deteriorated in places. A corbeled brick chimney rises from the center of the two-room addition. Rectangular in form, the addition is four bays wide along the south elevation, thus providing a single entry opening and window opening to each room. Fenestration of the north elevation consists of three window openings and a single-leaf entry. Window openings contain 6/6 sash with square-edged surrounds, slightly wider frieze with shed cap, and wood sills. Entry openings hold four-light wood doors with recessed panels. The west elevation of the addition has two openings on the first story and one in the upper gable end. These openings, covered from the exterior with plywood, hold 6-light windows, possibly fixed. The openings have square-edged surrounds, lacking the lintel caps found on the openings of the side elevations.

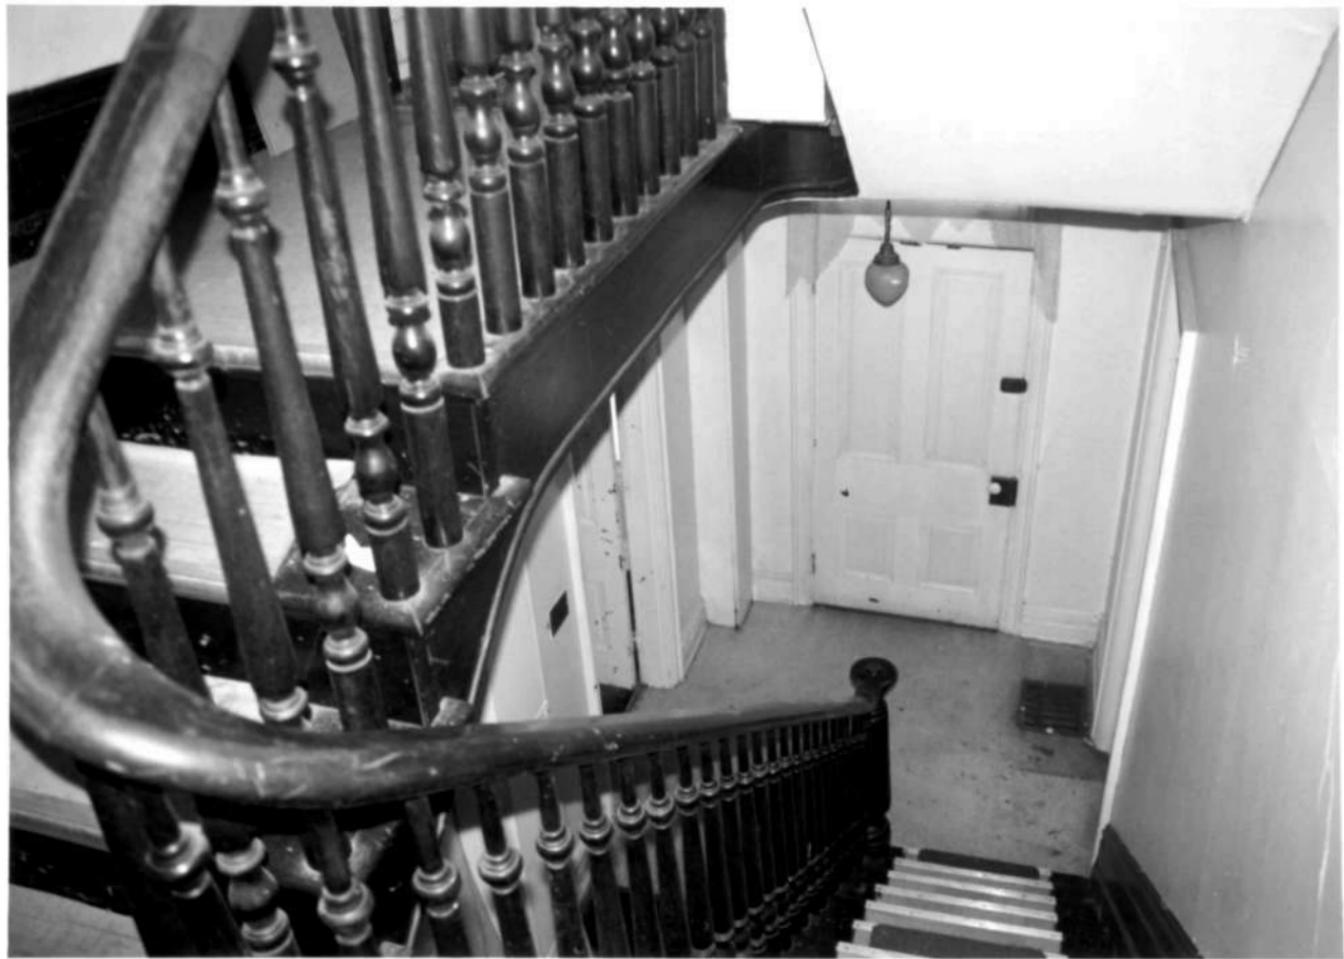
8 OF 17

MAIN HOUSE, STAIR, LOOKING TO FIRST FLOOR
LOOKING EAST

The central passage, now terminating at the western end of the stair because of the construction of a full bath, has carpeting over the original five-inch-wide wood floors, six-inch-high baseboards with scotia and ogee moldings, and horsehair plaster walls. The entry openings have five-inch-wide surrounds with ogee and ovolo moldings and four-paneled wood doors with metal lock boxes and ceramic knobs. The hollow newel stair, anchored to the southern wall of the passage, is indicative of the late nineteenth century. It has a fancy-turned newel, turned balusters, oval rail with gooseneck, and molded stair and wall stringers. The stair, now with a flush, hollow-core wood door at the second-floor landing, continues up to the attic half-story. This portion of the stair, which is not ornamented, is enclosed. It has a dog-leg form with vertical board walls and high risers.

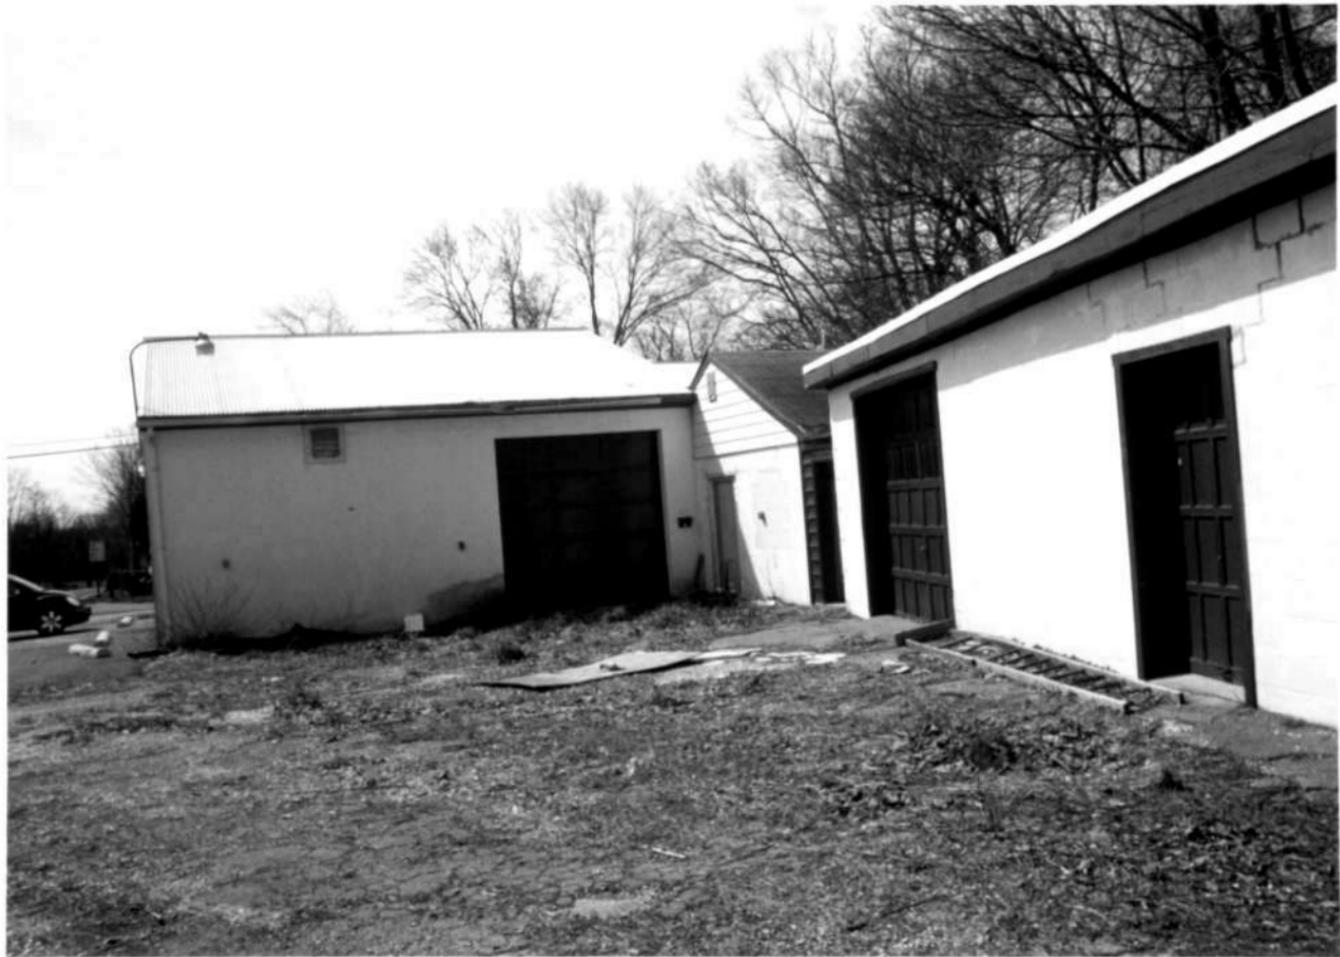
16 OF 17

COMMERCIAL BUILDING, LOOKING, SOUTHWEST

Commercial Building Exterior Description: The one-story commercial building on the property appears to have been constructed in three phases, the oldest being in the mid-twentieth century (circa 1958). It is a rectangular structure of concrete blocks painted white. Covered by a shed roof of corrugated metal sheets, the one-story garage has a multi-paneled wood vehicular door that rolls up. This opening is located in the southwestern end bay. A smaller opening, presumably for pedestrians or narrower vehicles, is located at the northeastern end bay. It holds a multi-paneled roll up door. The overhanging roof has a boxed cornice with no applied ornamentation. Stepped back from the façade of the building is a wood-frame hyphen clad in wood weatherboard siding. It is pierced on the south elevation by a wide, single-leaf opening. The hyphen has a shed roof and boxed cornice that abuts that of the one-story building to the east. A one-and-a-half-story concrete block building has a front-gabled roof with no overhanging eaves and an unadorned raking board. The upper gable end of the concrete block building is covered in aluminum siding. The façade, facing southward, is pierced by a wide, single entry opening. Ghosting indicates a rectangular window opening to the east of the entry has been enclosed. A small vent pierces the upper gable end.

Wrapping around the south elevation of the front-gabled structure is a larger concrete block building that is similarly constructed with concrete blocks, a gable roof, and aluminum siding in the upper gable ends. This building, possibly a late-twentieth-century addition, has a large double-leaf opening on the northeast elevation and a single-leaf opening on the southwest elevation. The south elevation has a fixed one-light window that is square, single-leaf entry door, and vehicular opening with multi-paneled roll-up door. The western elevations are minimally fenestrated; only a single-leaf entry under a shed-roof porch was noted. A concrete-block chimney projects from the exterior end of the third addition, which is covered by a stepped gable roof. The interior of the commercial building was not accessible; it was locked and not open for survey.

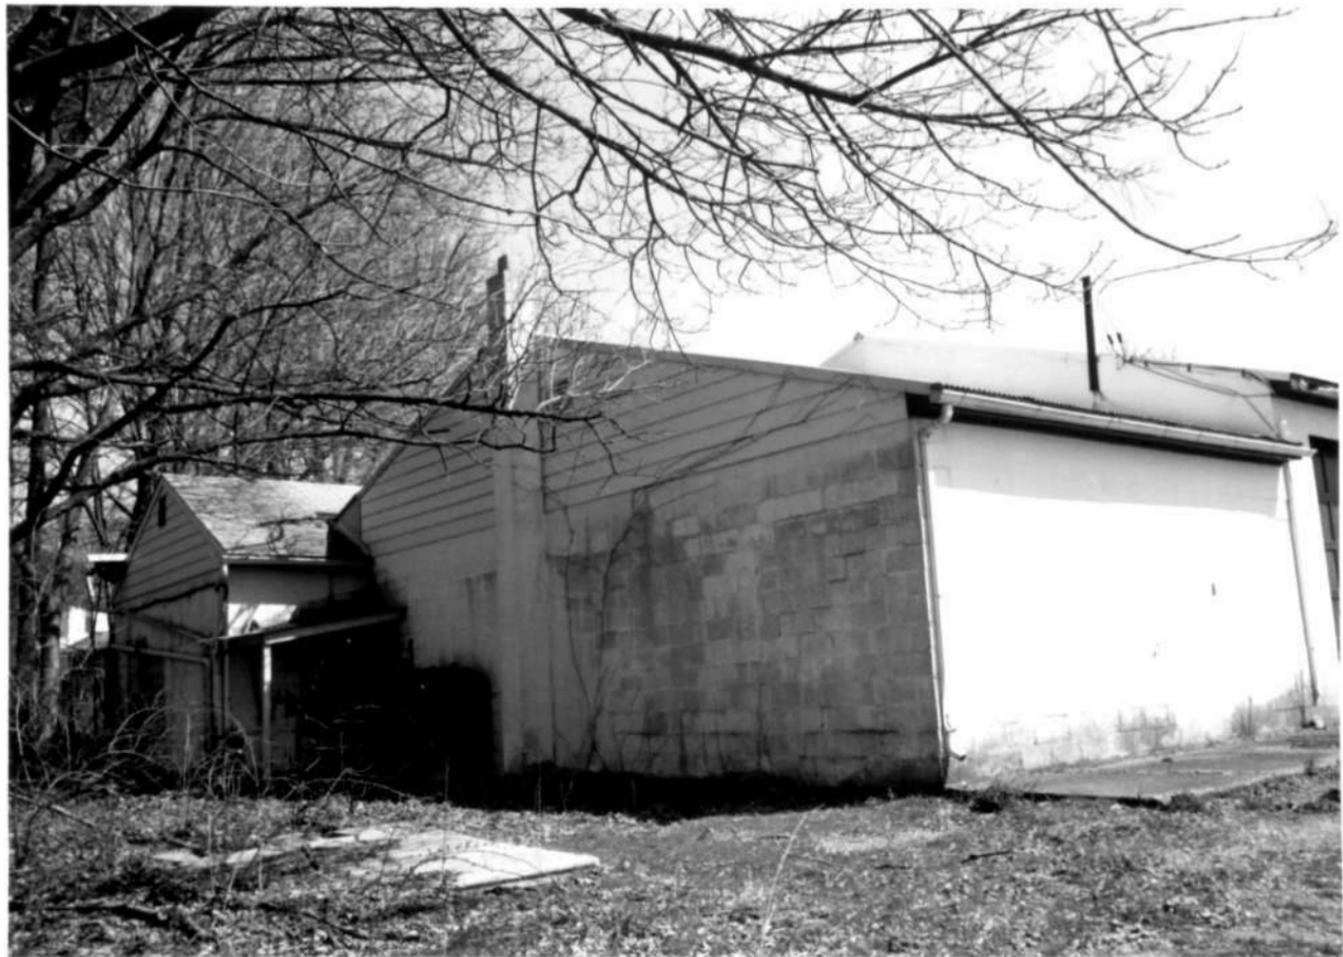
17 OF 17

COMMERCIAL BUILDING, LOOKING NE
