Addendum
WA-II-022
Frantz House
Lappans Crossroads

11. FORM PREPARED BY

ORGANIZATION: **Washington County Historic Sites Survey** DATE: **September, 1973**

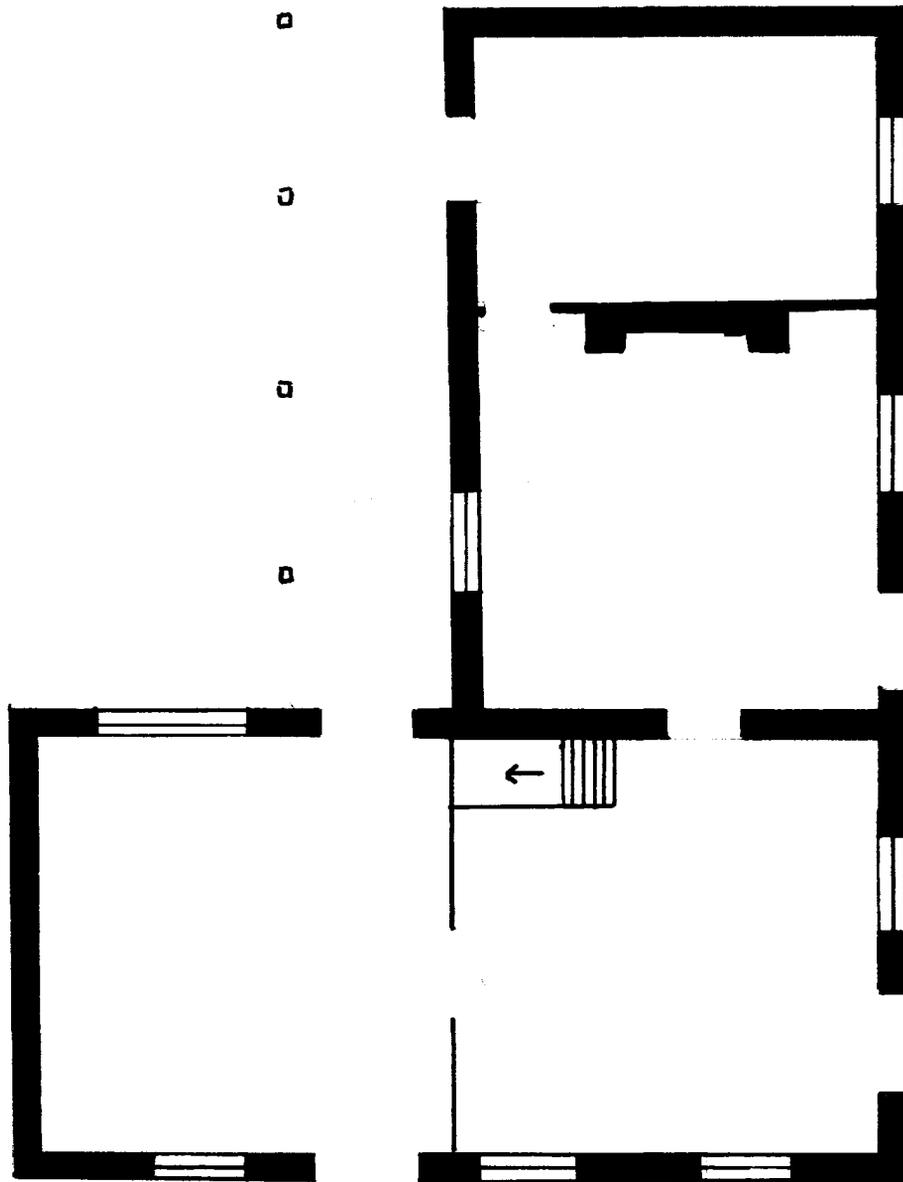
WA-II-022 APPROXIMATE FLOOR PLAN. N. →

that two periods of building are represented in this structure. Examination of the attic is necessary to form an assessment of the age of each section of the house. However, several features evident from observation of the exterior and the first floor of the interior would indicate that the rear section with its high second story windows and its large chimney displays earlier building techniques and may date from the late 18th century.
