Maryland Historical Trust State Historic Sites Inventory Form

Survey No. WA-II-1127

historic ROSEMONT

street & number 8105 Sharpsburg Pike not for publicationcity, town Fairplay vicinity of congressional district 6th

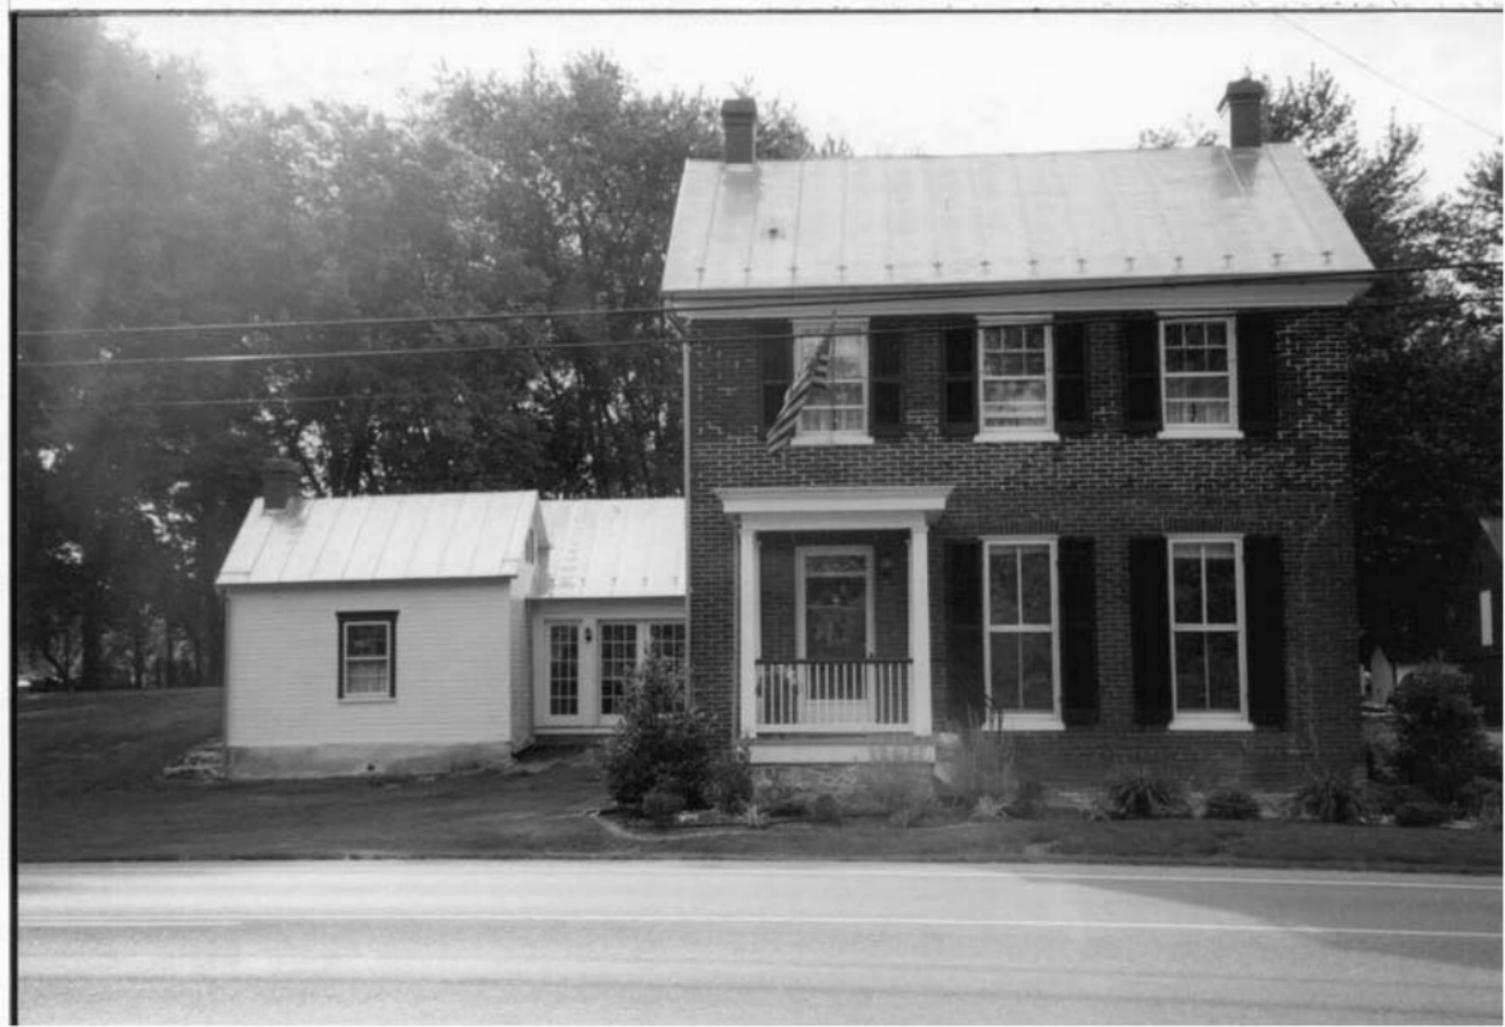
1 of 16

VIEW LOOKING EAST
MAIN HOUSE
Breezeway
Summer Kitchen

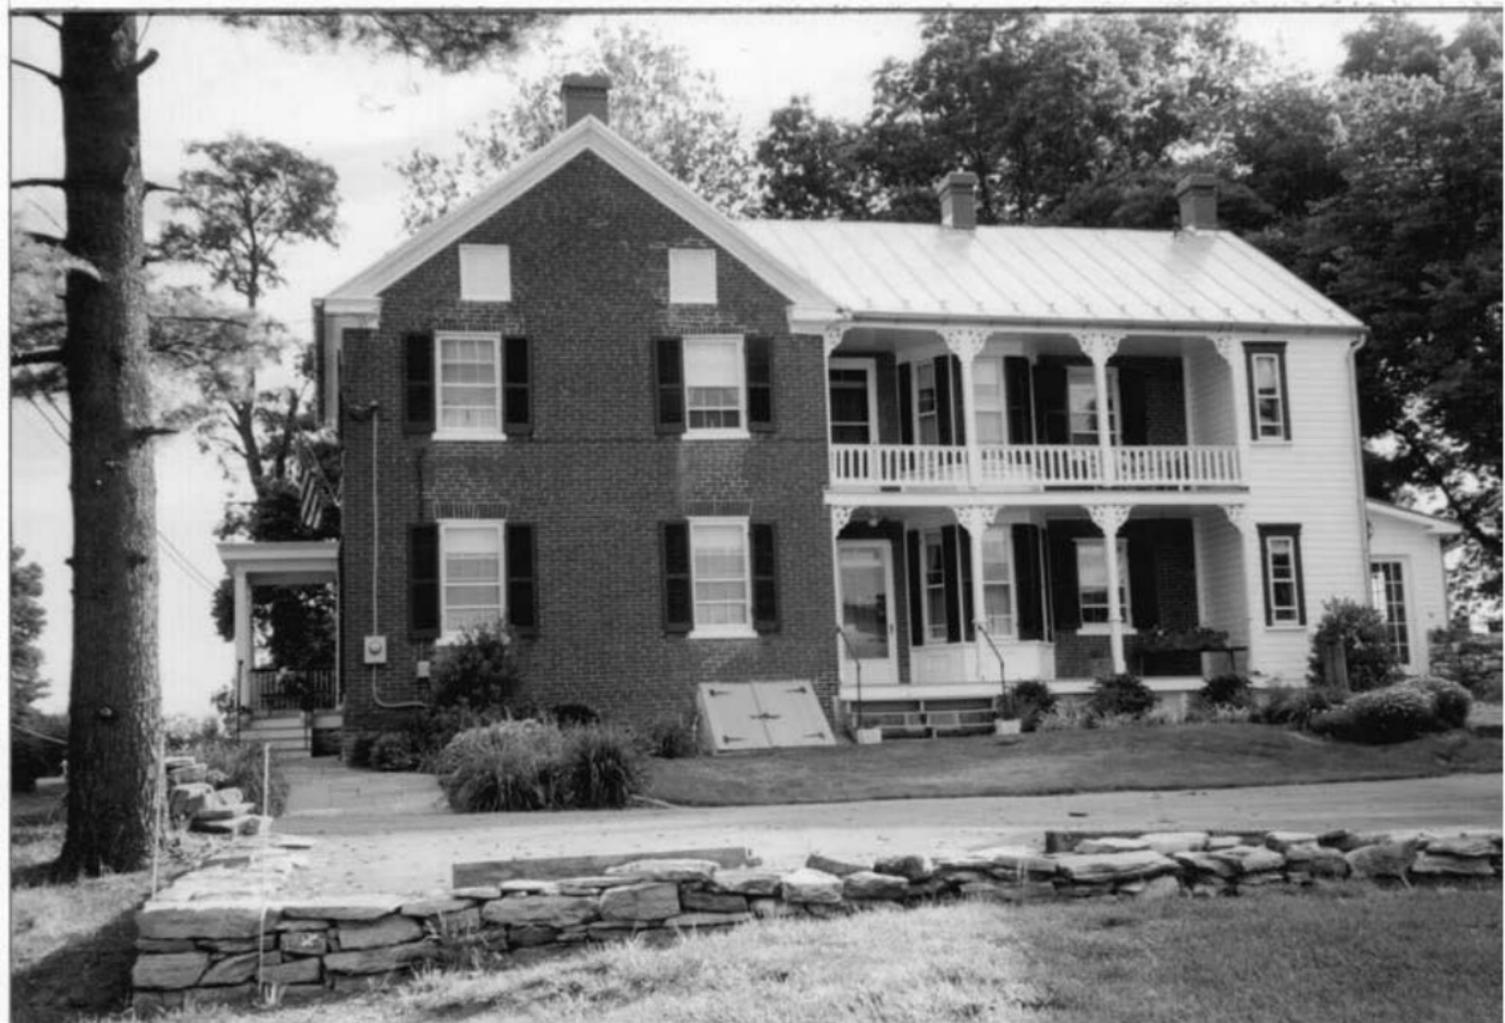
VIEW Looking North
MAIN House

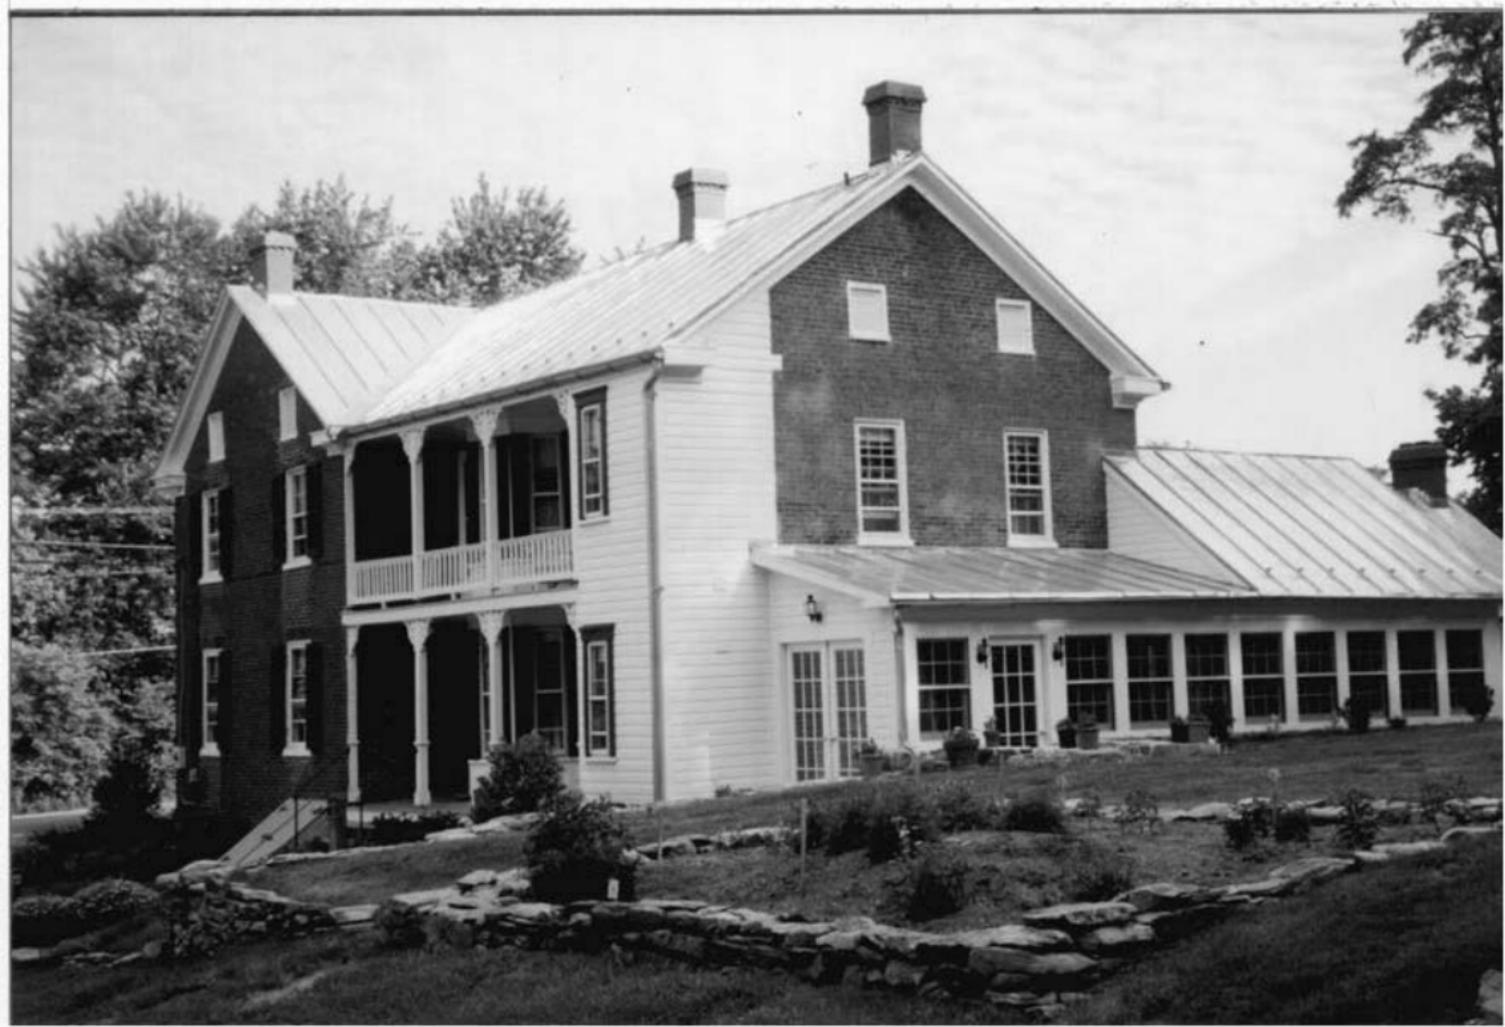
VIEW Looking Northwest
MAIN House

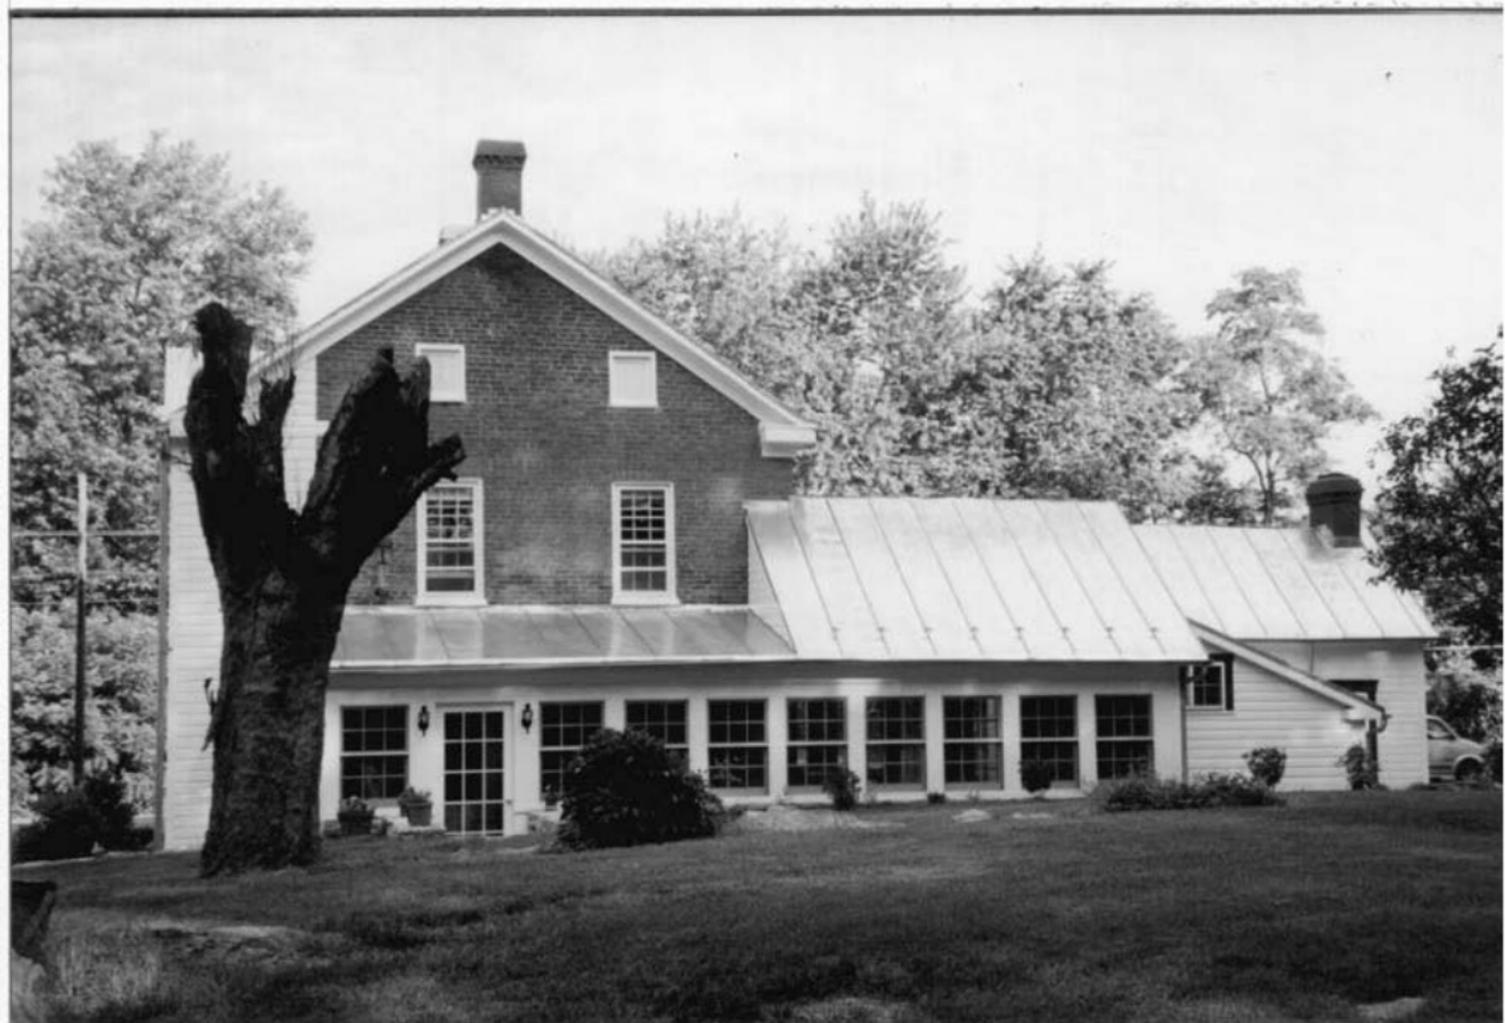
VIEW Looking West
MAIN House, enclosed breezeway,
Smokehouse, Summer Kitchen

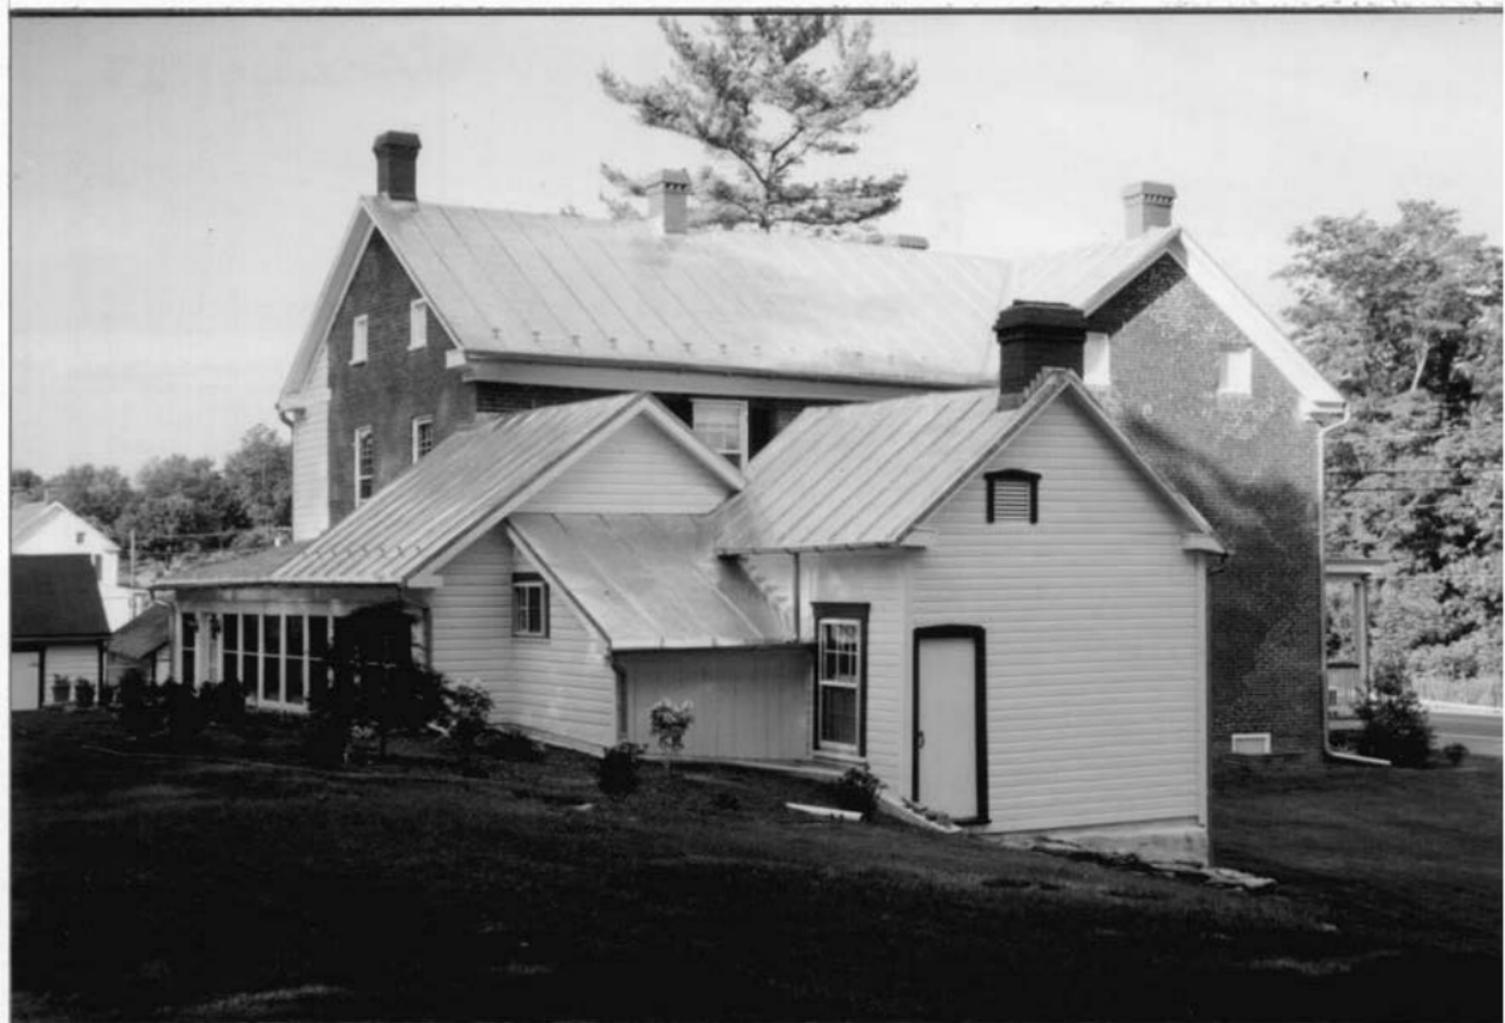
VIEW Looking Southwest
MAIN House
enclosed breezeway
Smokehouse
Summer Kitchen

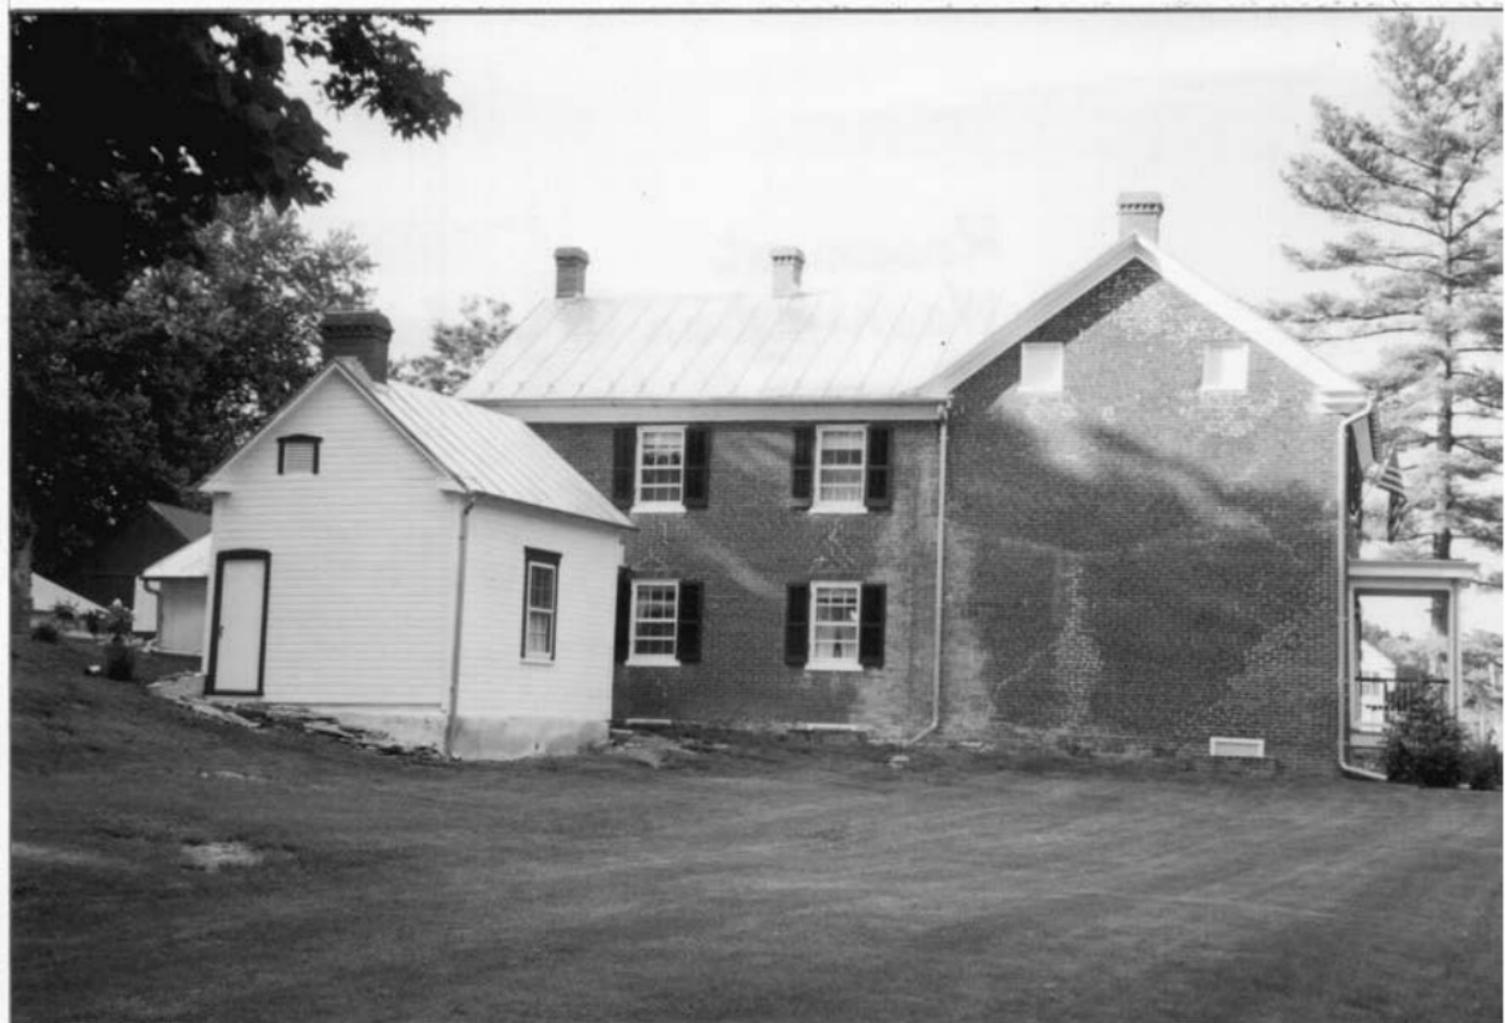
VIEW Looking South East
Summer Kitchen
MAIN House

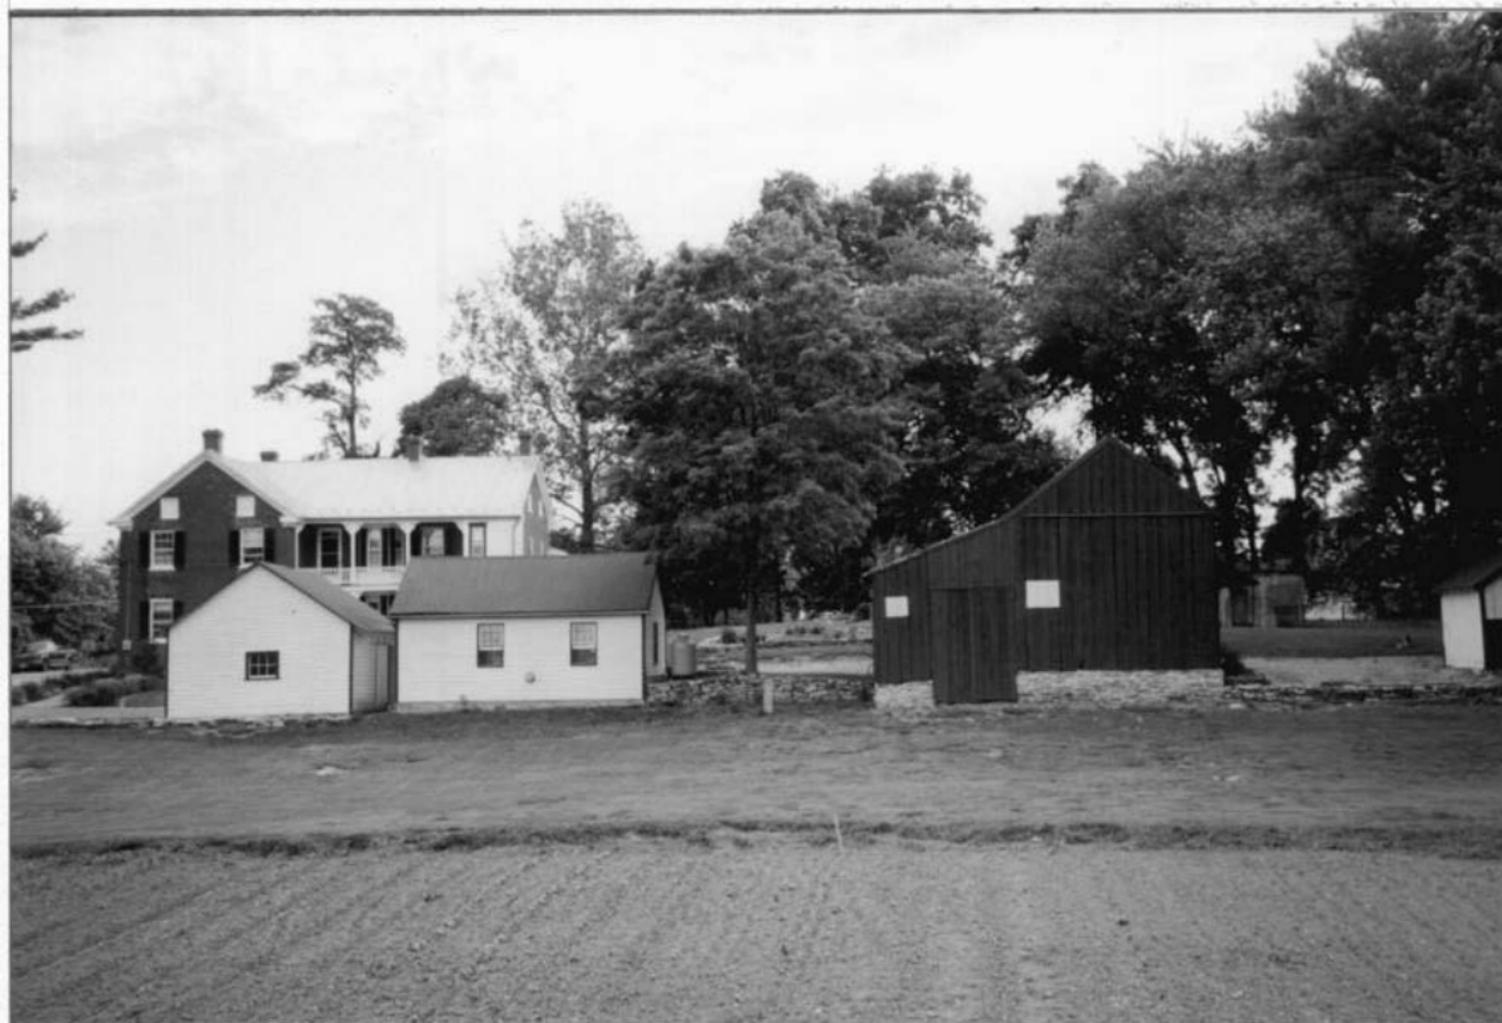
VIEW Looking North

Garage, Workshop, Barn, Hog pen
MAIN House in background

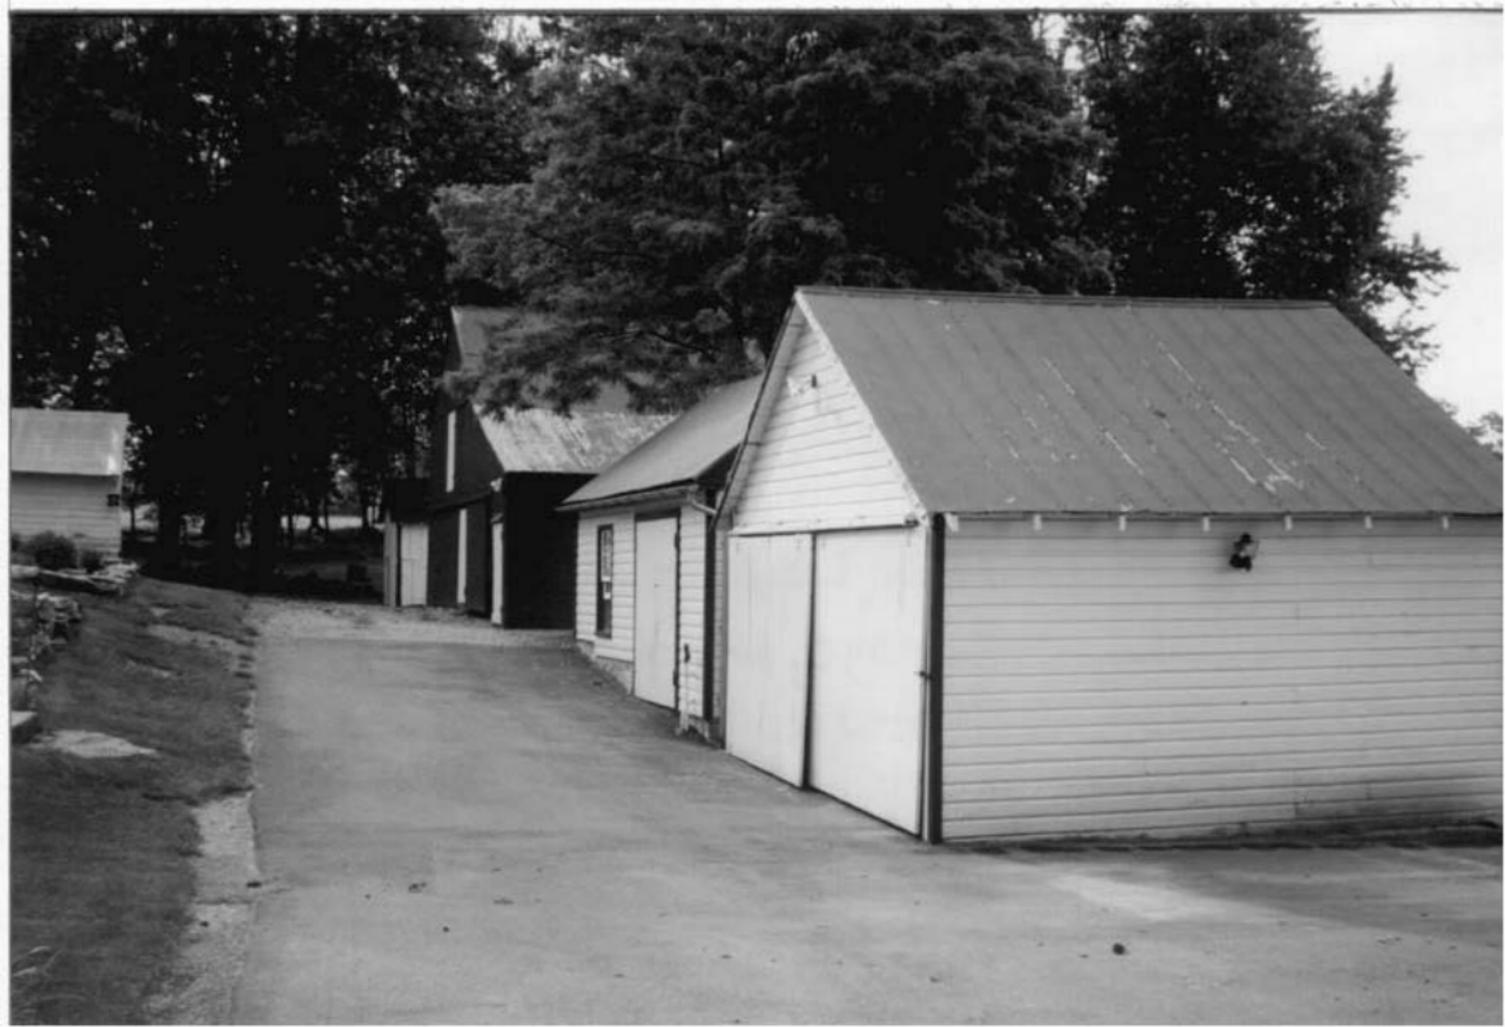
VIEW Looking East
Garage, workshop, barn, hog pen
potting shed (on left)

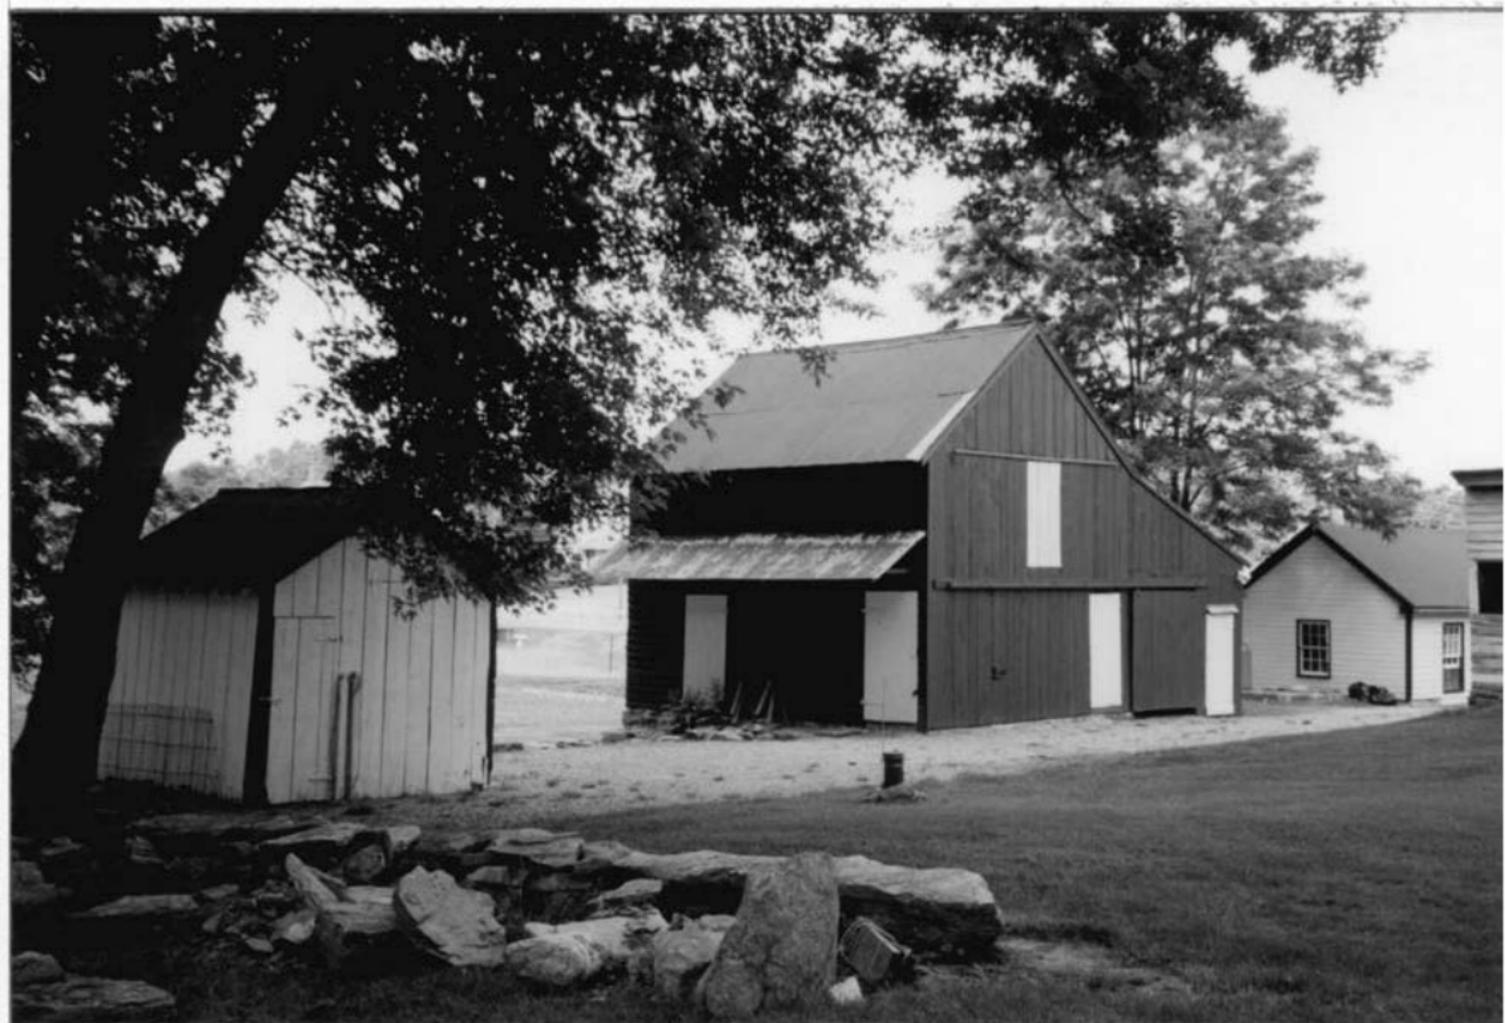
VIEW Looking Southwest
Hog pen, barn, workshop

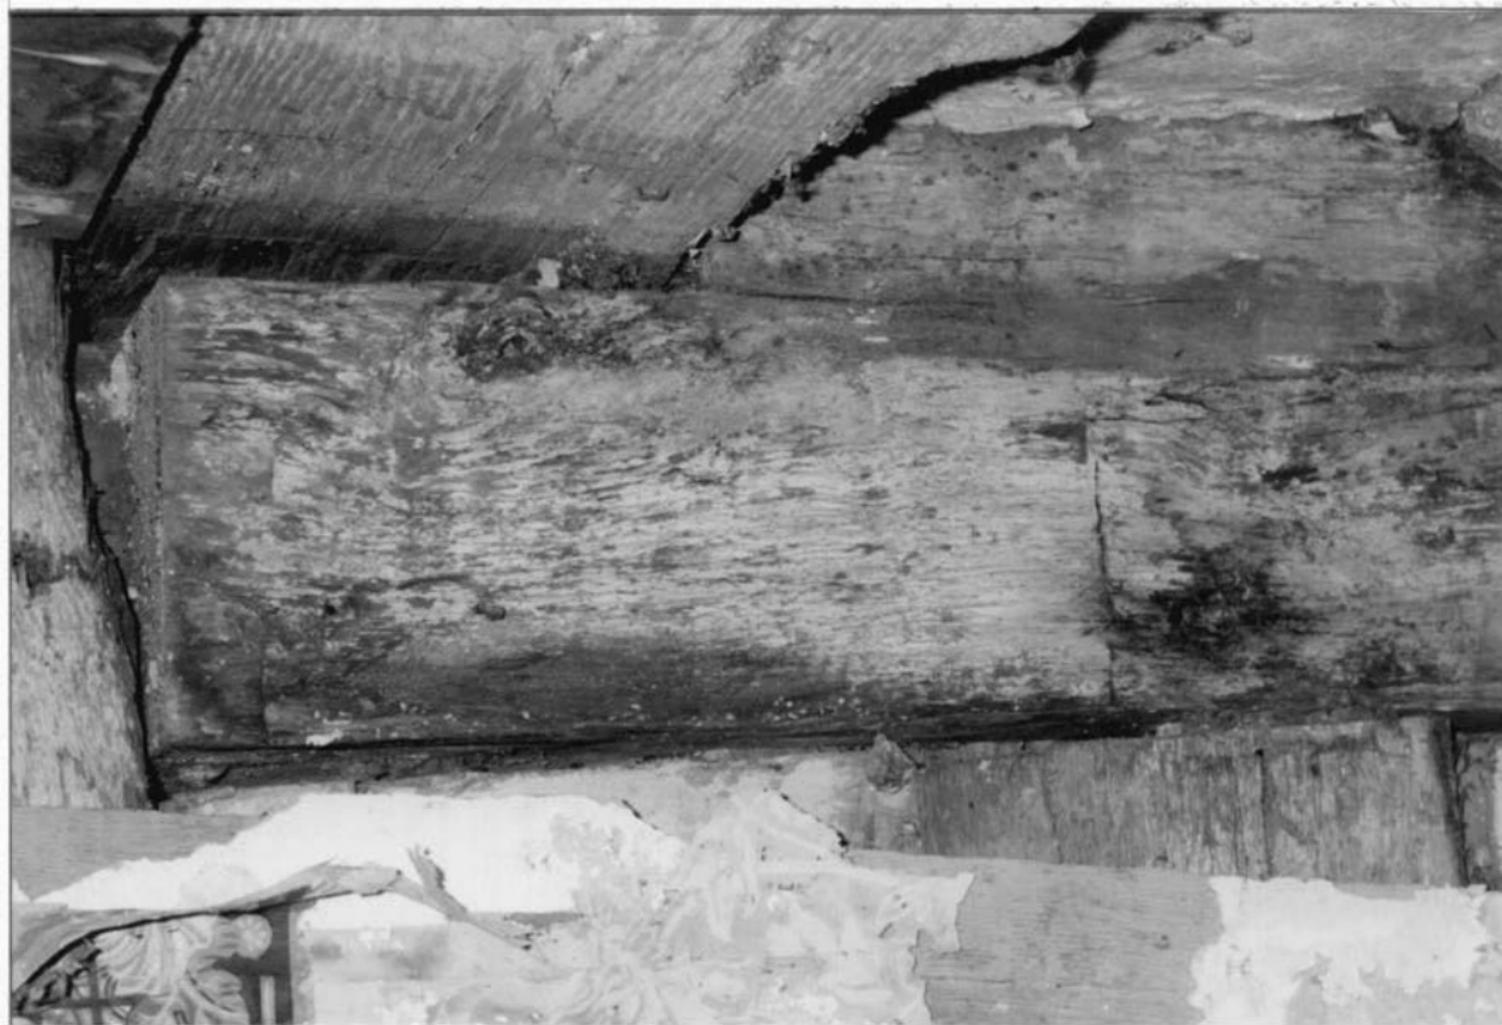
In recent years, the masonry below the main block's south windows was repaired. The log construction that was visible at this time included pegged angle braces. A corner post running the full two stories of the house in the northeast corner is visible under the stair on the first floor as well as in the corner of the stairwell in the attic. The logs appear to be tenoned into the corner post. This log in post construction is similar to that of a building at 201 S. Main St. in nearby Sharpsburg. In this case the structure is fully exposed and whitewashed.

close-up corner post
northeast corner attic

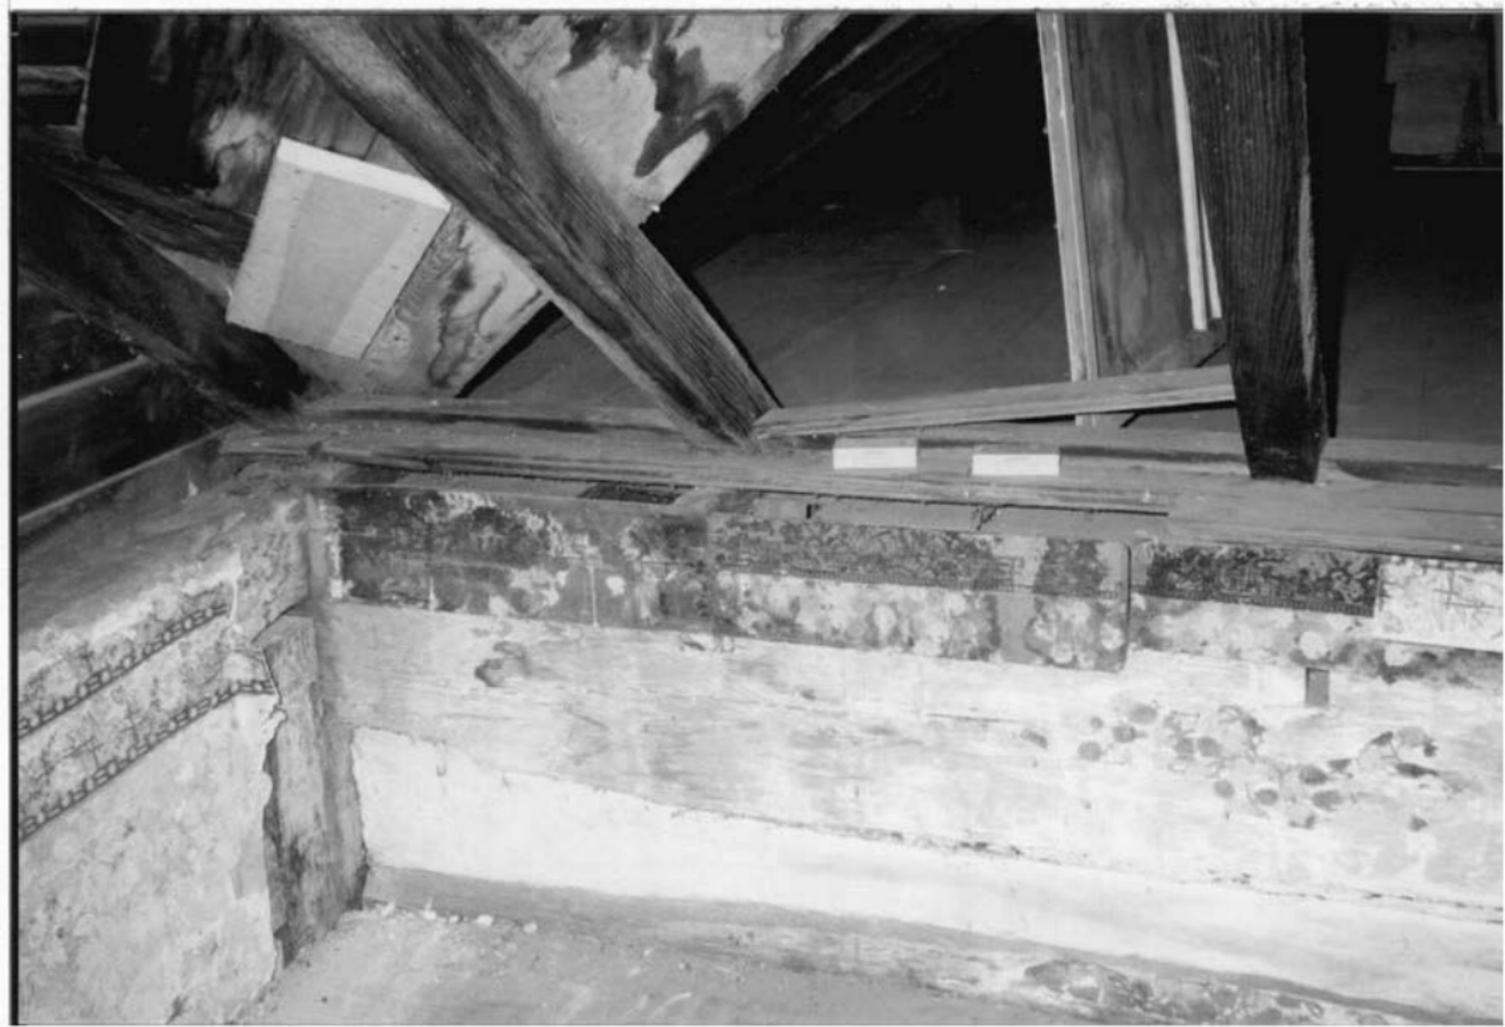
11 of 16

Corner post, northeast corner attic
with logs tenoned into it
remnants of ca 1880
wallpaper

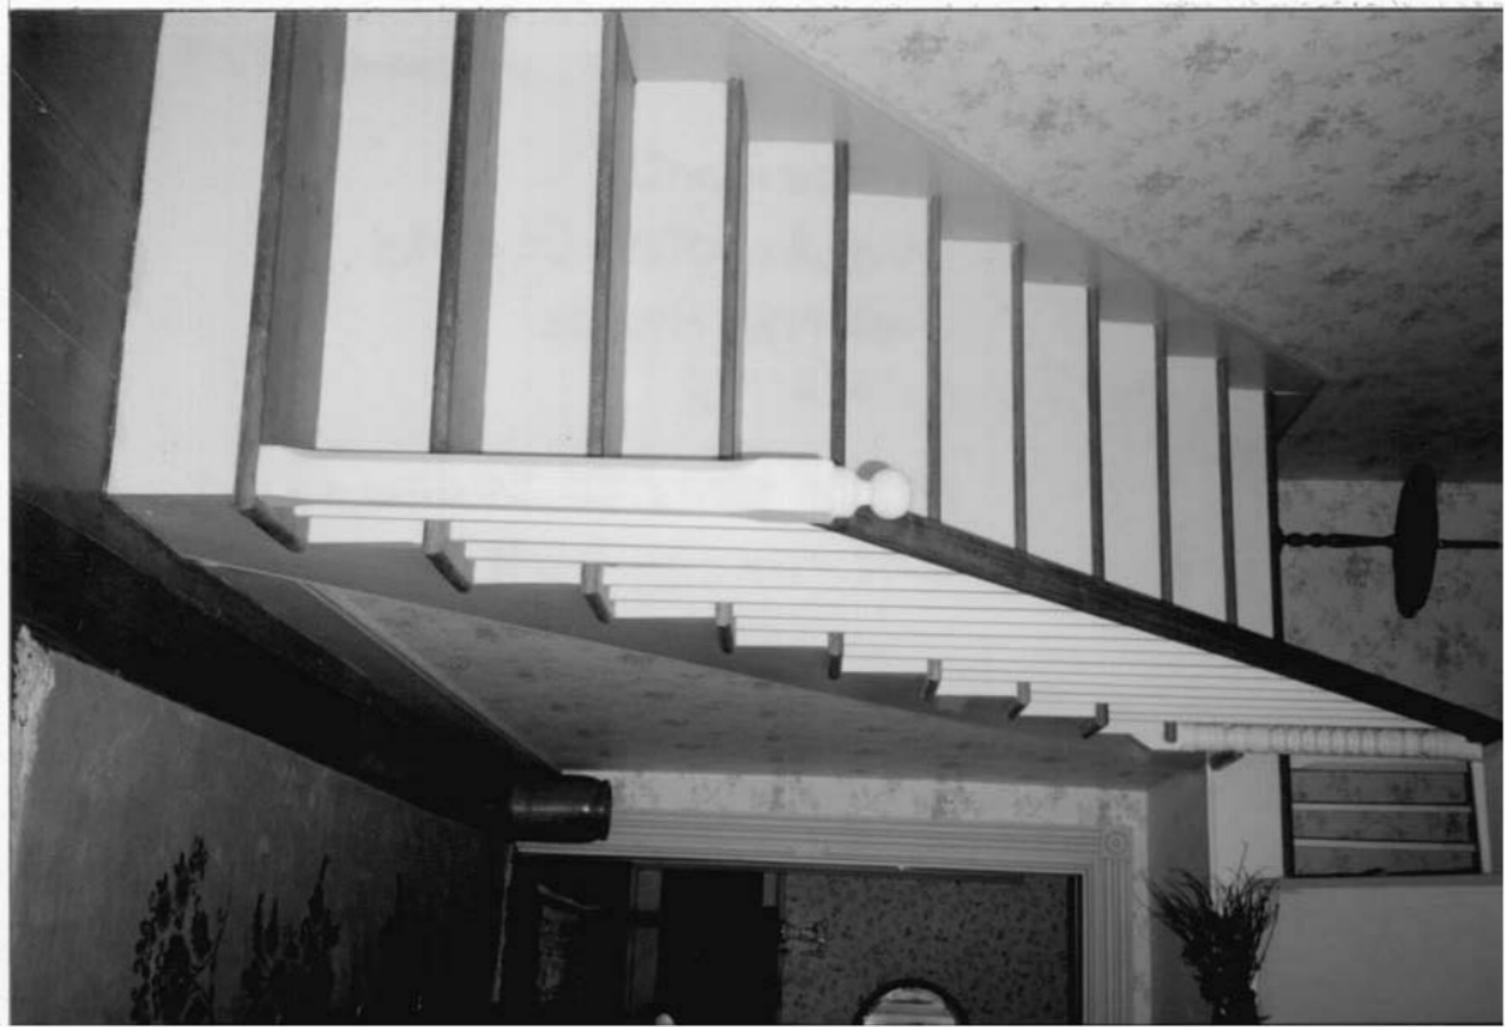
The main stairway rising along the north wall comprises square chamfered newell posts with rounded knob tops, pairs of rectangular balusters, and a rounded handrail. This stair was cut through the floorboards of the second floor, suggesting that it might be of mid-19th century construction, but not original. A fancifully turned post was added to support the corner of the attic stairs.

Front stairs to second floor
entrance hall

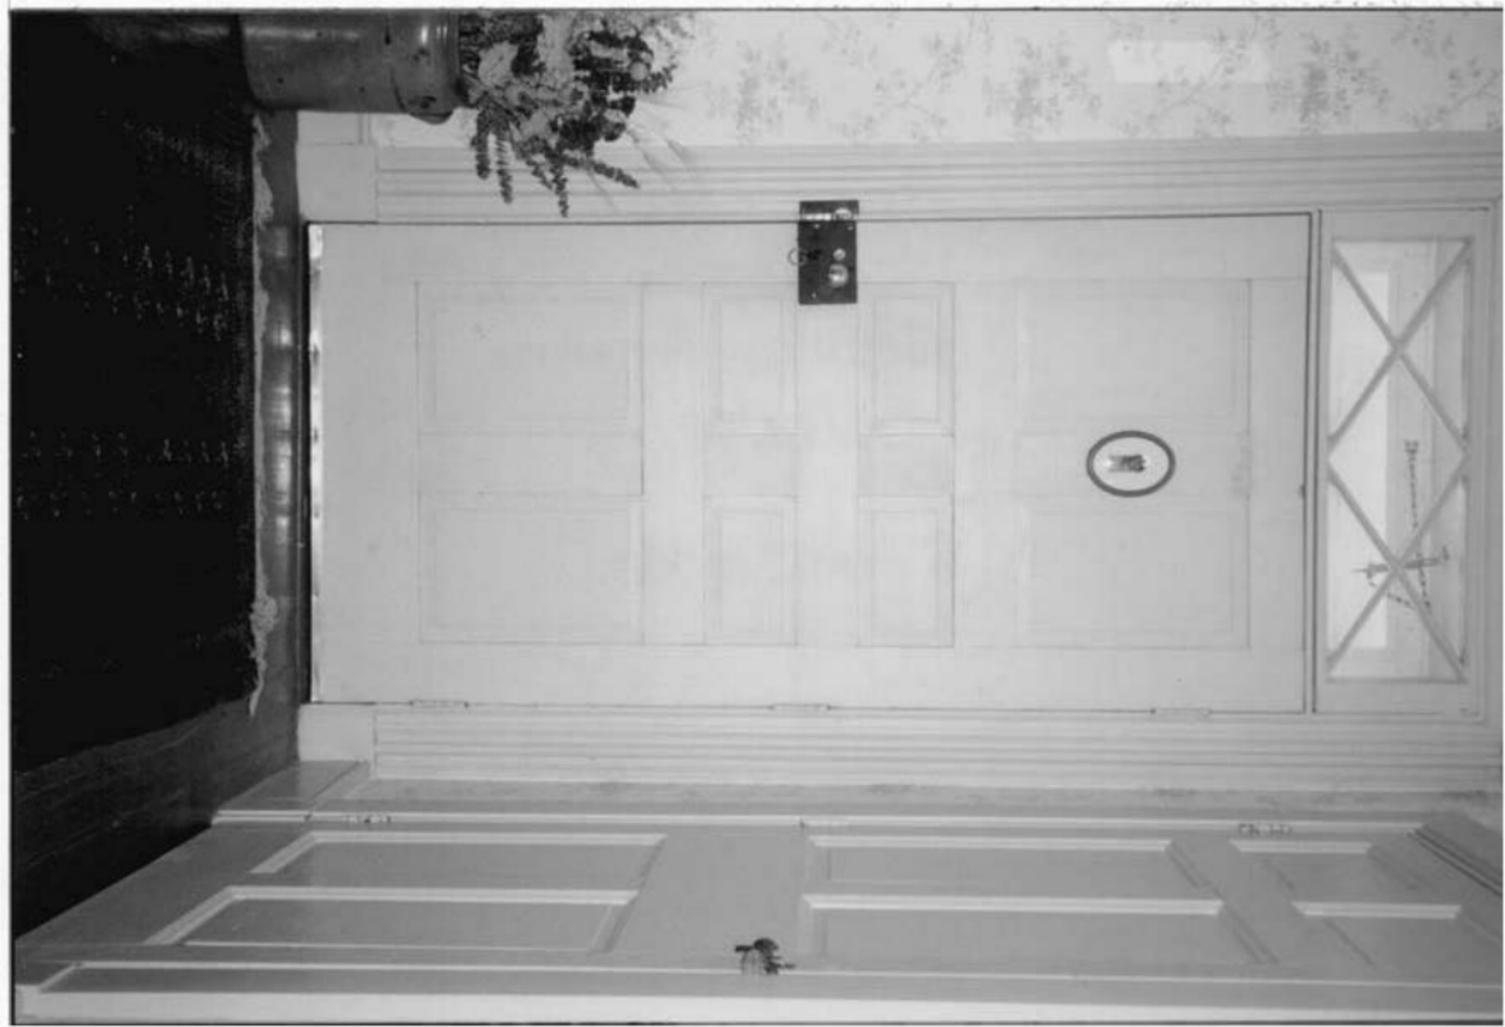
15 of 16

Rosemont's main entrance includes a transom and an eight raised panel door. This door, retrieved from a shed, has been restored to its apparent original position. Four horizontal rectangular panels in the center are adjoined by pairs of rectangular panels top and bottom.

Front door

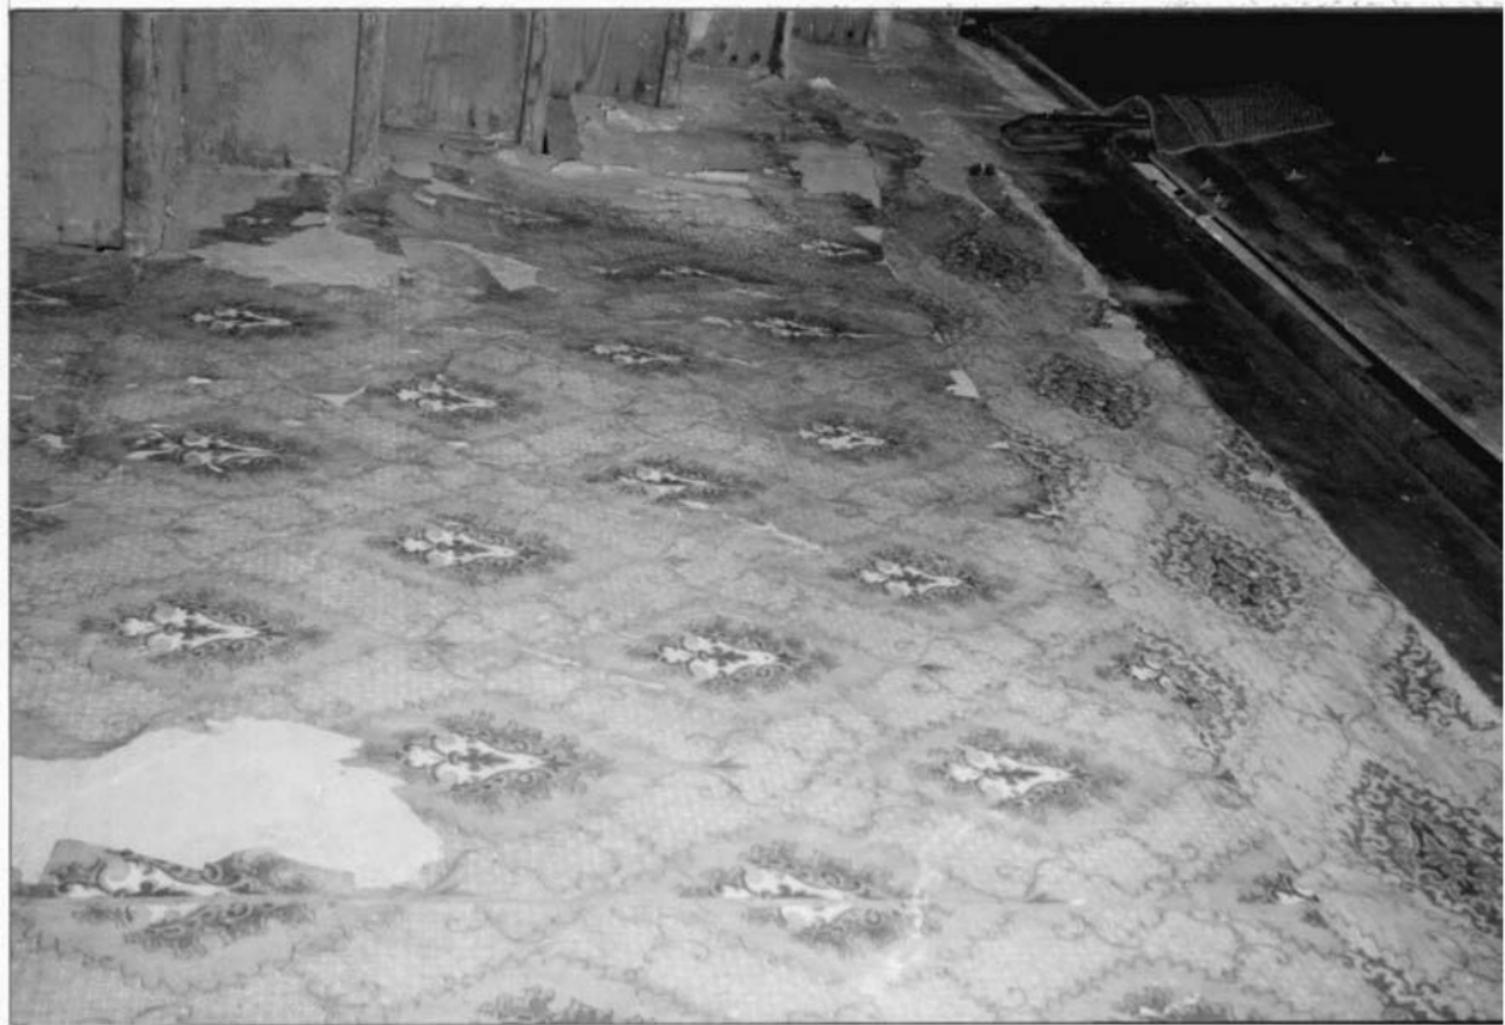
16 of 16

Both the front staircase to the attic and the rear staircase to the attic sidewalls contain several coverings of various wallpaper designs. Photographs of these coverings were provided to the Cooper-Hewitt Museum for dating. The wallpapers in the front staircase were identified as "Anglo-Japanesque" style borders meant to be cut before application-machine printed; c. 1880. The coverings in the back staircase were identified as c. 1895-1910-machine print.

Wallpaper ca 1895-1910
rear stairs to attic
