Maryland Historical Trust State Historic Sites Inventory Form

Survey No. WA-II-1127

historic ROSEMONT

street & number 8105 Sharpsburg Pike not for publicationcity, town Fairplay vicinity of congressional district 6th

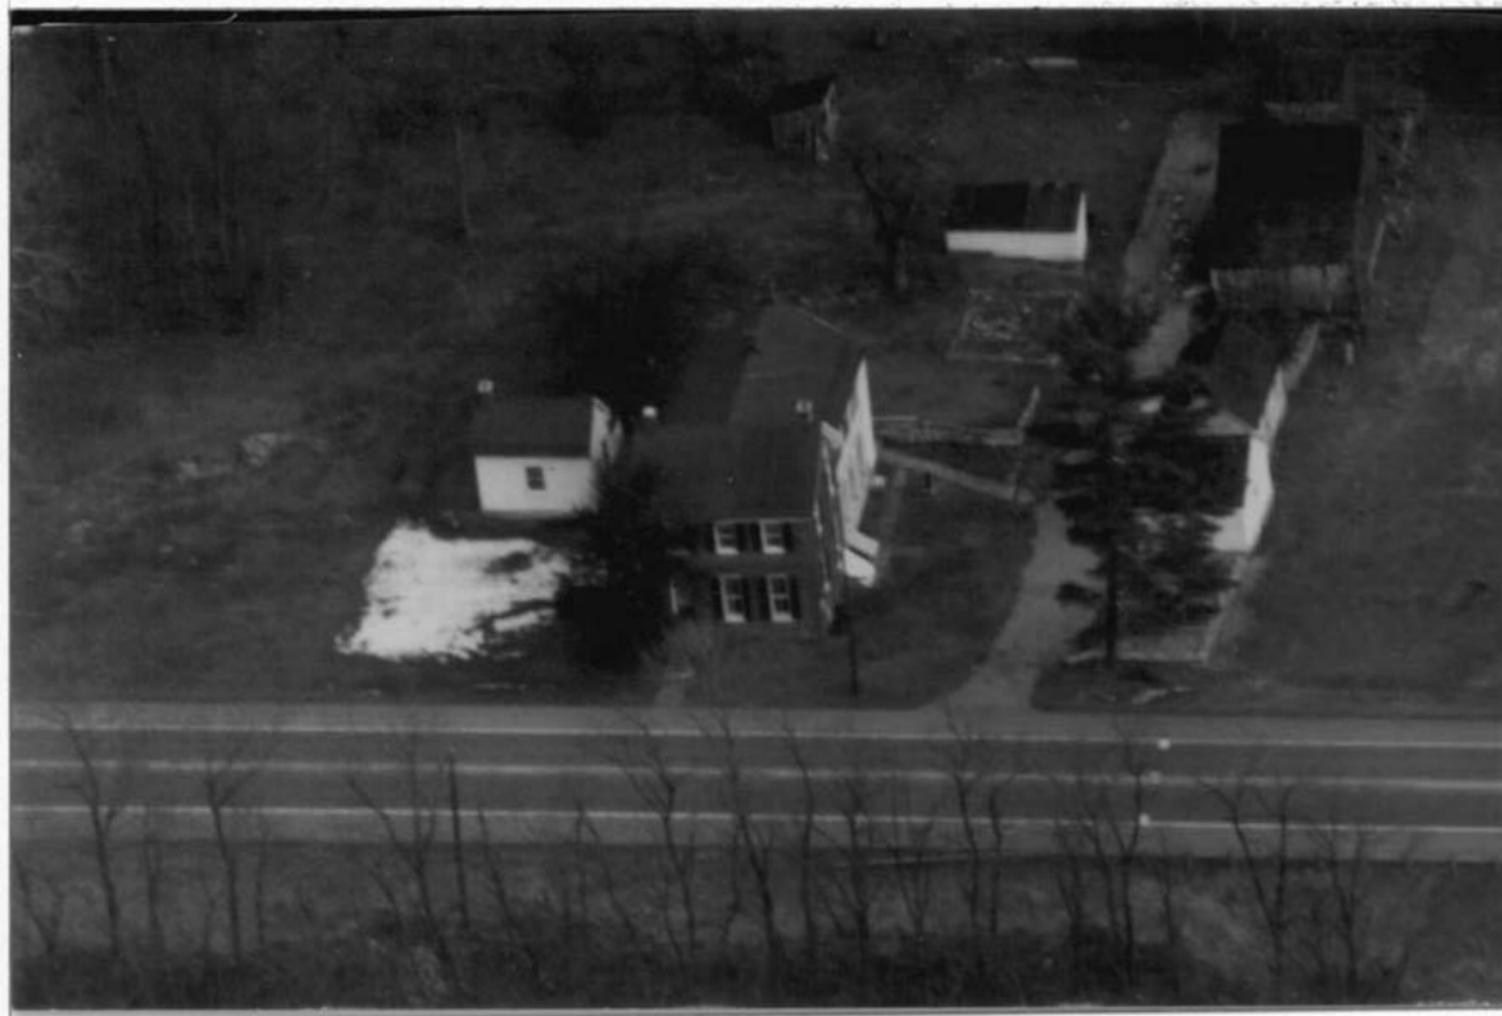
PHOTOGRAPH WAS TAKEN IN JANUARY, 1991. WHILE IT DOES NOT COMPLY WITH THE GUIDELINES FOR SUBMITTING PHOTOGRAPHS, IT IS SUBMITTED BECAUSE IT PROVIDES A VIEW OF THE PROPERTY KNOWN AS ROSEMONT PRIOR TO ITS RESTORATION.
