Maryland Historical Trust State Historic Sites Inventory Form

and/or common Helen Spiker Log House

Survey No. UA-II-473

WA-II-473
Greenbrier St. Park
DNR # 14 & 16

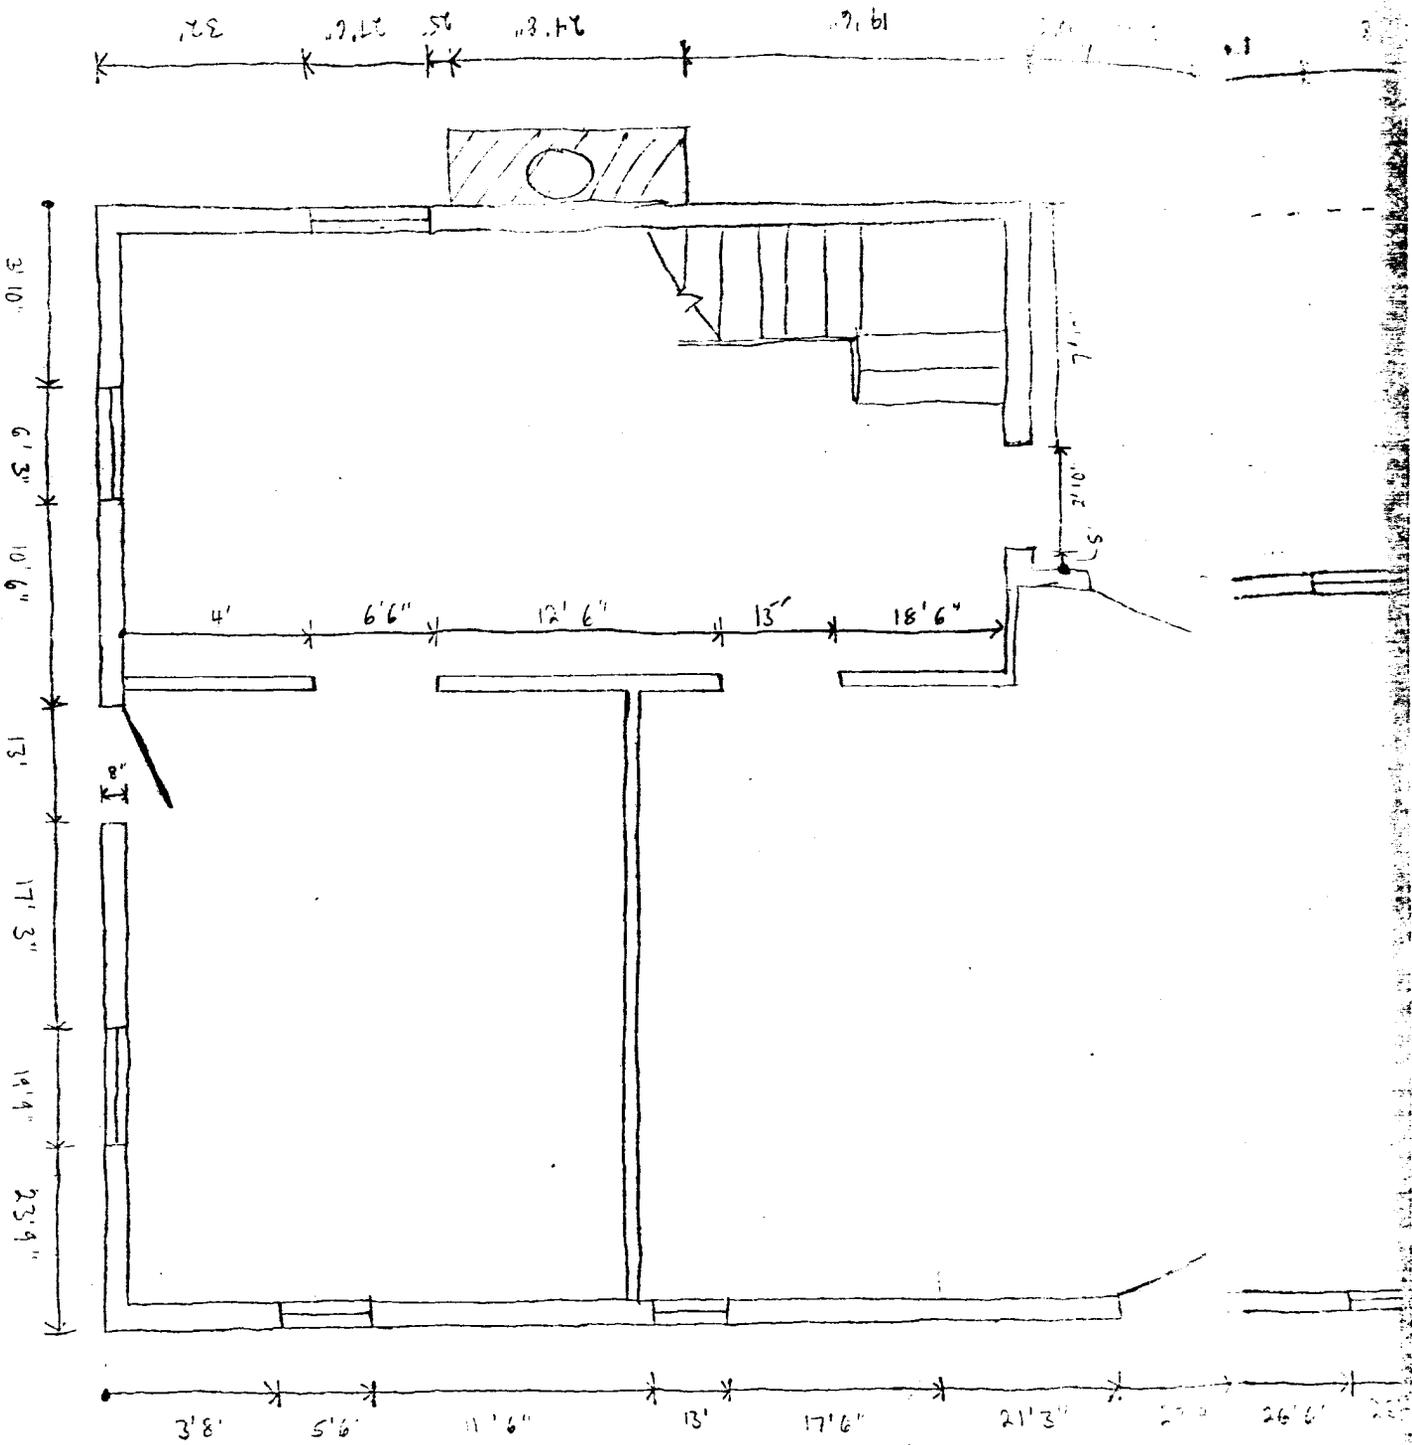
SPIKER LOG HOUSE.

The interior floor plan consists of three rooms with the stairs in the south room. The stairs are located in the southwest corner of the room and have a rounded ~~newel~~^{newel} post with square balusters. The stairs have serpentine stair ends. This south room provides ^{ac}~~ex~~cess to the other two rooms as the partition wall between the two northern rooms does not contain a doorway to provide direct access between those two rooms.

logs tie-in
from rear wall

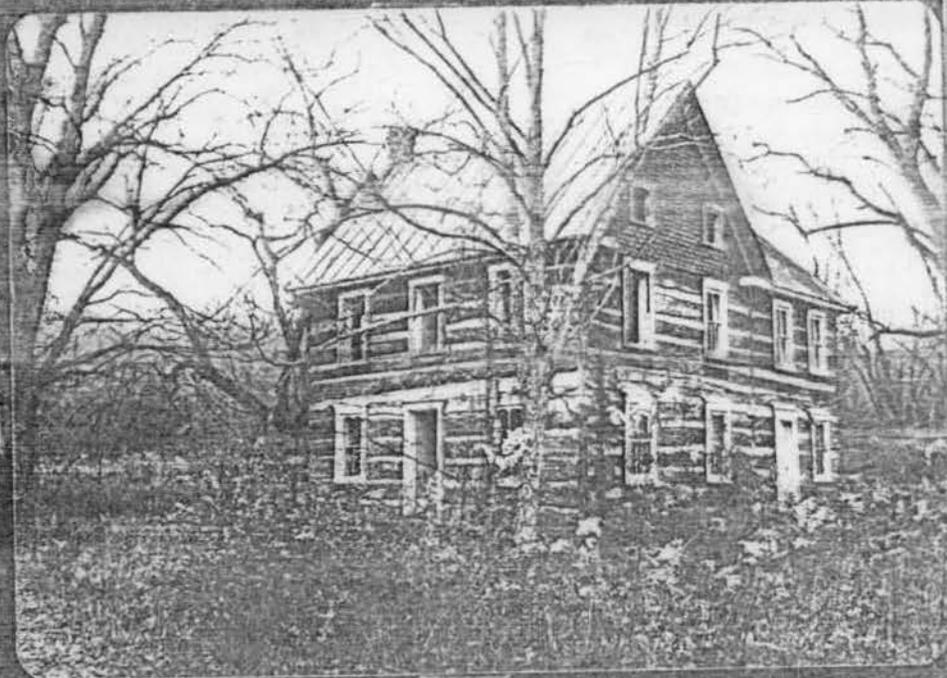
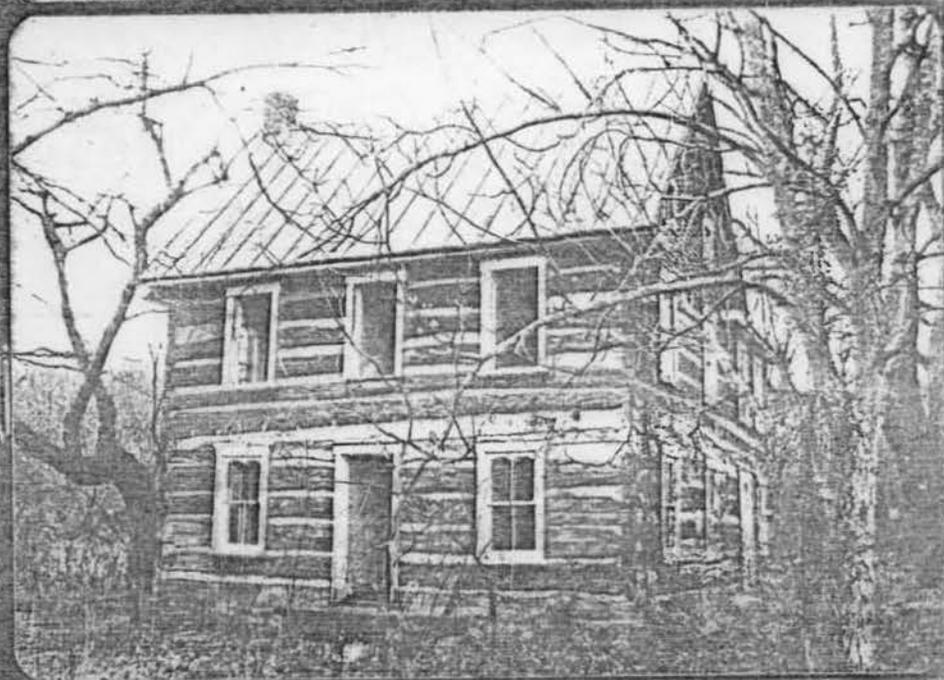
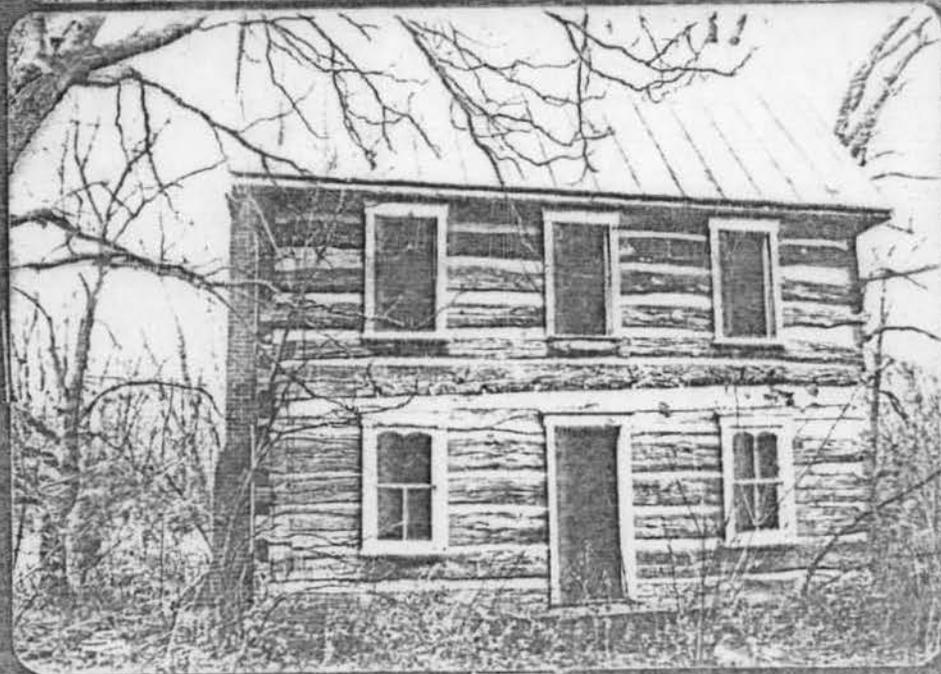
WA-II-473 Helen Spiker Log House
top - East & North Facades
center - " "
bottom - East Facade

The Helen Spiker Log House is a two-story, three-bay by two-bay structure with a two-bay ell. The main facade faces east and has a central entrance with two-over-two sash windows in the outer bays of the first story and three bays in second story. The window and door frames are set out from the log providing evidence that the log was once covered in weatherboard siding that has been removed from the structure. The logs are V-notched at the corners and have wide spaces filled with stones, woodchips, and mortar. The structure sits on a stone foundation that is partially collapsed. It has a steep gable roof covered in sheet metal.

The north facade has an entrance in the easternmost bay of the ell. Two-over-two sash windows^{are} on the other three bays of the first story and the four bays of the second story. The gable is covered in asphalt shingles and has two small windows. The box cornice returns at the gable end. The south facade has an early twentieth century brick chimney centrally located with a basement entrance running below the chimney. Two-over-two sash windows are located one on each story and the gable ornamentation is identical to the north gable end. The ell on the south side has a double-tiered porch that is falling down. The porch has an entrance and a window leading to it on each floor. The west gable end has a early twentieth century chimney and a single window on each story.

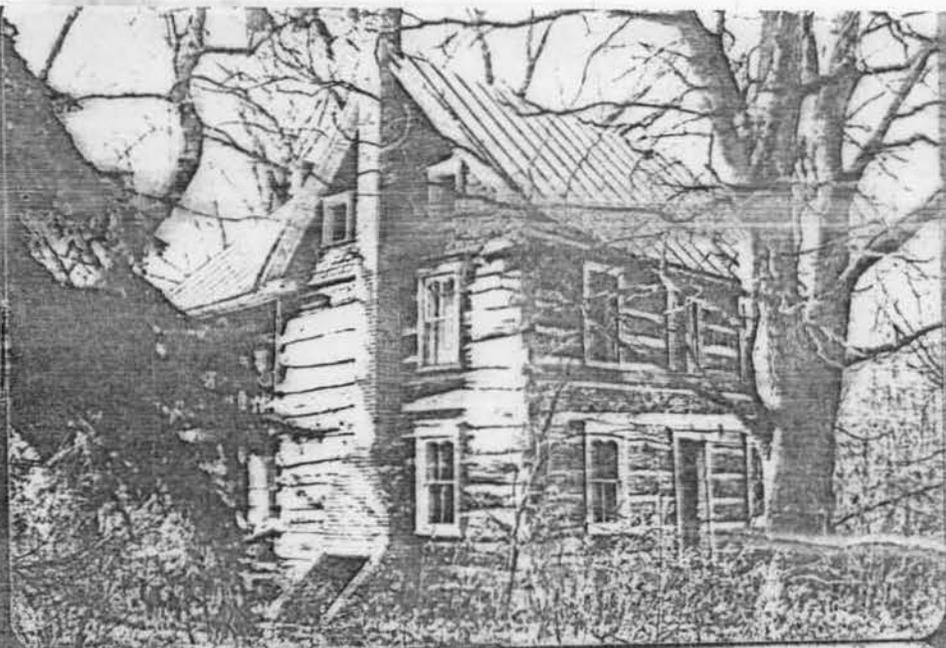
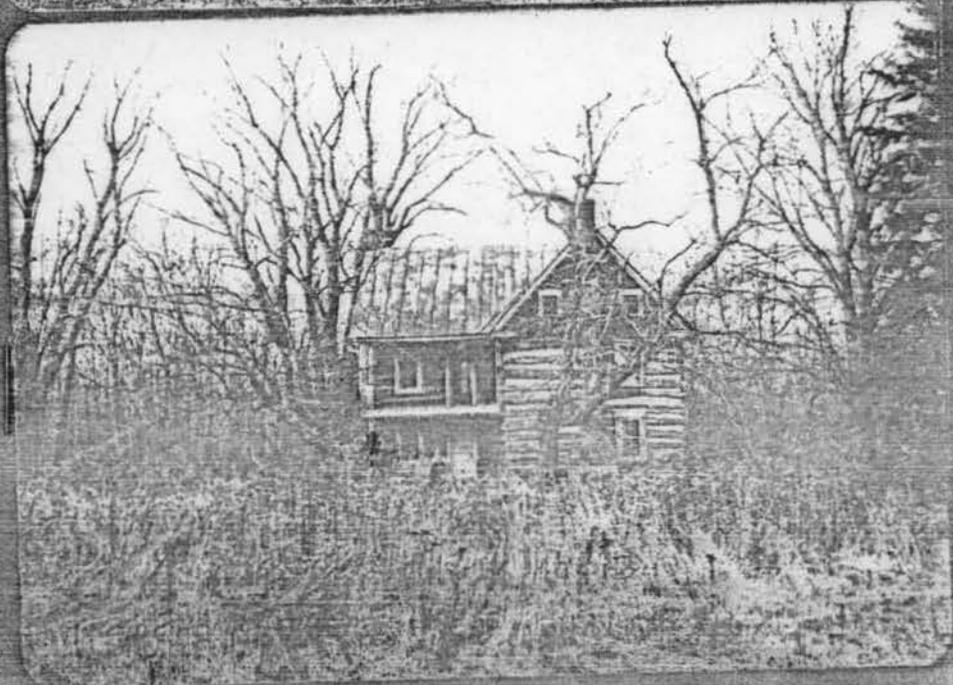
WA-II-473 Helen Spikes log House

top - East + South Facades

center - South Facade

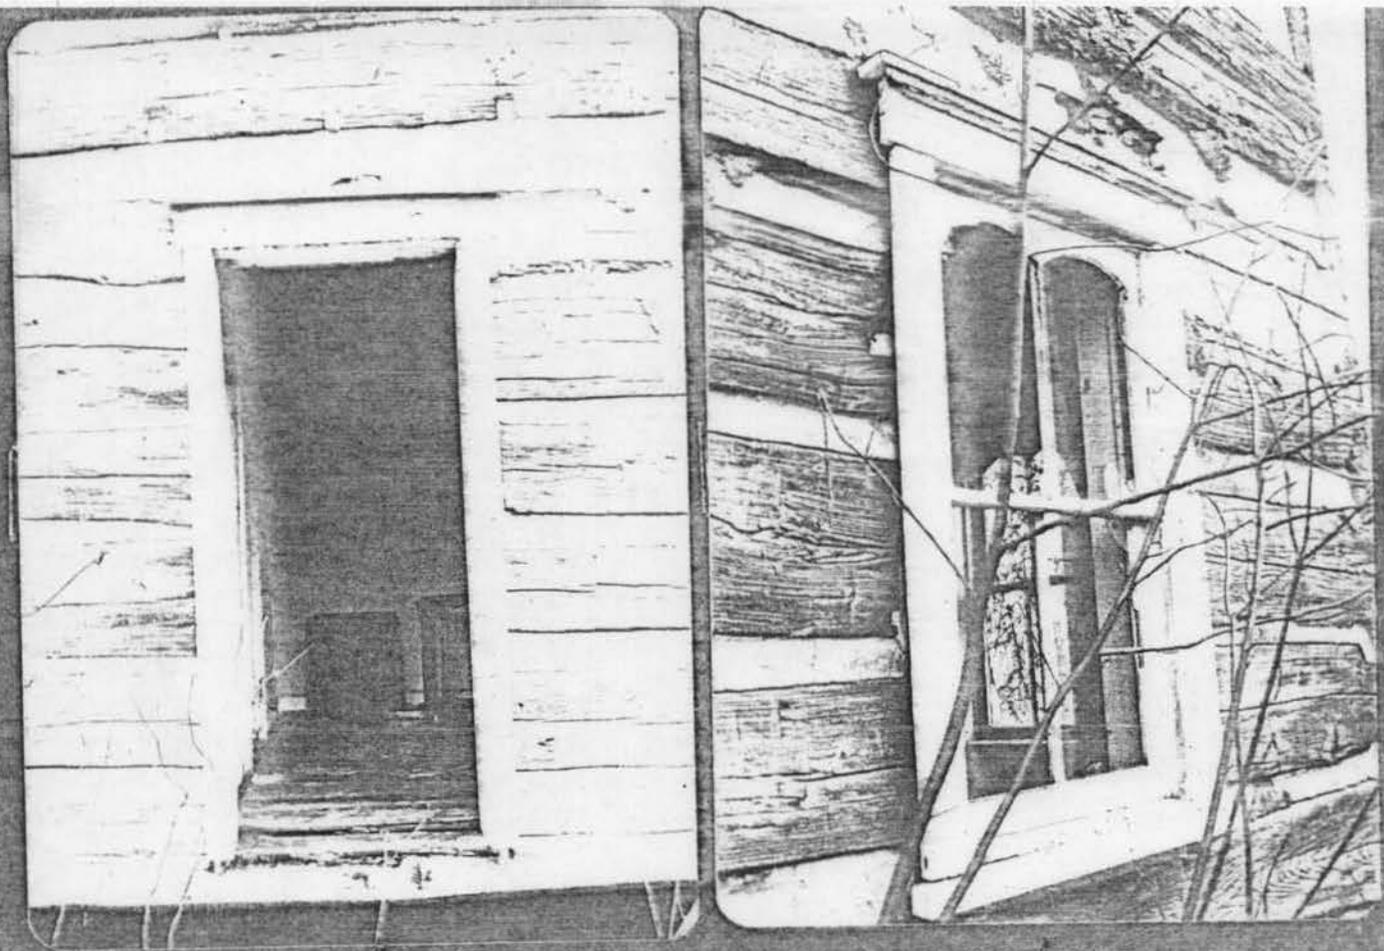
WA-II-473 Helix Spiker Log House
right. - Window frame
left - Door frame

The basic element of ornamentation to the structure are the door and window frames. They are relatively unelaborate with board frames consisting of a band of beading down the center in a serpentine-molded top. The sash is two-over-two sash with the upper sash consisting of wood arches on each pane. The arched upper sash was a popular technique in this section of Washington County.

The Spiker house does show an influence of late nineteenth century domestic architecture in its window frames. The frames are constructed of a mass-produced board frame with beading down the center of the board. The window sash uses a popular Victorian style with the two upper panes having round-arches. The gable end windows have a similar arrangement consisting of two pane windows with each pane having an arched top. This style of window sash was particularly popular along the eastern section of Washington County.

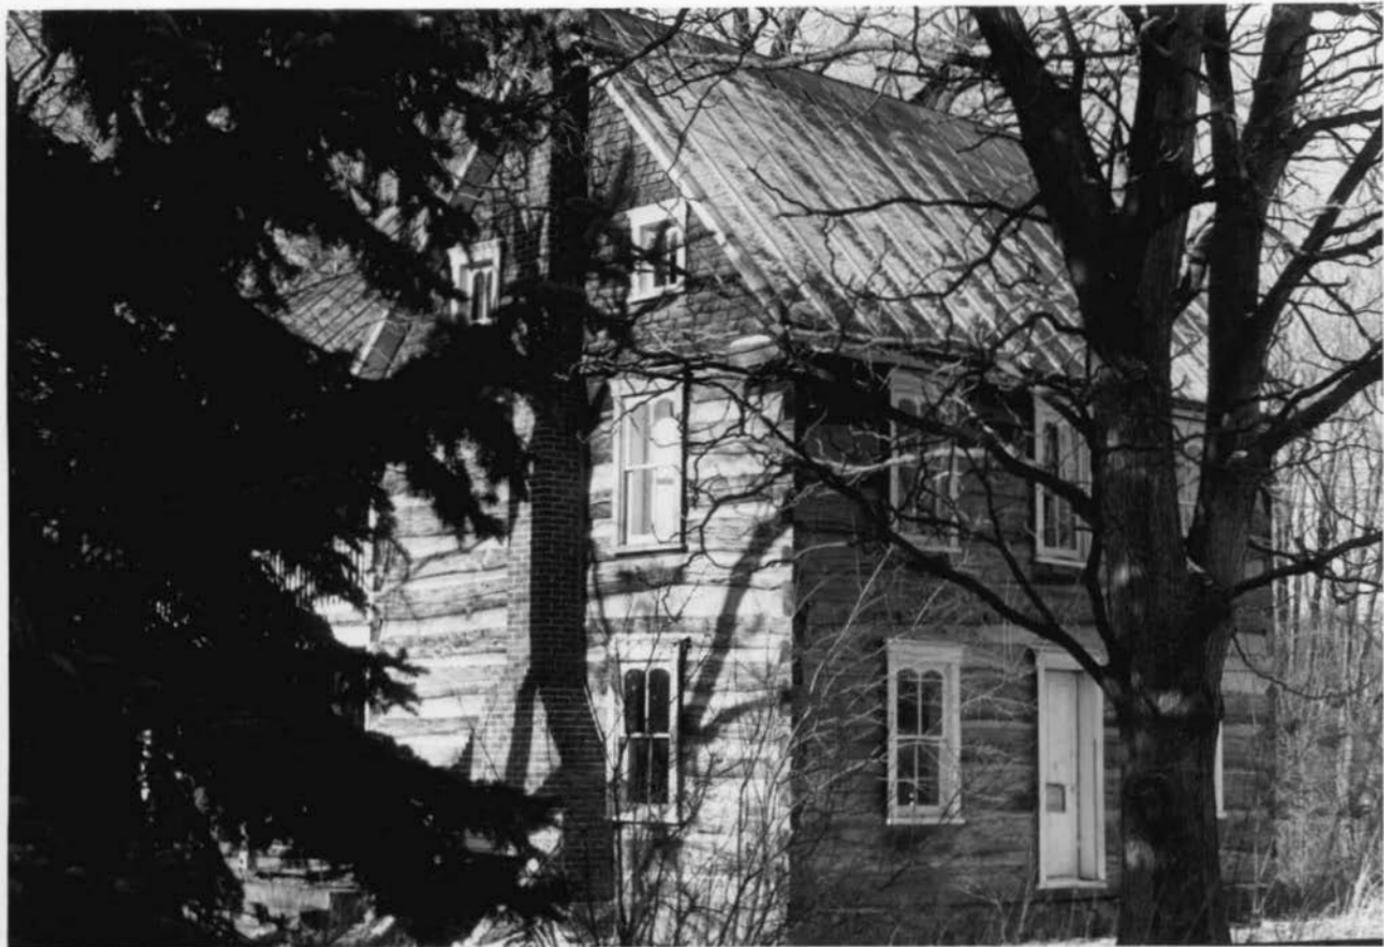
S.W. view

The house is a two story, three bay L-shaped log building resting on stone foundations. The wall construction is exposed and weathering of the logs suggests that they have been uncovered for some time. Window and door trim is set out ~~to receive~~ to receive siding. The logs are hand hewn and display inverted "V" notching at the corners. *It is likely that the logs were sided originally*

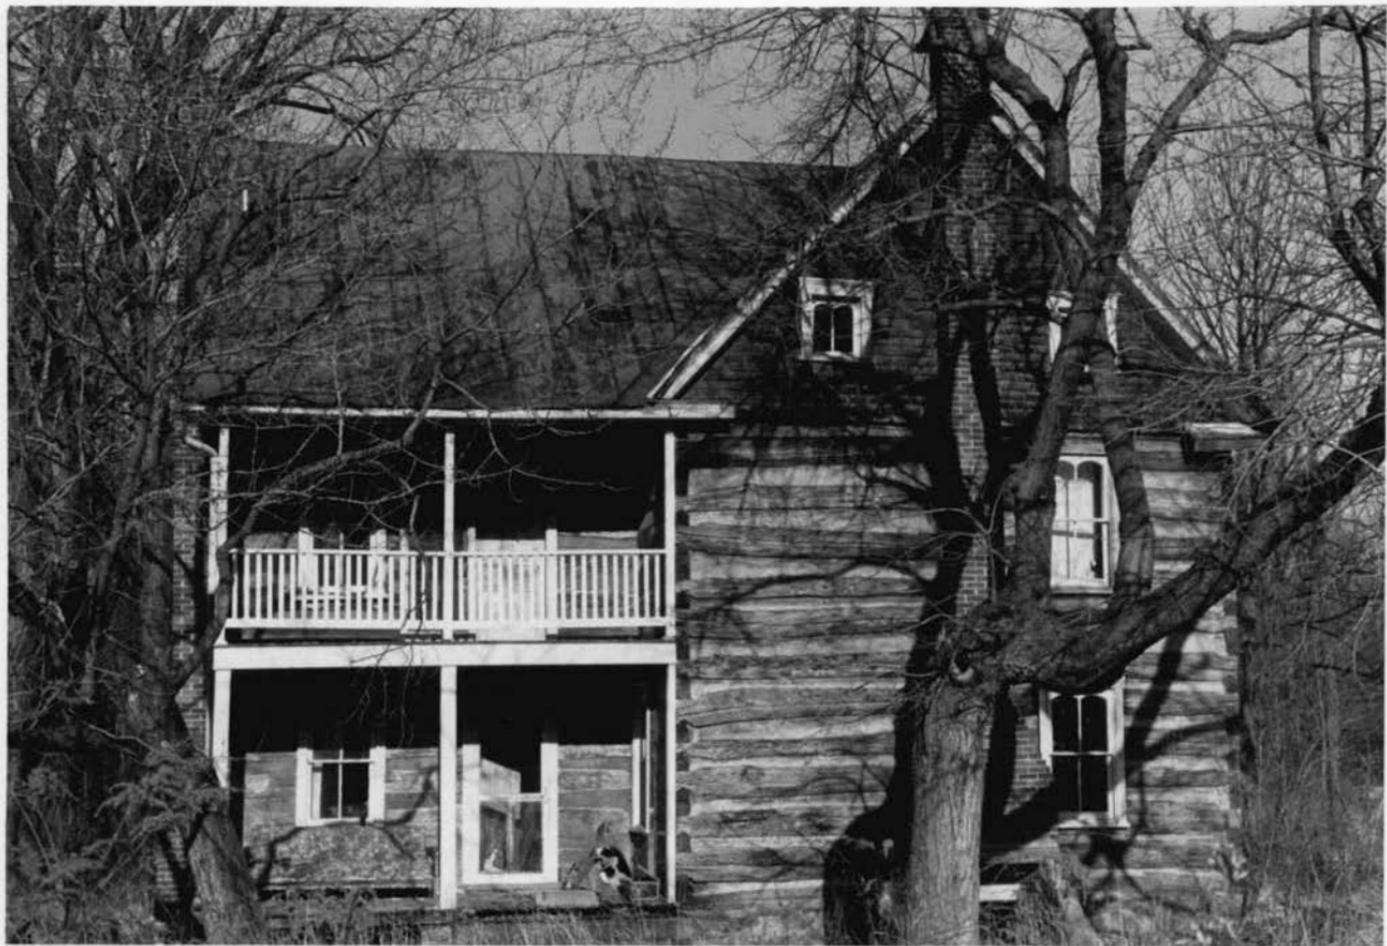
W. View

The gables of the house are sheathed with asphalt shingles. Twentieth century exterior brick chimneys are located against the south end wall and the east end wall. The roof is covered with standing seam sheet metal.

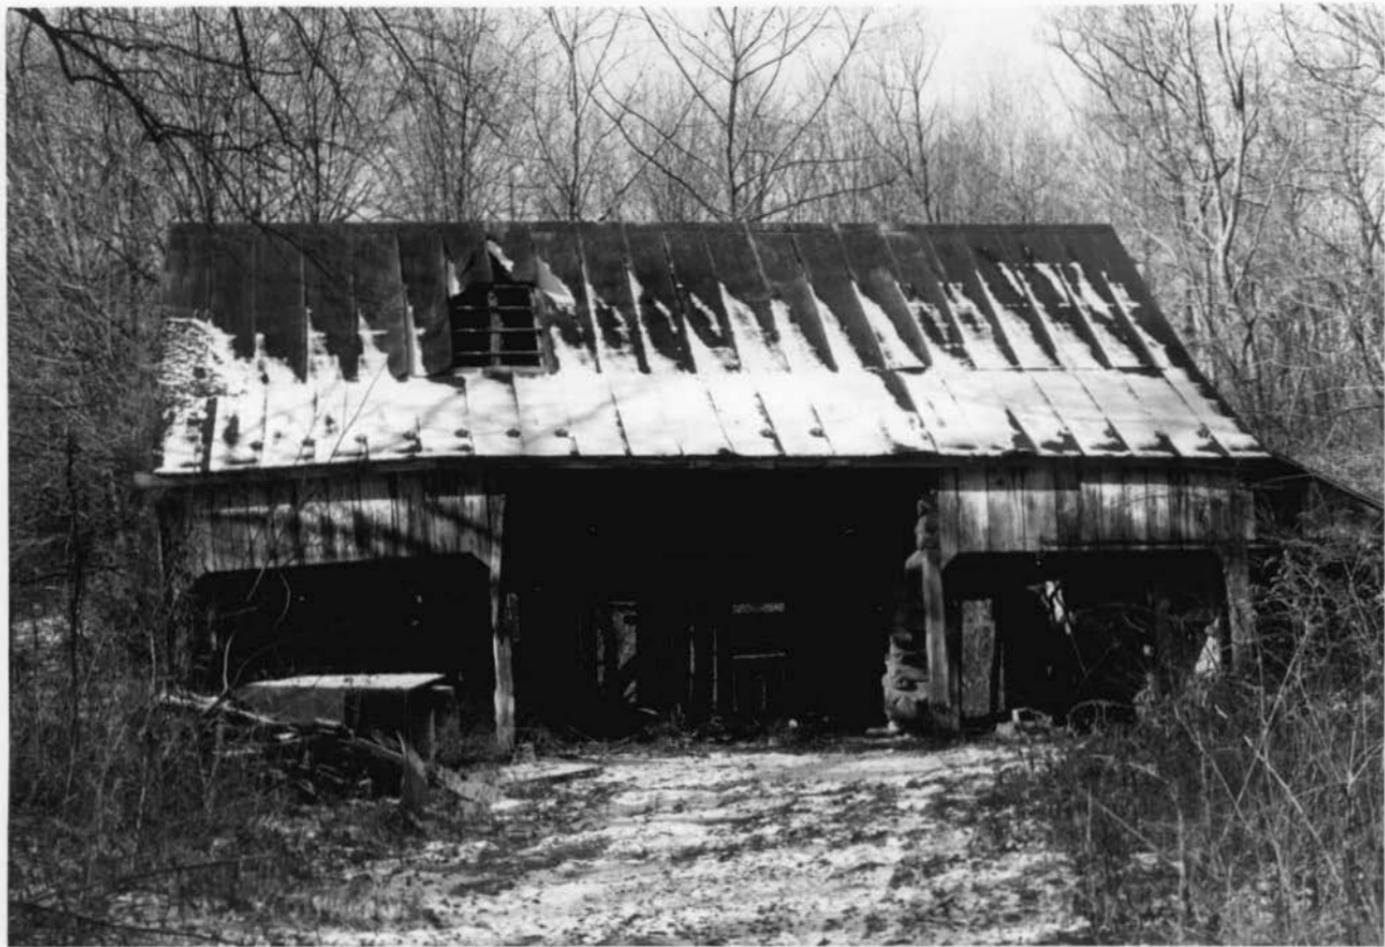
WA-II-473
Greenbrier State Park
Barra - W. View
Jan. 1978

West of the house is a two pen log barn constructed of round logs some of which still retain their bark. The barn also has a log forebay supported by massive wooden posts. The bark roof is of corrugated sheet metal which is missing in some areas. The barn is in deteriorated condition but is salvageable.
