**MARYLAND HISTORICAL TRUST  
DETERMINATION OF ELIGIBILITY FORM**

Property Name: Brick Veneer House Inventory Number: WA-II-481  
 Address: 8714 Sharpsburg Pike City: Fairplay Zip Code: 21733  
 County: Washington USGS Topographic Map: Funkstown (1953, rev. 1971)  
 Owner: Genevieve McNamee et al Is the property being evaluated a district? \_\_\_yes  
 Tax Parcel Number: 90 Tax Map Number: 62 Tax Account ID Number: 008066  
 Project: Intersection Improvements, MD 65 and MD 68 #WA142A21 Agency: Maryland State Highway Administration  
 Site visit by MHT Staff: X no \_\_\_yes Name: \_\_\_\_\_ Date: \_\_\_\_\_  
 Is the property located within a historic district? \_\_\_yes X no

WA-II-481      Brick Veneer House

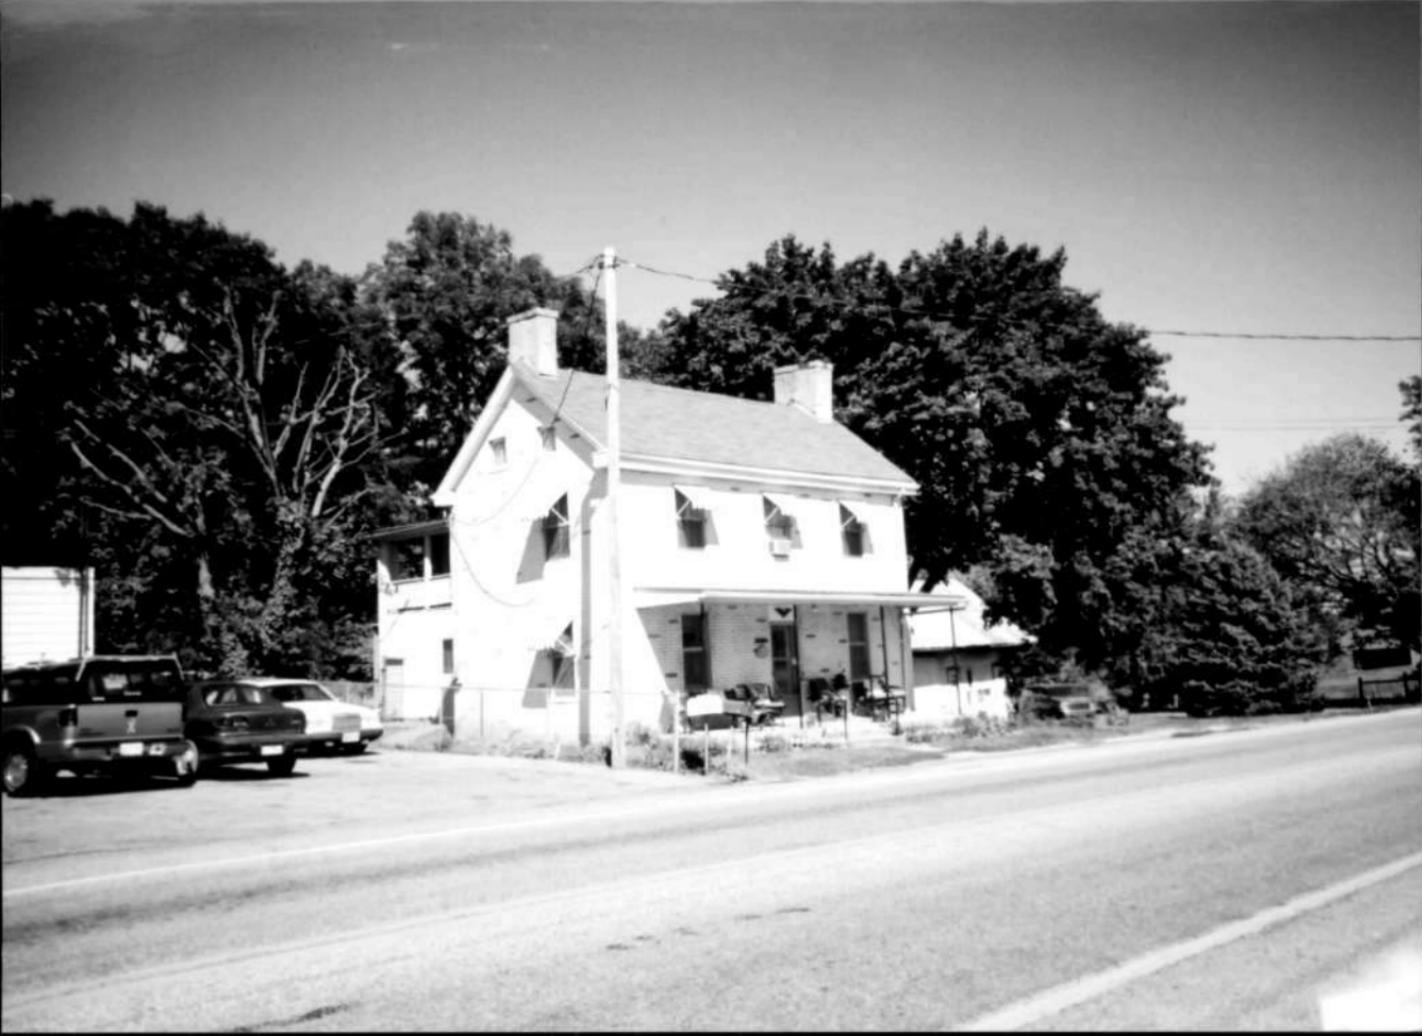
<No. 2A> B&WMC

This house has been extensively altered on the exterior, although it retains its original massing largely intact. The exterior is currently covered with a non-historic beige-colored brick veneer which dates from the mid-20<sup>th</sup> century period. The full-length 1-story porch on the east façade is not original and most probably replaced an earlier porch. Window sash on the first story of the east façade are not original, as are the metal awnings that top most of the house's windows.

LOOKING NW FROM ROAD

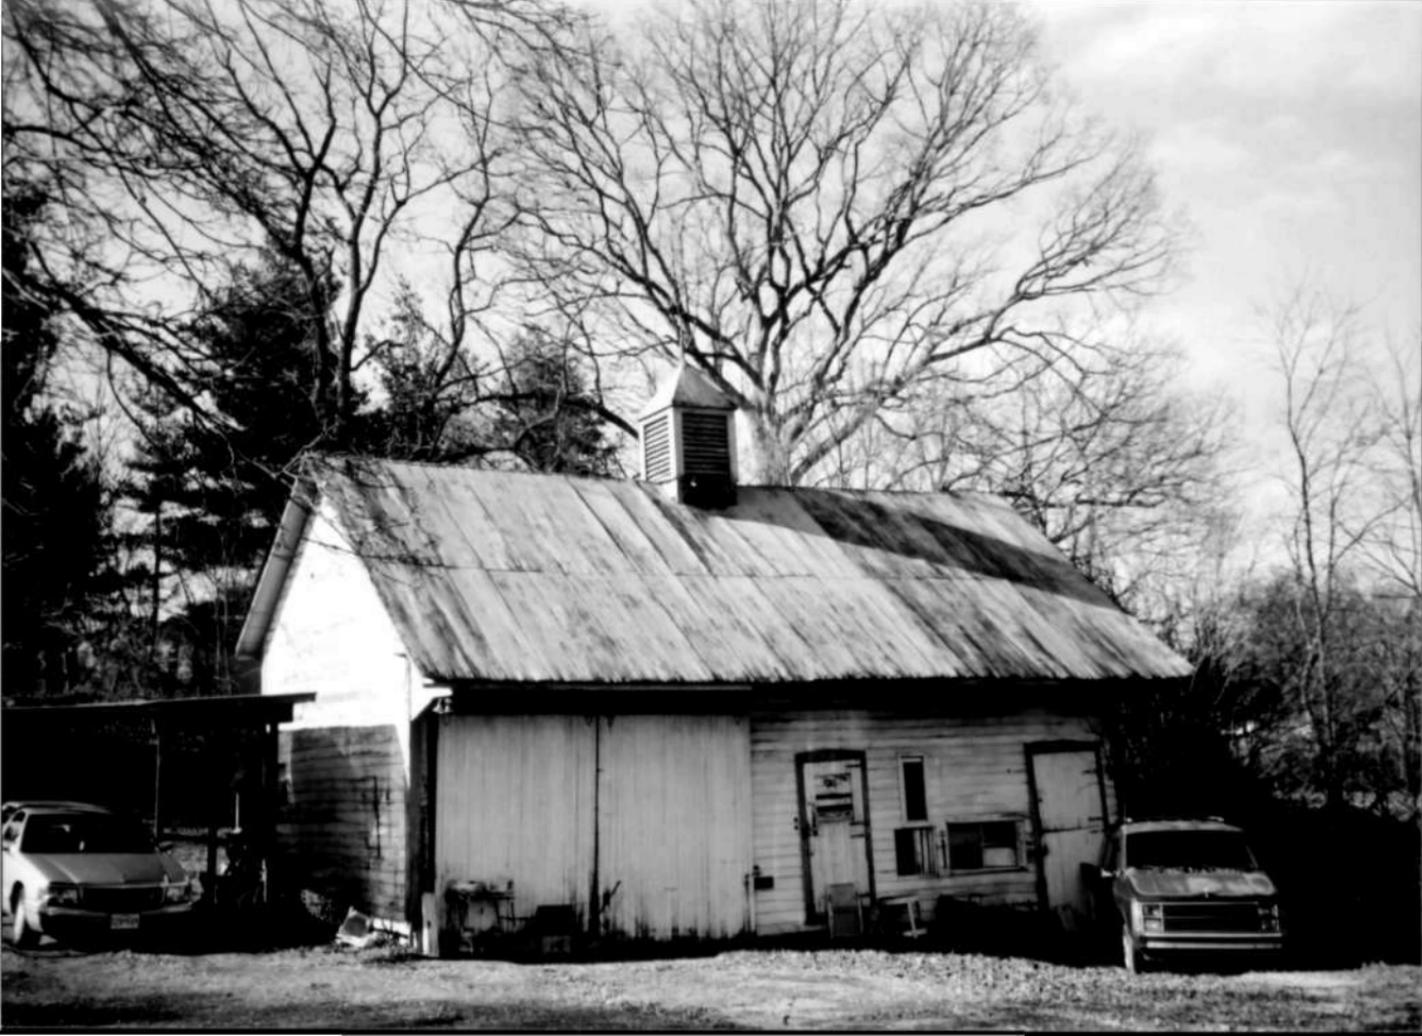
<No. BA> B&WMC

FAIRPLAY, WASHINGTON COUNTY  
CARRIAGE HOUSE, LOOKING WEST

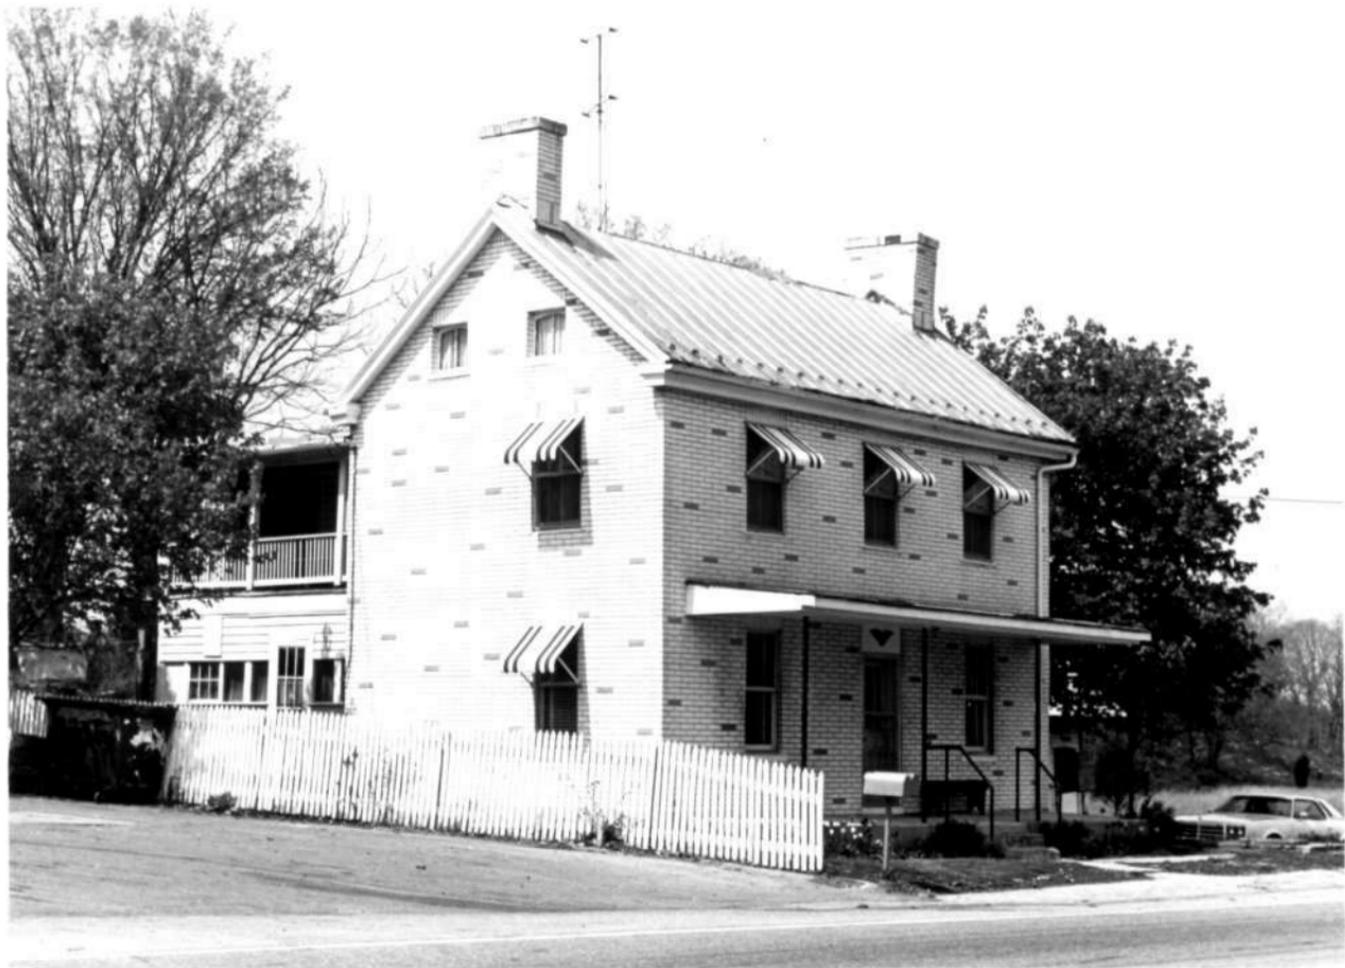
This house is a three-bay by one-bay house that appears to have been built in the late 19th century. It was remodeled in mid-20th century with a mult-colored brick veneer. The brick work is done in the beige brick with an occasional brown brick inserted in the stretcher bond pattern. The full-length one-story porch on the main facade is from the period of the remodeling as are the white and brown stripped aluminum awnings. Other elements of the house that appears to be late 19th century are the metal gable roof and the ell with a two-story porch on the inside of the ell.

1. Brick Veneer House           WA-II-481
2. Washington County, Maryland
3. Joe Getty
4. May 1983
5. Maryland Hist. Trust, Annapolis, Md.
6. South & east elevations; camera facing  
northwest
7. 1/1
