WA-II-486      Frame House

Late-19th century

Lappans

# Maryland Historical Trust State Historic Sites Inventory Form

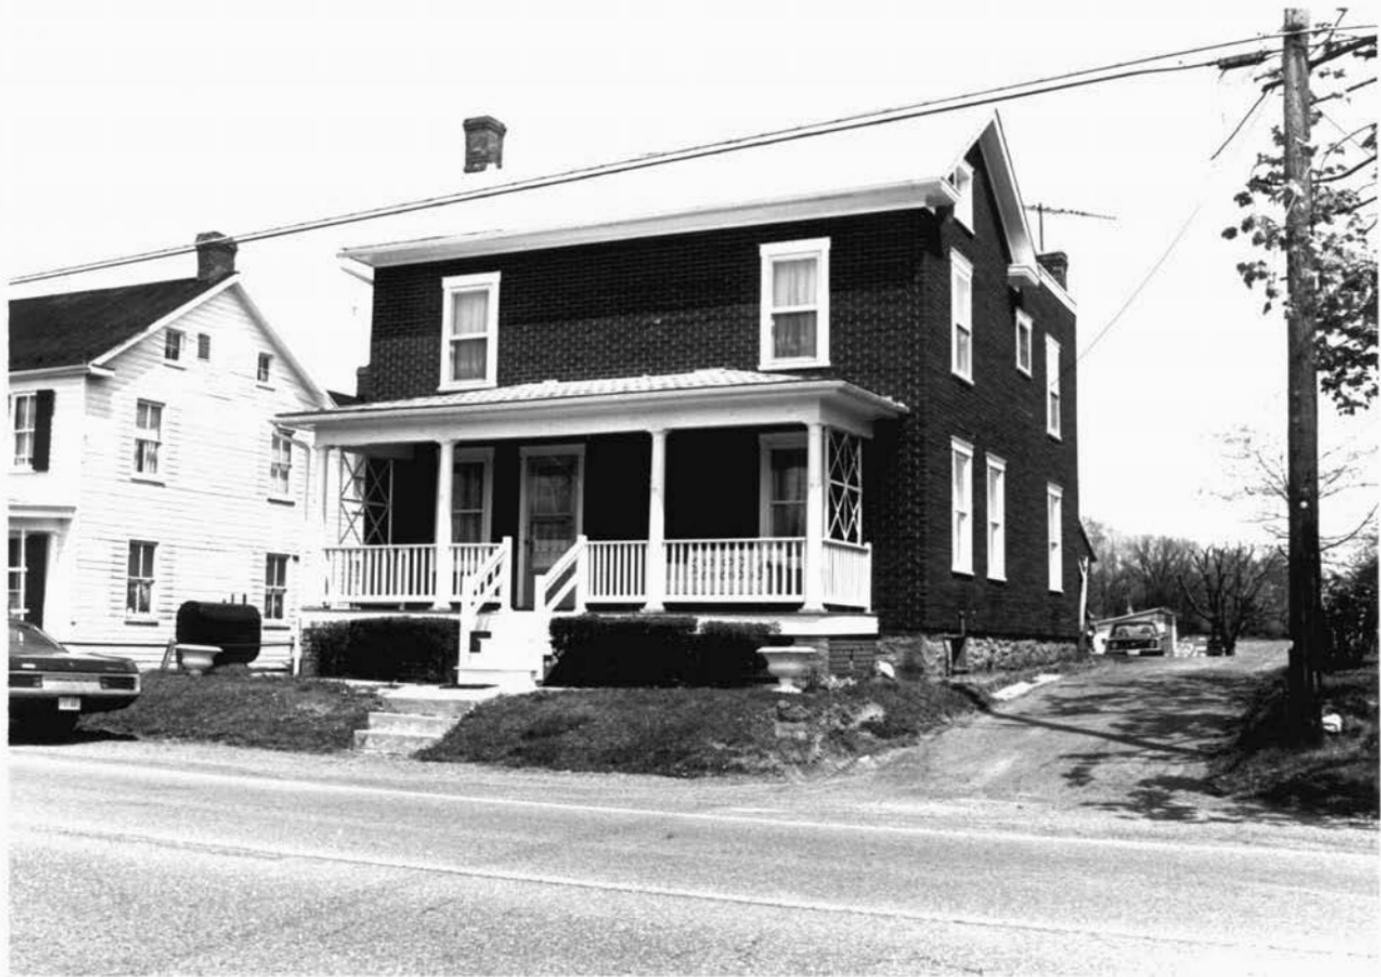
1. Frame House           WA-II-486
2. Washington County, Maryland
3. Joe Getty
4. May 1983
5. Maryland Hist. Trust, Annapolis, Md.
6. West & south facades; camera facing  
northeast
7. 1/1
