WA-II-490 Frame House

Maryland Historical Trust State Historic Sites Inventory Form

Survey No. WA-II-490

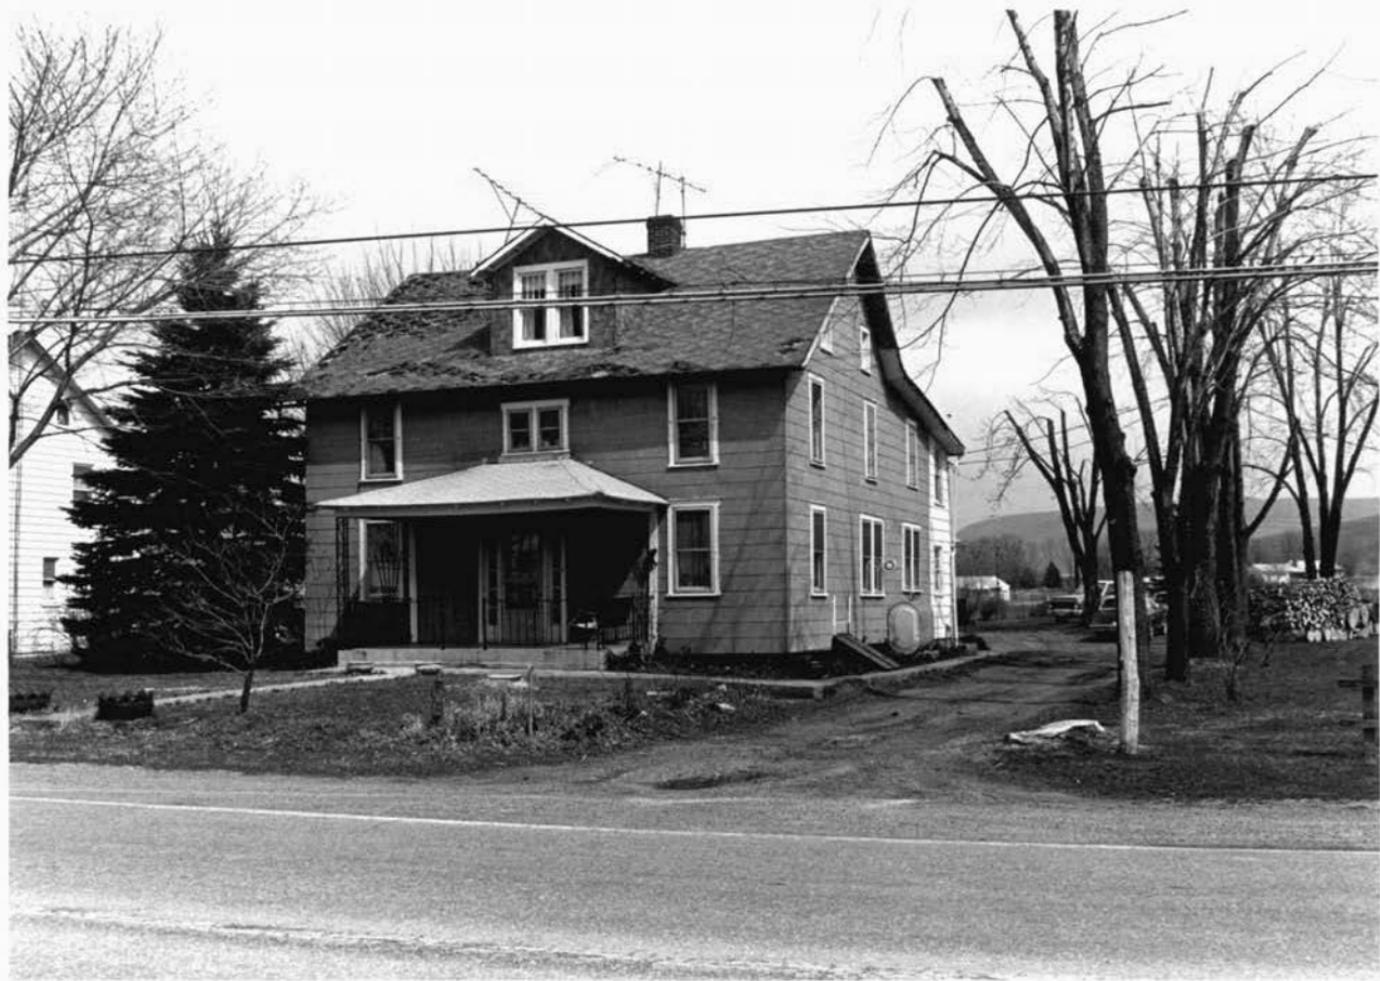
1. Frame House WA-II-490
2. Washington County, Maryland
3. Joe Getty
4. May 1983
5. Maryland Hist. Trust, Annapolis, Md.
6. West & south elevations; camera facing
northeast
7. 1/1
