WA-II-493      Frame House

# Maryland Historical Trust State Historic Sites Inventory Form

Survey No. WA-II-493

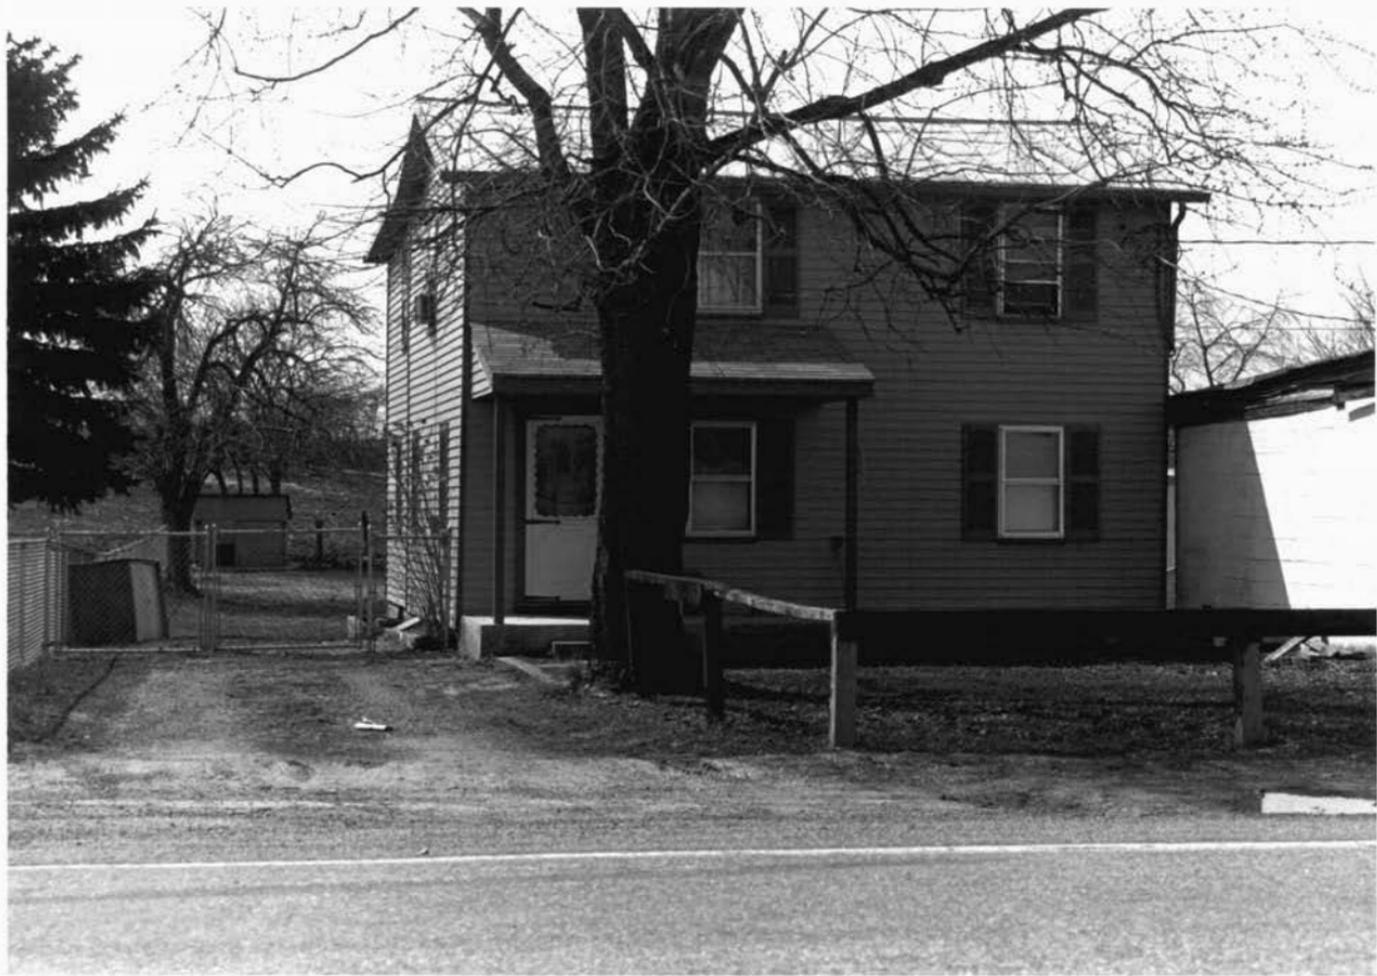
1. Frame House            WA-II-493
2. Washington County, Maryland
3. Joe Getty
4. April 1983
5. Maryland Hist. Trust, Annapolis, Md.
6. East elevation; camera facing west
7. 1/1
