Survey # WA-II-987                      Approximate date ca. 1925-30  
Street Address 76 North Main Street  
Town, State Keedysville, Maryland  
private X, public

Description

MARYLAND COMPREHENSIVE HISTORIC PRESERVATION PLAN DATA

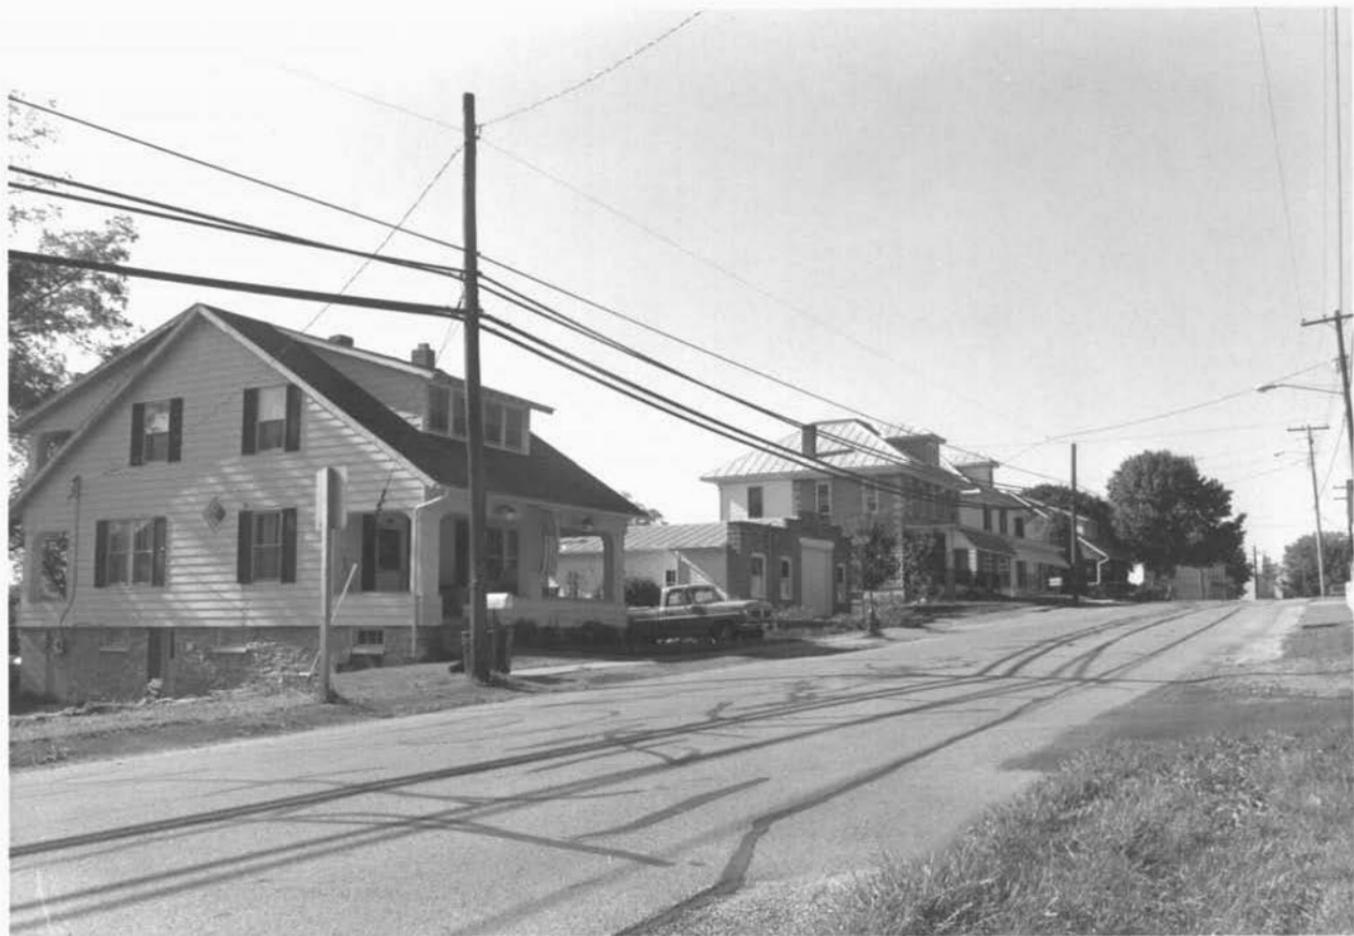
#6

Typical of the 1925-30 period is this aluminum sided frame bungalow, said to be a Sears catalogue house. It is a one-and-a-half story structure with a deep porch beneath an overhang, and shed-roofed dormers front and rear. The porch columns are stuccoed and may indicate the original finish of this house. A small frame garage with bi-fold doors is located behind the house.

76, 74, 72, 70 N. Main St., Keadysville, MS  
SE view, N + W elevations
